RI 9660 REPORT OF INVESTIGATIONS/2003

Evaluation of Systems to Monitor Blind Areas Behind Trucks Used in Road Construction and Maintenance: Phase 1

Todd M. Ruff

February 2003

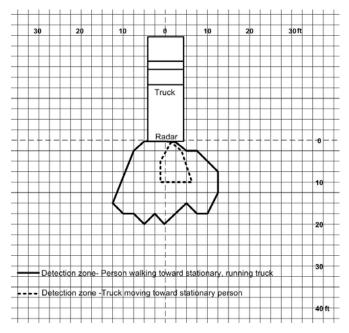
Figure 5.—Detection zones for person and Guardian Alert radar system.

To determine the detection zone of a person, the test subject walked toward the rear of the truck and recorded where reliable detection occurred. The detection zone for a person with a stationary truck is shown by the solid line in figure 5. The total

Significant differences in the detection zone were seen when tests were conducted with the truck moving in reverse. The dashed line of figure 5 shows the detection zone for a person standing still and facing the radar while the truck moved slowly (3-5 km/hr [2-3 mile/hr]) in reverse. The range of the system decreased to approximately 3 m (10 ft), and the width no longer covered the width of the truck. An exact reason for this decrease in the detection zone was not found, but the manufacturer suggested the cause could be vibration or moving at a speed too slow for reliable detection (Guardian Alert, 2000). However, tests conducted by moving at the same reverse speed toward other objects, such as a building or vehicle, did not show the same decrease in detection. It is suspected that a combination of slow reverse speeds and the smaller radar cross section of a person contributed to the decrease in the detection zone.

Several different mounting locations were tried to determine if the detection zone could be improved for a moving truck. The radar unit was relocated to the center of the bumper area, just above the hitch, and no improvement was seen. The radar unit was then moved to a higher location in the center of the sand hopper at a height of 1.8 m (6 ft). Still no improvement in detecting a person was seen when the truck moved. The system was also tested on a dump truck with several different mounting configurations, and the same problems were seen.

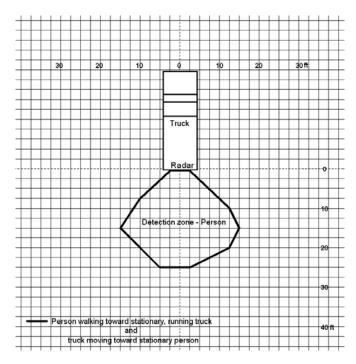
Figure 8.—Detection zone for person and Preview radar system.

To determine the detection zone for a person, the test subject walked toward the rear of the sanding truck and recorded where reliable detection occurred (figure 8). The test subject then remained stationary while the truck was moved slowly (3-5 km/hr [2-3 mile/hr]) in reverse. No significant changes were seen in the detection zone. The range for both scenarios was 7.6 m (25 ft), and the width of the detection zone was adequate to detect a person standing 30 to 60 cm (1 to 2 ft) away from the outer edge of the rear tires. However, at this mounting

height, a crouching person might not be detected immediately next to the tires, and the tilt of the radar would need to be increased if possible.

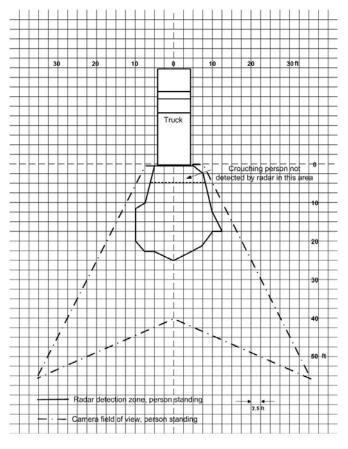
Figure 11.—Detection zone for Preview radar system and field of view for Clarion camera on a sanding truck.

After mounting the systems, the final radar detection zone and the FOV for the camera were recorded as shown in figure 11. The radar's detection zone for a person standing behind the truck (inner solid line) adequately covered the width of the truck and extended 7.6 m (25 ft) from the back. However, the system did not detect a person crouching or

kneeling immediately behind the truck. The downward tilt of the radar system was increased to improve detection of a crouching person, but the system began to sense the truck itself, which caused false alarms. The tilt angle was reset to 20°.

After mounting the system, the FOV for the camera was recorded as shown by the outer dashed line in figure 11. The FOV was adequate to show a person standing or crouching immediately behind the truck. This view extended to 12 m (40 ft) from the center of the hitch plate. The fisheye effects of the wide-angle lens account for the odd shape of the FOV.

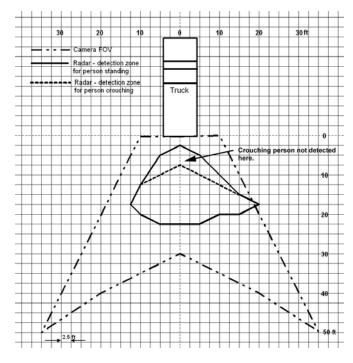
Figure 15.—Detection zone for Preview radar system and field of view for Clarion camera on dump truck.

After the system was mounted, the final radar detection zone and FOV for the camera were recorded as shown in figure 15. Because of the mounting height of the radar, a person was not detected immediately behind the truck. This was because a person could walk underneath the radar beam at close distances.

The mounting height also resulted in poor detection of a crouching person when close to the truck, as indicated by the dashed line inside the solid line of figure 15. A standing person was detected at distances between 0.76 and 6.9 m (2.5 and 22.5 ft) from the back of the truck, while a crouching person was detected at distances between 2.3 and 6.9 m (7.5 and 22.5 ft). The radar system was mounted several feet above the manufacturer's suggested mounting height, which caused the detection zone to be inadequate for this truck. Tests continued, however, because the addition of the camera system provided redundancy.

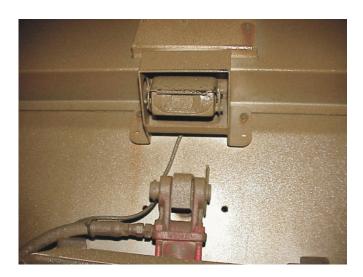
Figure 18.—Mud build-up on Clarion camera.

because (1) mud and snow build-up on the lens occurred quickly in forward gear (figure 18), obstructing the camera view, and (2) glare from headlights distracted the driver during night operations. After this change was made, the camera system operated reliably on warmer days. However, in snowy conditions, ice and snow quickly covered the camera when traveling forward. This caused the lens shield to become frozen in the closed position, making the camera unusable even in reverse. After a few days of operating under these conditions, the lens shield mechanism failed and was stuck in the closed position even after snow and ice were cleared from the camera. A heated camera enclosure or some other method to keep snow and ice from building up on the camera would be required before using this system on a sanding truck.

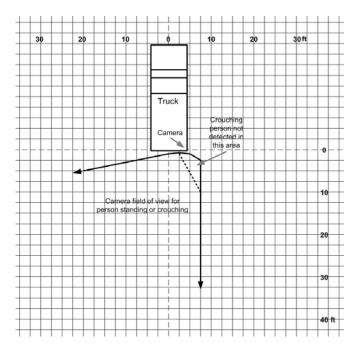
Figure 20.—Field of view for a person and Intec camera system.

extended from the back of the truck out to the horizon. The right side of the FOV was blocked by the camera enclosure. The area between the dotted line and the truck represents the area where a crouching person could not be seen in the video monitor because the person was beneath the camera's FOV. Full coverage of a crouching person behind the truck could be achieved by tilting the camera further downward, but there is a tradeoff between close coverage and the distance that the FOV extends on the left side of the truck. Results of this initial test showed that the camera system could be useful, so long-term tests on a dump truck were conducted during the summer months.

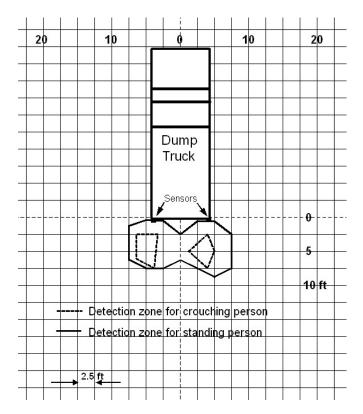
Figure 24.—Detection zone for person and Hindsight sensors mounted on dump box corners.

As suggested by the manufacturer, the two sensors were temporarily mounted on the lower corners of the dump truck's box (just below the tailgate hinge points) as shown in figure 23. The alarm was situated at the rear of the truck for easy viewing for these initial tests. Several problems were seen with this mounting configuration, including the potential for damage to the sensors when material flowed through the tailgate and the lack of continuous detection of a crouching person behind the truck, as shown by the dashed lines in figure 24.

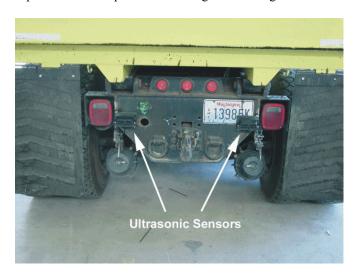
Figure 25.—Final mounting position of Hindsight sensors.

An alternative mounting position for the sensors was tested (figure 25). This placed the sensors on the hitch plate and closer together, which resulted in a more continuous detection zone for a person, as seen in figure 26. The total range of the system was 2.4 m (8 ft), and detection covered most of the width of the truck except the corners of the dump box. The system did not generate false alarms in a clear area on asphalt, and the mud flaps were not detected. Despite the short detection range, long-term tests on a dump truck were conducted.
