Evaluation of a Self-Contained Breathing Apparatus

Involved in a Near Miss in the Fire Service

Birmingham Alabama Fire Department Request for a Scott® Safety Air-Pak® Model 4.5 unit

NIOSH Task Number 21002

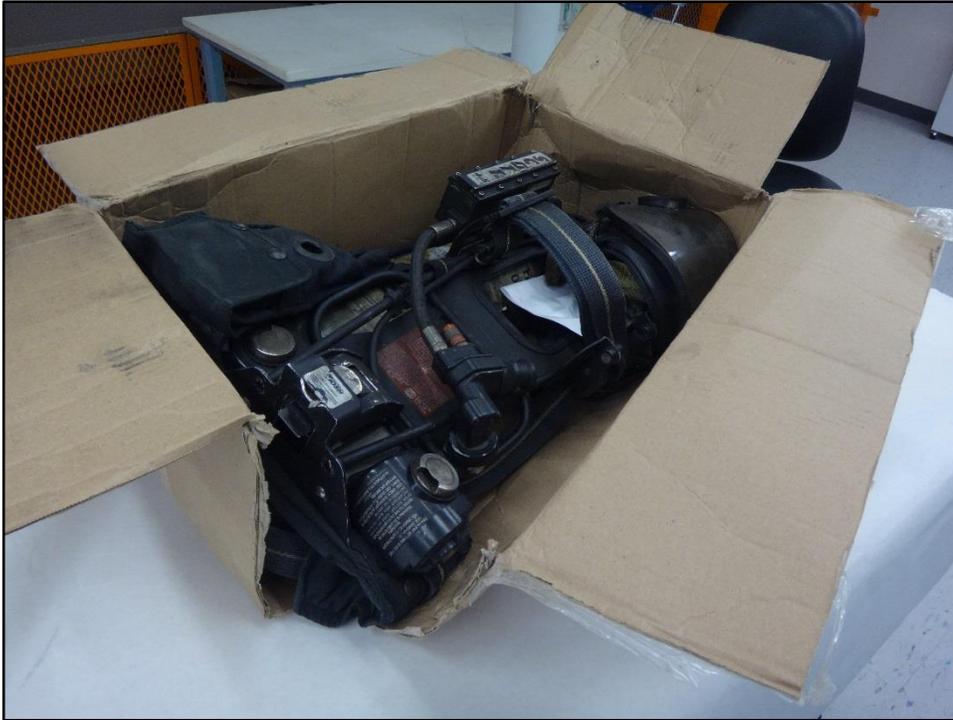
The SCBA was received in a cardboard box (refer to **Figures 1 – 3** in **Appendix III**).

- Cardboard box was received damaged, box was split open.
- Cylinder received empty with valve open.
- Mask mounted regulator (MMR) was locked into the waist strap with donning switch on, and regulator active.

Figure 1: Cardboard box containing SCBA.

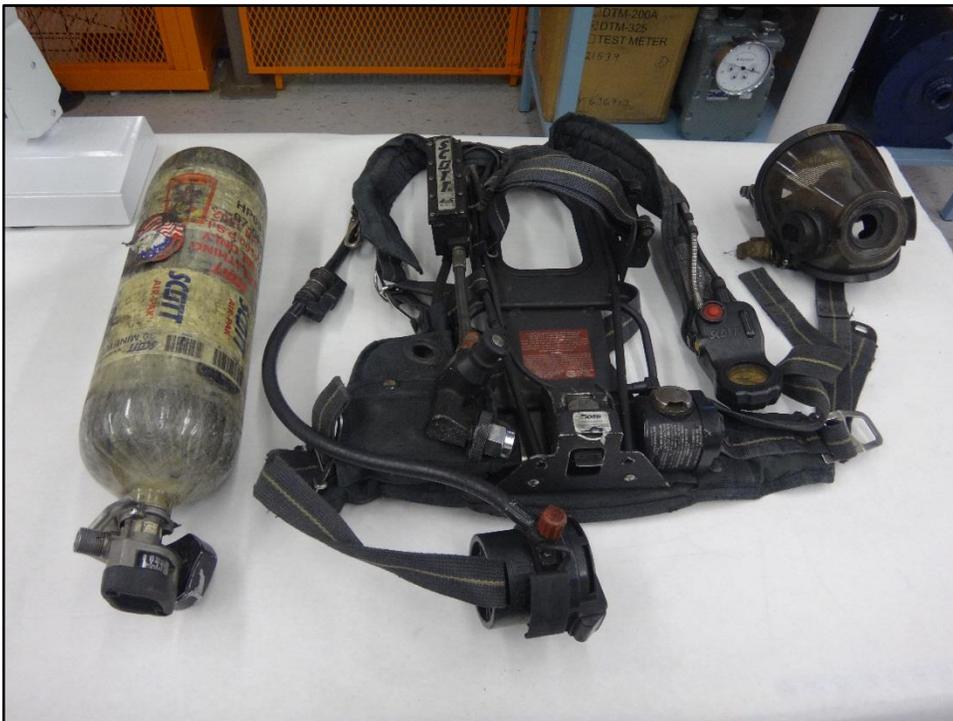
Figure 2: Inside of cardboard box.

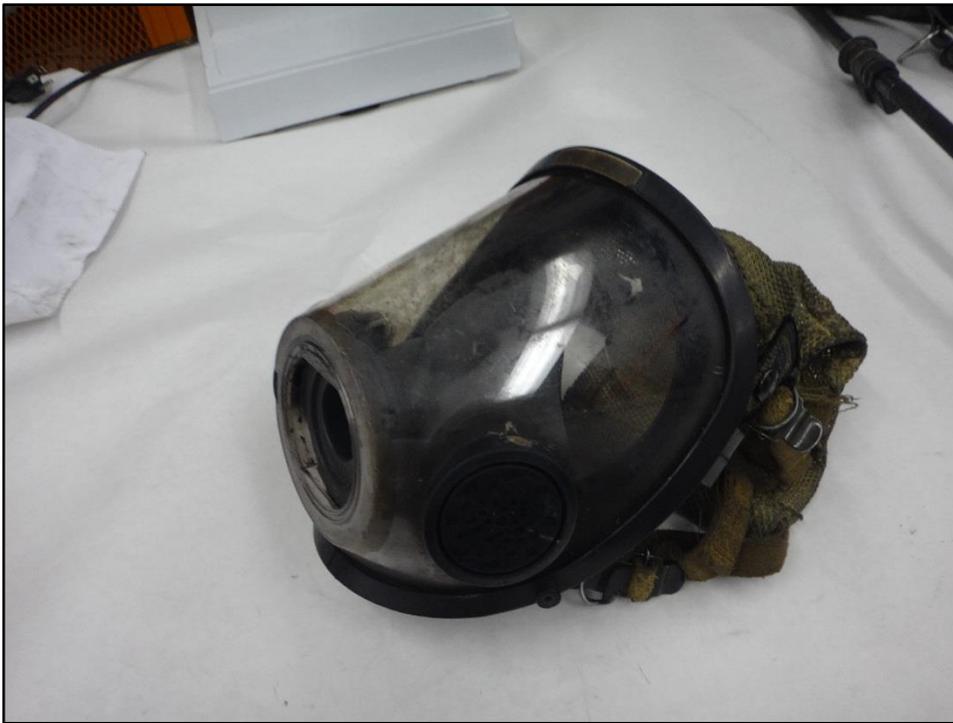
Figure 3: SCBA unit, facepiece, and cylinder out of bag.

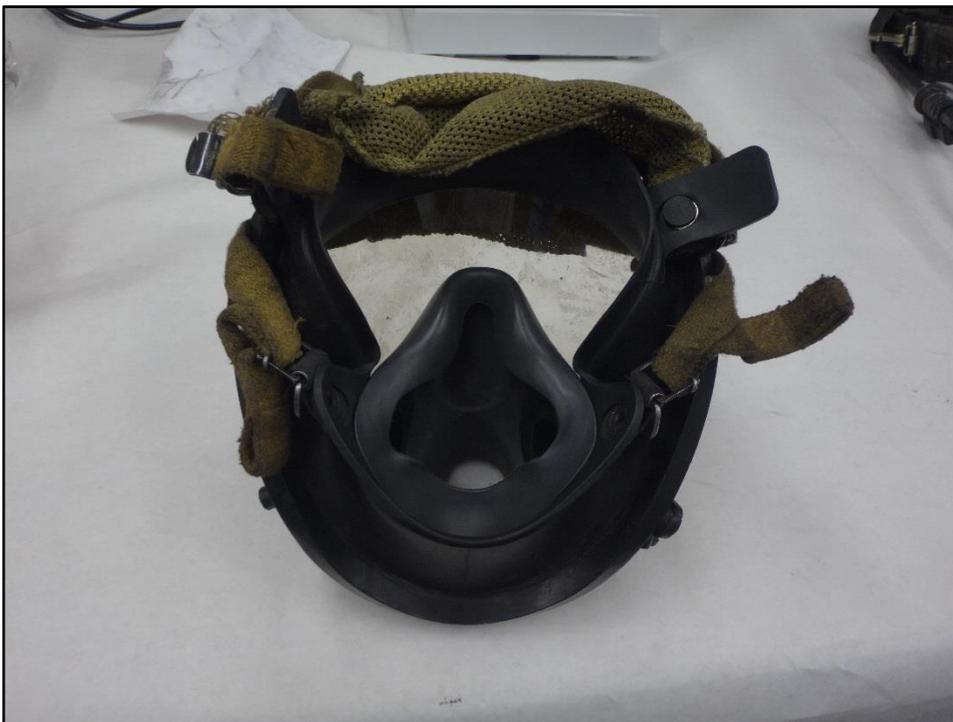
- Overall condition good but dirty.
- Lot number label present but illegible.
- Lens dirty, but in good condition with a few scratches.

- Hairnet straps dirty, but in fair condition; straps moved freely and held in place, held securely to facepiece.
- Strap at top left corner was frayed.
- Attachment points for straps were good.
- The facepiece seal “rubber” portion good.
- Regulator interface area good, with some debris.

Figure 4: Side view of facepiece.

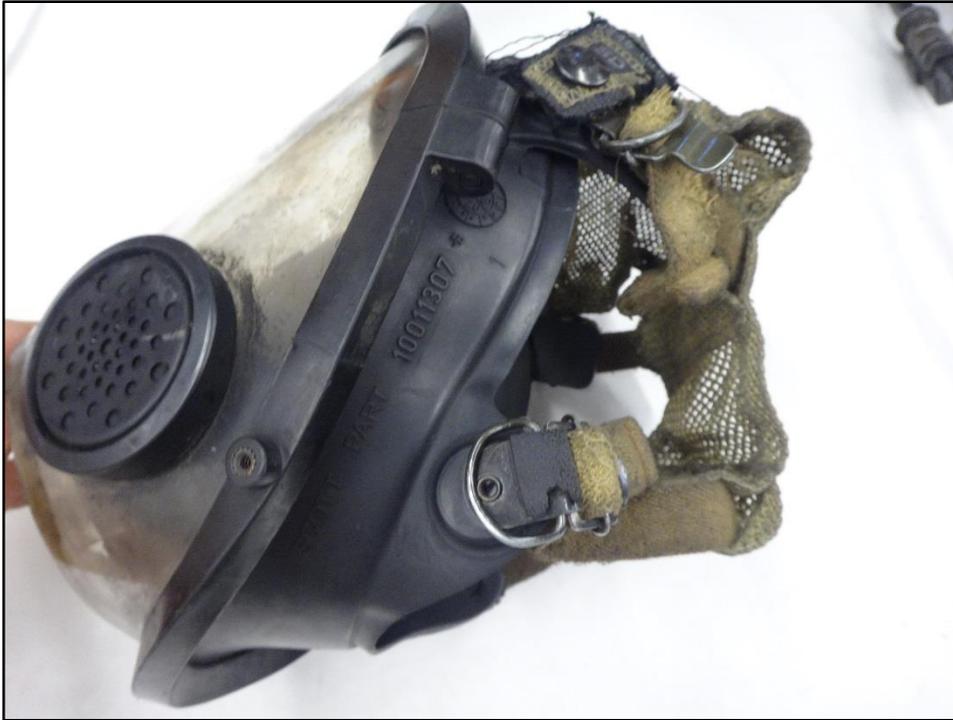
Figure 5: Inside view of facepiece.

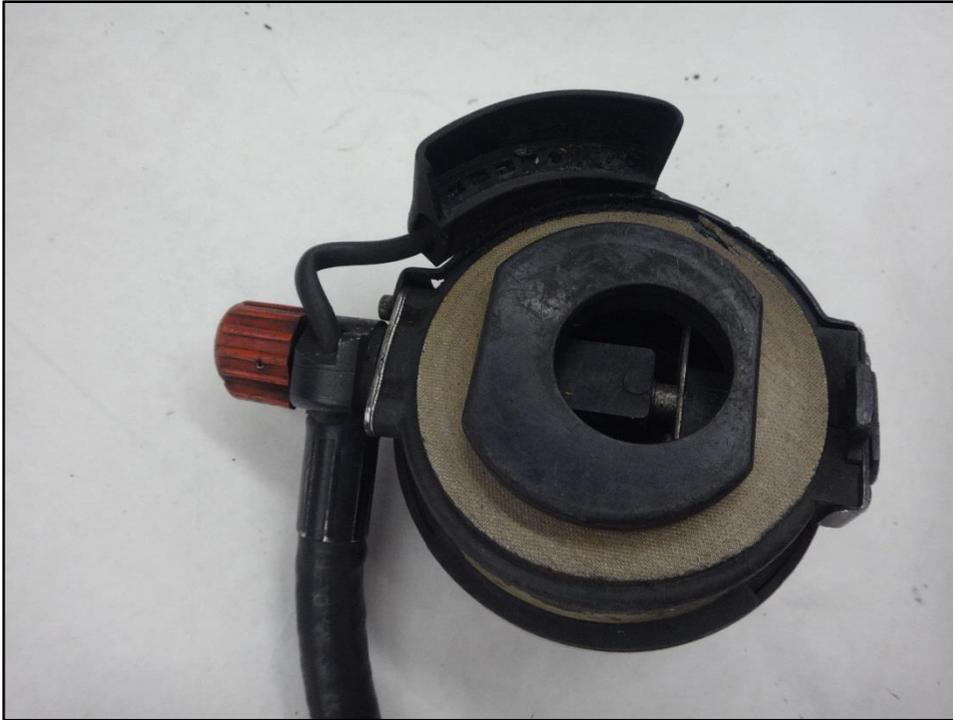
- Overall condition fair, with some damage.
- Outer case good with stickers present but illegible.
- Donning switch and cover in good working condition.
- Secured to low pressure line.
- Bypass in the open position.
- Bypass knob had signs of normal wear.
- Inside flange clean and in good condition.
- Sealing area had a small rip.
- Locking assembly functioned.
- Some damage found to rubber coating inside of the HUD.
- HUD loose from casing.

Figure 7: Mask mounted regulator connected to waist belt.

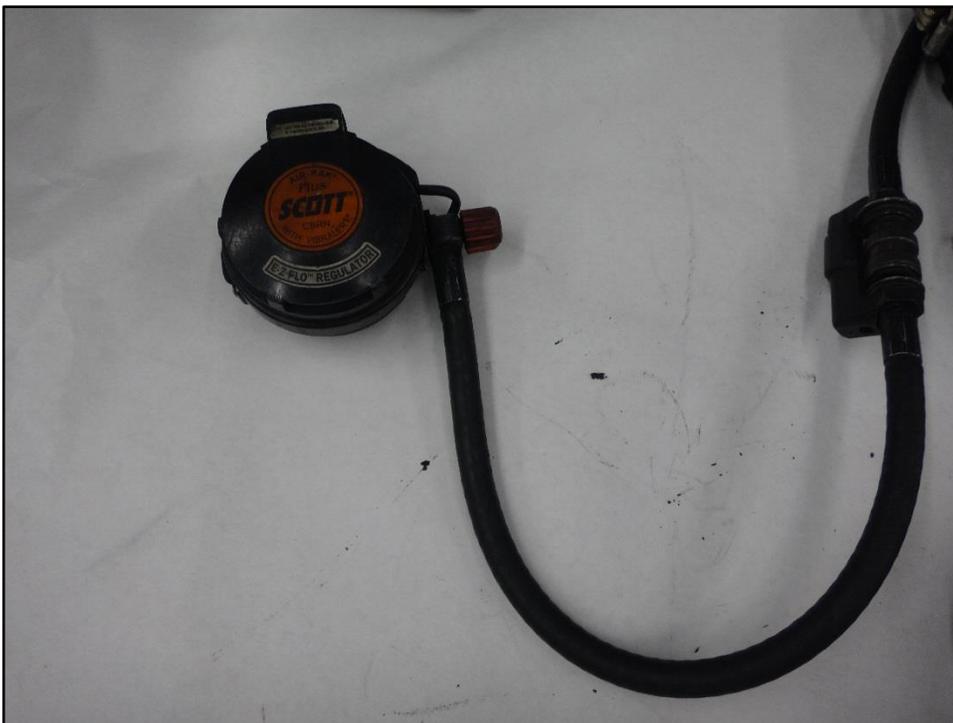
Figure 8: Inside flange, mask mounted regulator.

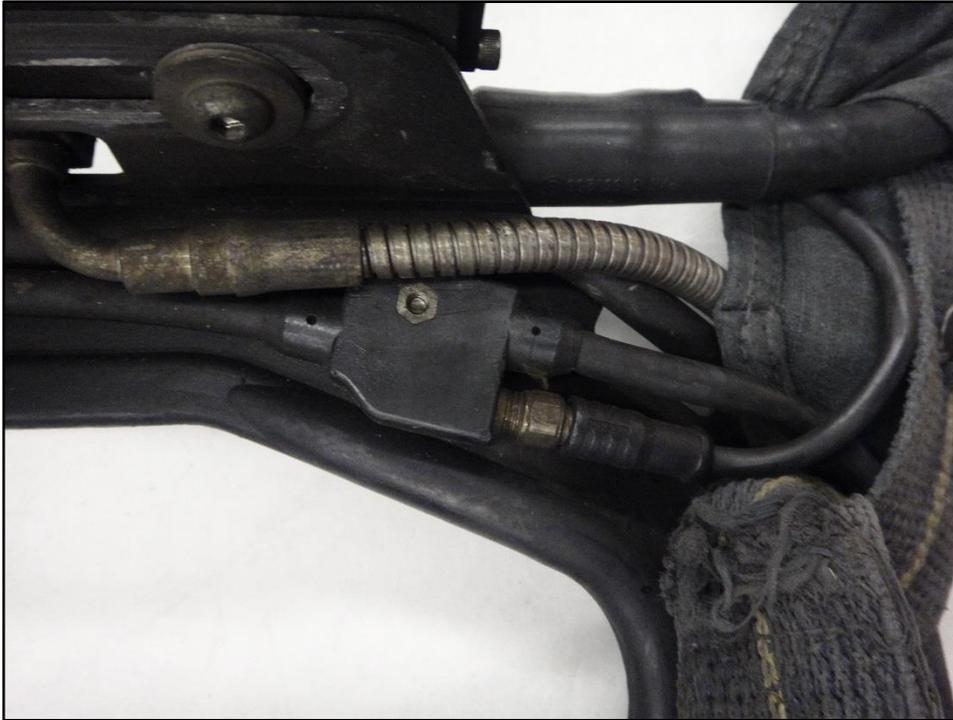
Figure 9: MMR, low pressure with Quick Disconnect.

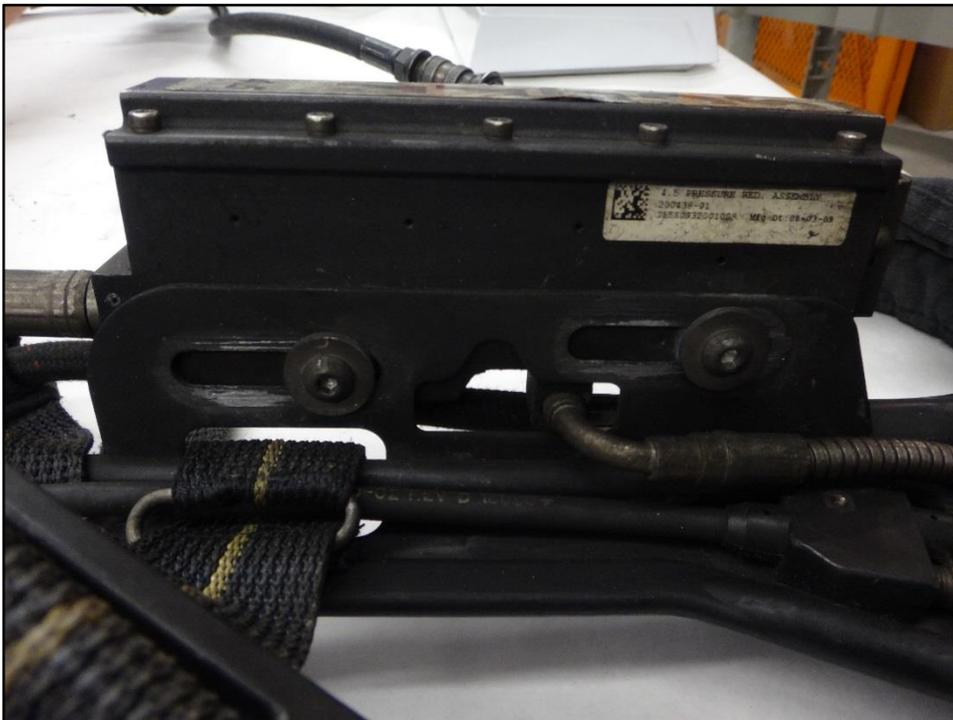
- Overall condition good.
- Secured at all attachments points.
- Quick Disconnect present and functioned.
- Line passed through the shoulder strap to the reducer.

Figure 10: Low pressure regulator hose and HUD connection.

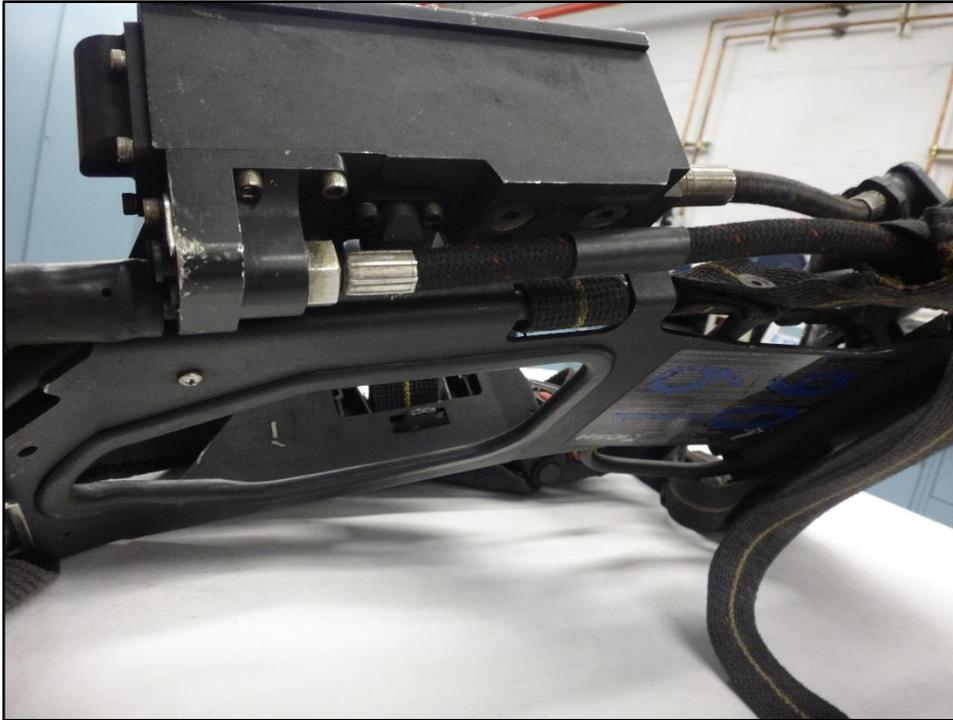
- Overall condition good with some wear.
- All air-line connections were secure.

Figure 11: Interior view of pressure reducer assembly.

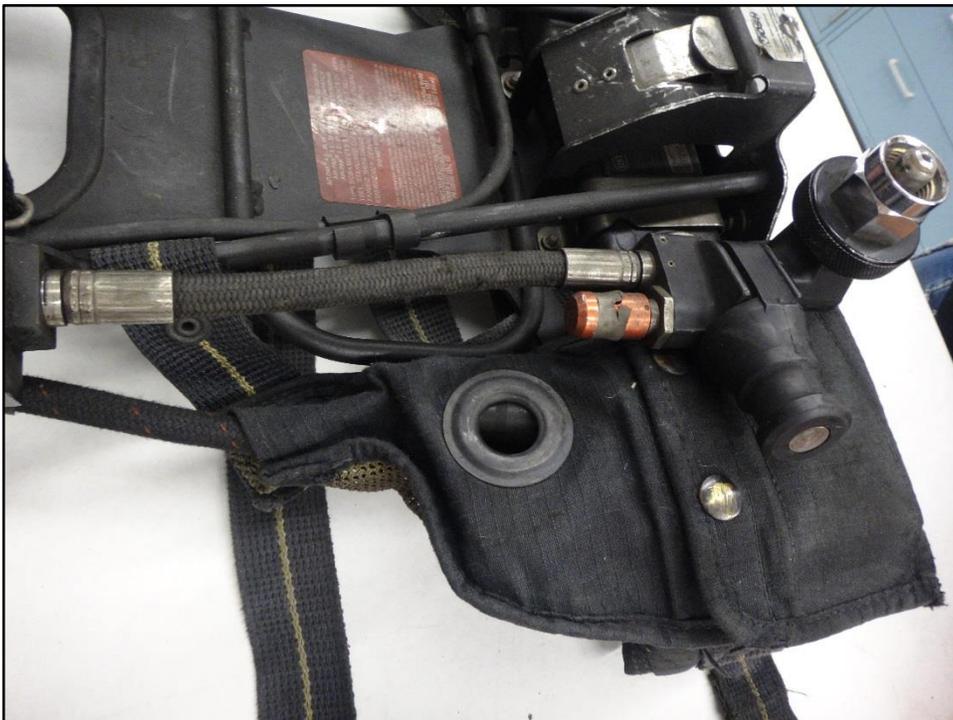
Figure 12: Bottom view of pressure reducer assembly.

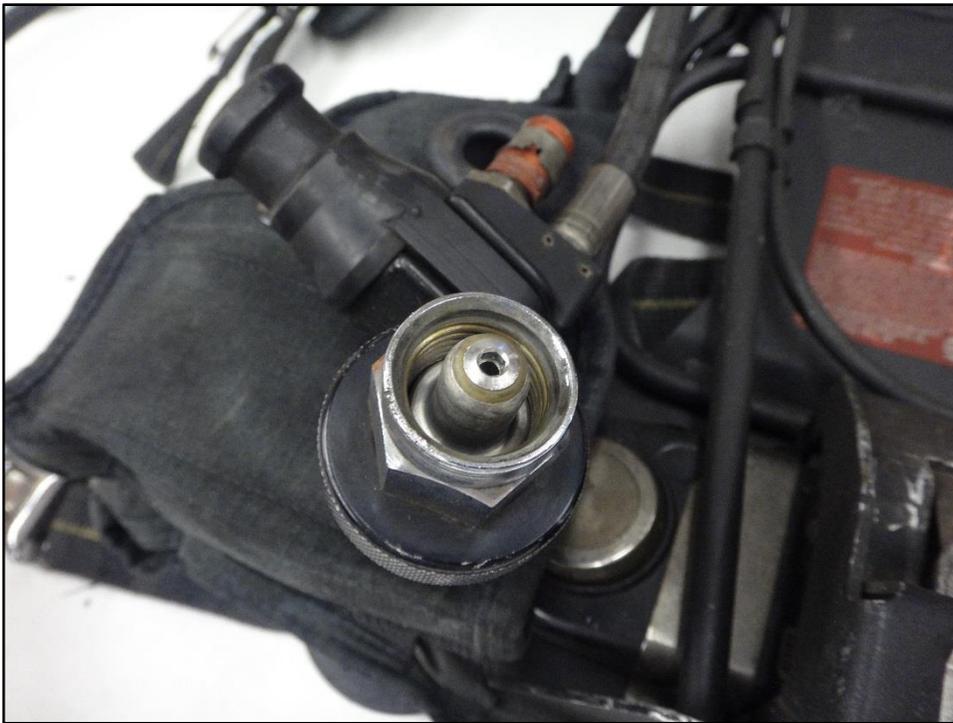
- Overall condition good, some scratches.
- Cylinder attachments thread clean, threads on and off, and “O” ring was in place.
- Quick-Fill appeared to have been dropped or hit causing the tip to be damaged.
- Pressure relief valve lightly damaged with a crack in covering.

Figure 13: High pressure hose and cylinder attachment.

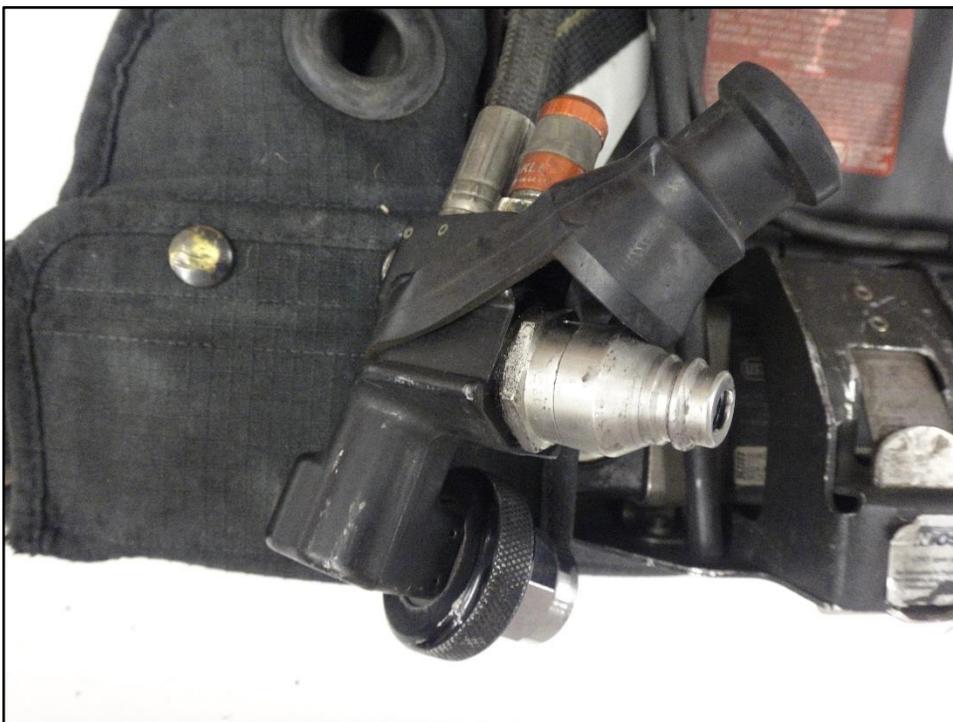
Figure 14: Cylinder attachment threads.

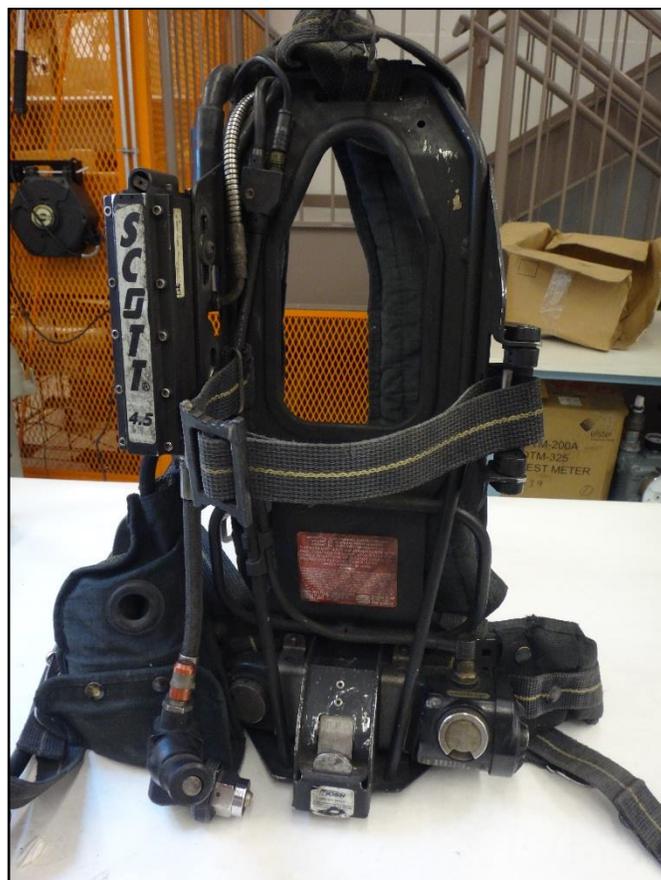
- Overall condition good.
- Held securely to backframe.
- Wire connection was connected to PASS.
- Wire held securely to backframe and ran to console assembly.

Figure 18: Control module.

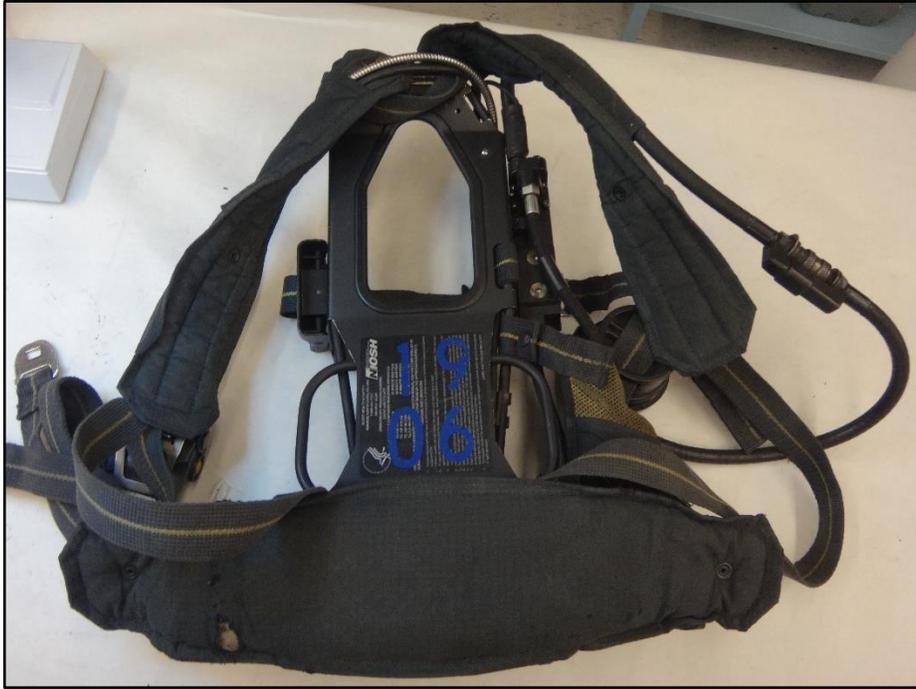
- Overall condition good.
- Shoulder straps attached to the frame.
- Cylinder strap and latch in good condition.
- Cylinder strap adjuster functioned.
- Damage to backframe at bottle connection point.

Figure 19: Inside of backframe.

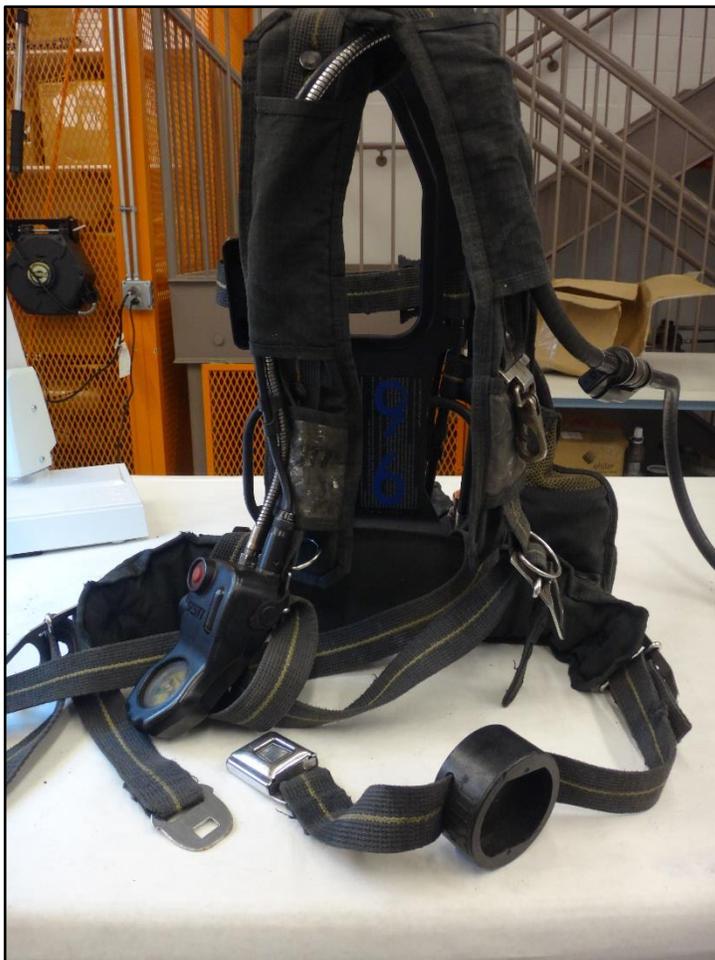
Figure 20: Back view of backframe and labels.

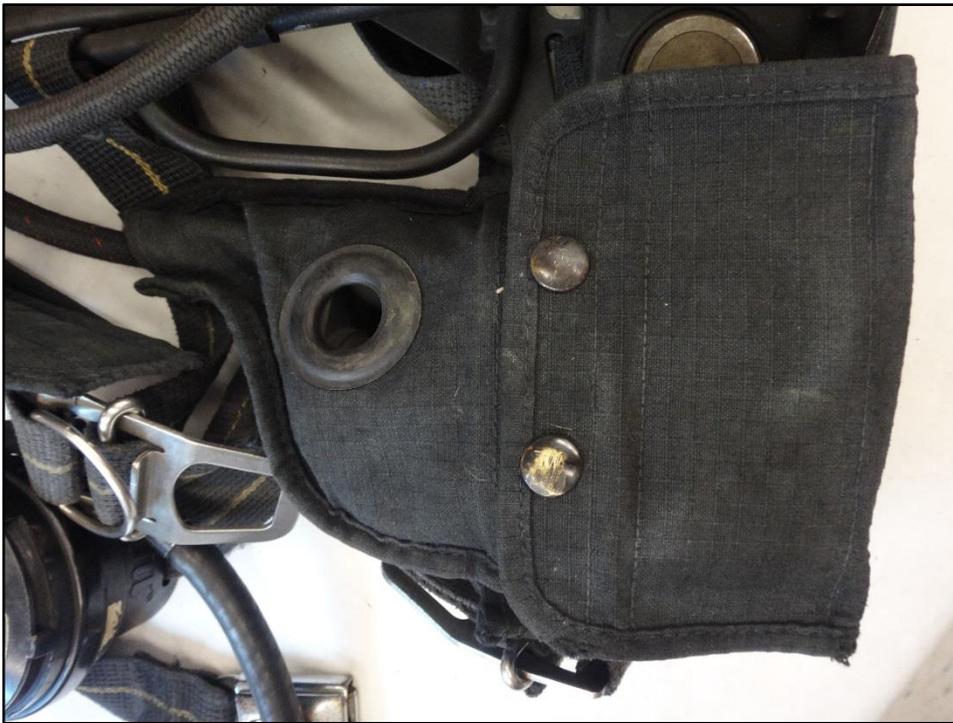
- Overall strap condition good.
- Both shoulder straps attached at the top of the backframe.
- Hose lines and wires passed through shoulder straps.
- All adjustable buckles moved and held in place.
- Waist area buckle latched and released.
- Lumbar strap in good condition.

Figure 21: Straps and buckles.

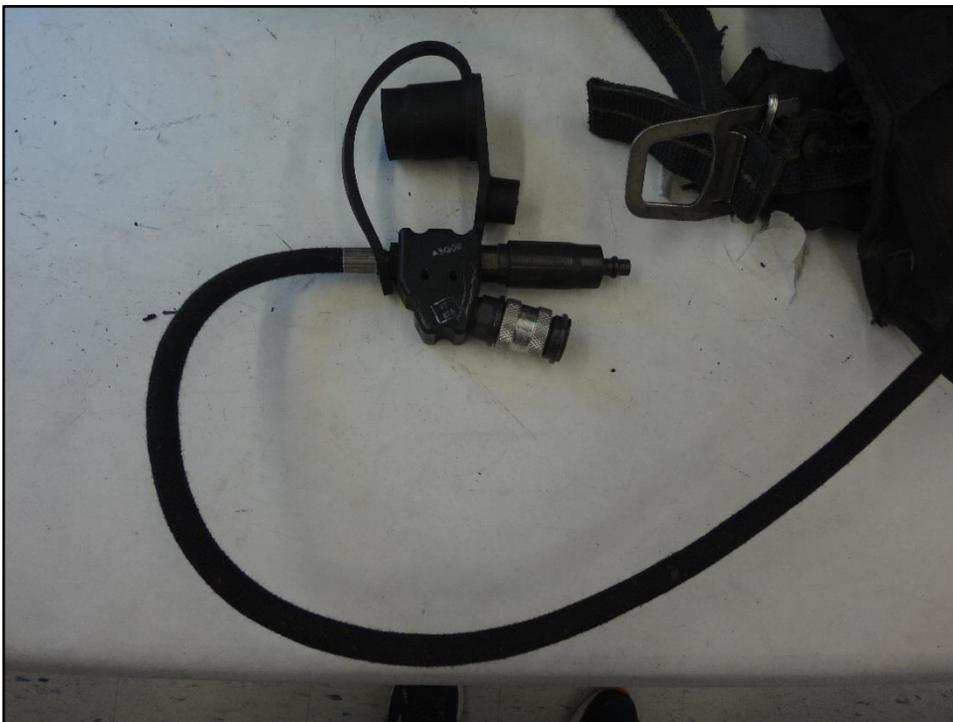
- Overall clean and in good condition.
- Rubber covering clean and functioned.

Figure 22: Auxiliary hose pouch.

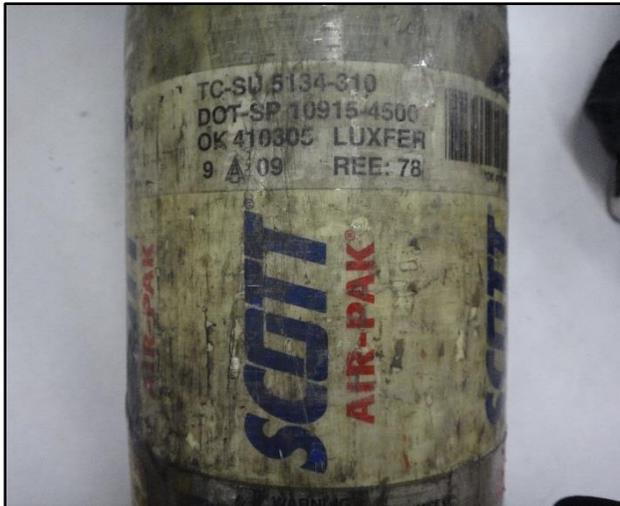
- Overall condition fair but scratched.
- Gauge was legible.
- Threads in good condition.
- As received, cylinder was empty with valve fully closed.
- Rubber bumper at base of cylinder valve was in good condition.

Figure 24: Overall condition of cylinder.

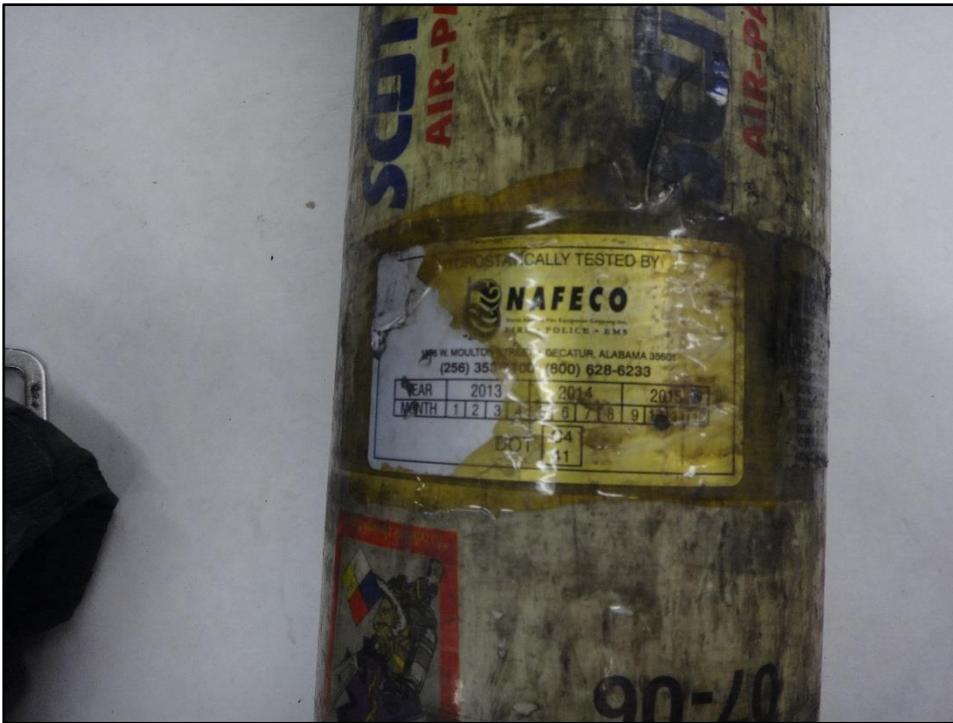
Figure 25: Identifying information on cylinder.

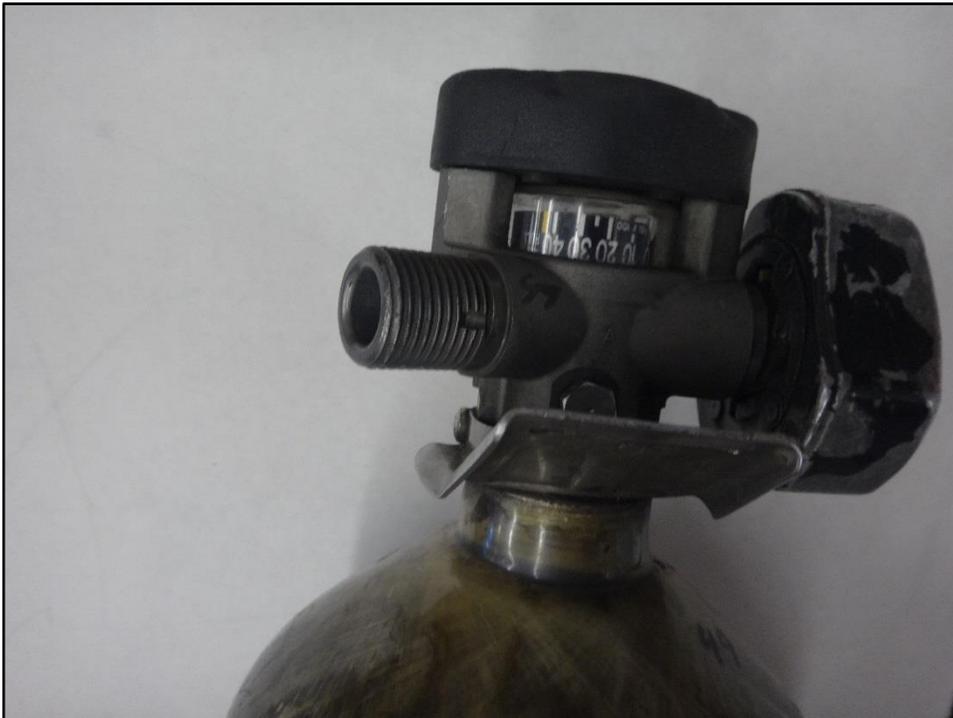
Figure 27: Cylinder gauge is legible, view of threads.
