Evaluation of a Self-Contained Breathing Apparatus for Potential Contribution to a Fatal Event in the Fire Service

Hamilton, Ohio Fire Department Request for Survivair Panther 30 minute, 4500 psig unit with NIOSH Approval Number TC-SU-5134-310 (August 3, 2016)

NIOSH Task Number 20731

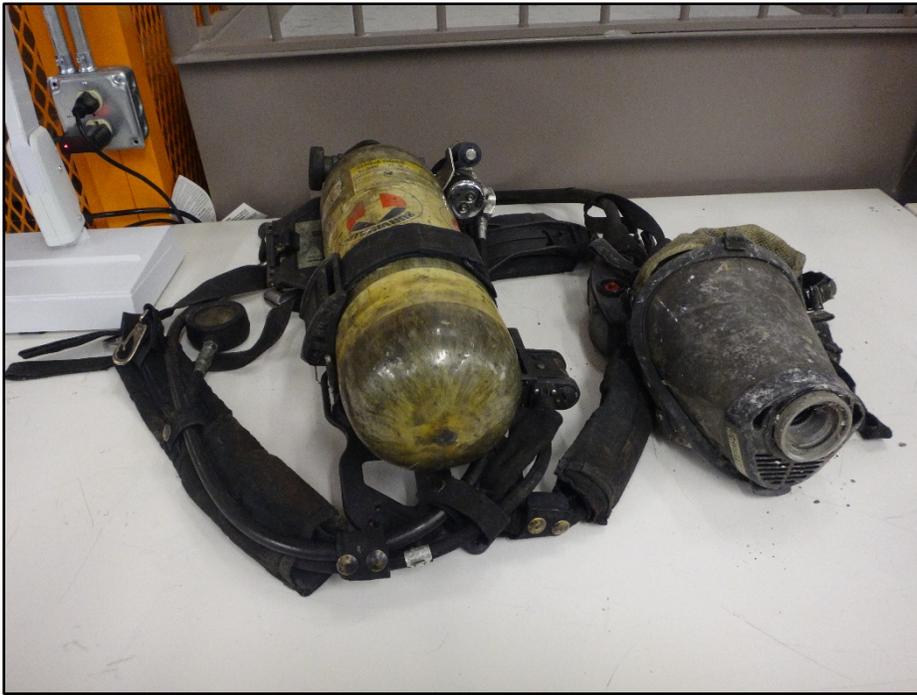
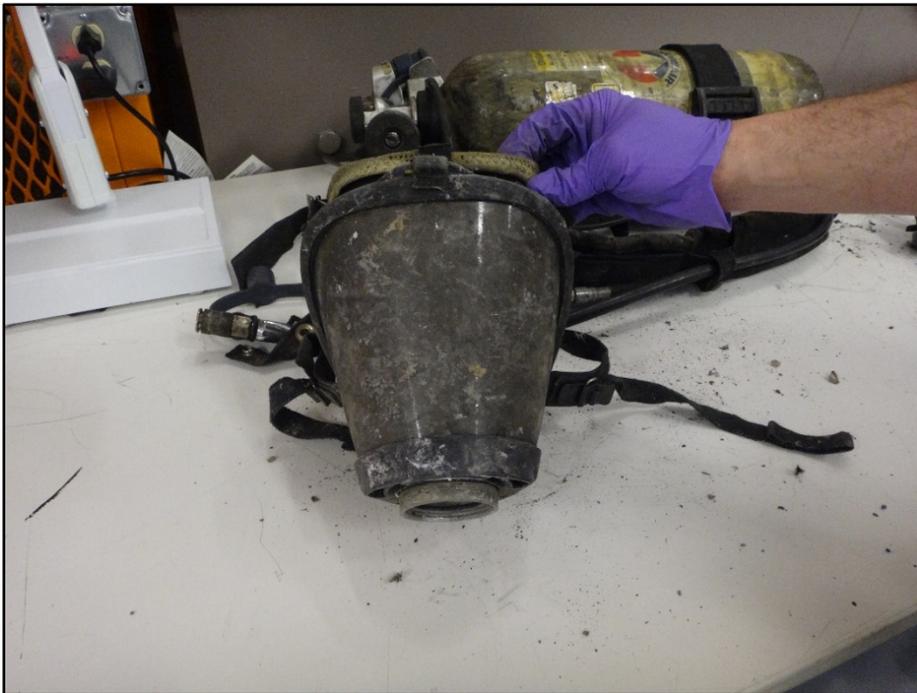
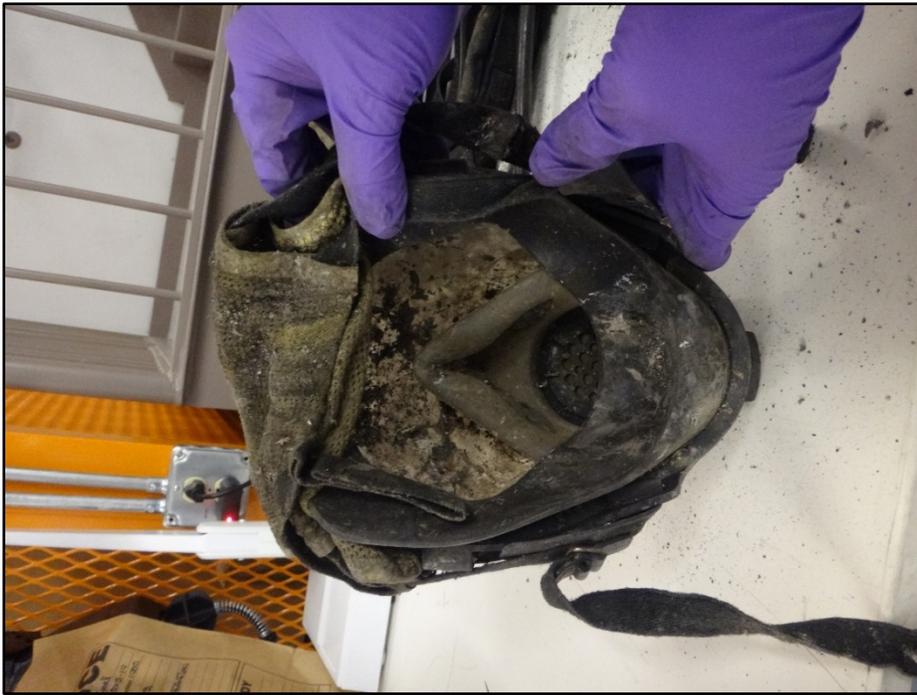
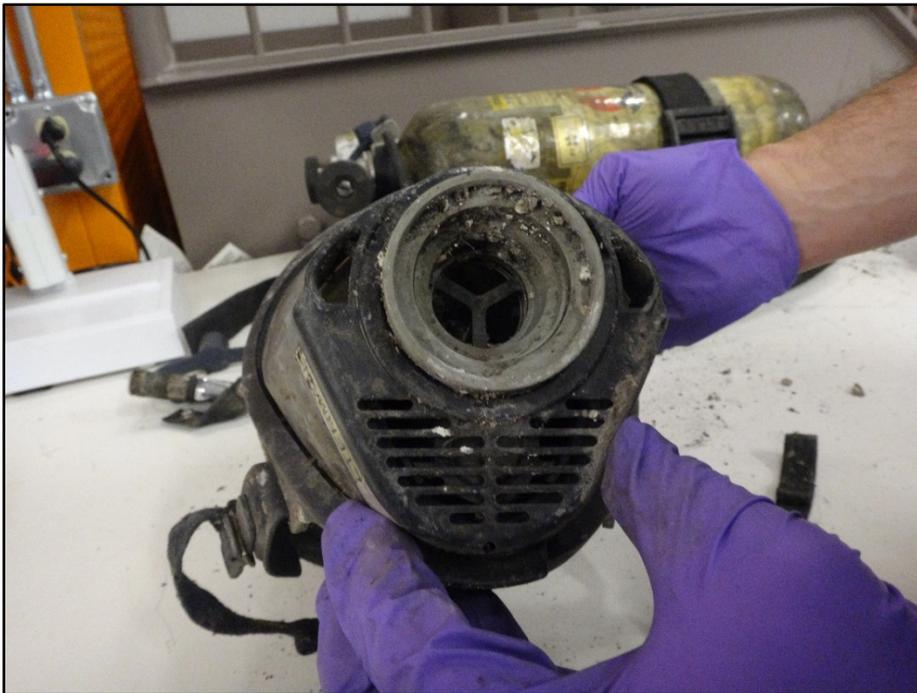
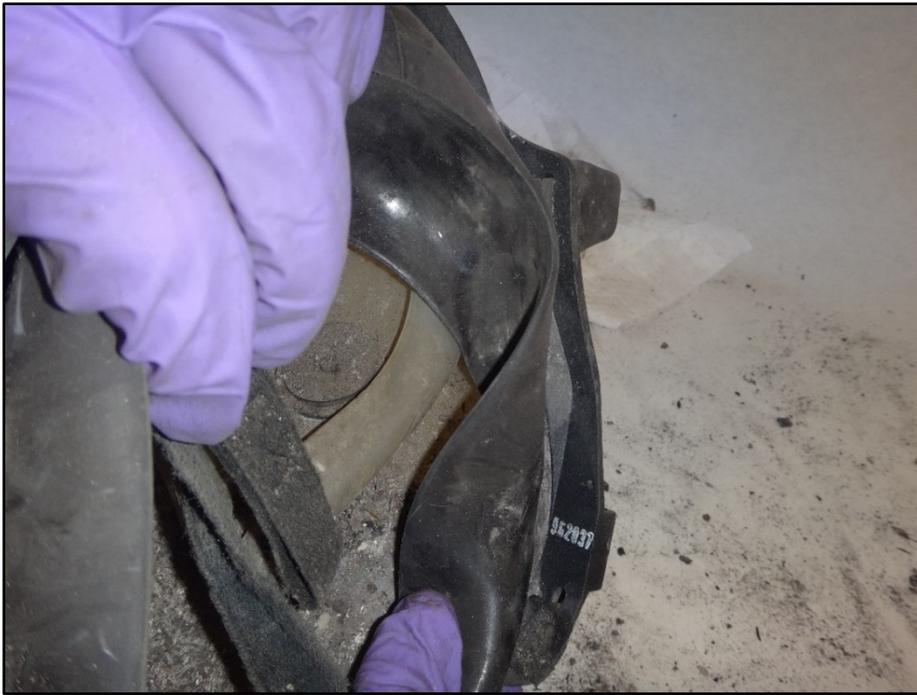
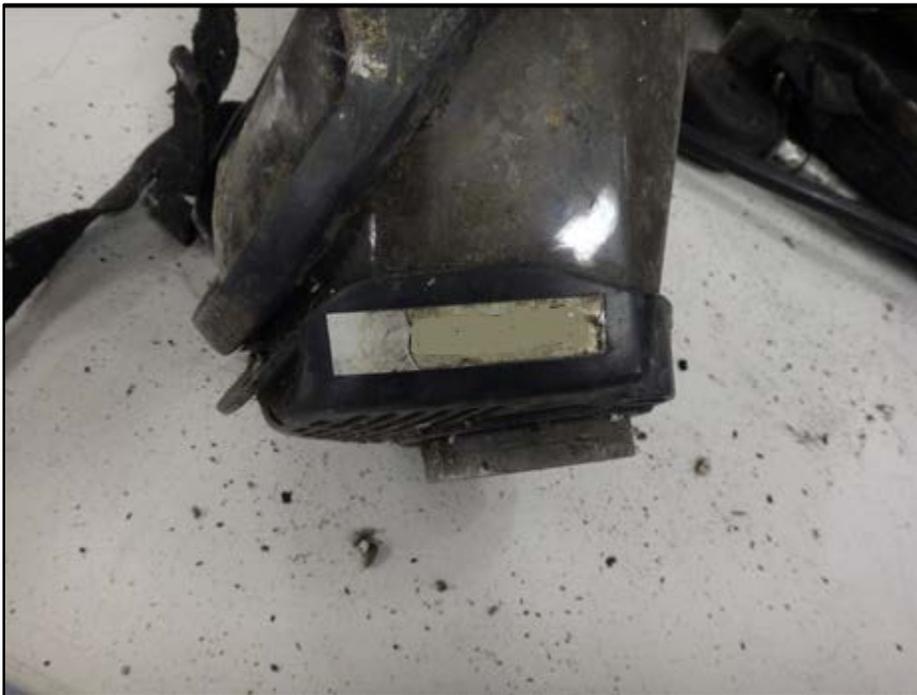
1. Facepiece: (refer to **Figures 3-8** in **Appendix III**)

- Overall condition is dirty, covered in drywall dust
- Lens and rings are dirty, covered in debris
- Lens appears to be covered in debris

- Lens retaining ring marking 962837
- Hairnet dirty, but in good shape
- Cheek tension straps twisted

Figure 4: Overview of facepiece, covered in debris

Figure 5: View of inside of facepiece, covered in debris

Figure 6: Bottom view of facepiece, debris inside

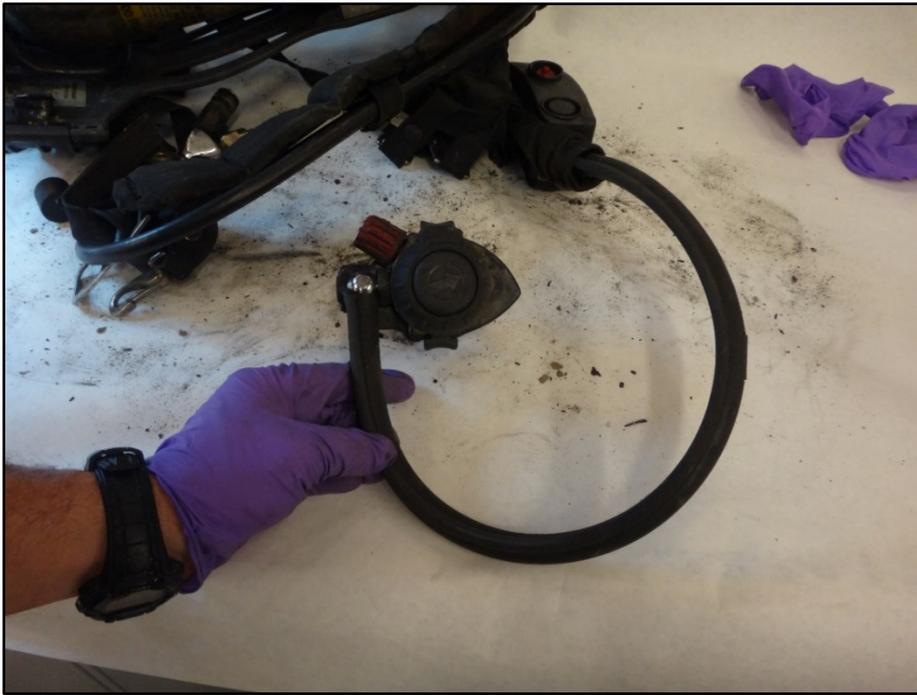
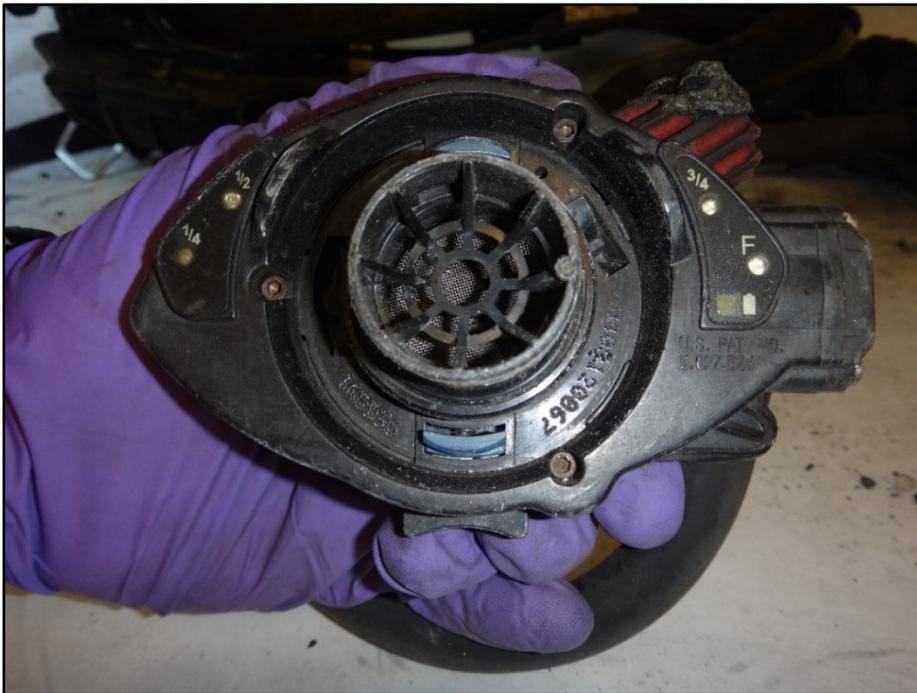
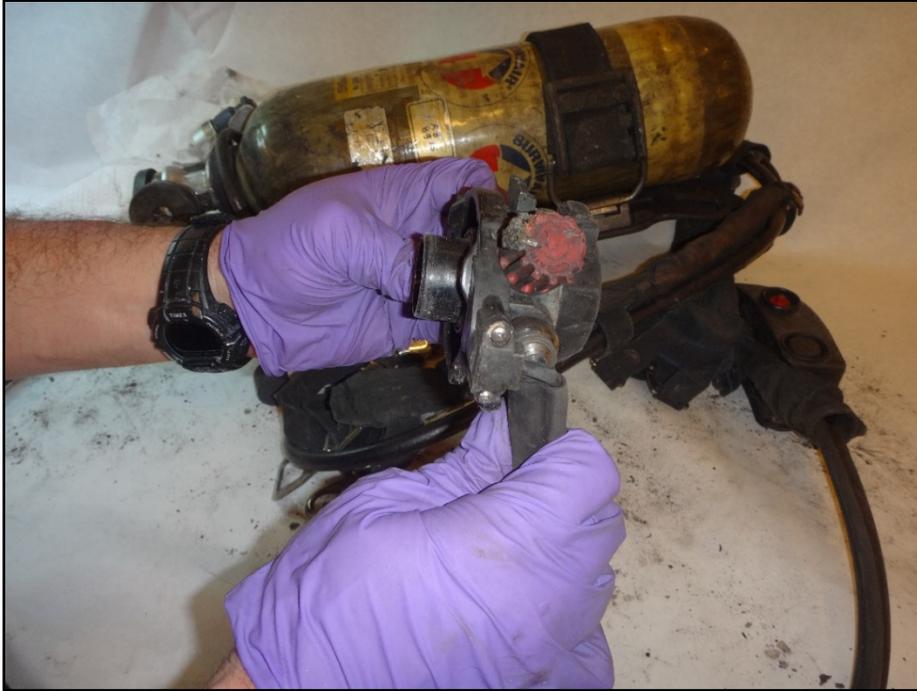
2. MMR with HUD: (refer to **Figures 9-11** in **Appendix III**)

- HUD INCLUDED
- Secured to low pressure line
- Bypass is closed, covered in debris
- Inside flange has no scratches and appears in good condition
- Sealing area is dirty; Patent #5097826
- Regulator can be attached and removed
- Locking assembly does function
- Quick disconnect not present

Figure 11: Heat damage to air supply valve

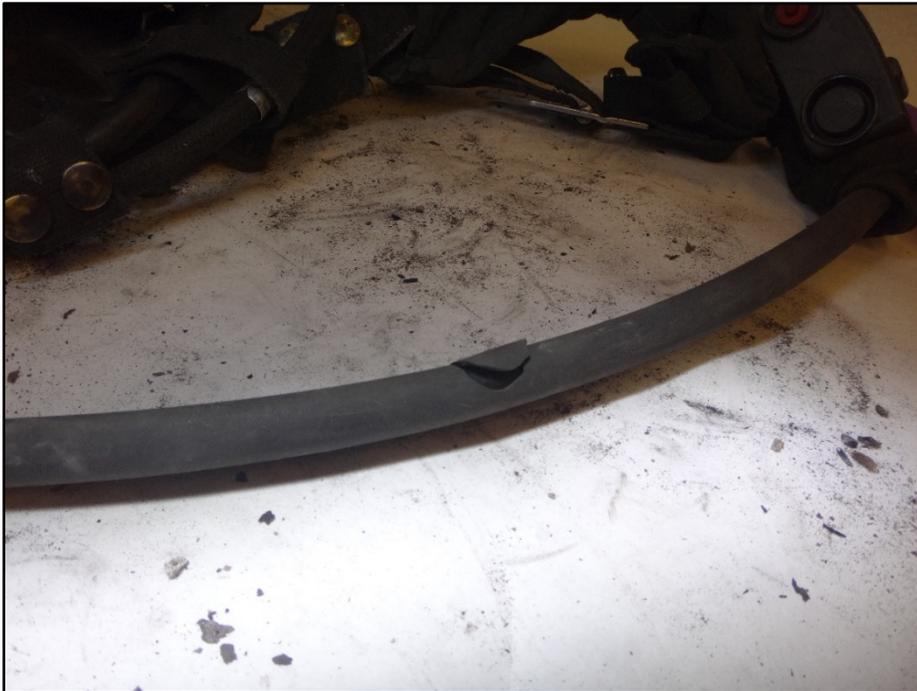
3. Low Pressure Line: (refer to **Figure 12** in **Appendix III**)

- Secured at all attachments points
- Quick disconnect not present
- Line runs through the shoulder strap to the reducer
- Tear in protective cover

Figure 12: Tear in protective cover of low pressure hose

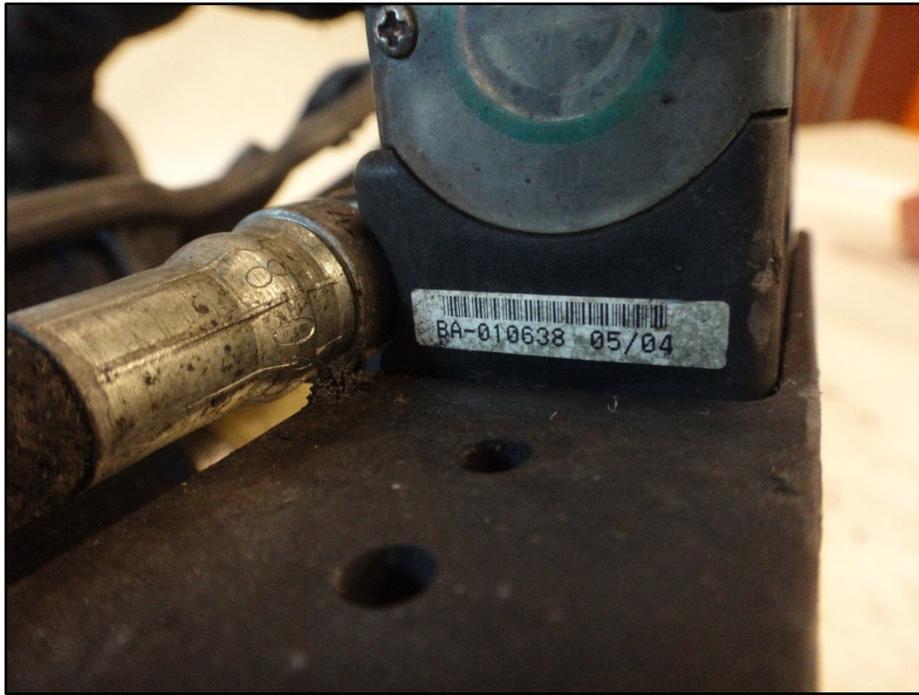
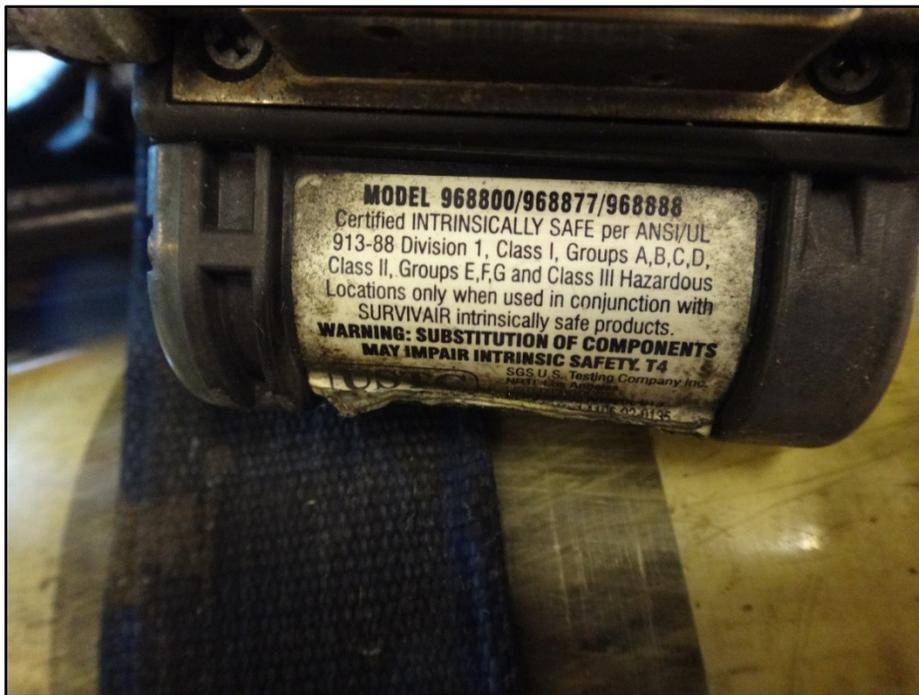
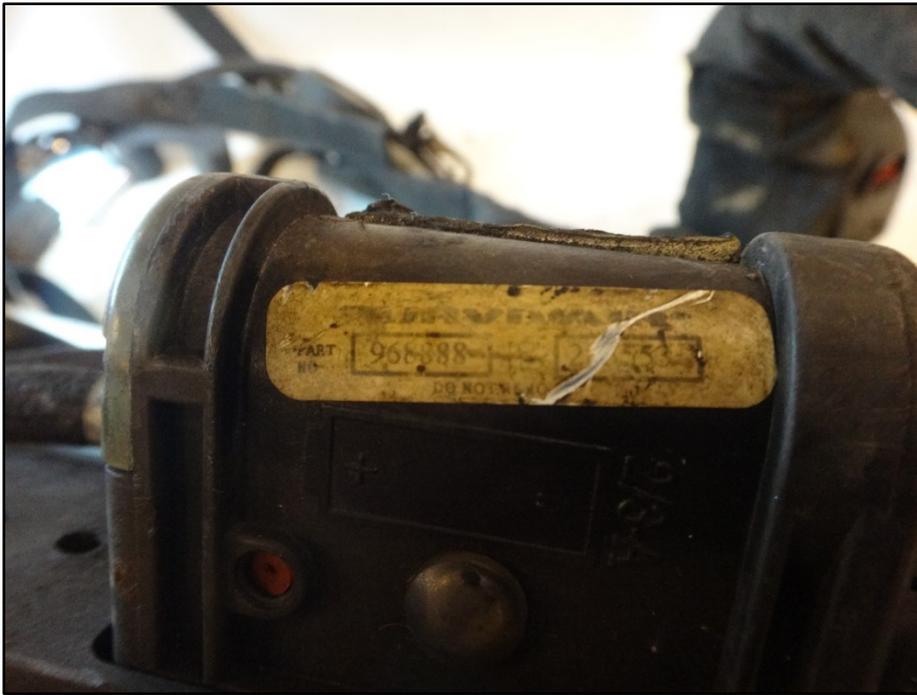
4. 4.5 Pressure Reducer Assembly: (refer to **Figures 13-15** in **Appendix III**)

- Barcode marking is present- BA-010638 05104
- Overall condition is fair to good, but dirty with scratches
- All airline connections are secure
- Disconnected from belt

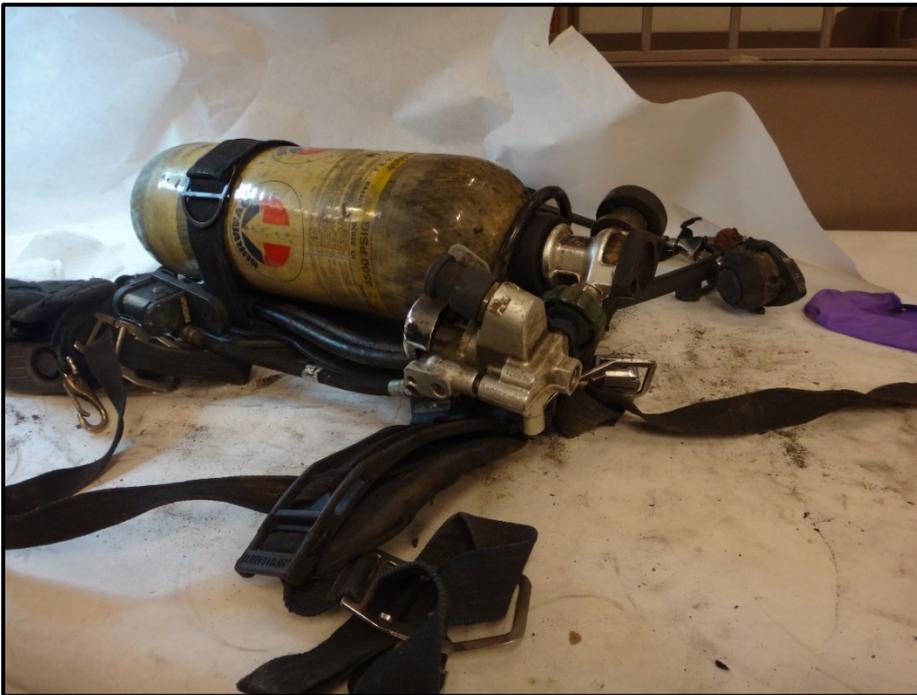
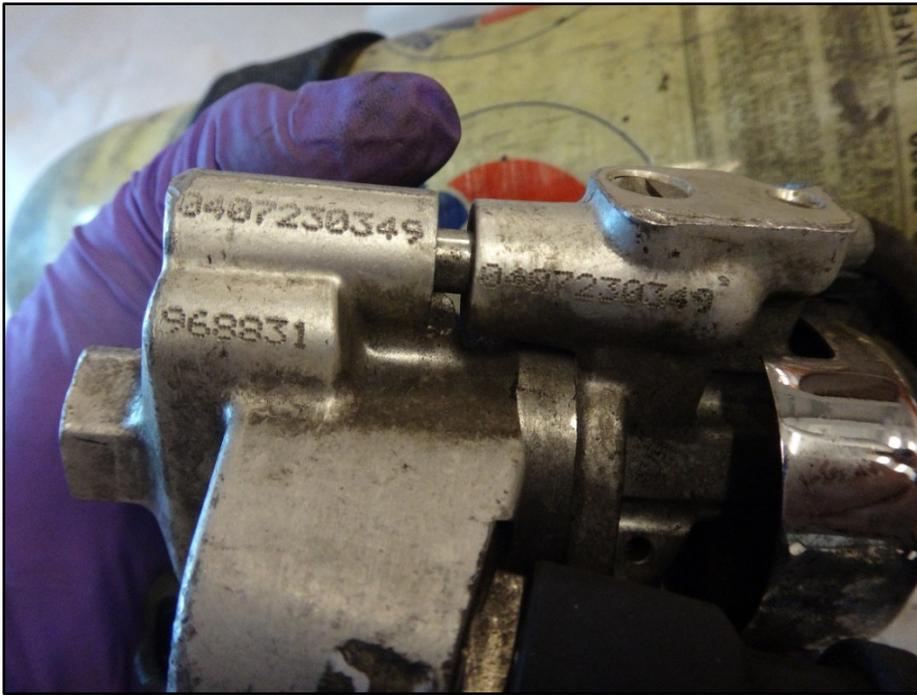
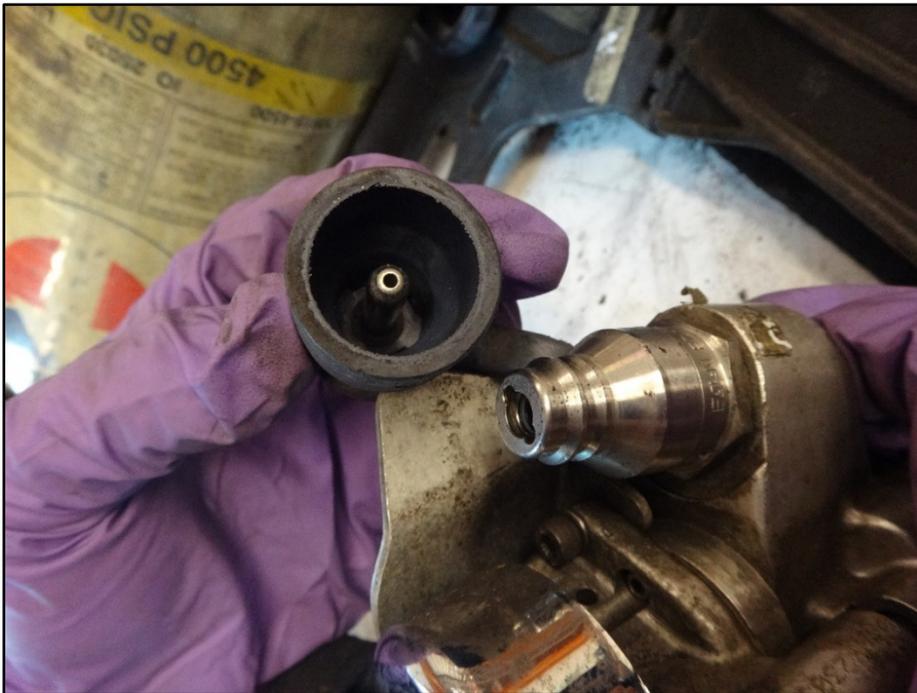
5. High Pressure Line & Cylinder Attachment: (refer to **Figures 16-18** in **Appendix III**)

- Overall condition is good with slight scratches
- Cylinder attachments thread corroded, threads on and off, “O” ring in place, but dirty
- Relief valve SVA 45K
- Eaton FD17-1002-10-04
- Three lines:
 - One goes to first stage regulator
 - Two low pressure lines go to auxiliary with male and female attachment points
 - One line goes to stand alone gauge

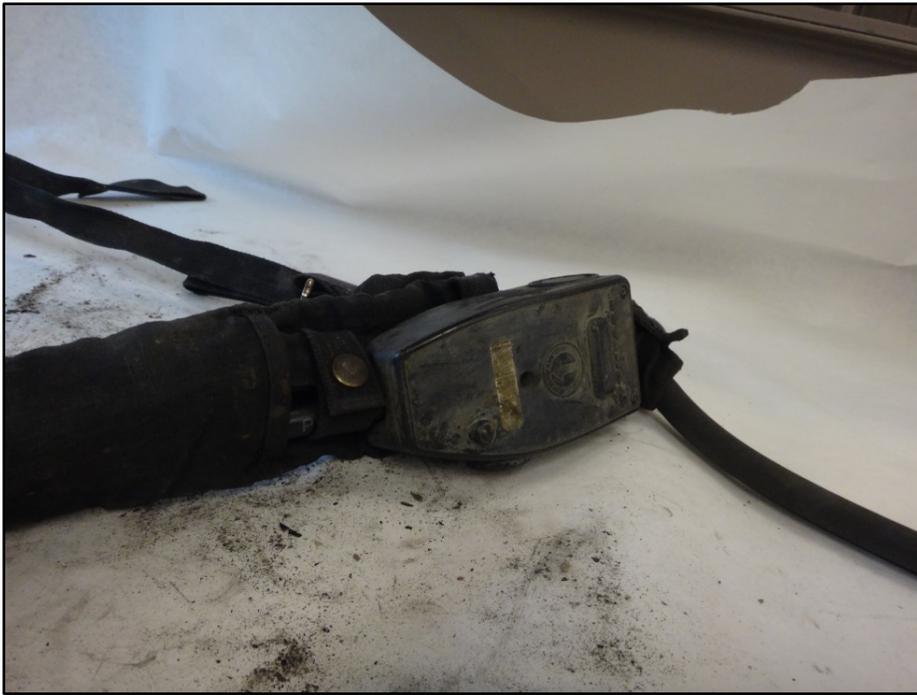
6. Console Compass Personal Alert Safety System (PASS) Version: (refer to **Figure 19** in **Appendix III**)

- Overall condition is good
- Lines are in good shape—pressure/electrical
- Protective casing slightly dirty; normal wear and tear
- SEI Label attached NFPA 1992, 1998 ed.
- PASS did turn on
- Additional port on PASS device has steel plug

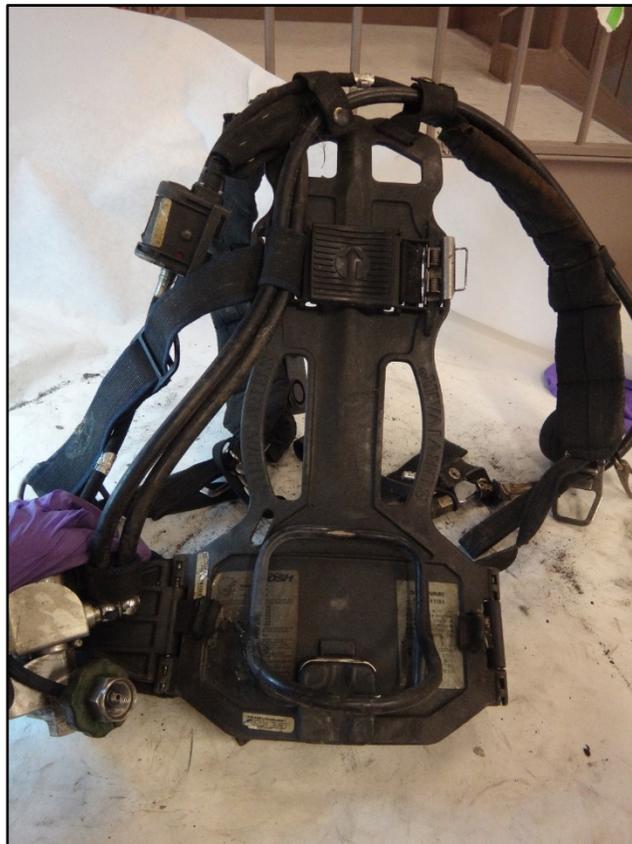
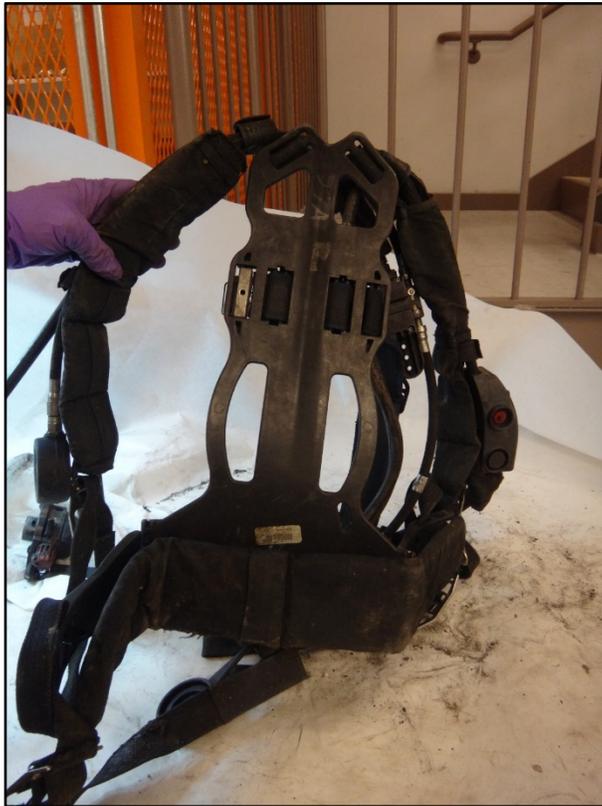
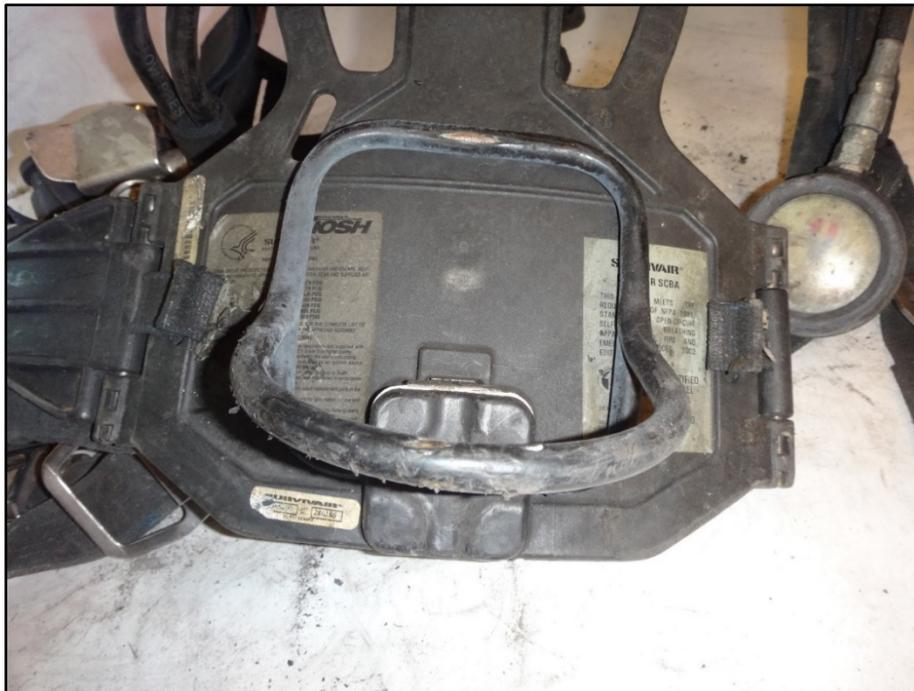
7. Backframe Assembly: (refer to **Figures 20-22** in **Appendix III**)

- Overall condition is good, but dirty
- Shoulder straps were attached to the frame
- Cylinder strap intact

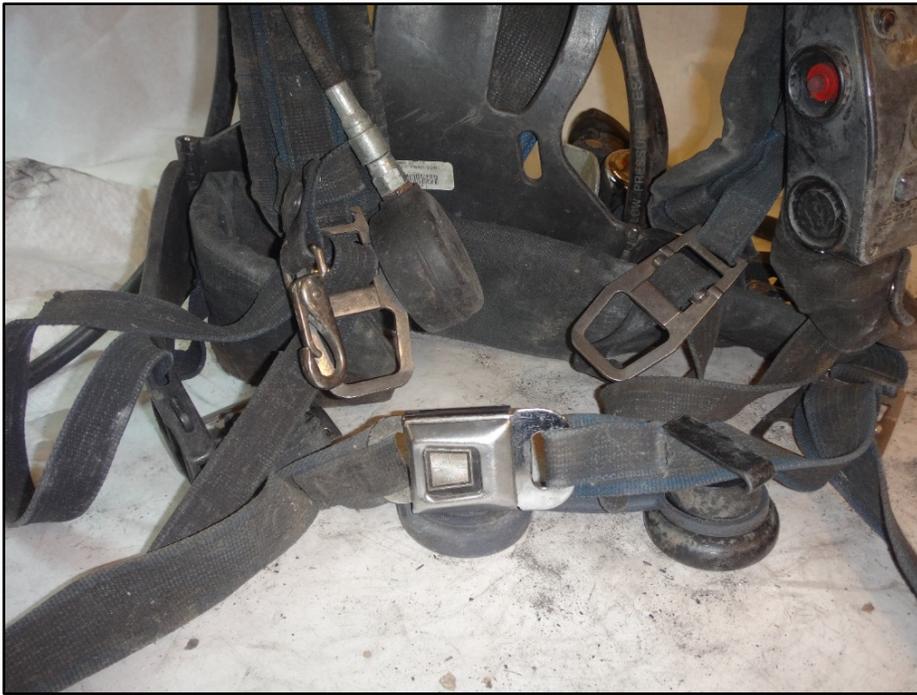
8. Straps & Buckles: (refer to **Figures 23** in **Appendix III**)

The unit did come with a corresponding facepiece. The overall condition of the unit and facepiece was fair to good with some dirt and debris. There was visible heat damage to the unit's straps. The cylinder

- Overall strap condition is dirty with some dye sublimation
- Shoulder strap attachment connected both sides
- Hose lines and wires pass through shoulder straps
- All adjustable buckles move and hold in place
- Waist area buckle latches and releases
- Heat damage to plastic latch on cylinder strap

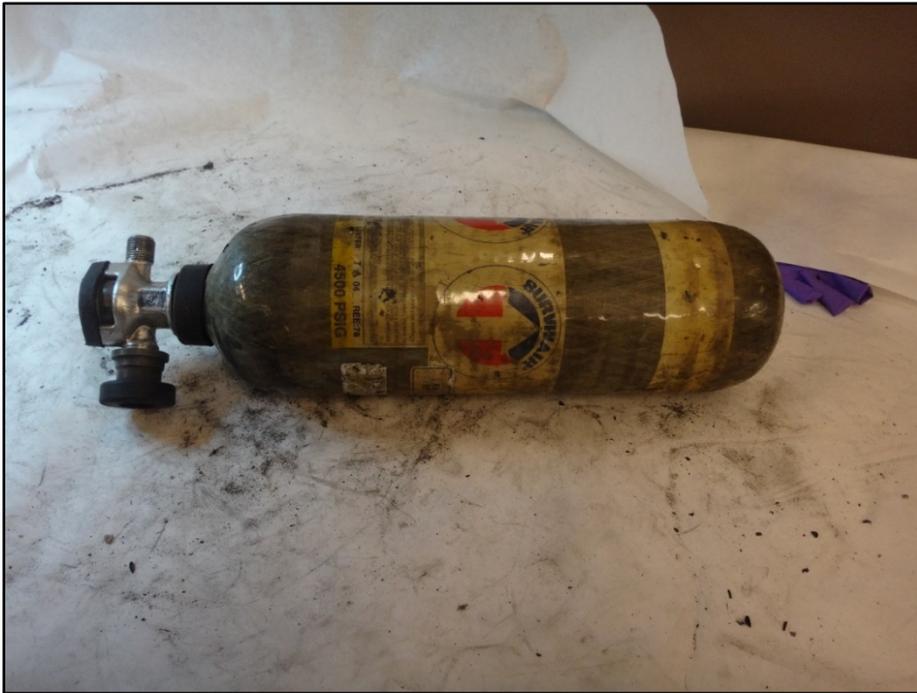
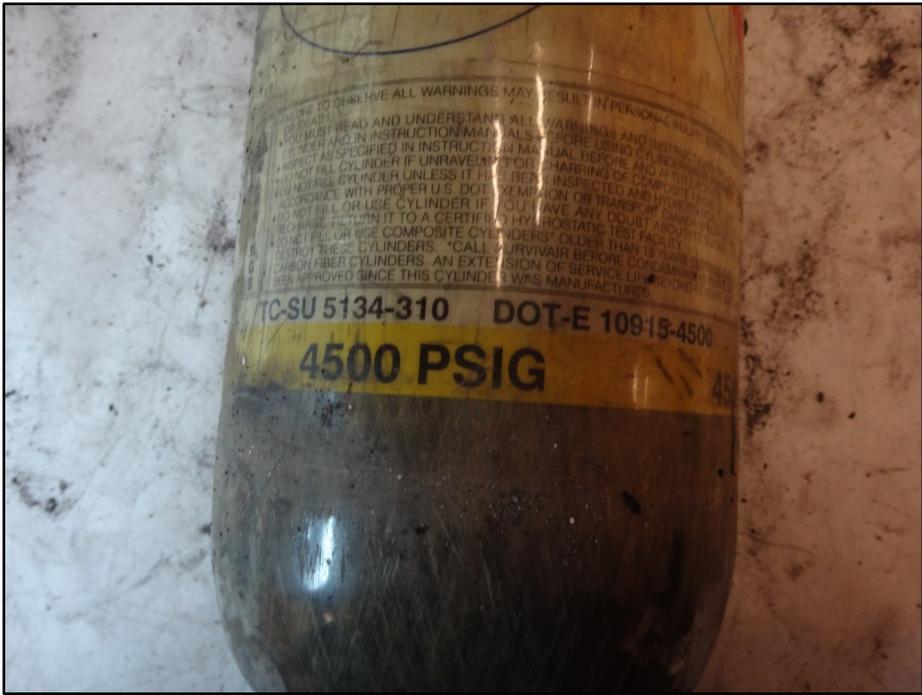
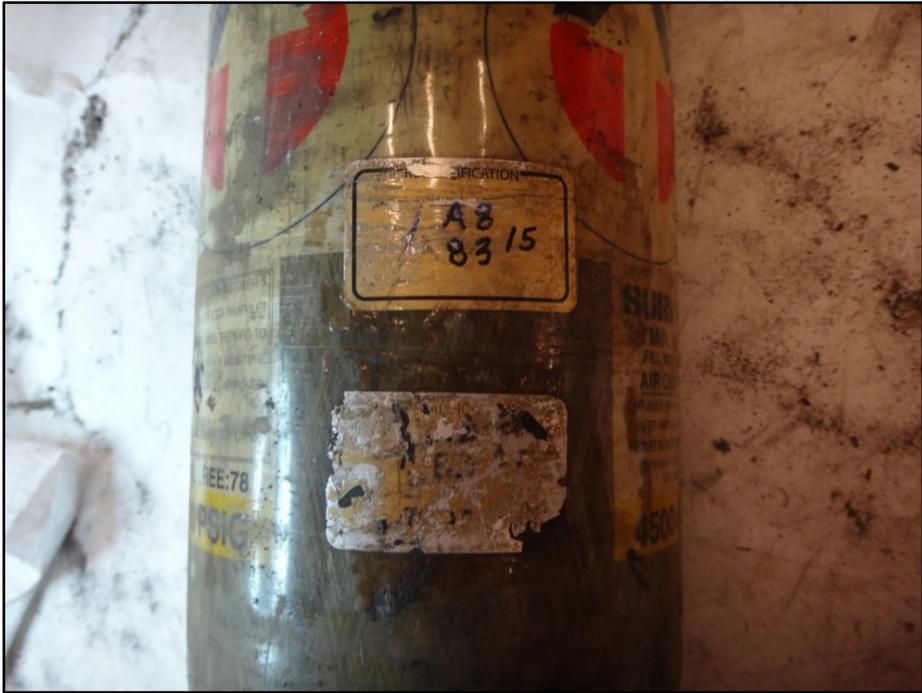
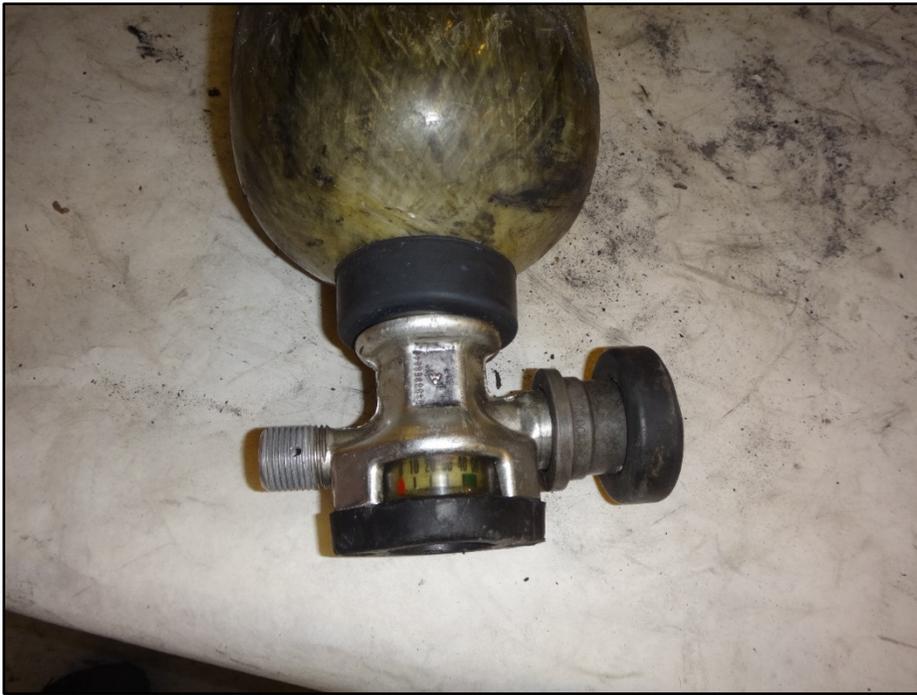
9. Cylinder & Valve Assembly: (refer to **Figures 24-27** in **Appendix III**)

The unit was provided with a corresponding cylinder which was found to also be in testable condition, however it was missing a date for hydrostatic testing. Under the applicable Department of Transportation (DOT) exemption, the air cylinder is required to be hydro tested every five years. For the air cylinder on this unit, the hydro date was not found, therefore, a retest would need to take place before it would be deemed safe to test this unit.

with the unit had some scratches and dirt present. The cylinder was opened and it was empty. This unit passed the NIOSH tests and NFPA air flow test.

- Overall condition is fair to good as there are some surface scratches and dirt present
- Gauge is readable
- Threads are dirty and corroded
- As received cylinder valve open and empty
- Rubber bumper at base on cylinder valve is in OK condition
- Rehydro/inspection date: Not found

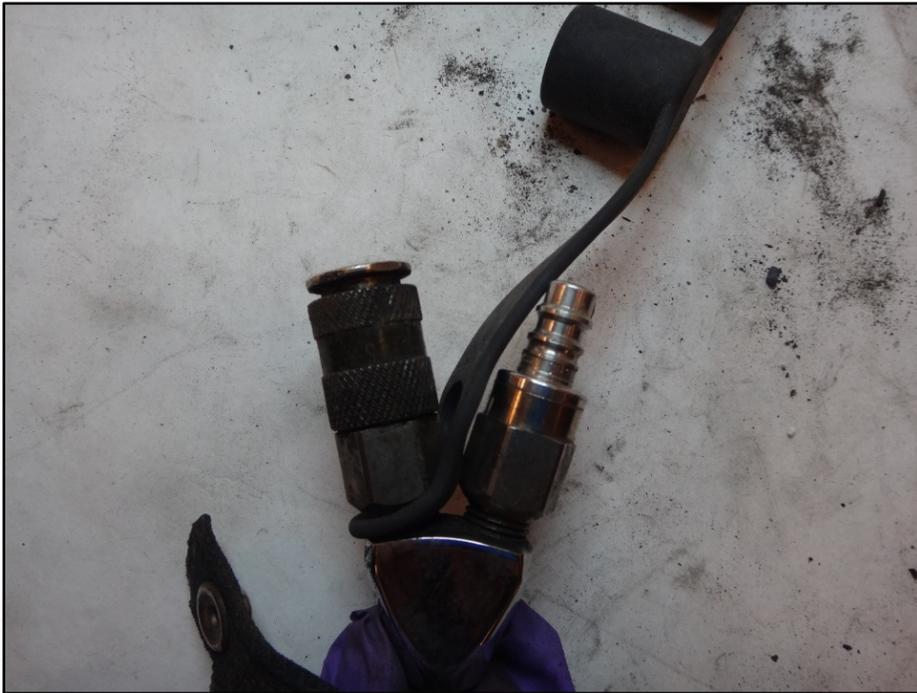
10. Auxiliary Hose: (refer to **Figures 28** in **Appendix III**)

- Female and male attachment points
- Cover in place, but off
- Quick disconnect on female port is stuck
- AISI303 on male port R1.4305
- On quick disconnect RECIUS type 25 NW 7.4

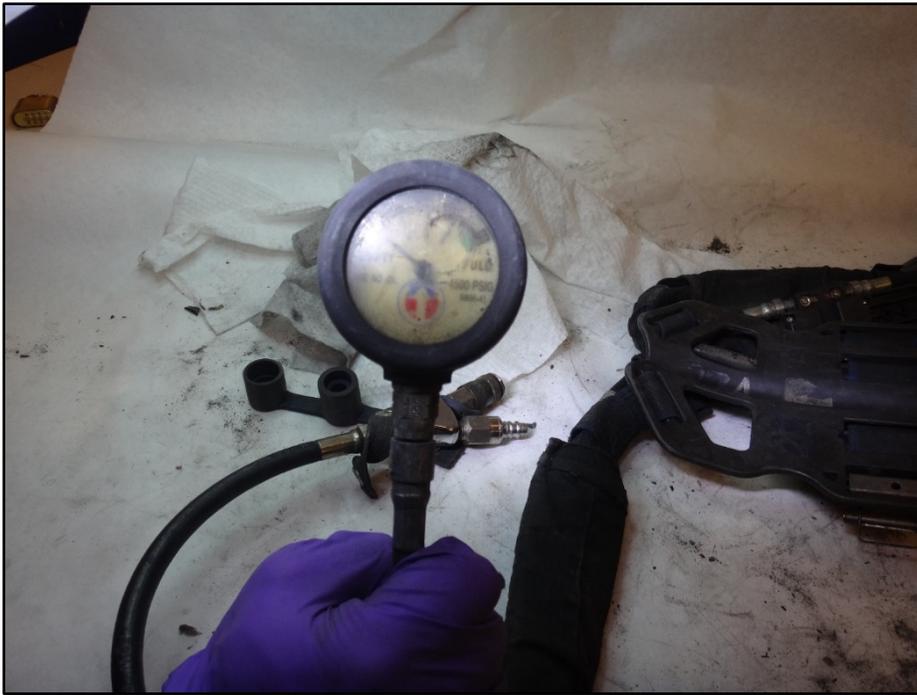
11. Standalone Gauge: (refer to **Figure 29** in **Appendix III**)

- Lens is scratched and dirty, but readable
- 9806-41

Figure 29: Standalone gauge, lens scratched but readable
