Evaluation of Five Self-Contained Breathing Apparatus for Potential Contribution to a Fatal Event in the Fire Service

Kansas City, Missouri Fire Department Request for MSA Firehawk® M7 model, 4500 psi units with NIOSH Approval Numbers TC-13F-550CBRN and TC-13F-549CBRN (July 27, 2016)

NIOSH Task Number 20619

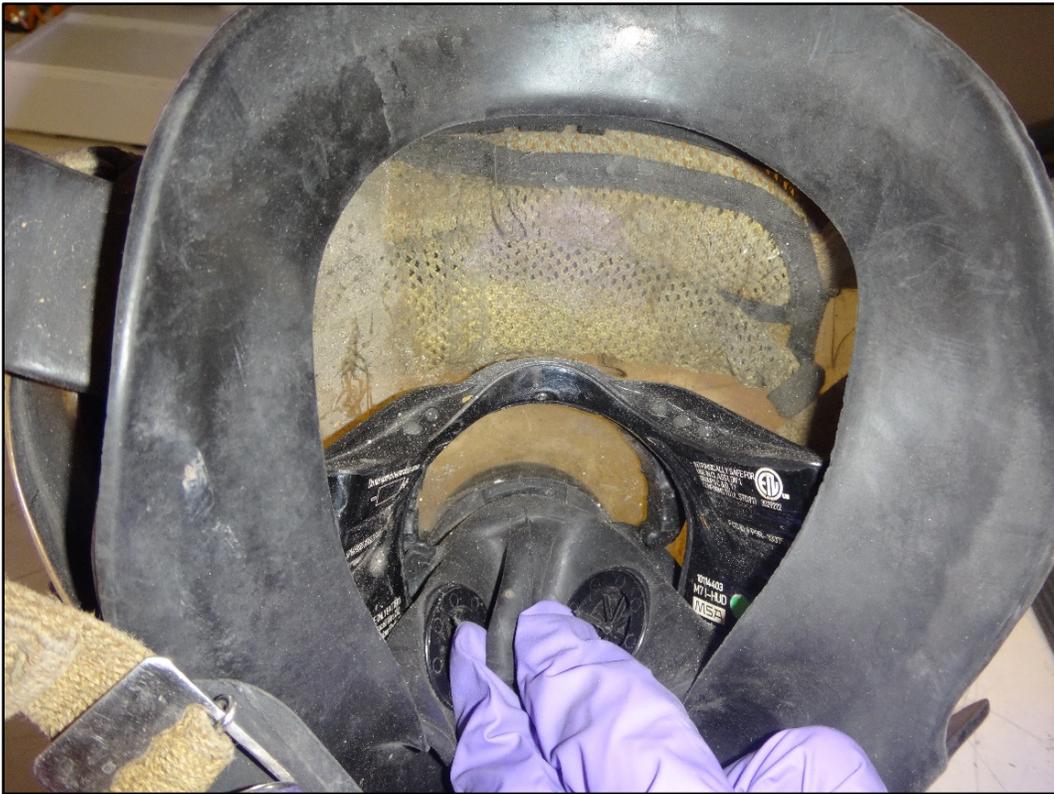
Figure 9: HUD is dislodged from facepiece

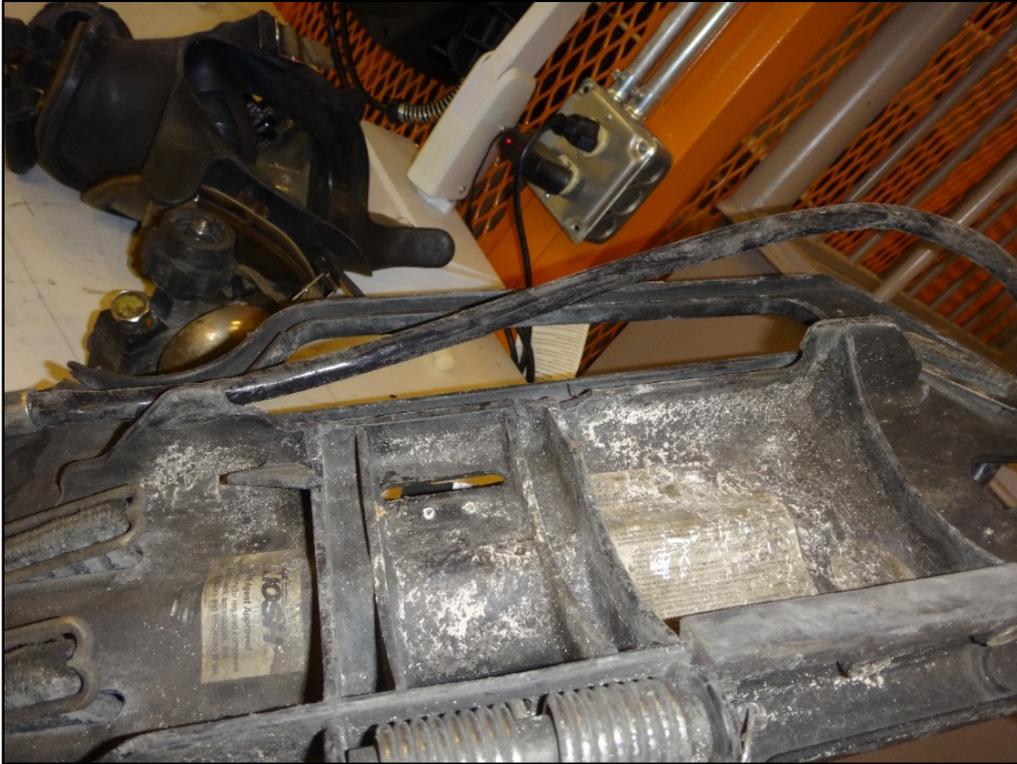
- Overall fair to good condition, cracked/broken frame, dirty.
- Shoulder straps were attached to the frame.
- Cylinder strap missing.
- Frame busted/broken at first stage and on side of frame.
- Frame cracked above right waist attachment.

Figure 29: Damage to right rib of backframe

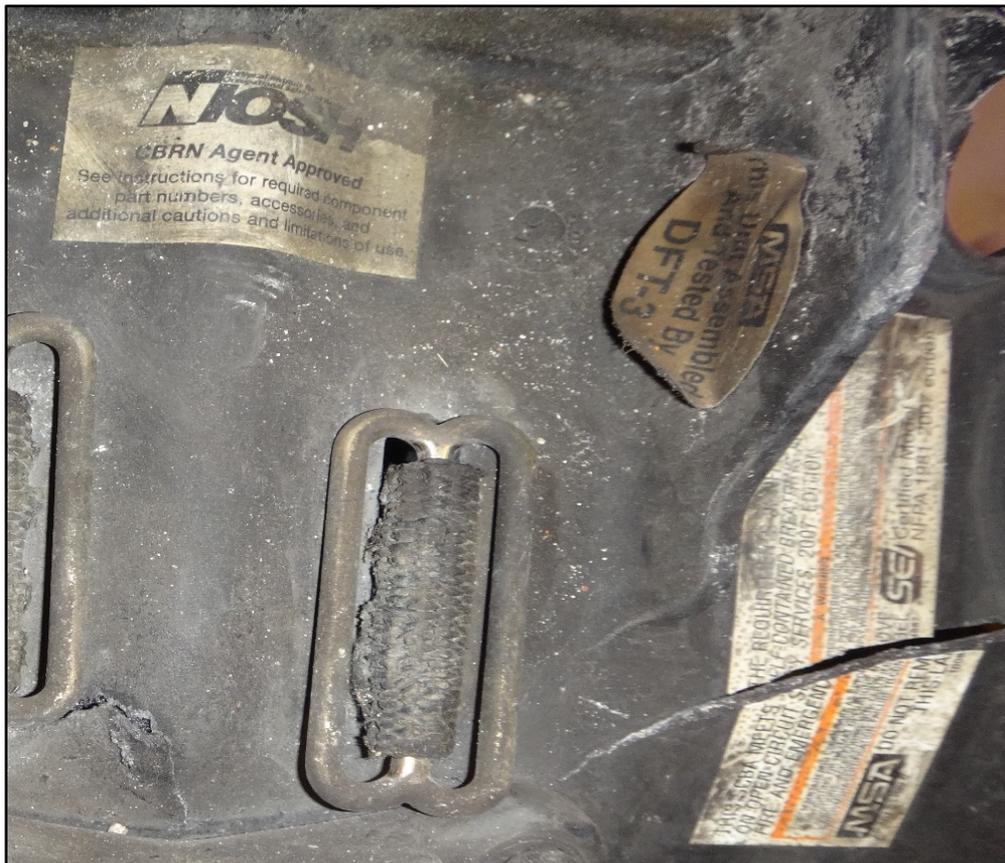
Figure 30: Labels inside of pack, damage to left side

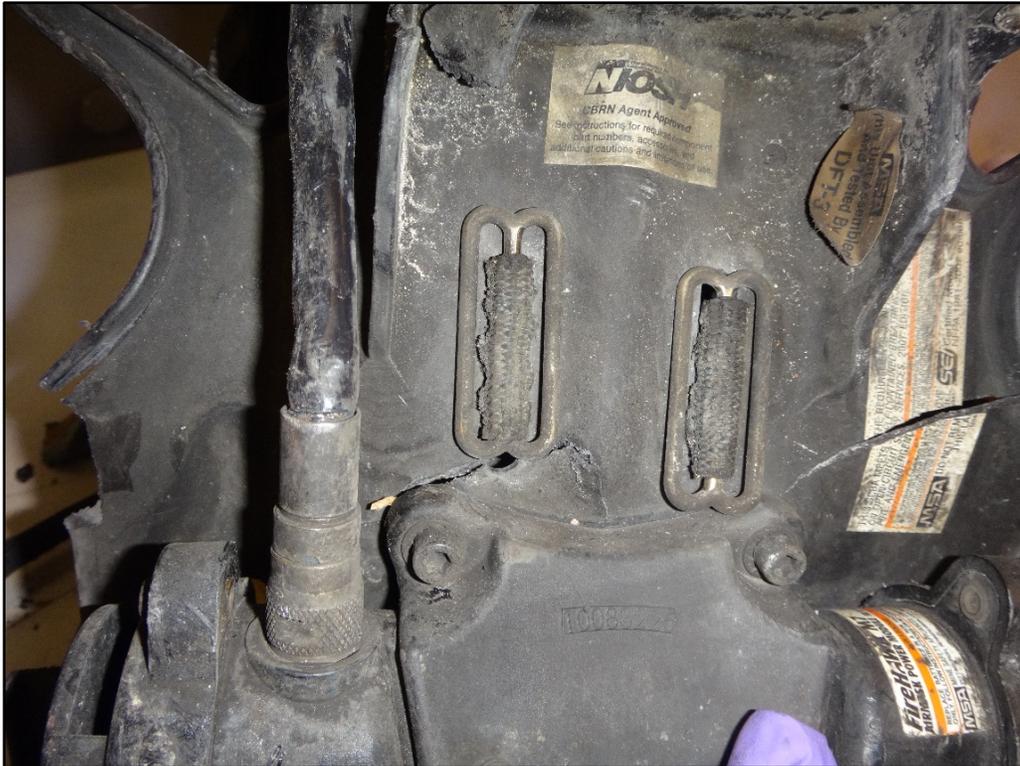
- Overall condition was good shape.
- Held securely to backframe.
- Wire connection connected to PASS device.
- Wire to backframe and ran to console assembly, backframe broke and wire not secure.
- Top left attachment broken away from frame.
- Electrical line had some physical damage but intact.

Figure 31: Damage/cracking to back frame at PASS control module connection

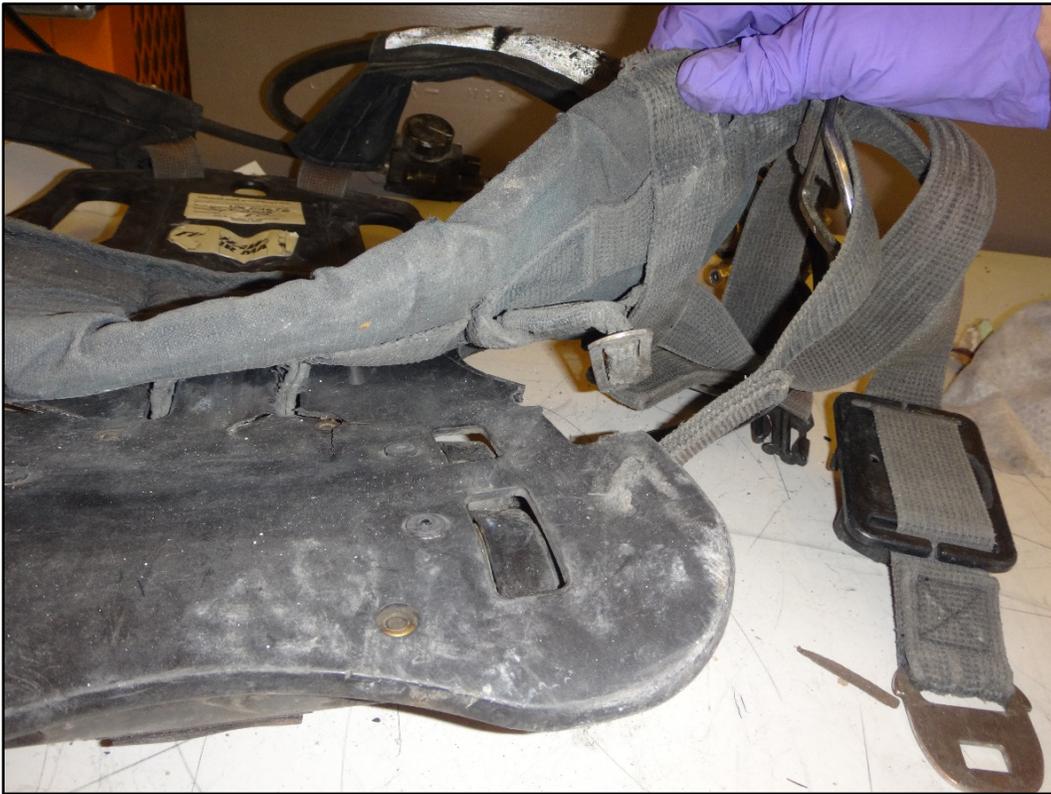
- Waist area buckle latched and released.
- Left side of lumbar broken away from frame.

Figure 34: Broken lumbar attachment

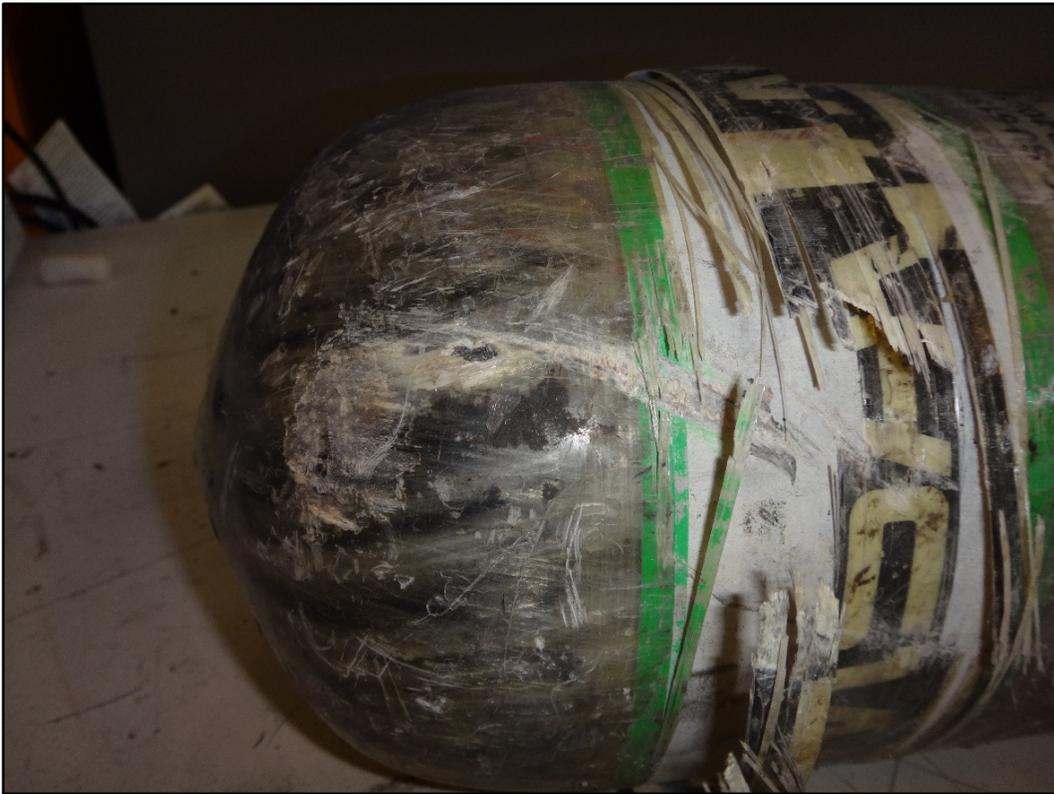
- Overall condition was fair to good as there are some surface scratches and dirt present.
- Gauge was readable.
- Threads ok – no corrosion.
- As received, cylinder valve closed with approximately 3000 psi.
- Rubber bumper at base on cylinder valve was in good condition,
- Carbon fiber unraveling.

Figure 36: Fraying in fiberglass coat

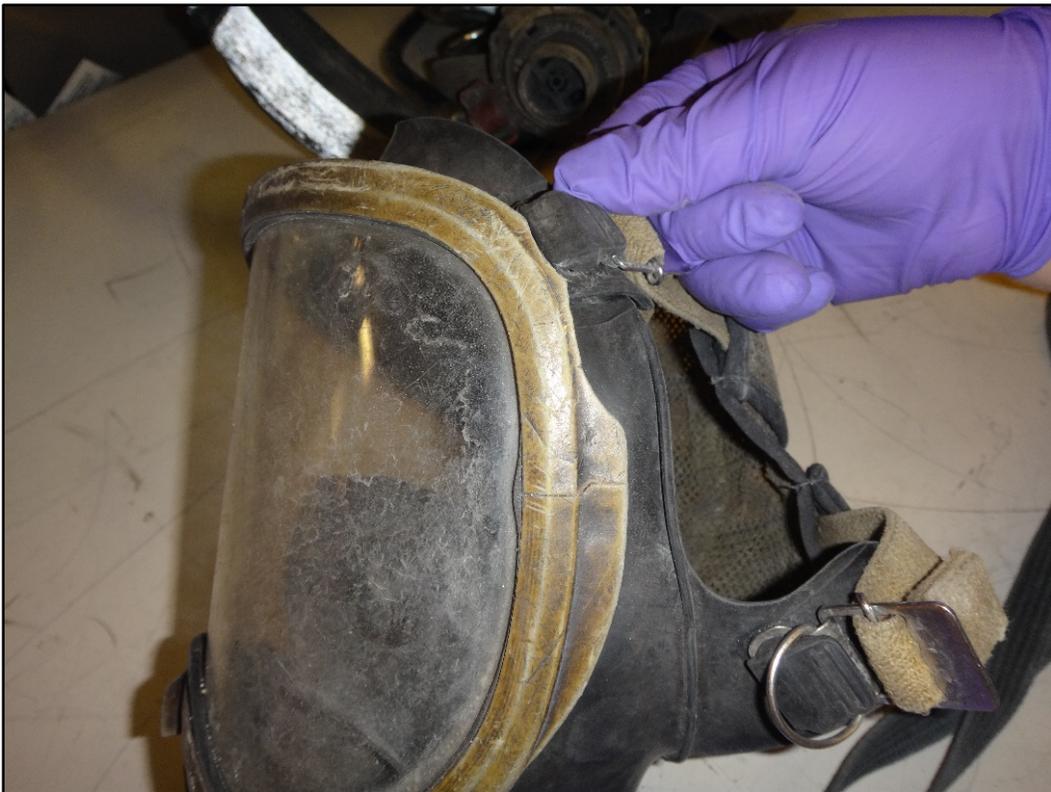
- MMR port dislodged from lens retaining ring.
- Lens appeared to be in good condition, but dirty.
- Flange of lens retaining ring cracked on upper left side.
- Hairnet dirty, but in good shape.
- HUD not present.

Figure 8: Damage to upper left corner of lens retaining ring

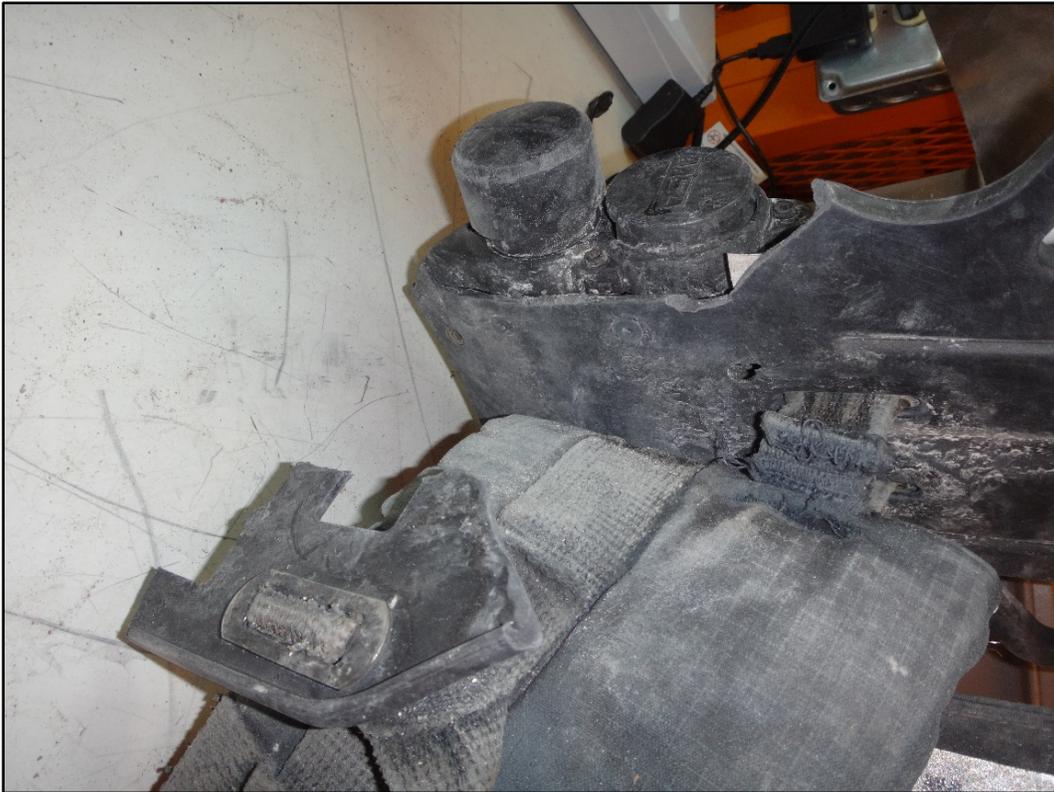
Figure 30: Damage to pack at bottom right corner

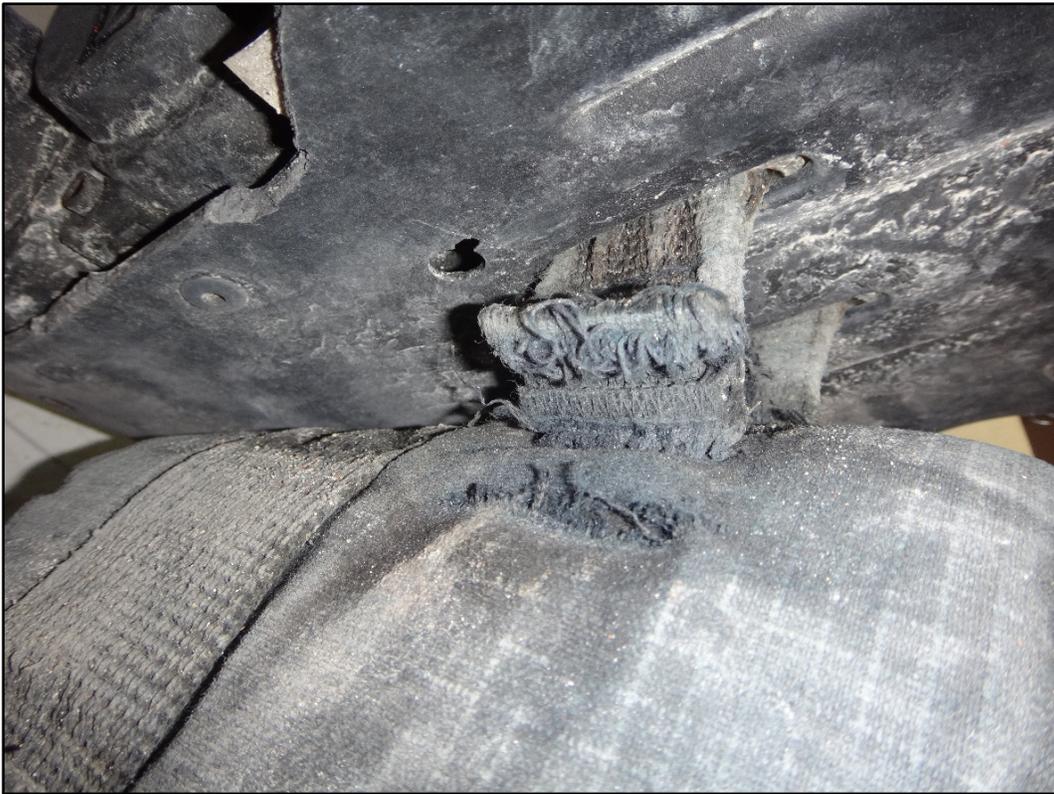
Figure 31: Ripped attachment on lumbar strap

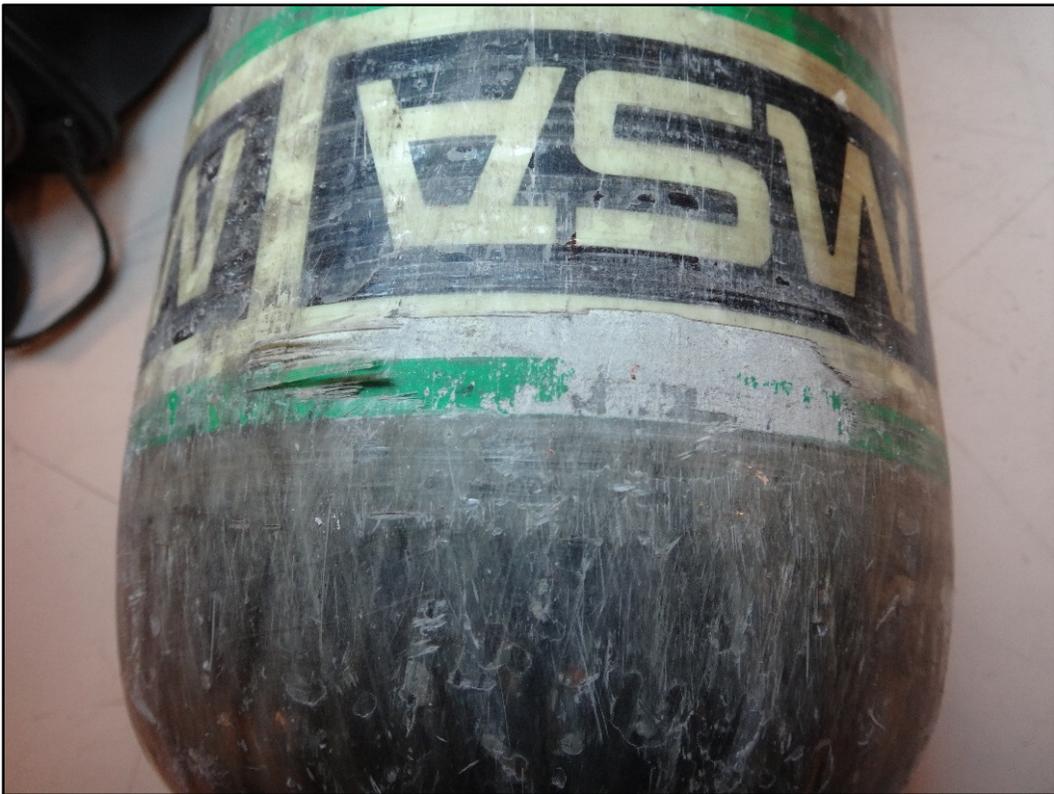
- Overall condition fair to good as there are some surface scratches and dirt present.
- Gauge is readable.
- Threads ok, debris in threads.
- As received cylinder valve open with no air remaining.
- Rubber bumper at base on cylinder valve in good condition.
- Rehydro label present: 09/11.
- Cylinder had gouges in it.
- Pressure relief valve #1011 7500PSId.
- Nick in fiber wrap.

Figure 38: Damage to cylinder coating

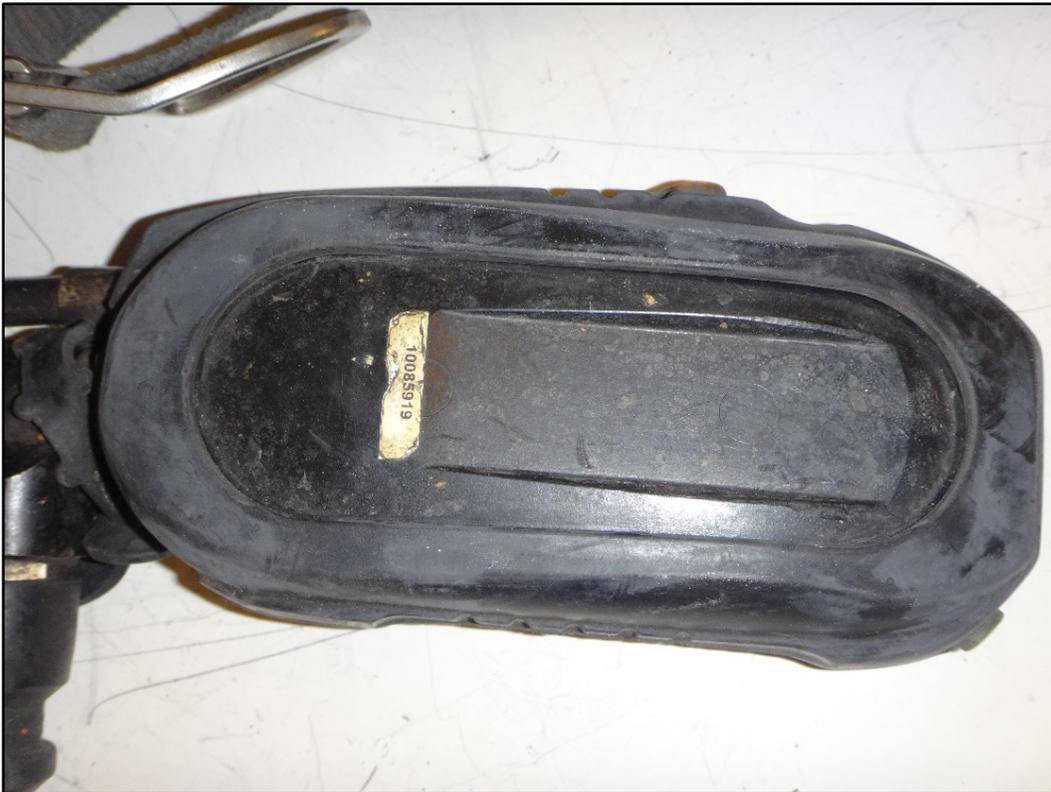
Figure 15: Back of PASS console, SEI label missing

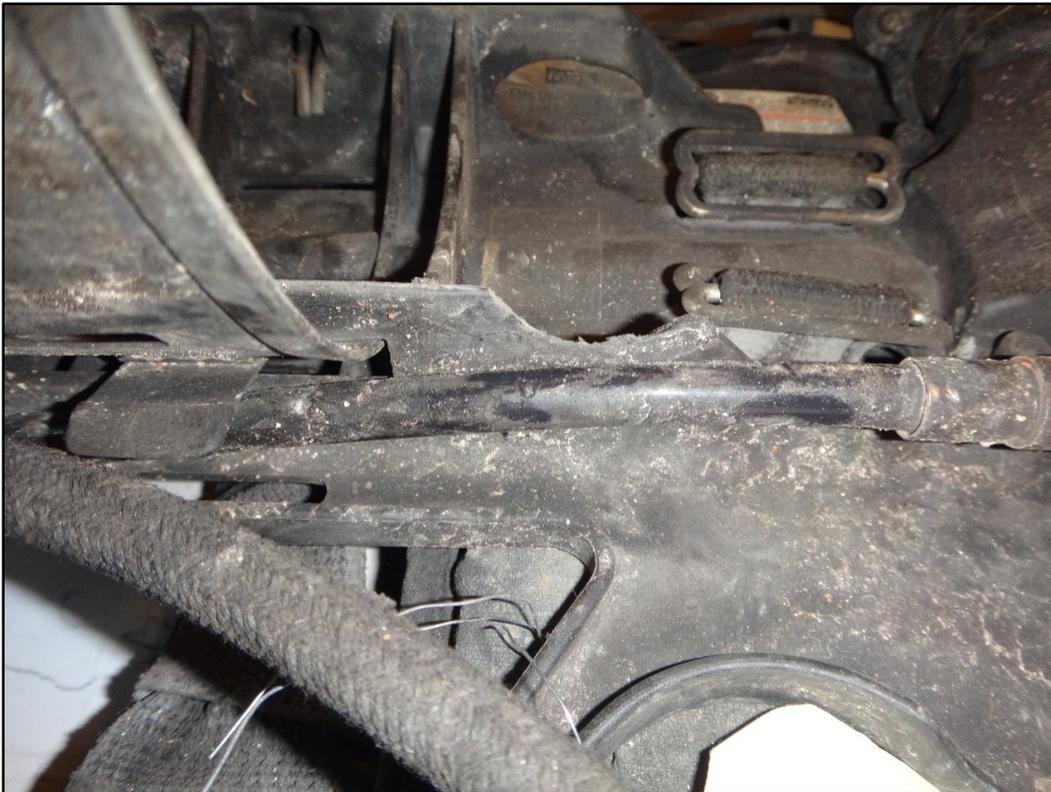
Unit LAE313526 did not come with a specified corresponding facepiece. The overall condition was fair to good with some dirt and debris. The rib of the backframe was broken just above the connection to the Personal Alert Safety System (PASS) control assembly. The cylinder with the unit had level two damage with gouges and dents throughout the bottle. Level two damage affects the fiberglass composite layer of the cylinder. This damage exposes the fiberglass composite layer and may further exhibit fraying of the exposed fiberglass composite. The cylinder was received closed with roughly 3800 psi in the bottle. This unit passed the NIOSH tests and NFPA airflow test.

- Overall fair to good condition, dirty.
- Shoulder straps were attached to the frame.
- Cylinder good, functional.
- Rib of frame broken just above connection to pass control assembly.

Figure 21: Broken rib of back

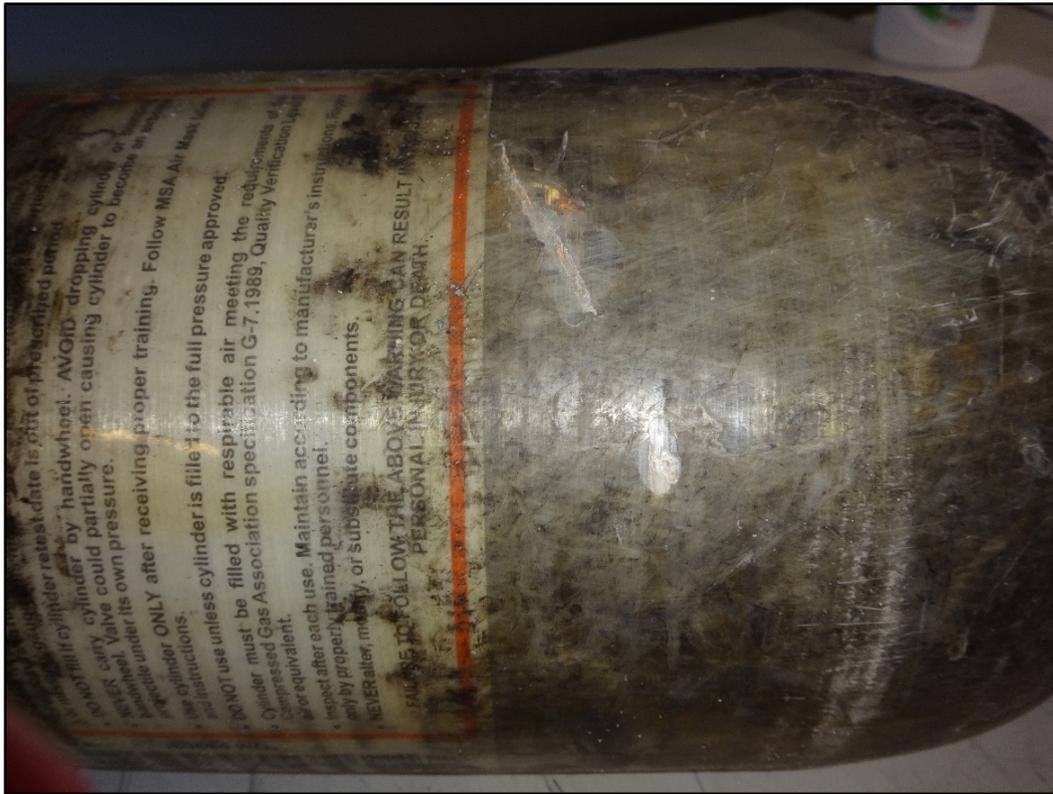
Figure 25: Damage to cylinder

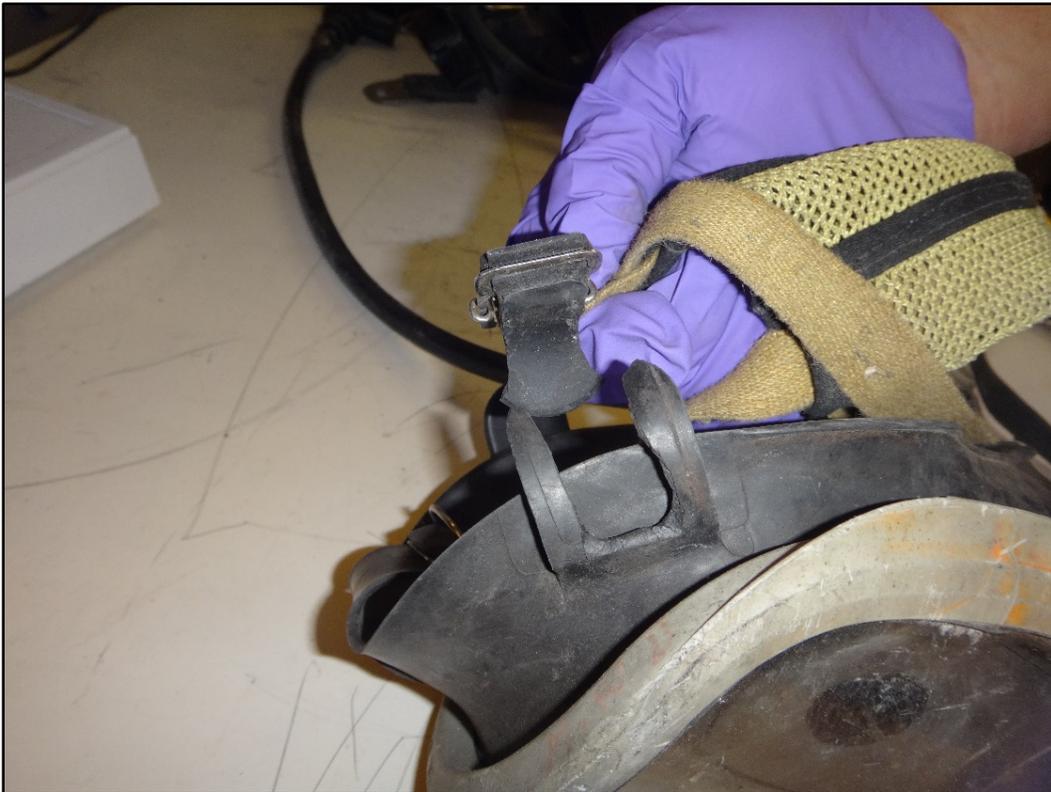
Figure 5: Broken hairnet attachment, upper left corner of facepiece

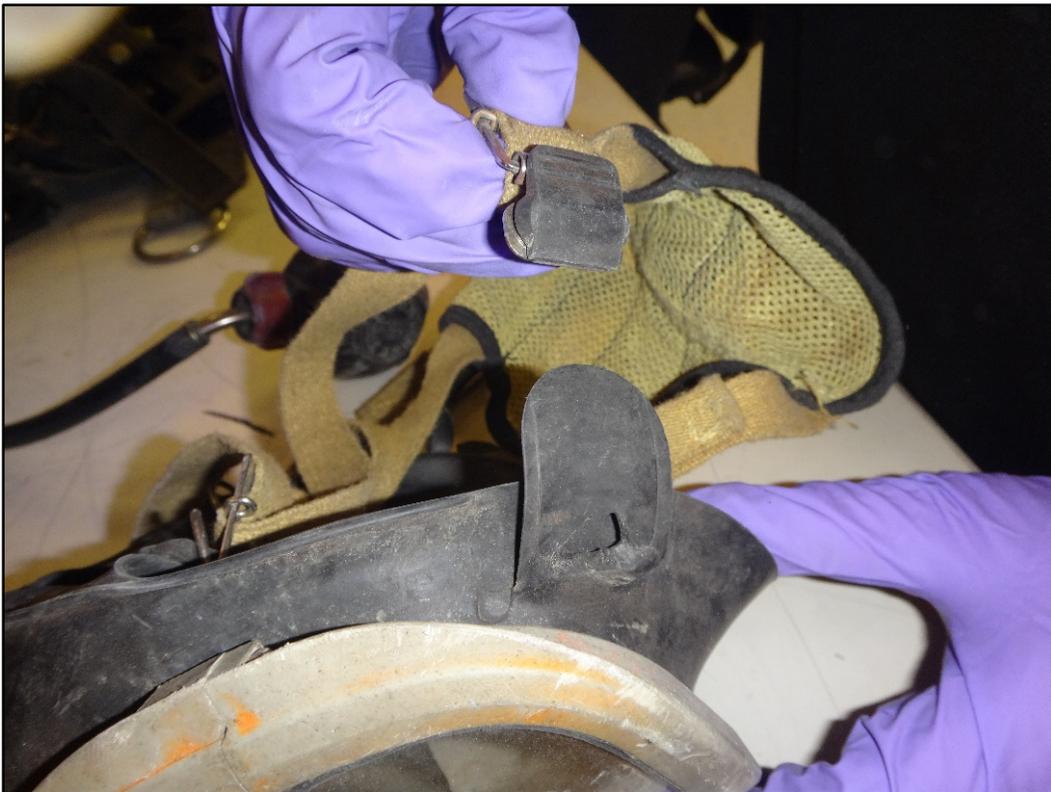
Figure 6: Broken hairnet attachment, upper right corner of facepiece

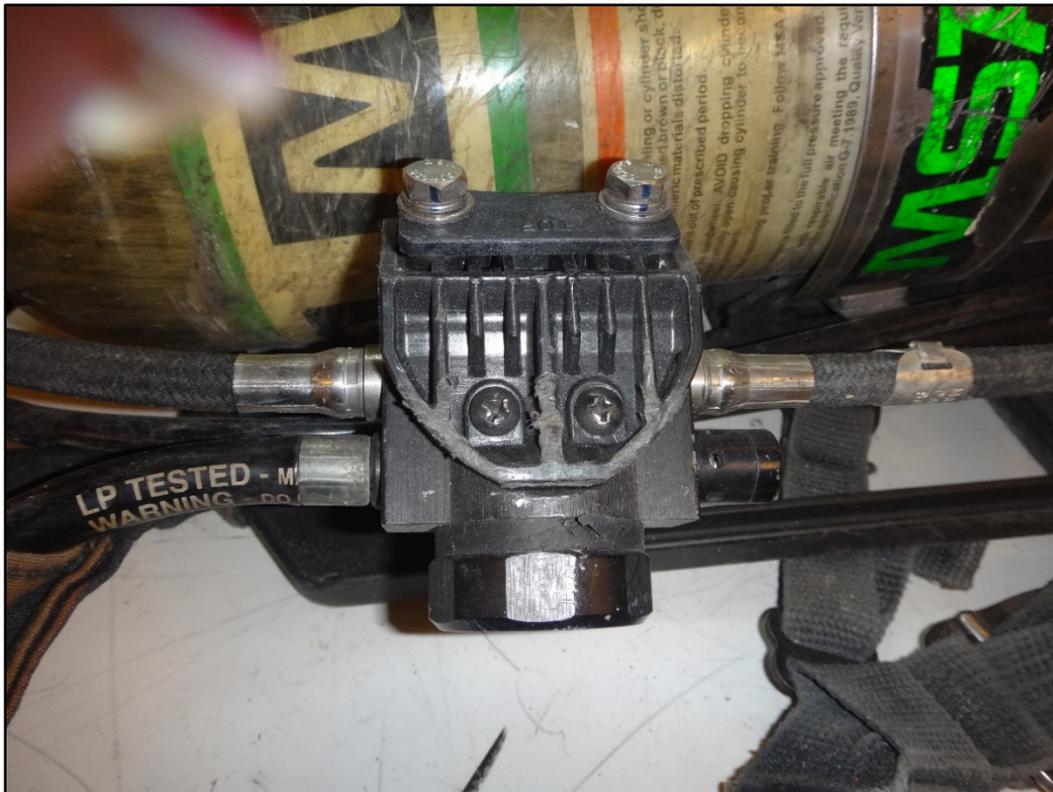
Figure 16: Pressure reducer assembly damage

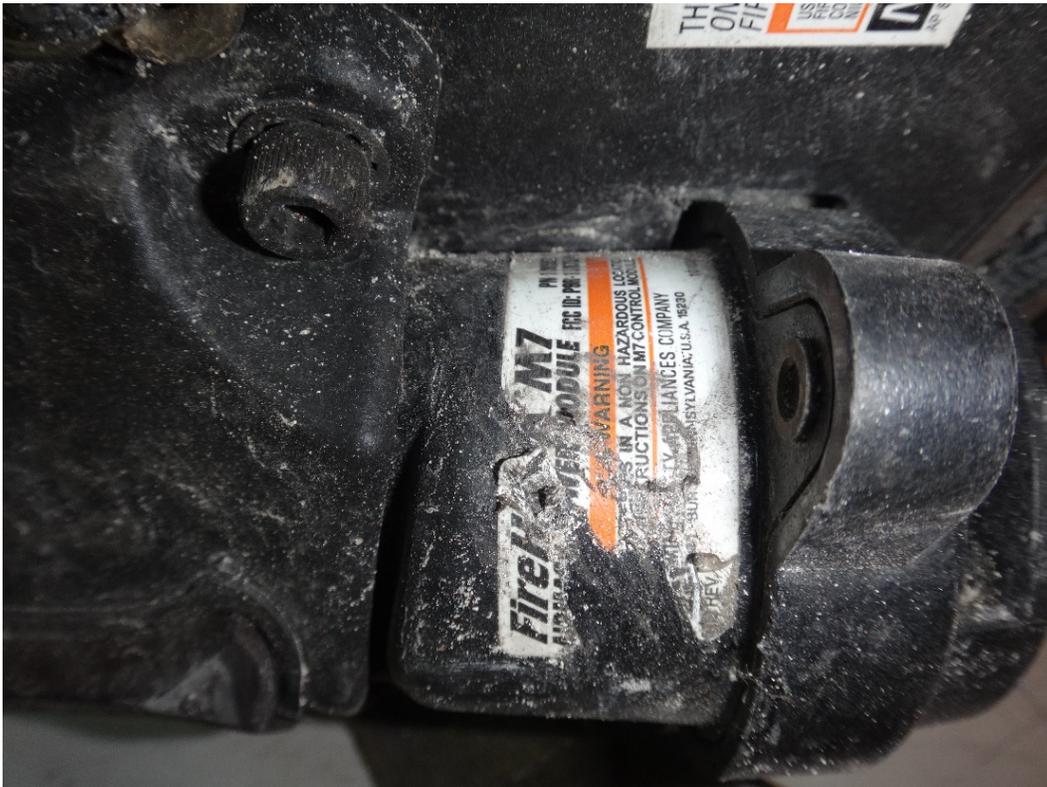
Figure 23: Damaged label on PASS control module

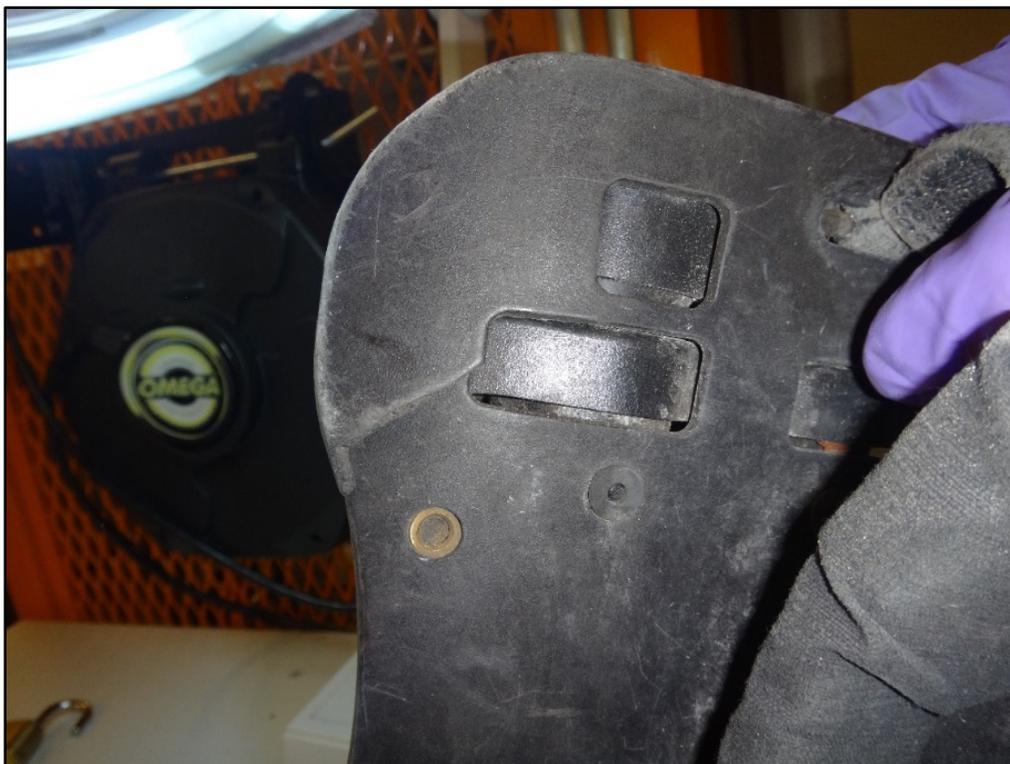
Figure 28: Broken lumbar attachment

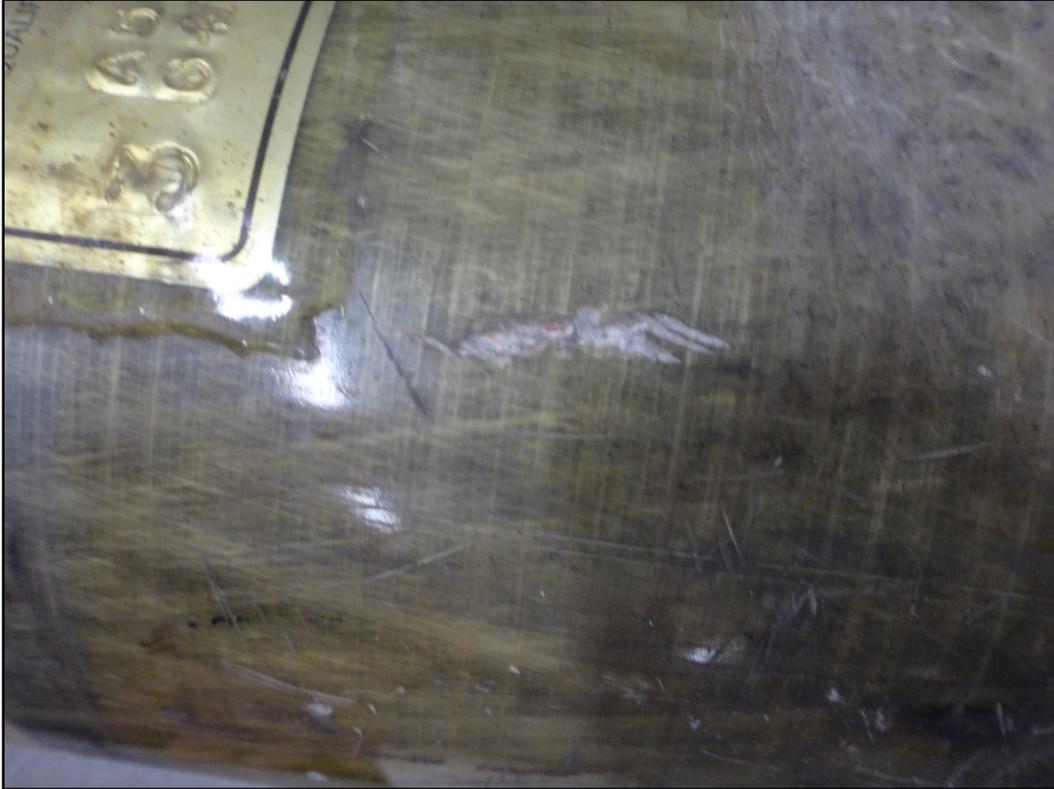
Figure 35: Damage through clear coat/fiber wrap in cylinder
