PPE CASE

Evaluation of Three Self-Contained Breathing Apparatus Involved in a Fatality in the Fire Service

San Antonio County Fire Department Request for three Scott® Safety Air-Pak® Model AP50 4.5 units

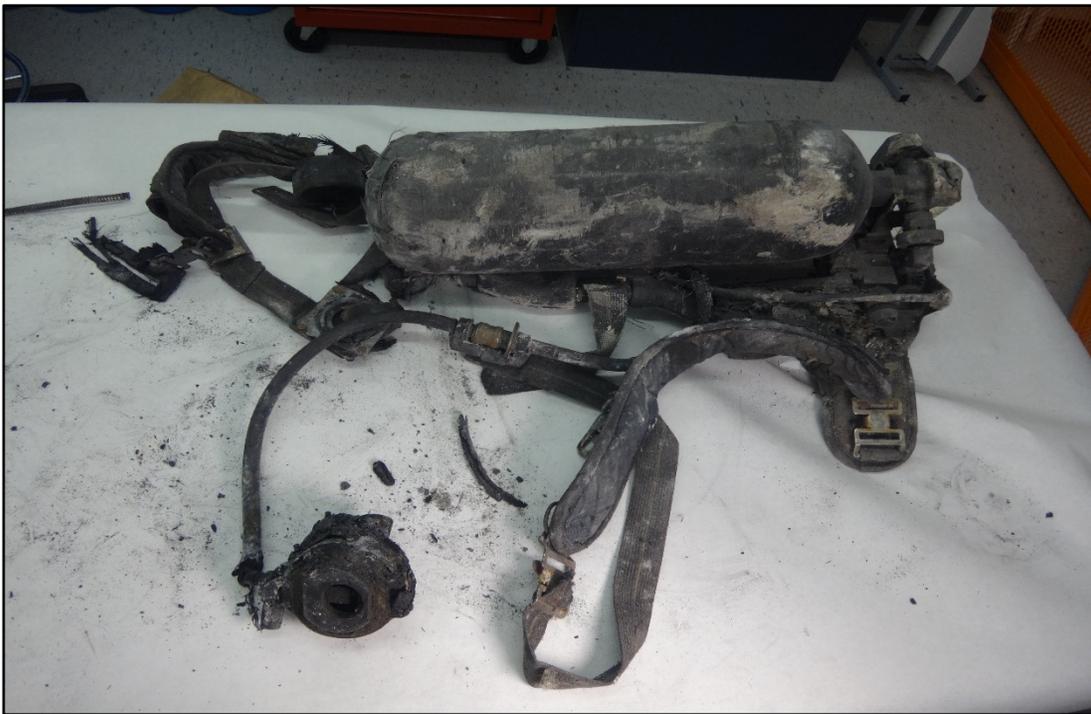
Figure 1: SCBA Unit #1 as received

- This unit received extensive fire damage and could not be inspected or tested

Unit #1 had extensive heat damage and could not be inspected or tested.

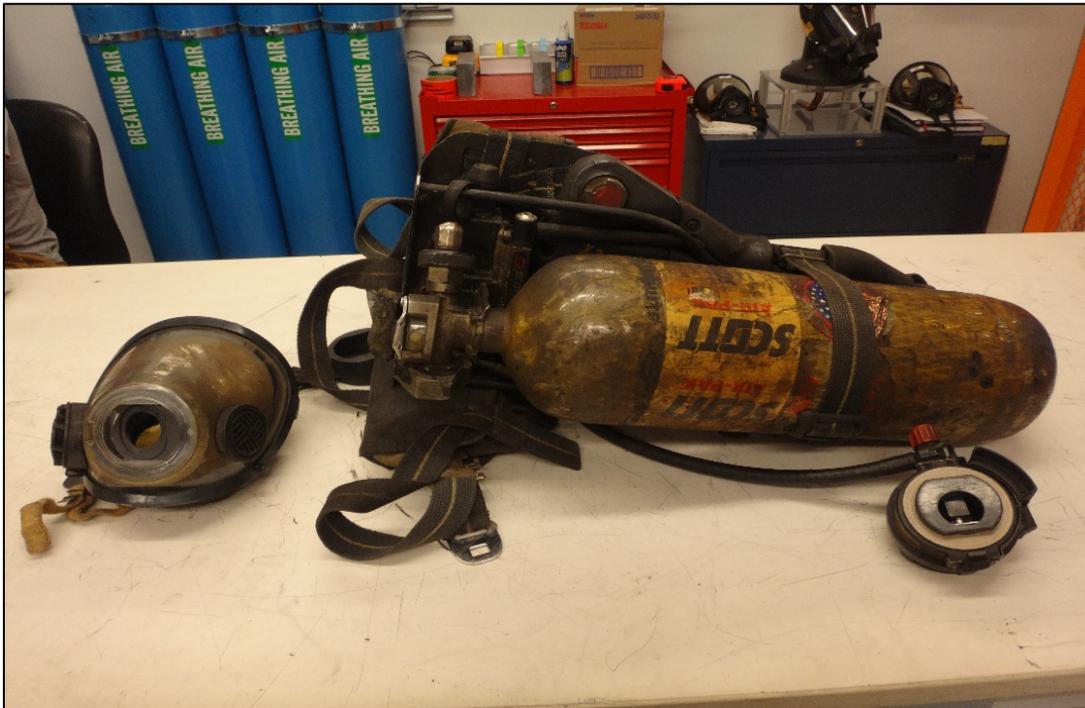
Figure 2: SCBA Unit #2 and cylinder as received

- Corrosion residue found on metal components of unit
- Cylinder received full and closed
- Bypass was closed
- Donning switch off, regulator inactive
- Mask mounted regulator (MMR) was not connected to facepiece

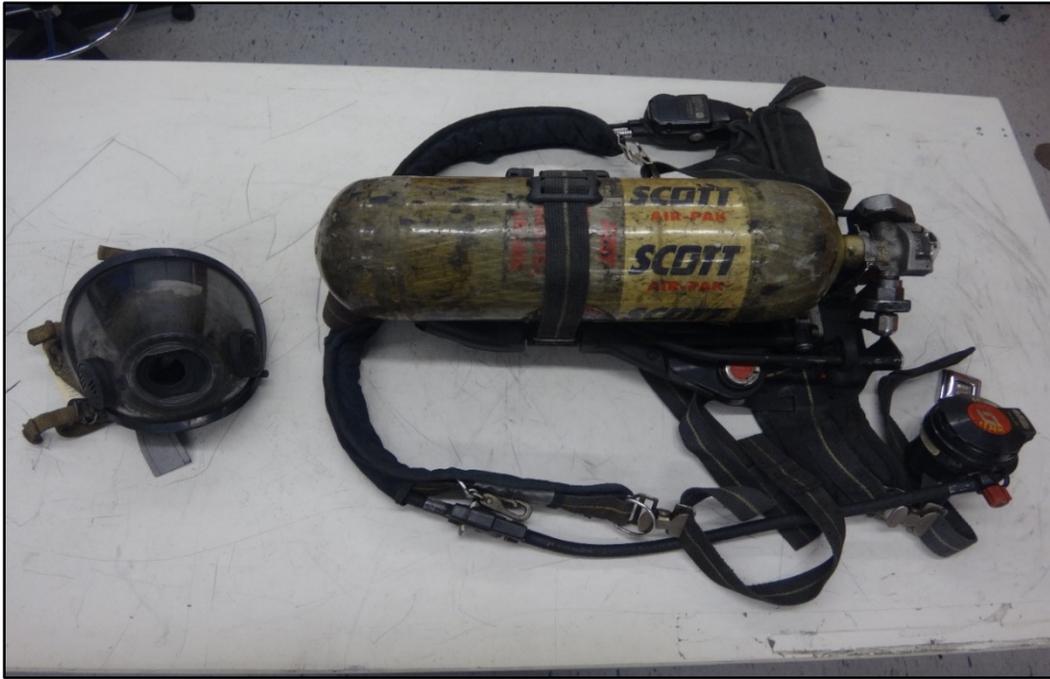
Figure 3: SCBA Unit #3 and cylinder as received

- SCBA Unit #3 was delivered by FedEx in a cardboard box to Lab H1513
- Corrosion residual found on threads on cylinder attachment
- Cylinder was received empty and closed
- Donning switch was off with regulator intact
- MMR was connected to waist belt

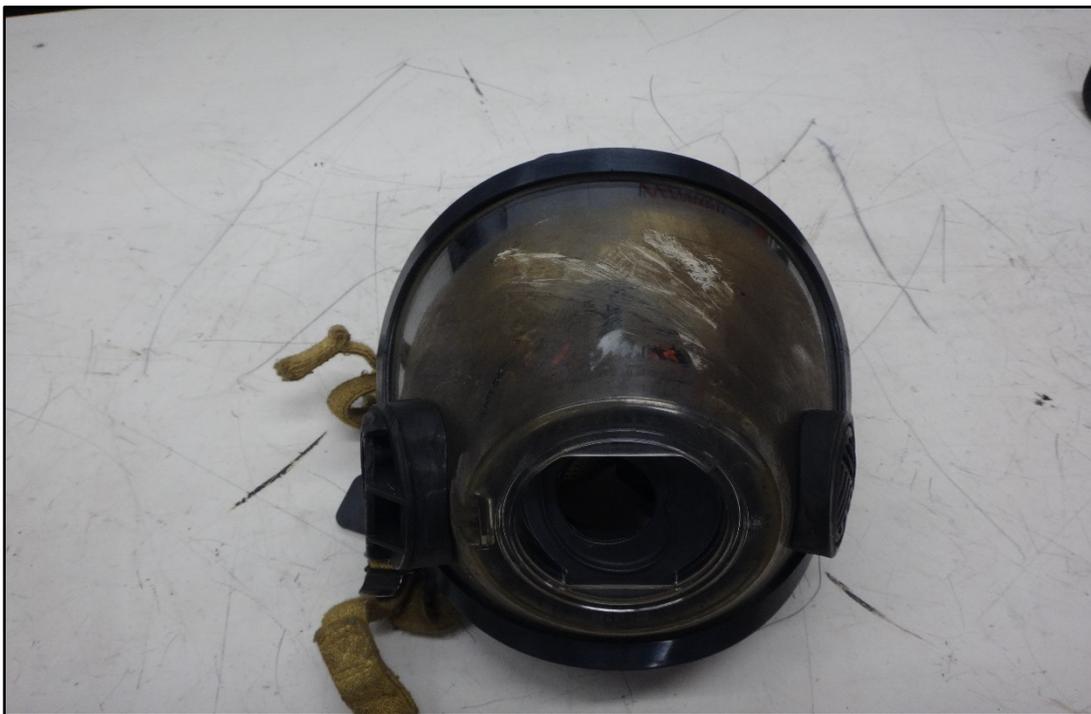
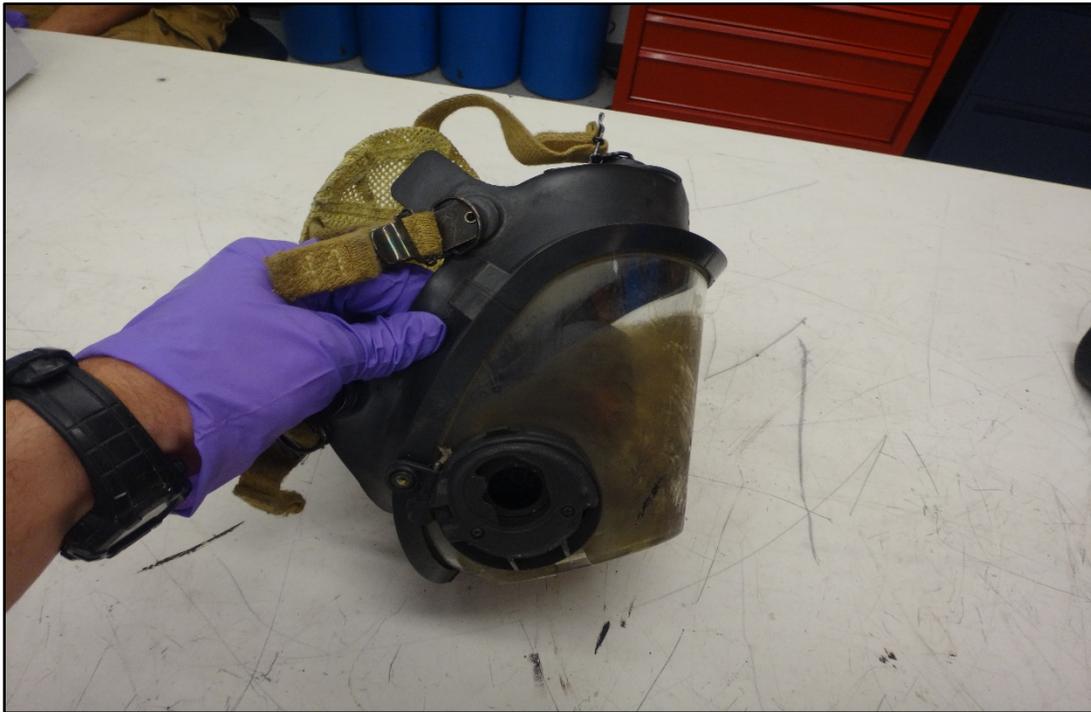
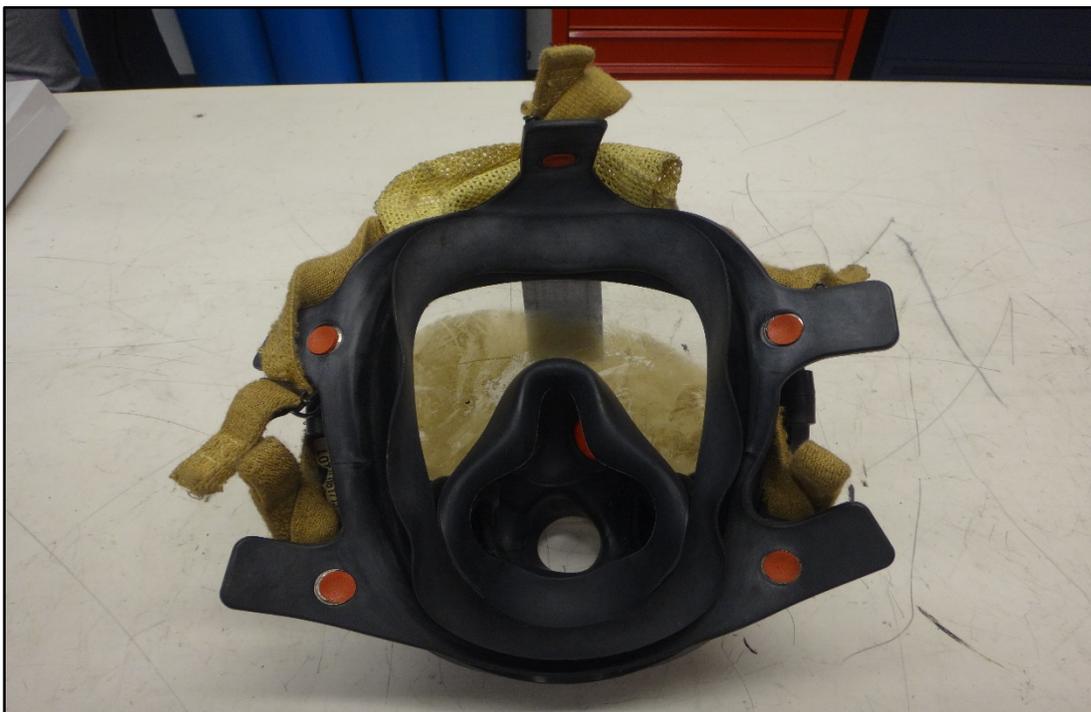
- Facepiece seal P/N: 31001740; Large; MFG date: 05/2015
- Nosecup P/N: 201128 1; Size: Large; MFG date: 4th Q 2015
- Retaining ring MFG date: 04/2015; P/N: 31002810; Lot# 061715; FT 968
- Lens P/N: 805337-13/-33/-36; MFG date: 11/2014
- Overall condition good, very dirty, very smoky
- Lens was clouded, dirty, with scratches
- Lens had thermal insult
- Hairnet was fair, but dirty
- Hairnet markings: 5655; 119950
- Hairnet straps good, straps moved freely held in place, held securely to facepiece
- Attachment points for straps were good
- The facepiece seal was in good condition
- Regulator interface area was in good condition

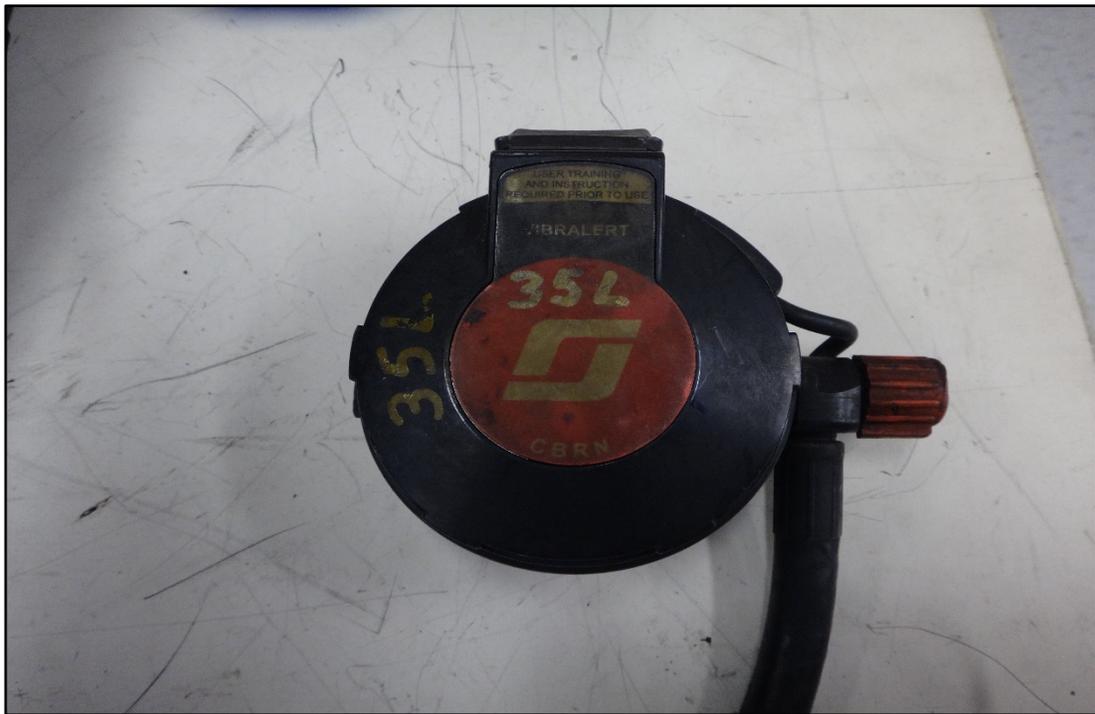
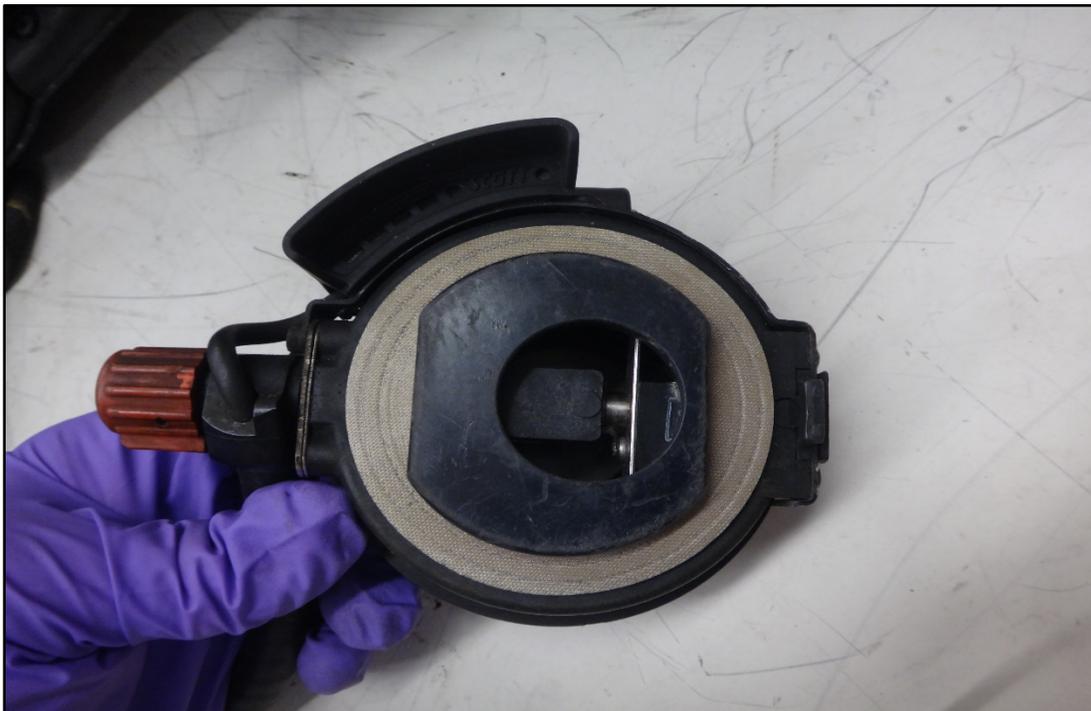
- Air-Pak® X3 with Vibralert and Heads Up Display (HUD)
- Regulator assembly P/N: 200077-50; S/N:115S1528000122; MFG date: 07-06-15
- Other markings; A3Q15 stamped; 099X scribed/written
- Overall condition fair with signs of heat damage
- Outer case good and front label was also in good, but dirty condition
- Donning switch was in good condition
- Bypass found open, bypass knob in good shape
- Sealing area was dirty with no signs of fraying around the edge, but had minimal scratches
- Regulator could be attached and removed
- Locking assembly functioned, but sticky
- HUD fully intact

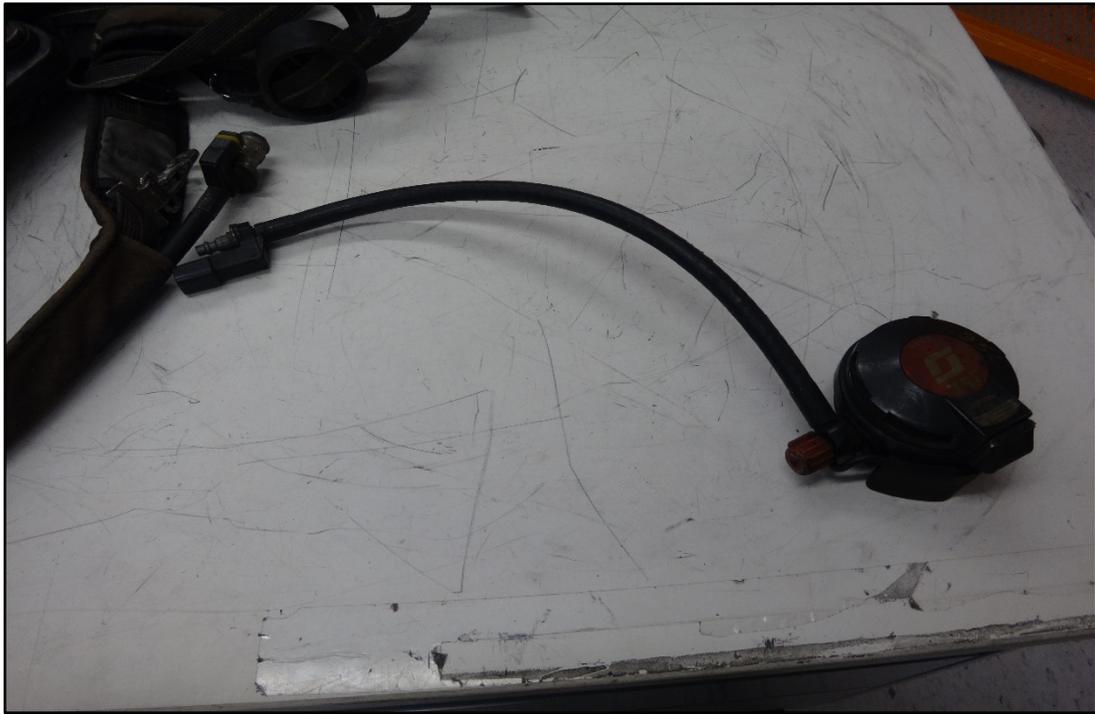
Figure 9: Low pressure hose and Quick Disconnect

- P/N: SCOTT 31901446
- Overall condition was fair to poor; signs of heat damage and abrasion
- Attached from pack at Quick Disconnect
- Quick Disconnect was in good condition and functioned
- Line ran through the shoulder strap to the reducer

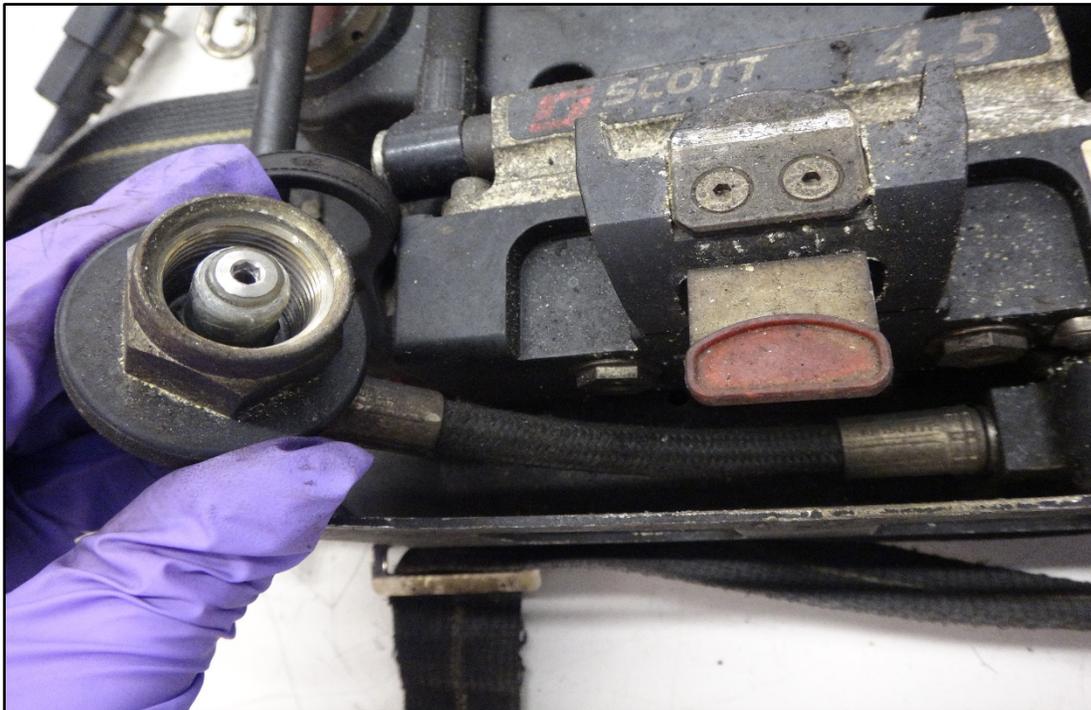
Figure 12: High pressure hose and cylinder attachment

- Overall condition was good, but dirty and signs of corrosion
- Cylinder attachments threads dirty, corroded, threads on and off, “O” ring in place
- RIC/UAC system connector markings: Eaton FD17-1002-10-04
- RIC/UAC system connector cover in good condition, connection dirty

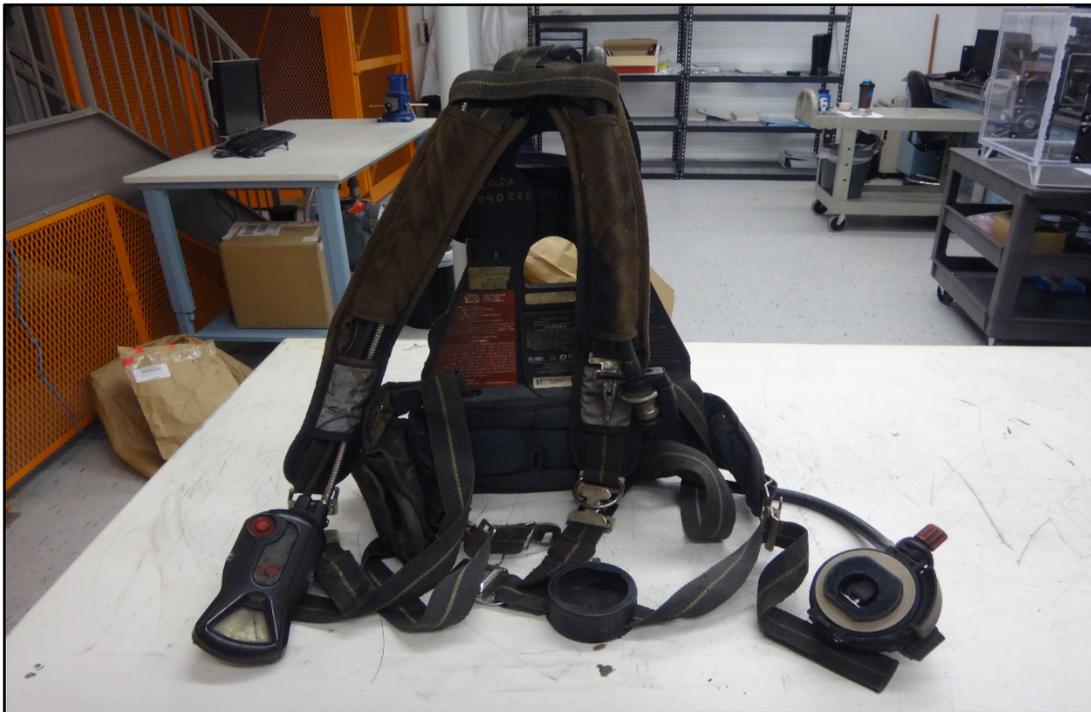
Figure 16: Straps and buckles

- Overall strap condition was fair with significant signs of corrosion and heat damage
- Both shoulder straps attached at the top of the backframe
- Hose lines and wires passed through shoulder straps
- All adjustable buckles moved and held in place
- Waist area buckle latched and released
- Lumbar strap was in good condition; with heavy dye-sublimation

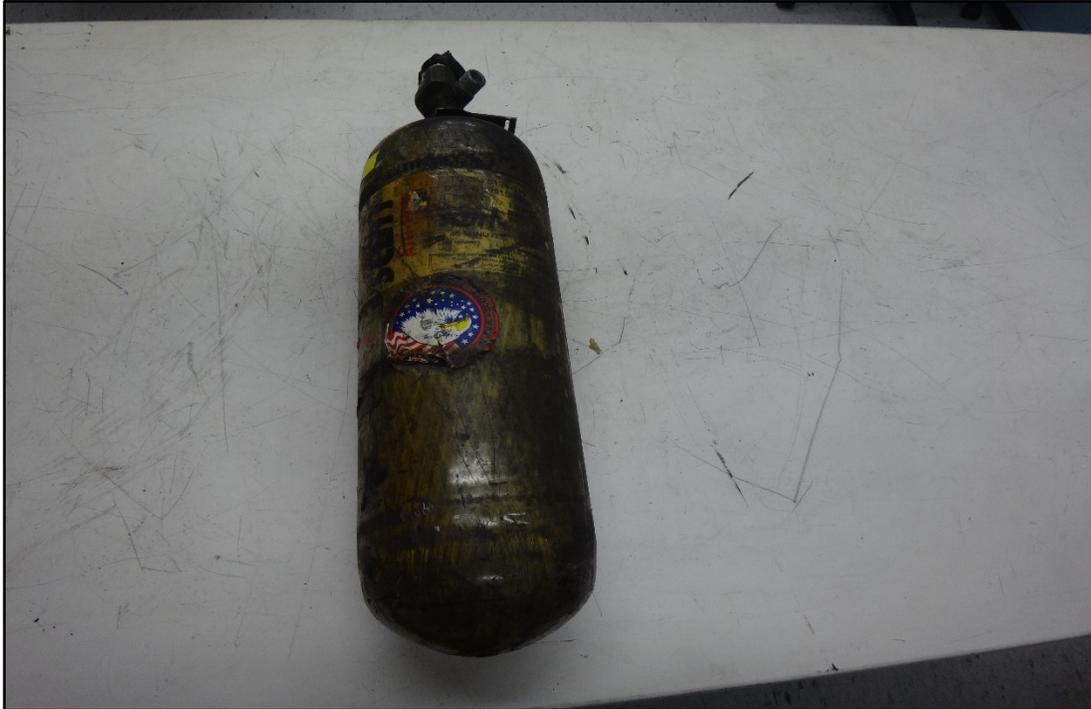
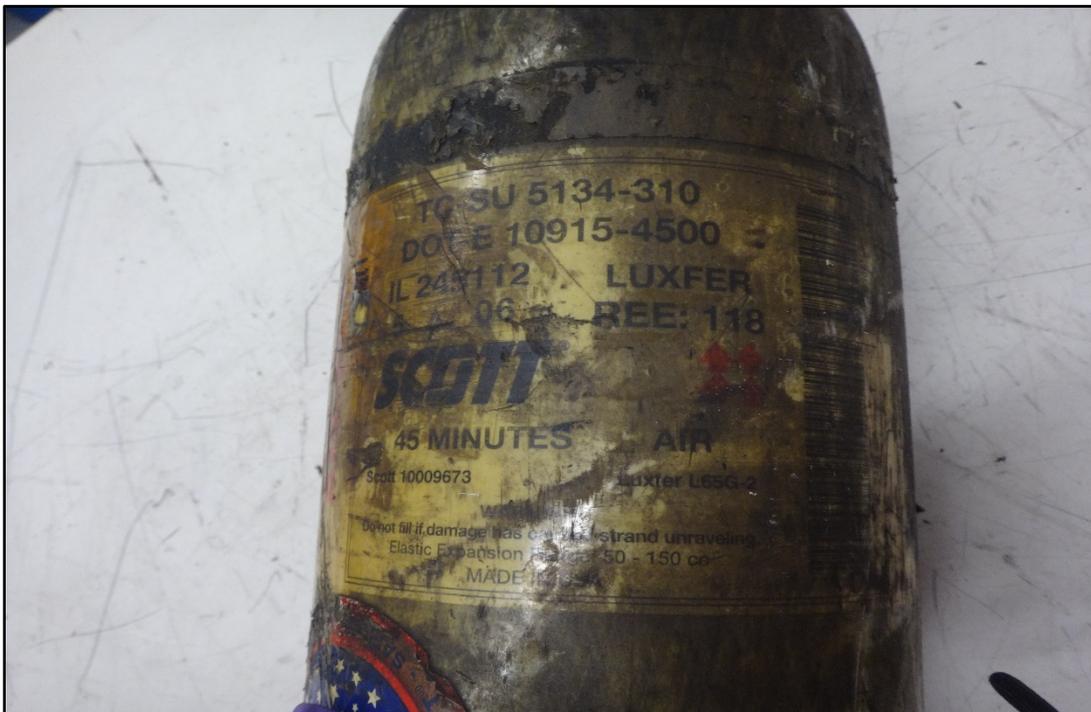
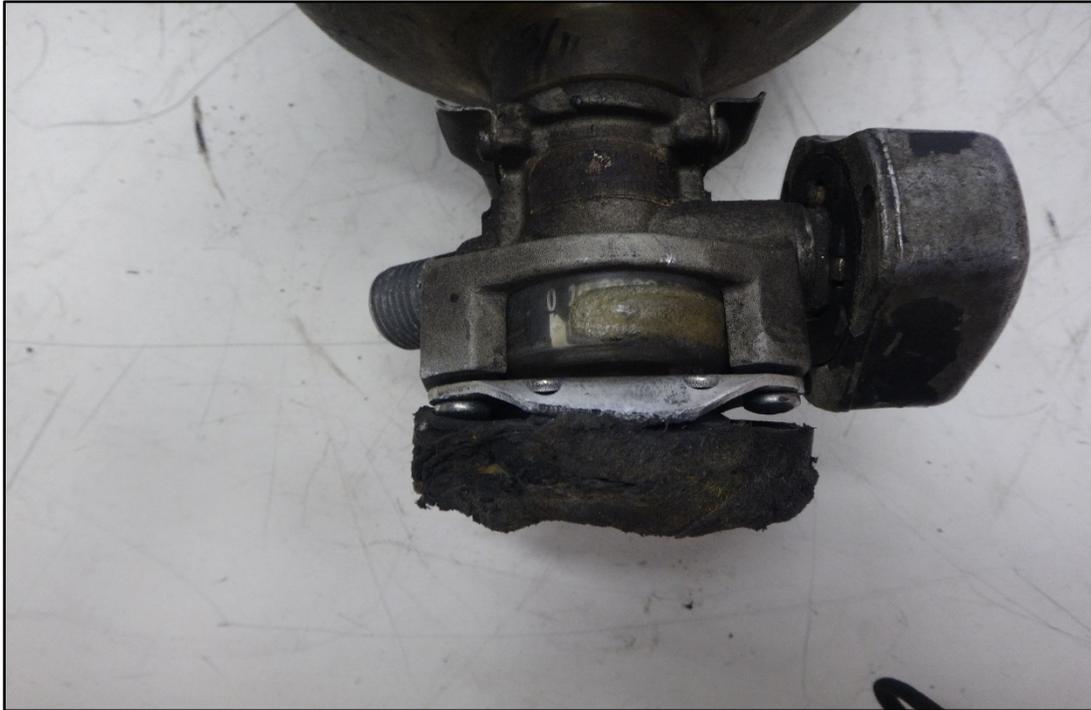
-
- Hydro date: 5/2006 45 Minute, 4500 PSI
 - Overall condition was fair, with signs of heat damage
 - Gauge not easily readable; signs of heat damage
 - Threads dirty with corrosion
 - Rubber bumper had heavy signs of heat damage
 - As received cylinder valve closed and empty

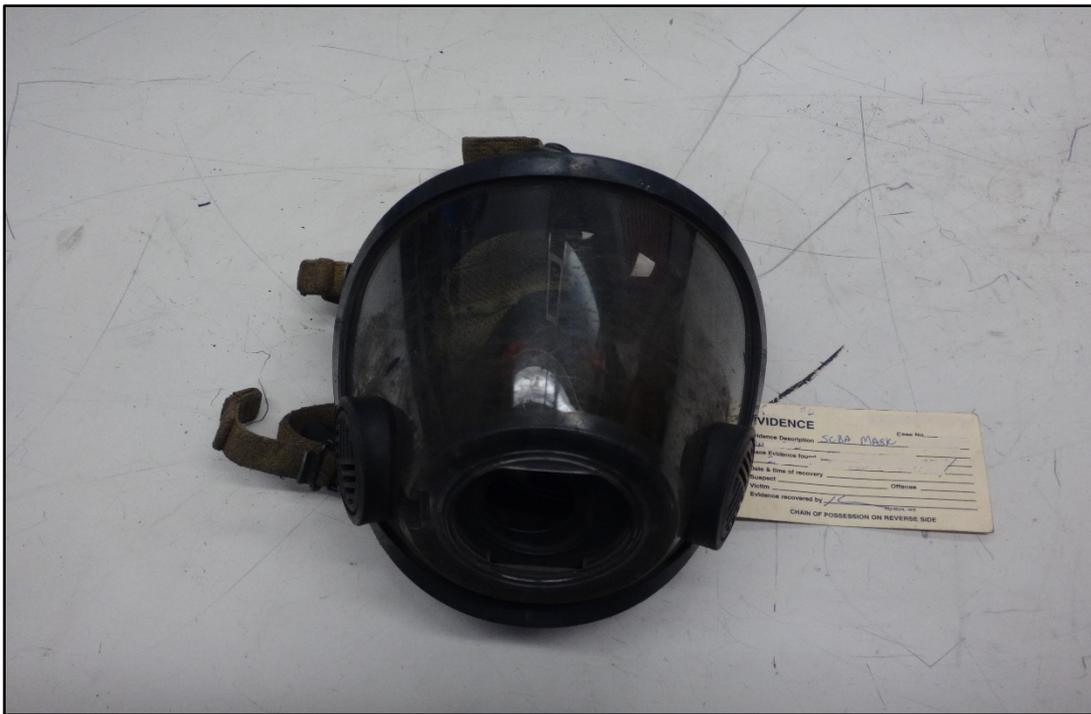
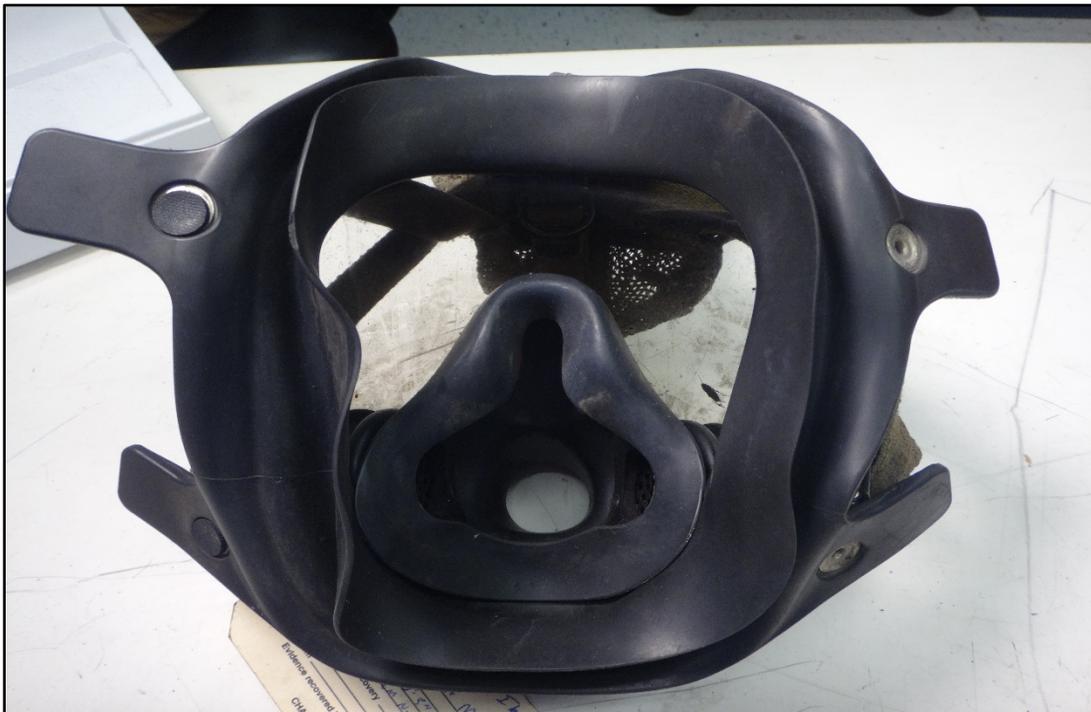
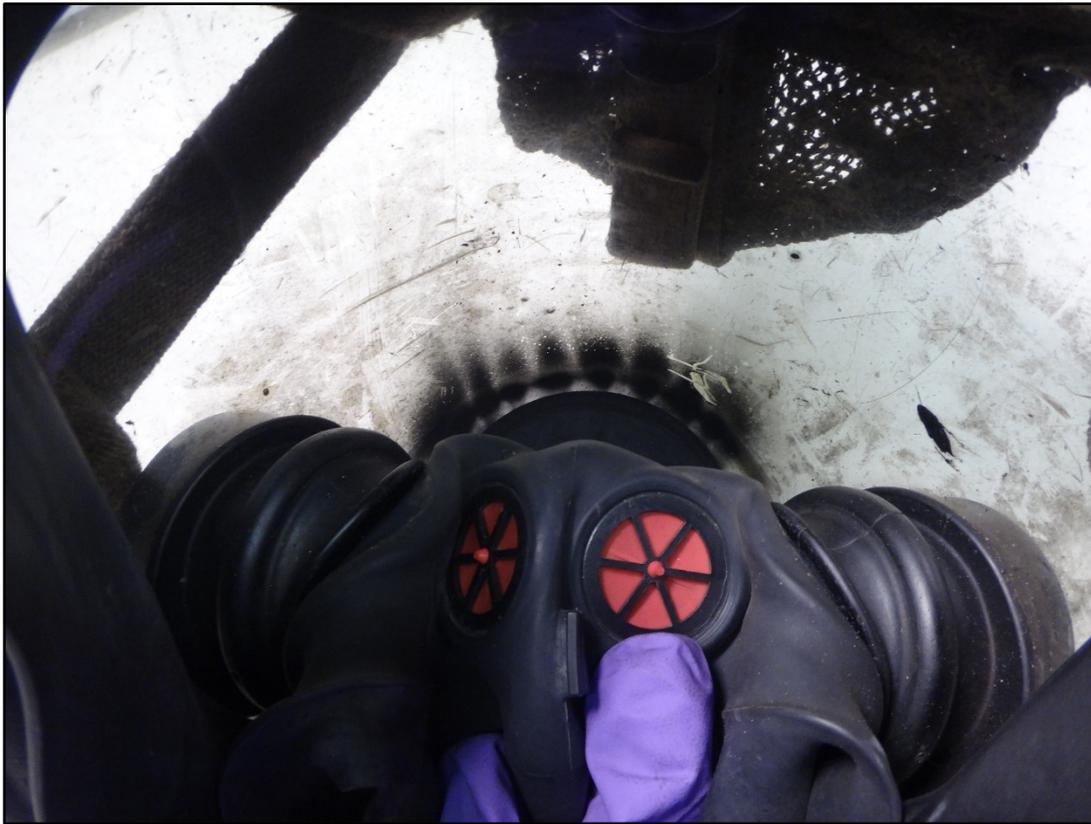
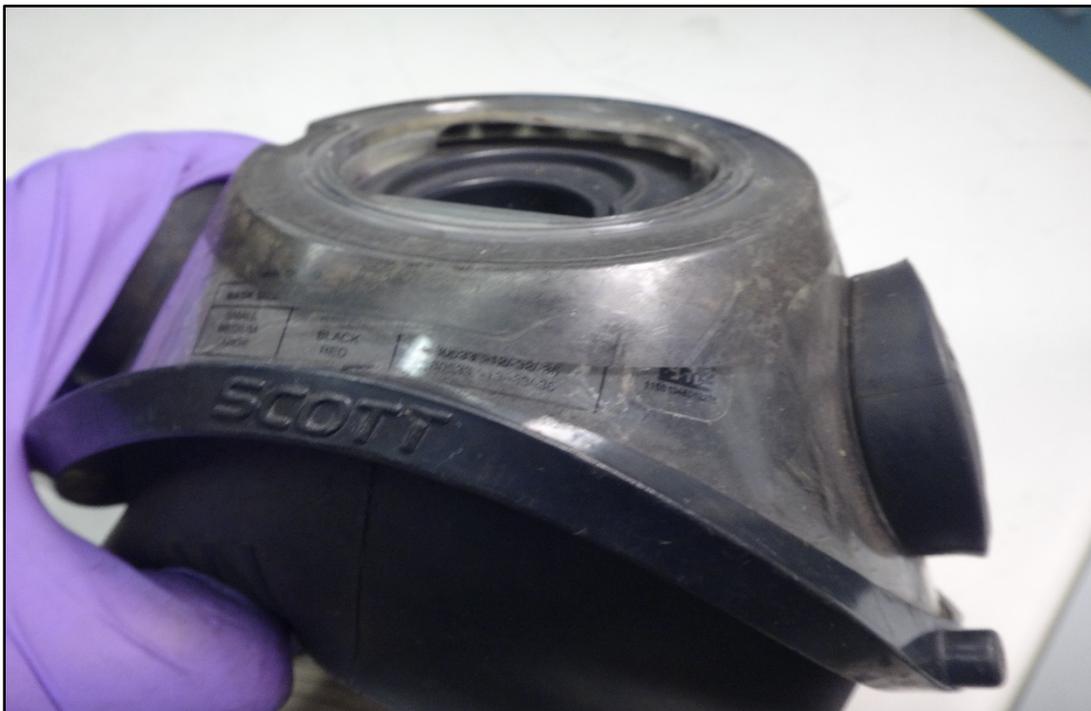
- Facepiece seal P/N: 31001739 1; MFG date: 11/2013
- Nosecup P/N: 201127 1; Size: Medium; MFG date: 3rd Q 2013
- Retaining ring MFG date: 11/13; P/N: 31002809
- Lens P/N: 805337
- Overall condition was fair, but very dirty
- Lens was fair, but dirty, with scratches
- Hairnet was fair, but very dirty
- Hairnet straps good, straps moved freely, held in place, and held securely to facepiece
- Attachment points for straps were good
- The facepiece seal was in good condition
- Regulator interface area was dirty and smoky

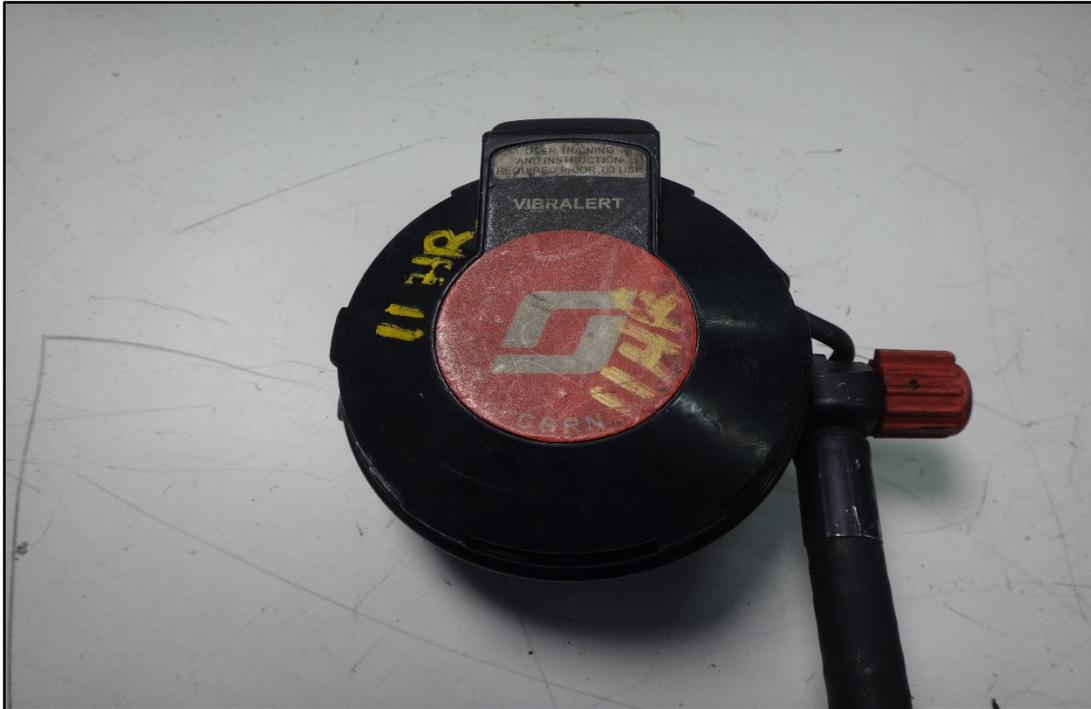
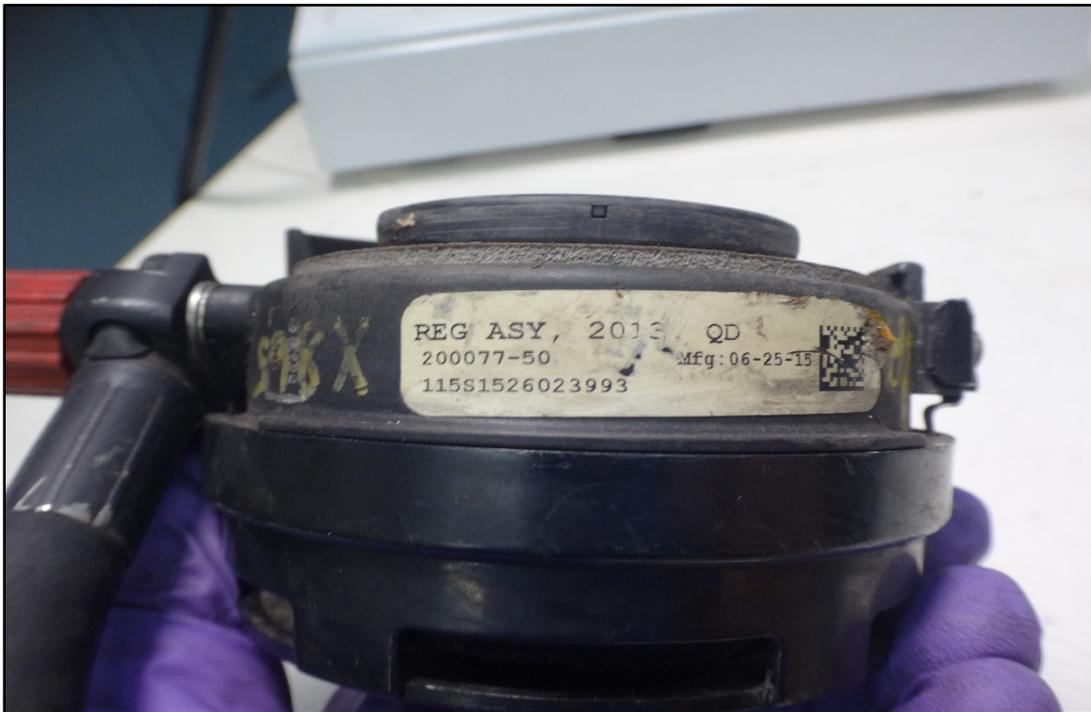
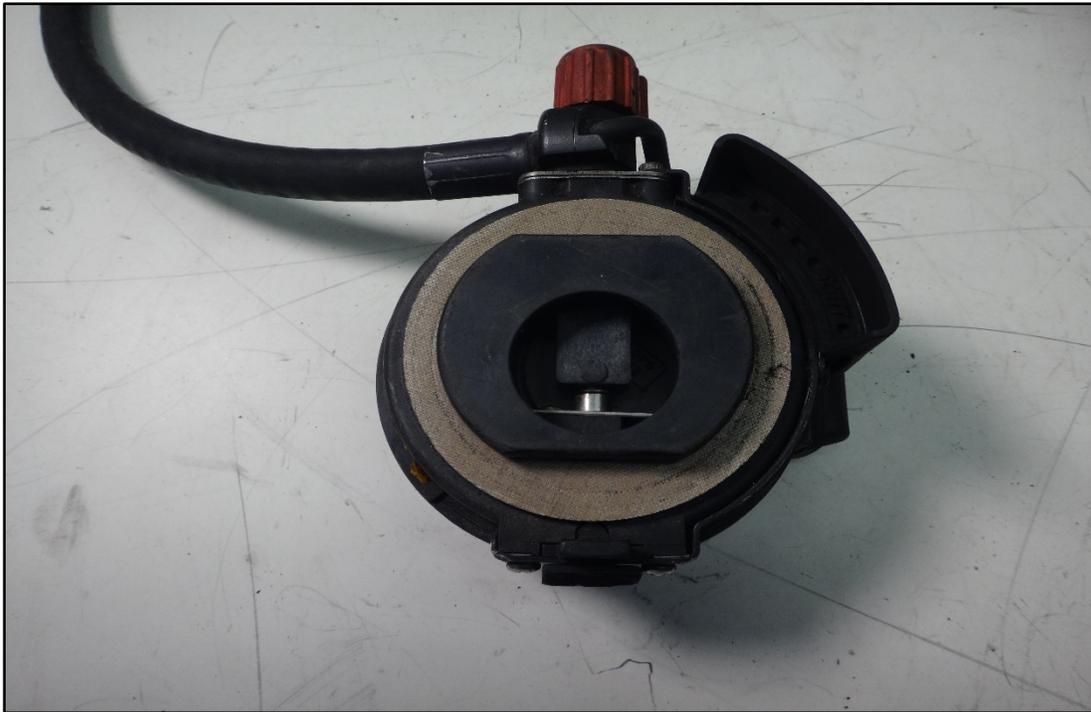
- Air-Pak® AirPak® X3 with Vibralert and with Heads Up Display (HUD)
- Regulator assembly P/N: 200077-50; S/N: 115S1526023933; MFG date: 6-25-15
- Other markings; 11 HR; X865
- MMR was attached to waist belt
- Overall condition was fair with no sign of heat damage
- Outer case good and front label was also in good, but dirty condition
- Donning switch was in good condition
- Bypass closed, bypass knob was in good shape
- Sealing area dirty with some signs of fraying around the edge and had minimal scratches
- Regulator could be attached and removed
- Locking assembly functioned
- HUD fully intact

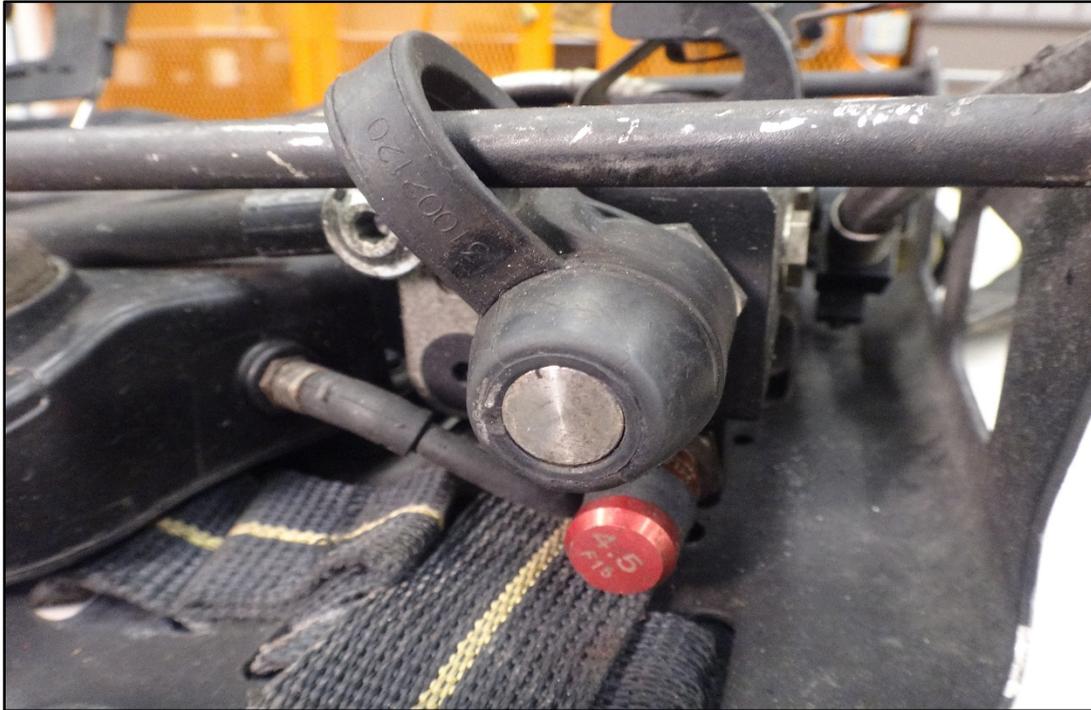
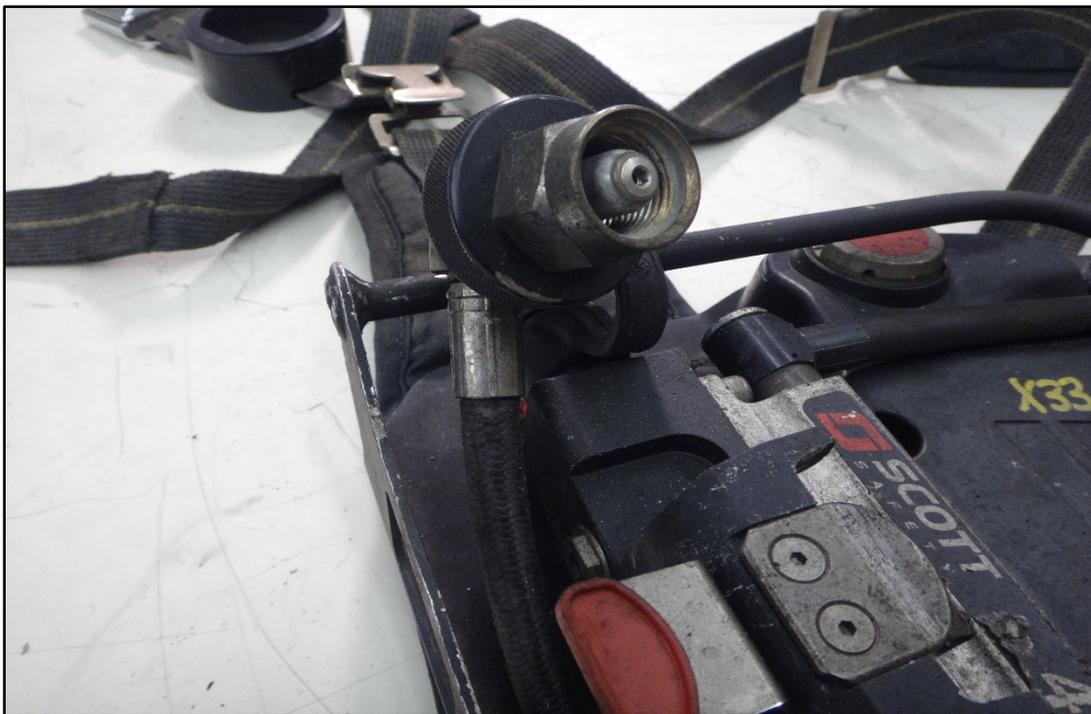
- Overall condition was good, but dirty

- Cylinder attachments threads dirty, corroded, threads on and off, “O” ring in place
- RIC/UAC system connector markings: Eaton FD17-1002-10-04
- RIC/UAC system connector cover in good condition, connection dirty

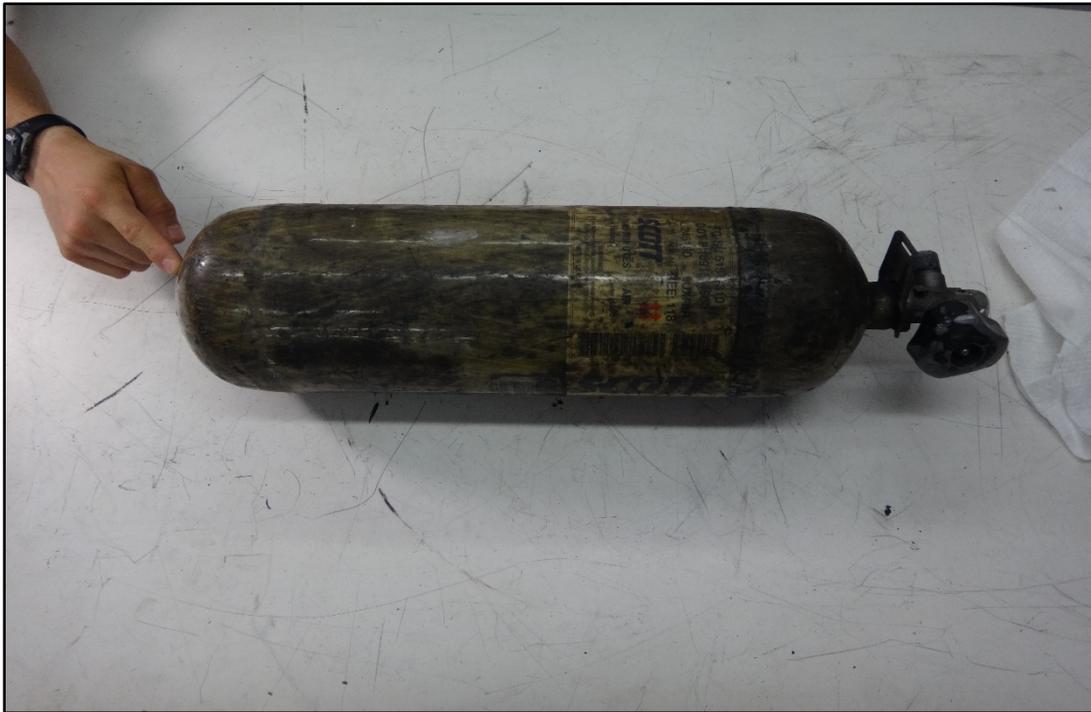
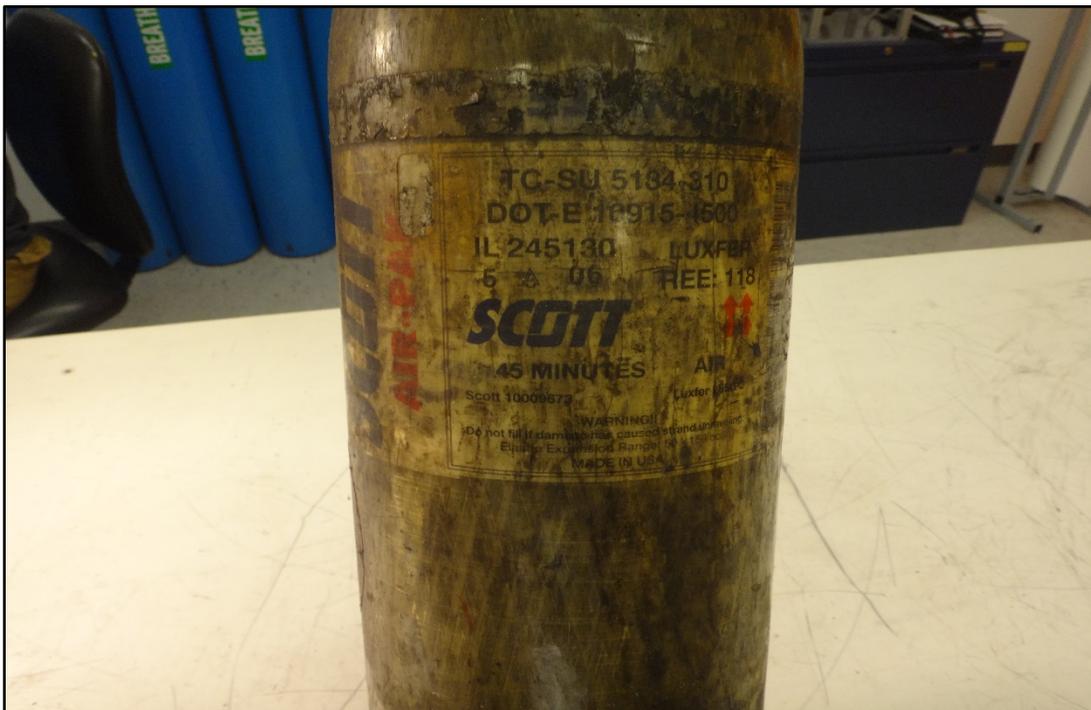
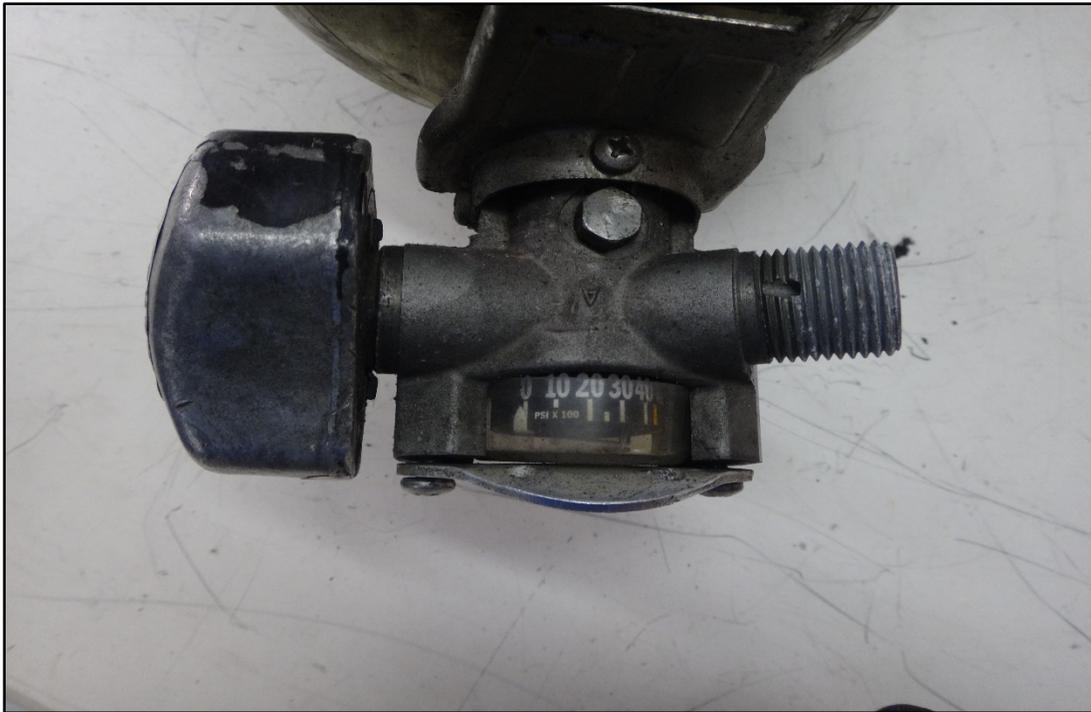
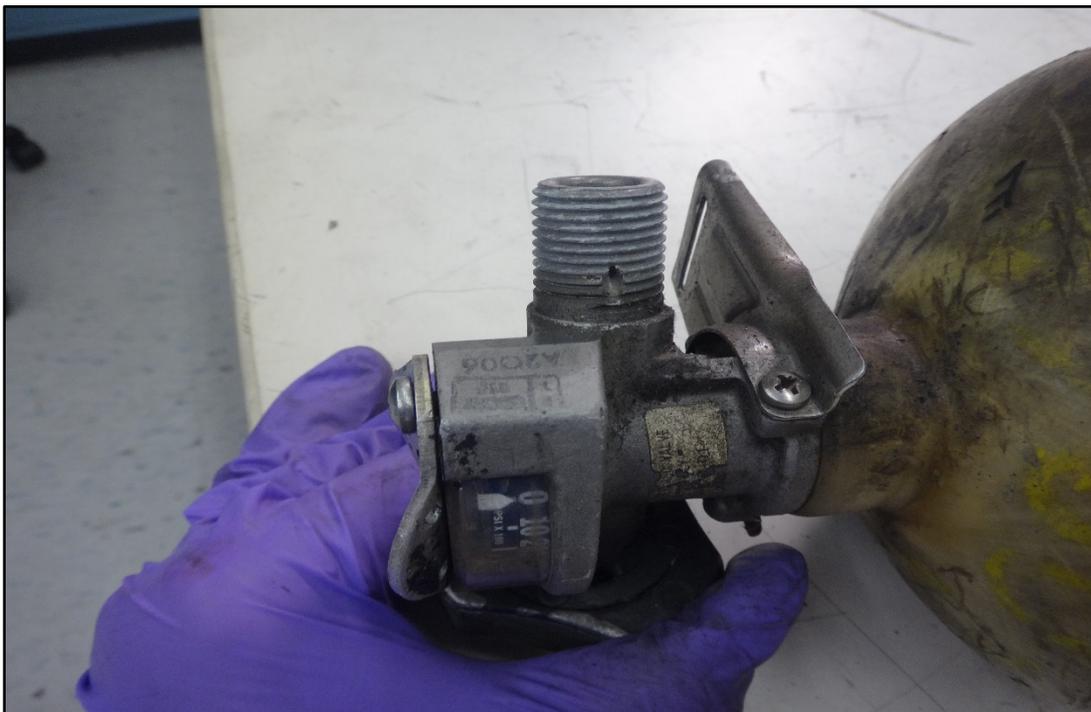
- Scott P/N 10009673
- DOT-E-10915-4500; IL 245130
- TC-SU-5134-310
- Luxfer P/N: L65G-2; REE 118
- Hydro date: 5/2006 45 Minute, 4500 PSI
- Overall condition was good
- Gauge readable
- Threads dirty with corrosion
- Rubber bumper missing; metal attachment for bumper loose
- As received cylinder valve closed and was empty
