TRITIUM RELEASE - CIRCA 1974

ECR 317311-105

December 13, 1974

M. R. Boss F. D. Hobbs Environmental Control

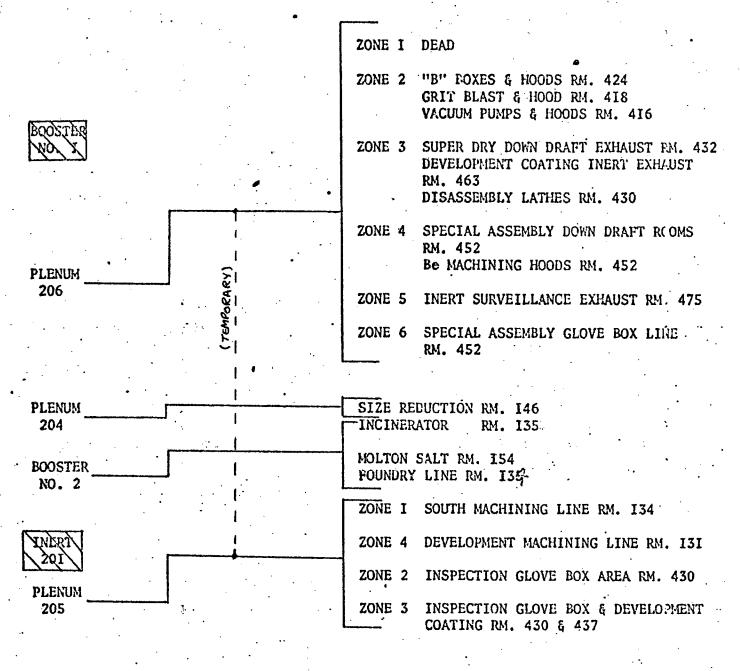
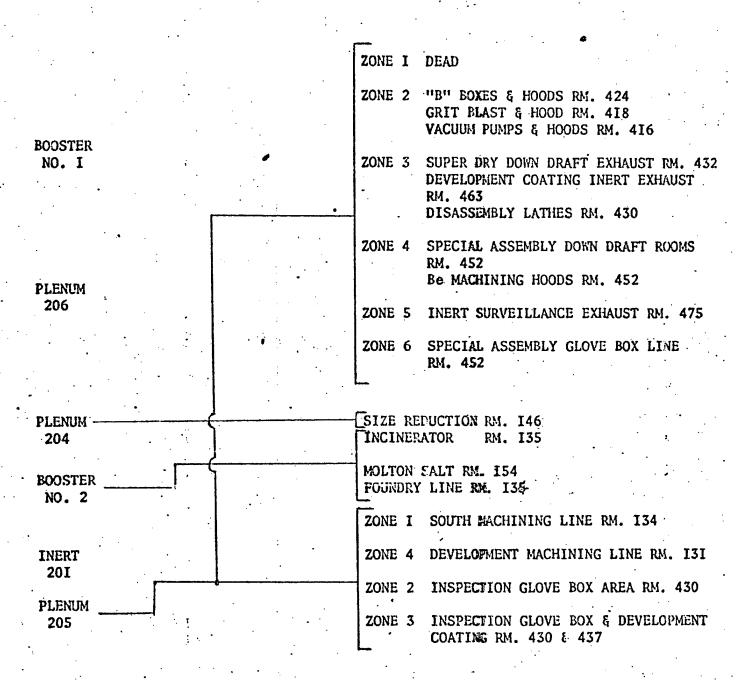
Construction modification to the effluent ventilation system is shown in the accompanying diagrams. Two new exhaust plenums were constructed in 1974. As shown, System 205 was placed in service in February 1974 and exhausted the dry air glovebox system in Building 776. At this time, exhausted air from the special assembly room was diverted, via temporary ductwork, to System 205 and this condition persisted until early August when Plenum 206 was completed. This temporary connection between 205 and 206 explains the tritium contamination found in both systems.
