IN-DEPTH STUDY REPORT:
CONTROL TECHNOLOGY FOR AUTOBODY REPAIR SHOPS:
SMALL PARTS PAINTING IN A DOWNDRAFT BOOTH

BASF Corporation
Whitehouse, Ohio

REPORT DATE
June 1999

REPORT NO
ECTB 179-17a

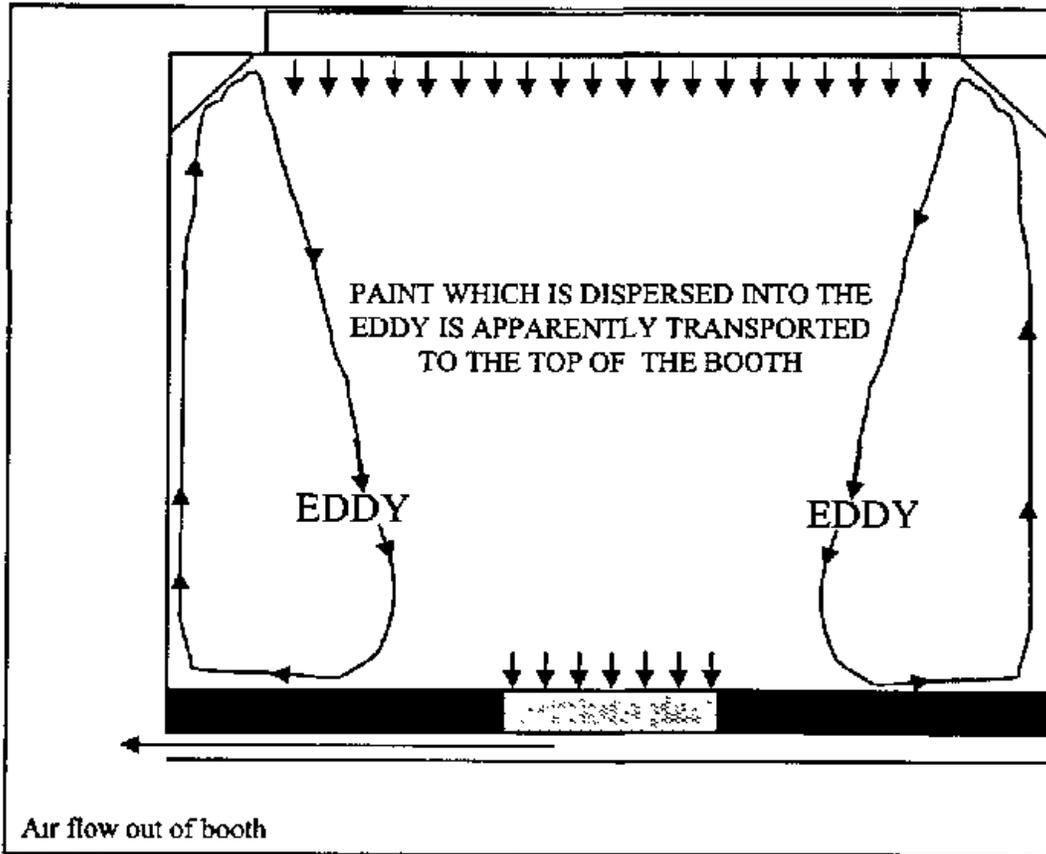
Figure 6 Observed airflow patterns in booth Note, the actual airflow patterns appeared to be more three dimensional

The total booth flow was measured to be 3.35 m³/sec (7100 cfm). The air flow from the ceiling was 0.15 m/sec. A two-dimensional view of the airflow patterns in a quiescent booth without the disturbance is presented in Figure 6. Actual airflow traces with helium bubbles and the smoking wire generator indicated that the air flow was much more three-dimensional in shape than can be described by a two-dimensional figure. Helium bubbles and smoke indicated that the eddy involves a net flow of air from the lower back corner of the booth toward the front of the booth. About 5 or 6 feet from the front of the booth, this air flow made a twisting turn toward the exhaust trench in the floor.

The large eddies pictured in Figure 6 are located under the cornices in the booth. The cornices are used to hide electrical connections and light fixtures. The cornice may be necessary for fire

safety and to isolate electrical connections from the paint overspray mist. However, the cornice causes an eddy which can ultimately lead to the contamination of the incoming air flow. A two-dimensional model of air flow in this booth was developed to evaluate the role of the cornice in the development of the eddy. The results of the CFD modeling is presented in Figures 7 and 8. Figure 7 shows a two-dimensional model of the current booth. The shape of the eddy agrees with observations presented in Figure 6. The model in Figure 8 suggests changes in geometry which minimizes the eddy size.

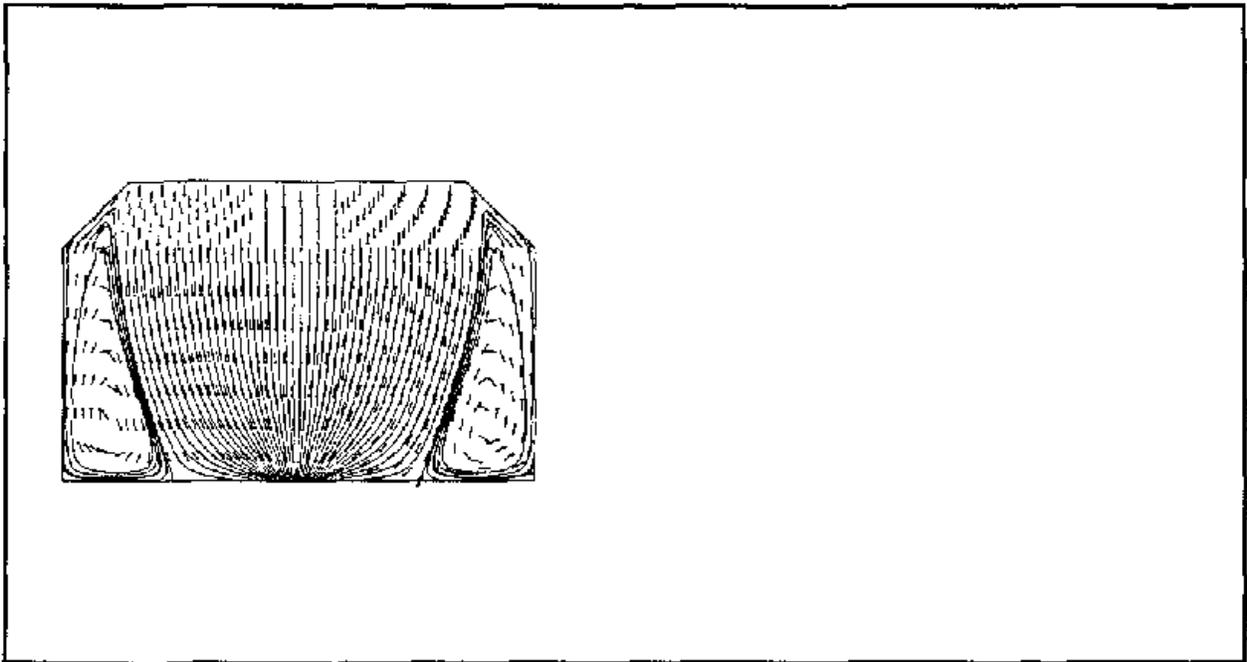
Figure 7 Predicted airflow patterns in existing downdraft booth. The arrows indicate direction of air flow. The solid lines indicate particle paths. The particles were released at the level of the bottom of the cornices.

The results of the theoretical analysis on the existing booth and a theoretical booth are shown in Figures 7 and 8. The solid path lines are shown in each figure along with the velocity vectors (represented as arrows). The path lines show the flow path of massless particles released from a surface within the computational domain. The velocity vectors have been constrained to a fixed length to provide information on the flow patterns only and are not scaled by velocity magnitude. The theoretically estimated airflow patterns (see Figure 7) in the existing booth are in substantial agreement with the visually observed airflow patterns (see Figure 6). If the booths could be designed to eliminate these eddies, perhaps exposures could be reduced. Figure 8 explores two possible design changes which might minimize eddy formation. On the right side of the booth in Figure 8, the cornice is replaced with a slanted wall. The eddy is restricted to the lower right side of the booth. On the left side of this booth, the cornice has been eliminated and the air inlet filters extend all the way to the wall. This eliminates the eddy. In both cases, the eddy is not transporting air contaminants into the worker's breathing zone.

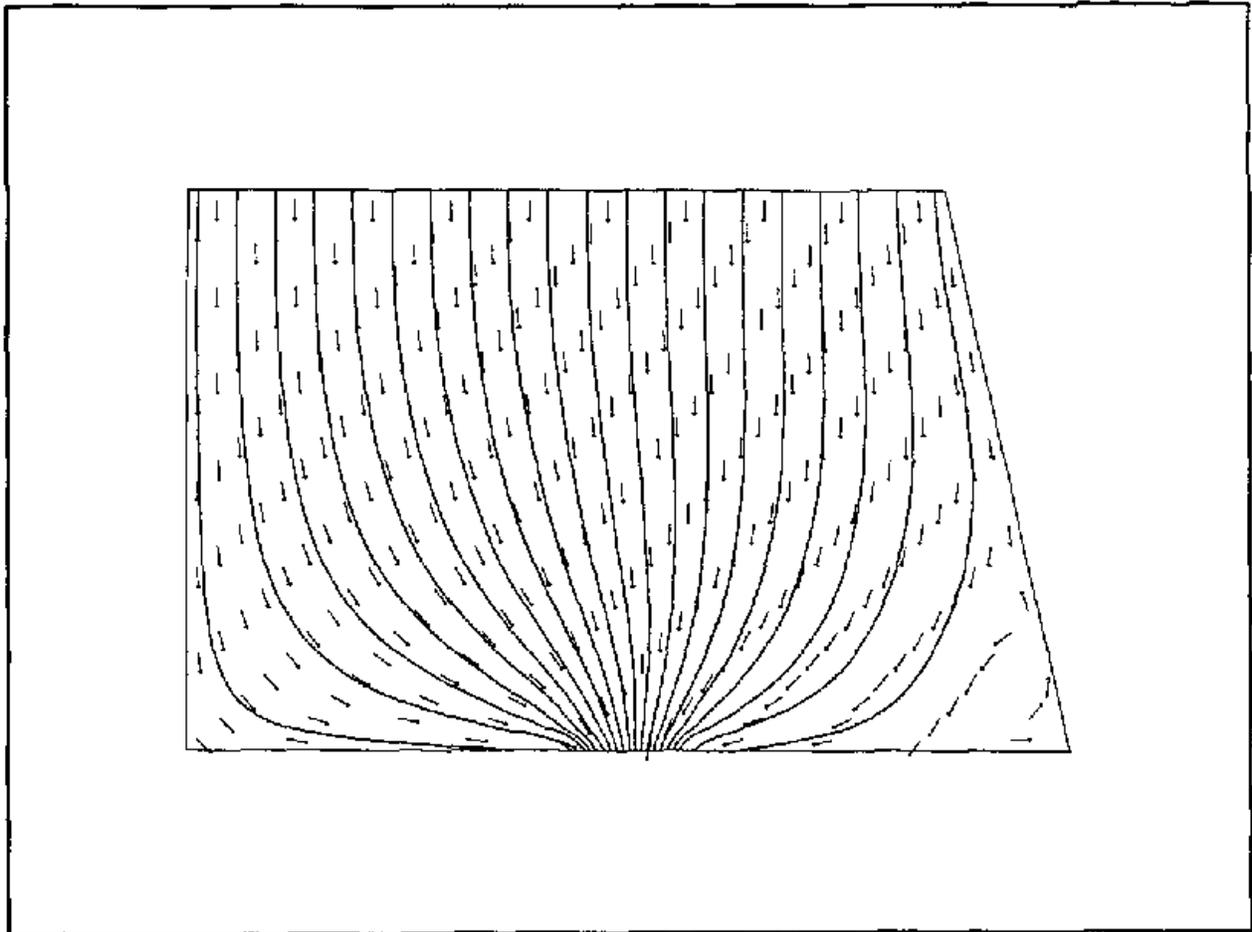
Figure 8 Predicted airflow patterns in a hypothetical booth. On the right side of the booth, the cornice was replaced with a slanted wall. On the left side of the booth, the cornice was eliminated and the air filter in the ceiling was extended to the wall. The solid lines indicate the path of particles released at the ceiling and the arrows indicate the direction of the air flow.

On the right side of the booth, the cornice was extended from ceiling to the floor of the booth. Essentially, the right wall of the booth is sloped slightly. On the left side of the booth, the cornice was eliminated and the inlet air distribution filter was extended to the wall on the left side of the booth. On the left side, the model predicts that the eddy would be eliminated, and on the right side under the slanted wall, the size of the eddy is reduced and the eddy only reaches a height of about 2 feet. Thus, these computations suggest that the eddy can be minimized by altering the geometry of the booth.
