Personal Protective Equipment Conformity Assessment Studies and Evaluations

Evaluation of a Self-Contained Breathing Apparatus Involved in a Fatality and a Near Miss While Operating at a Structure Fire

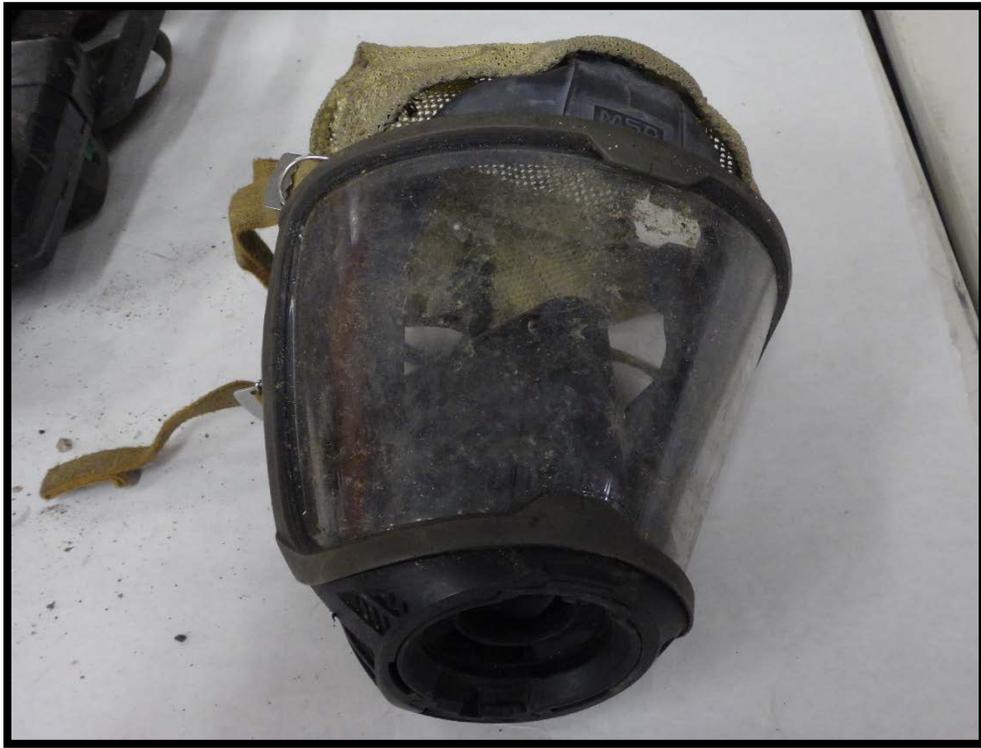
Figure 5: Top view of facepiece

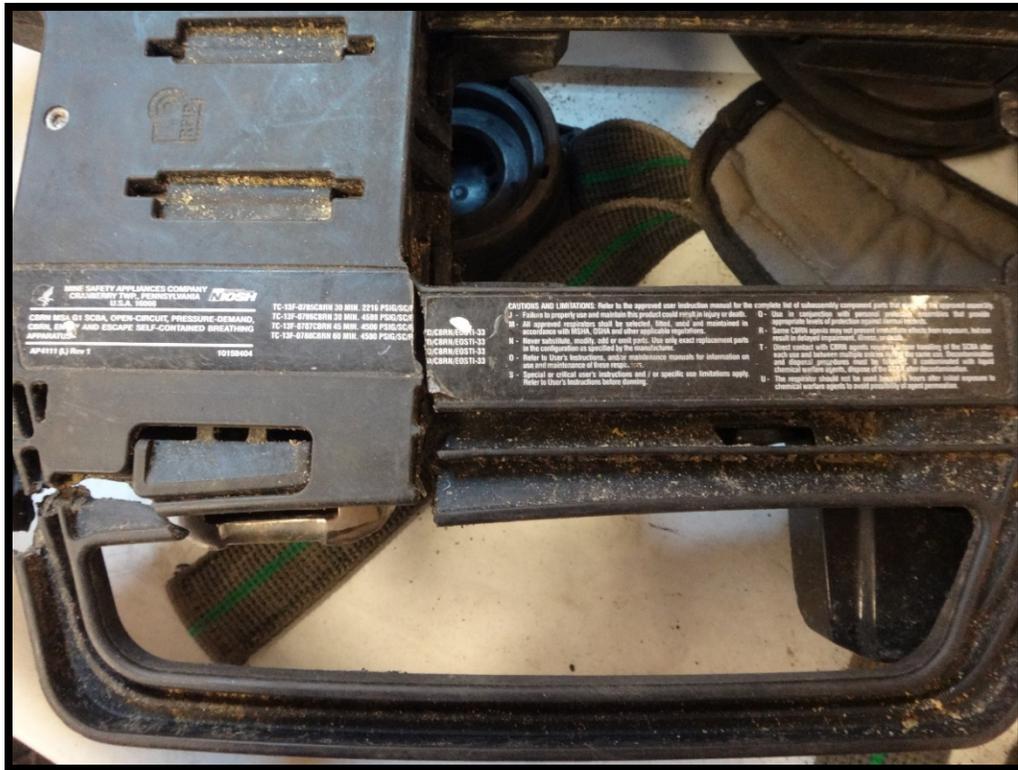
Figure 26: Broken sections of backframe

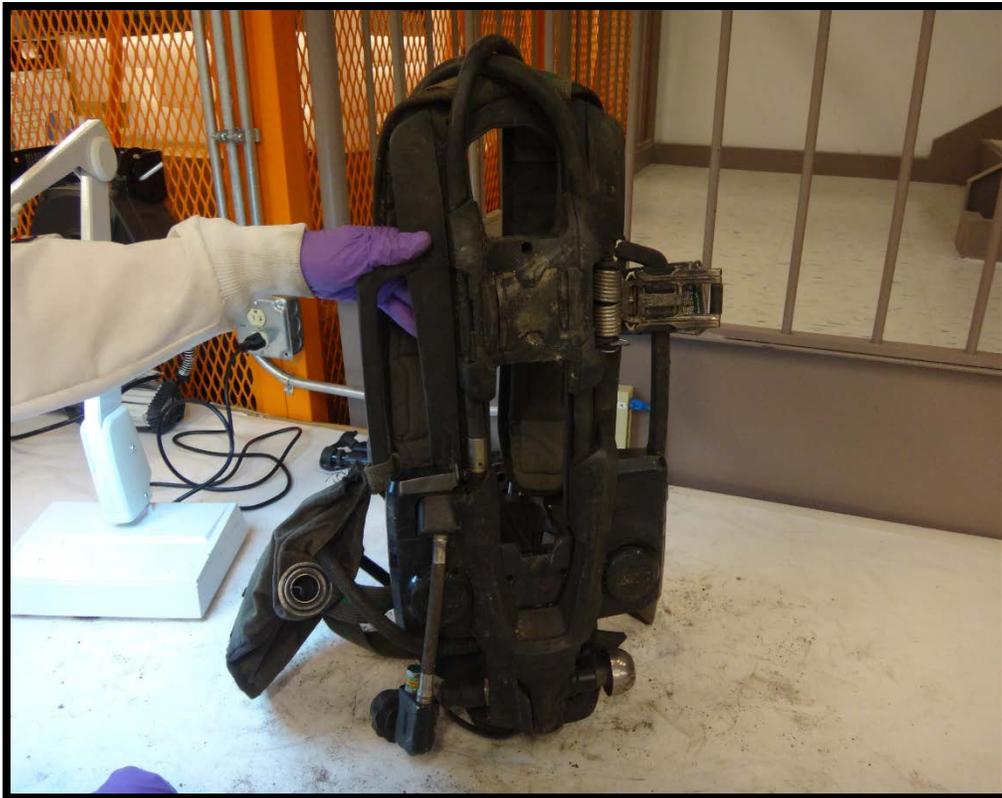
Figure 27: Front view of backframe

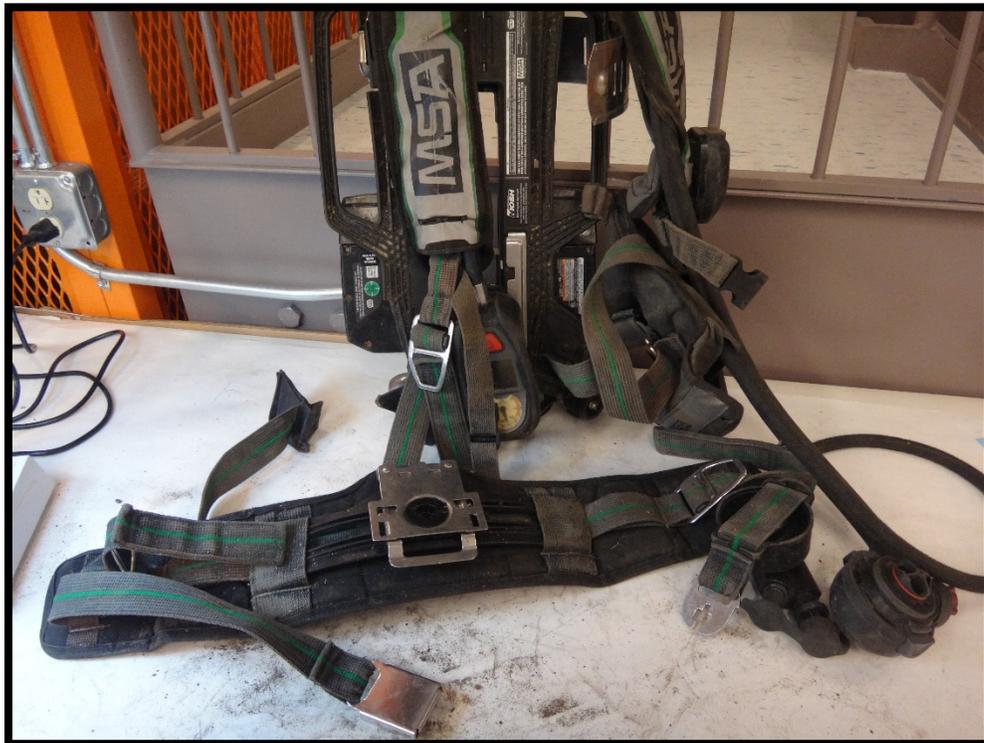
Figure 28: Overview of straps and broken waist belt connection

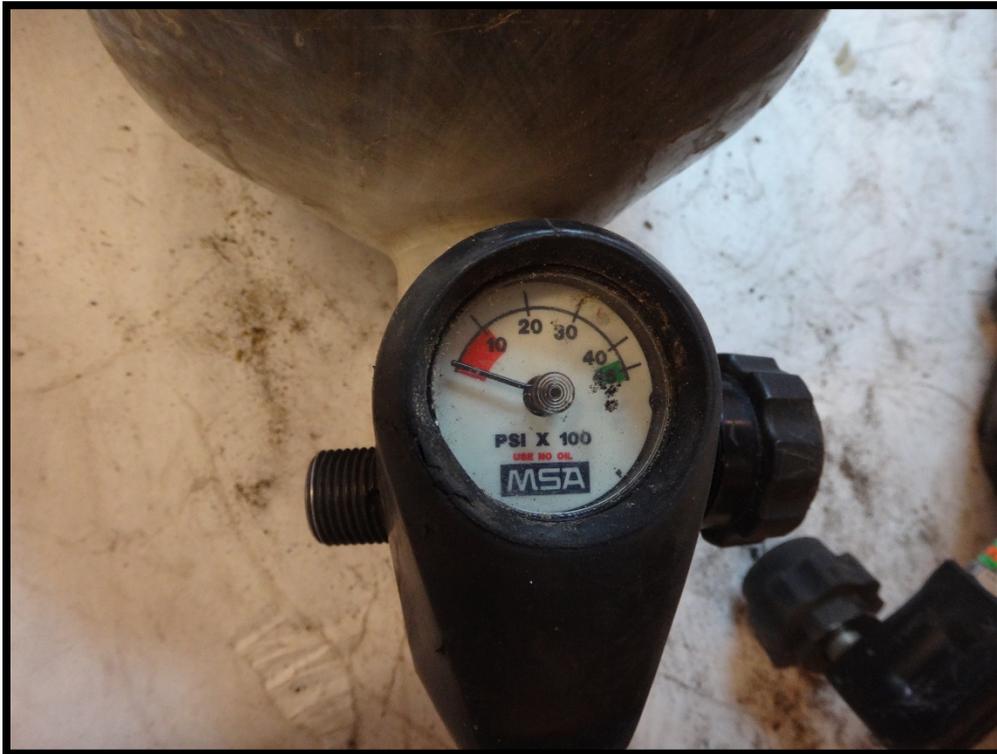
Figure 29: Cylinder gauge and cylinder threads

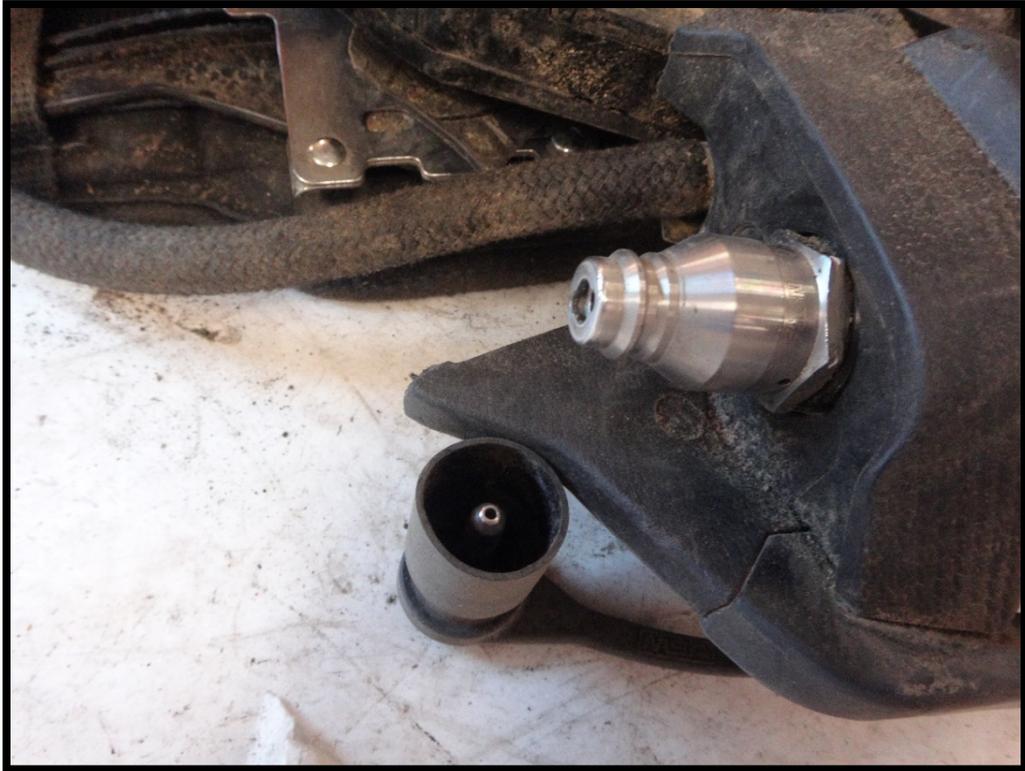
Figure 37: UAC as found with cap off

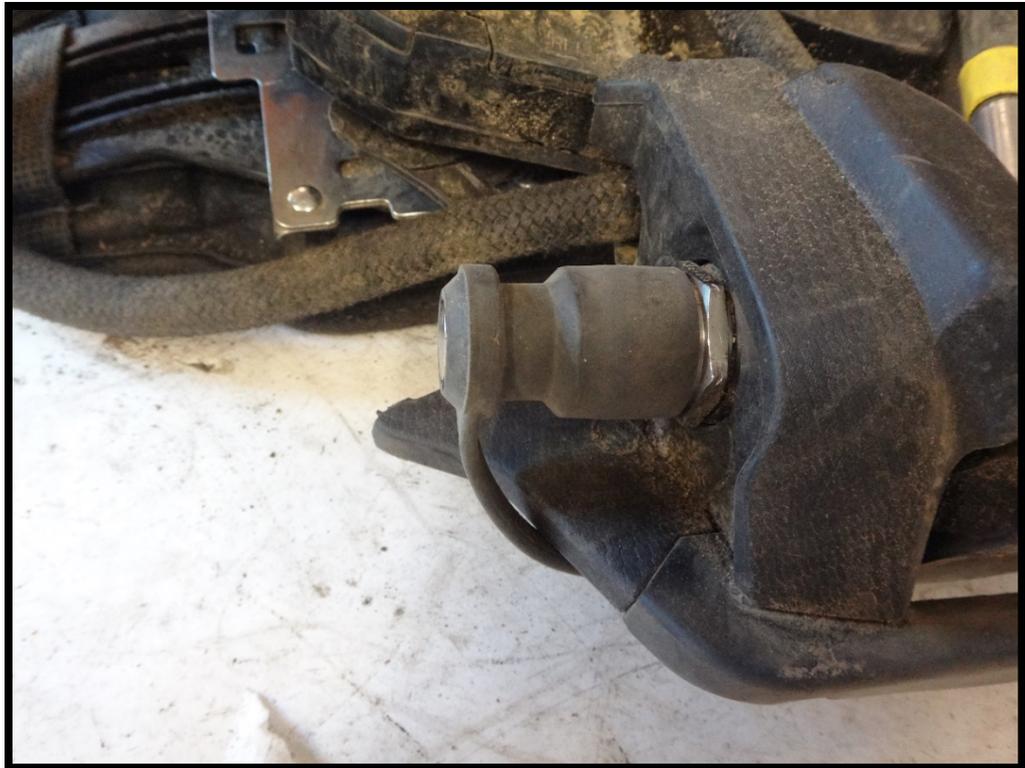
Figure 38: UAC with cap on

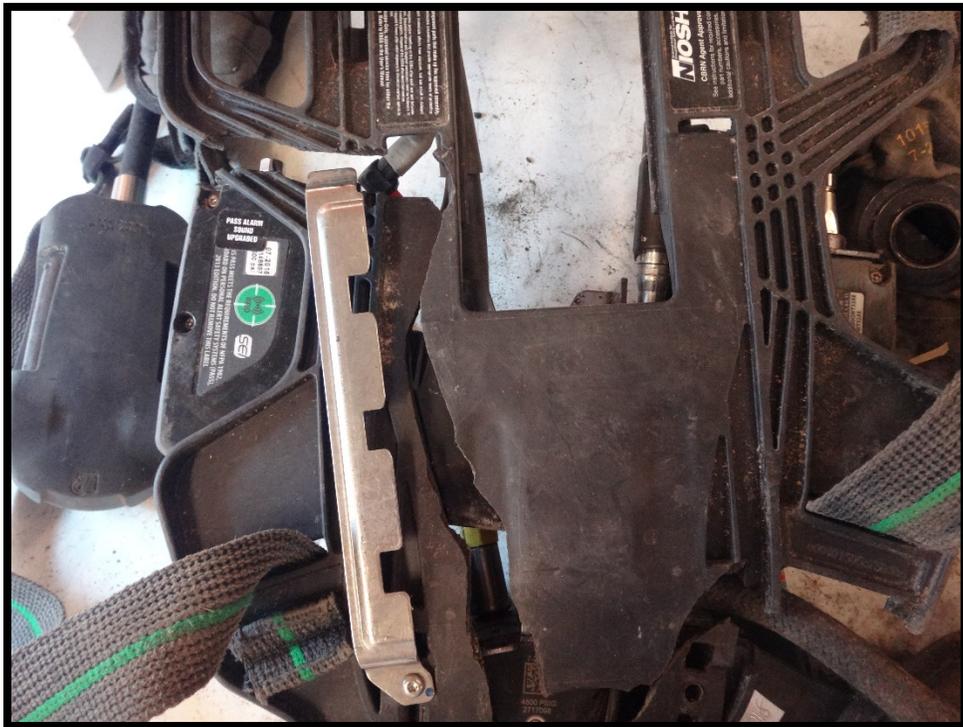
Figure 46: PASS power module with cracked plastic housing

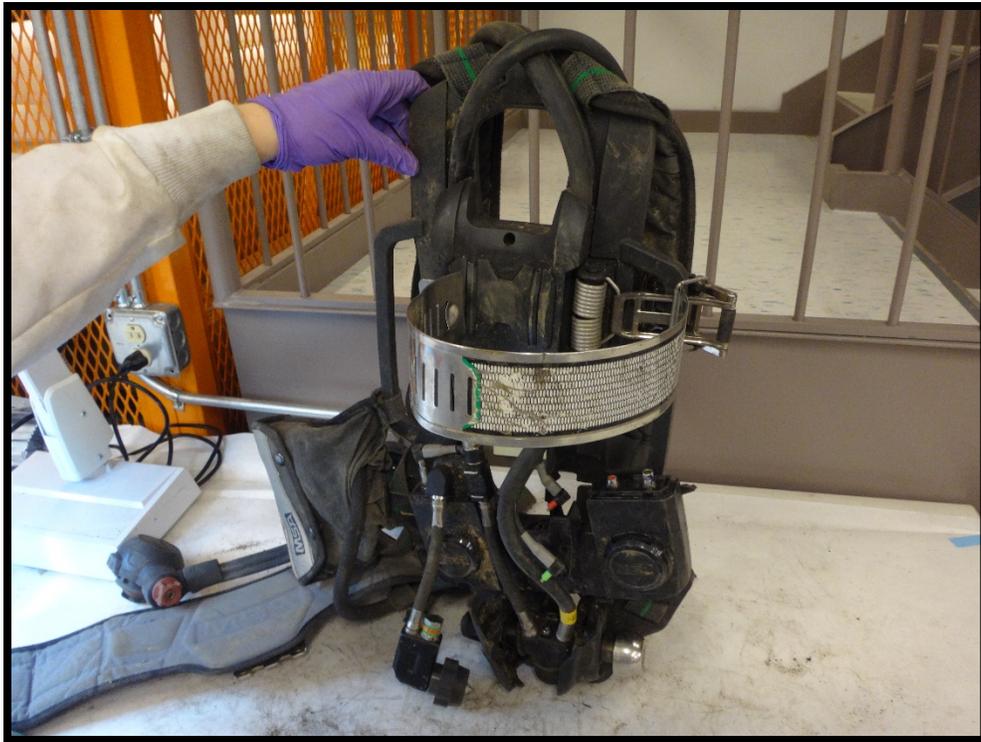
Figure 47: Backframe with broken cylinder retaining strap

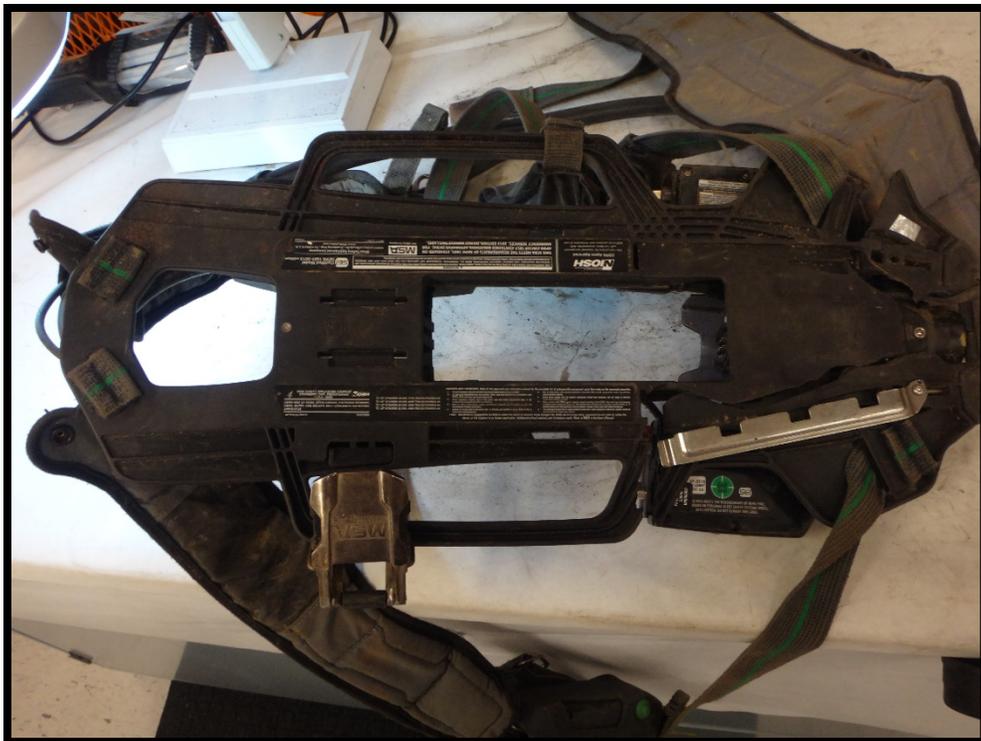
Figure 48: Backframe with labeling
