# PPE CASE

## *Personal Protective Equipment Conformity Assessment Studies and Evaluations*

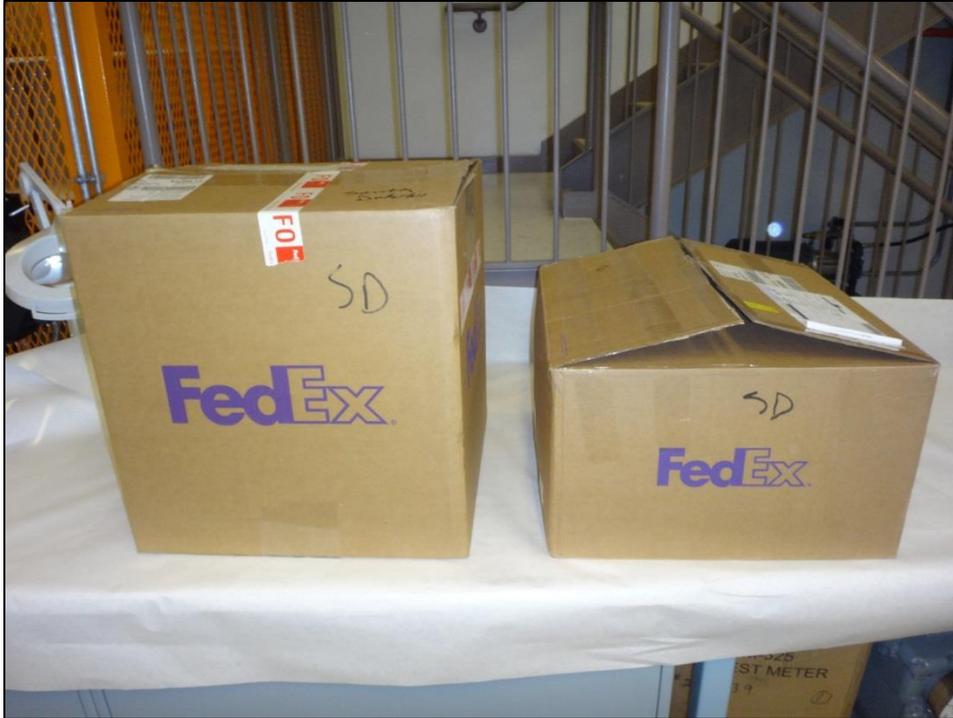
Figure 1: Cardboard box containing SCBA.

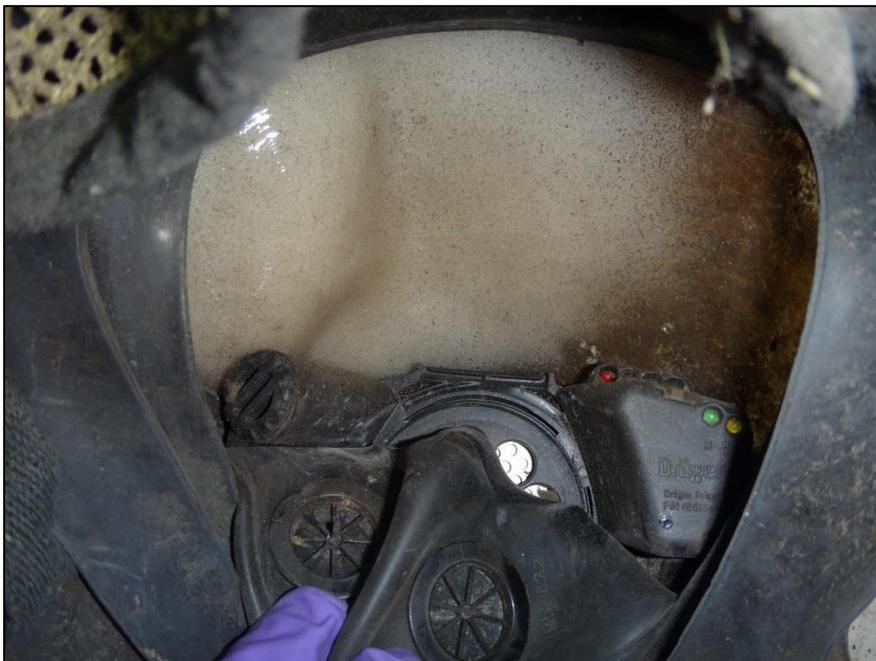
**Figure 8: View of HUD, damage to lens from inside view, loose nosecup.**

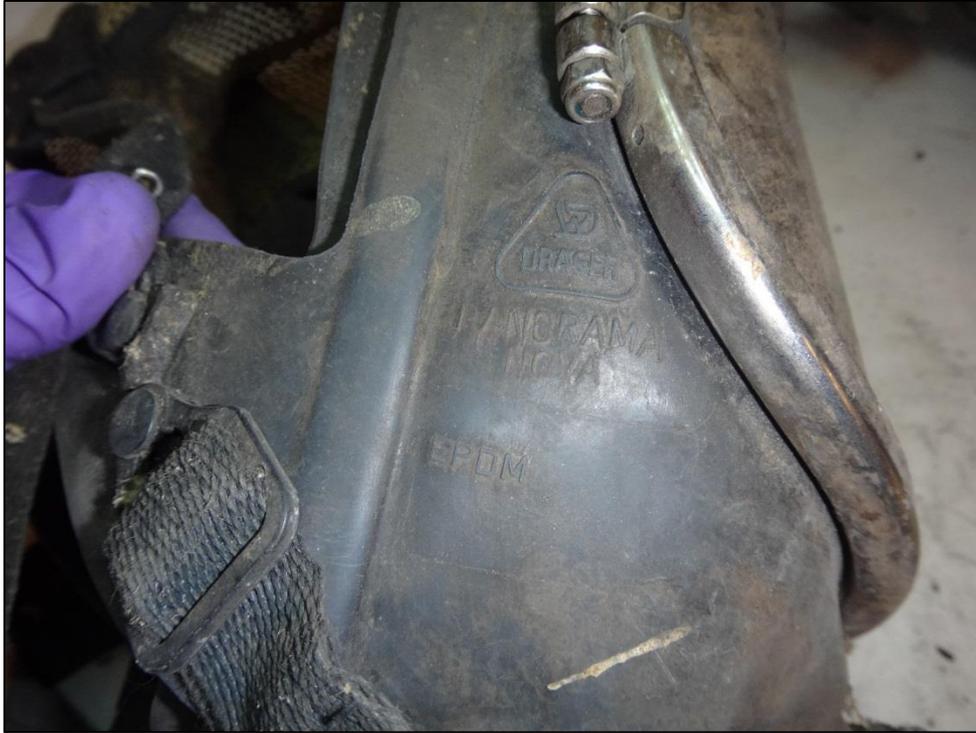
**Figure 9: Outside facepiece identifying markings.**

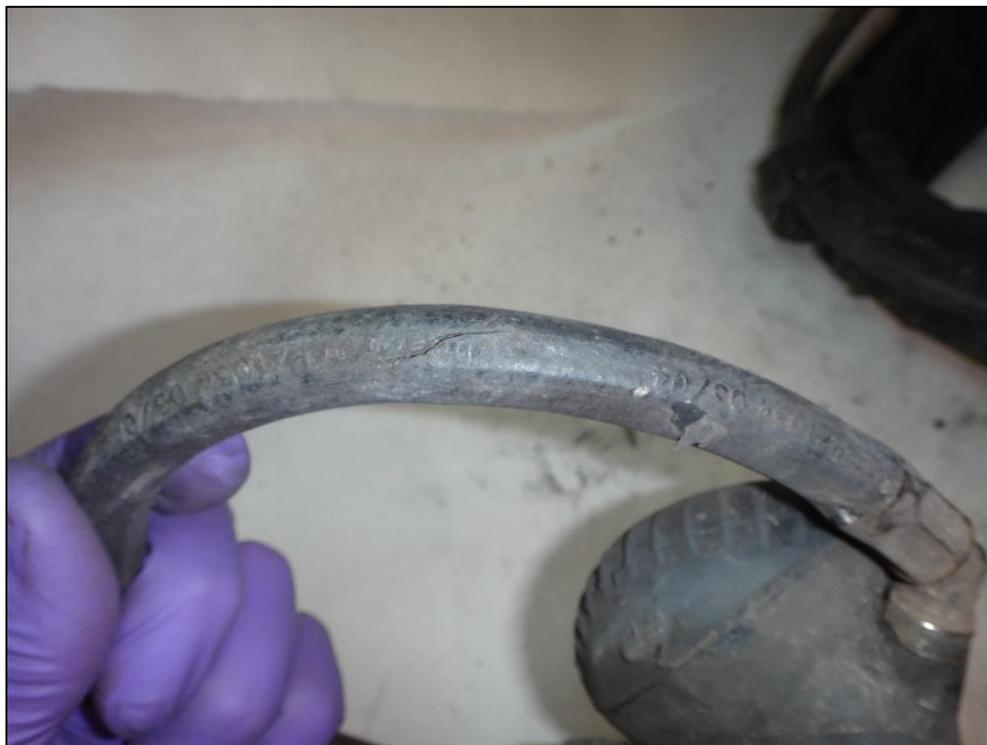
**Figure 14: Low pressure hose with damage.**

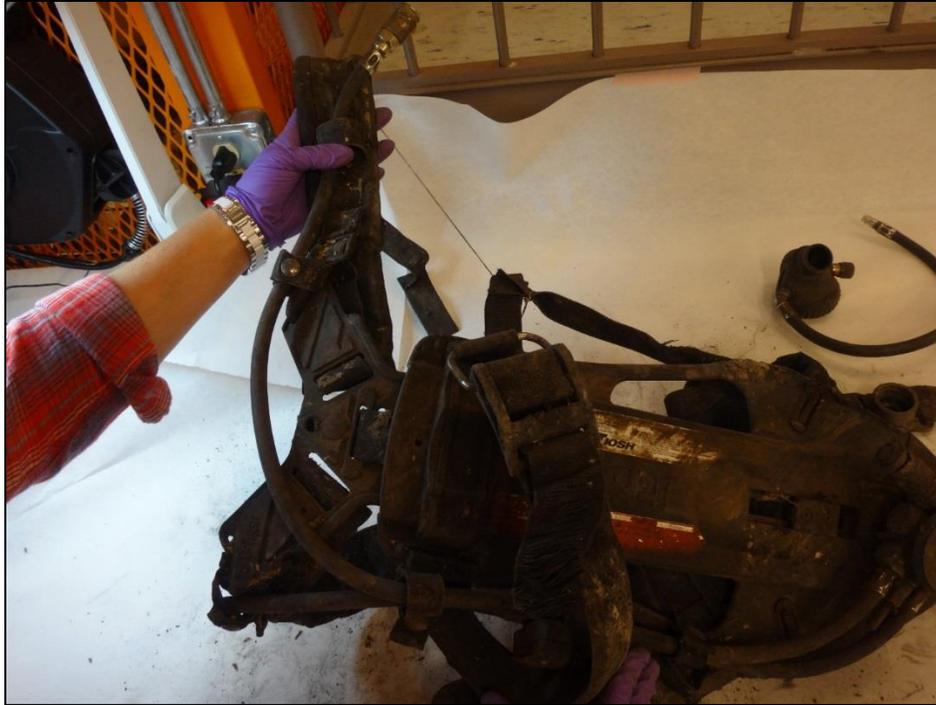
**Figure 15: Another view of the low pressure hose with damage.**

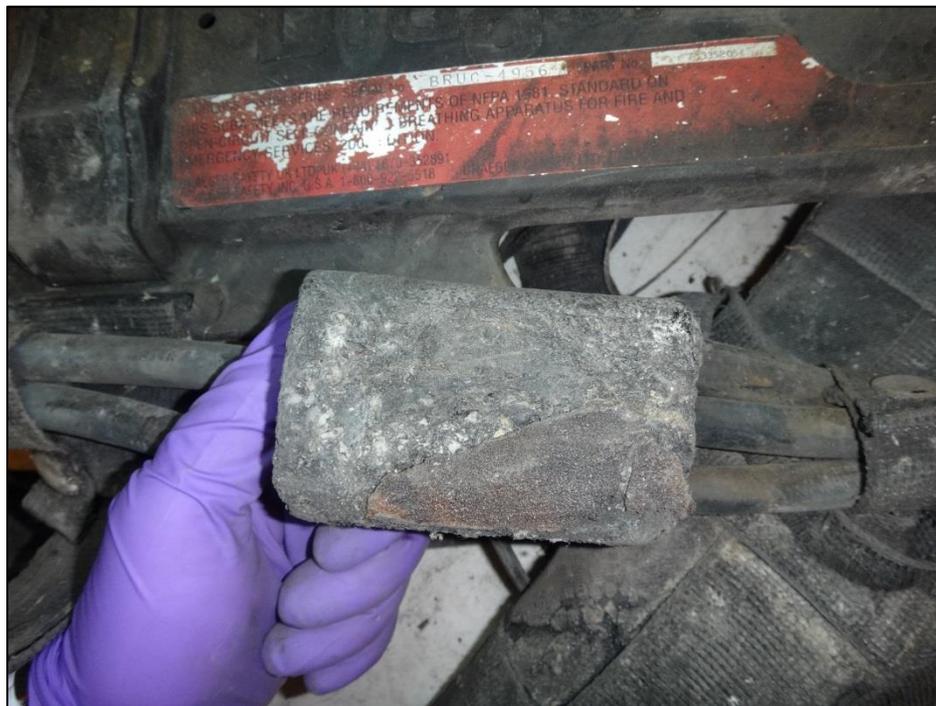
**Figure 16: Pressure reducer assembly front view.**

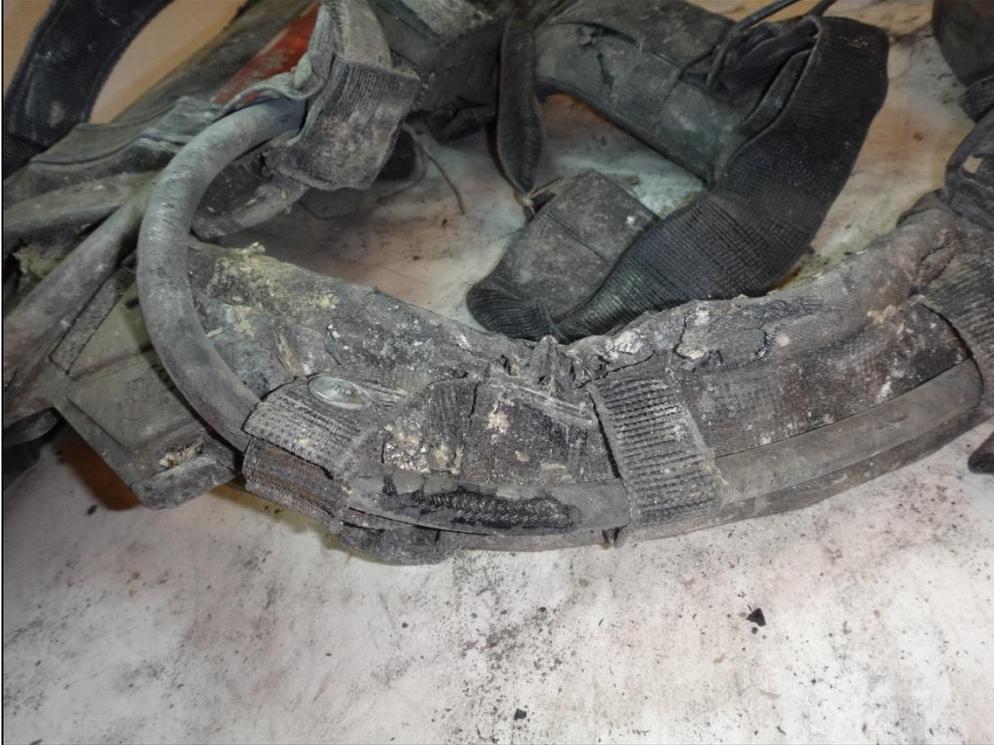
**Figure 23: Damage to high pressure line to PASS console.**

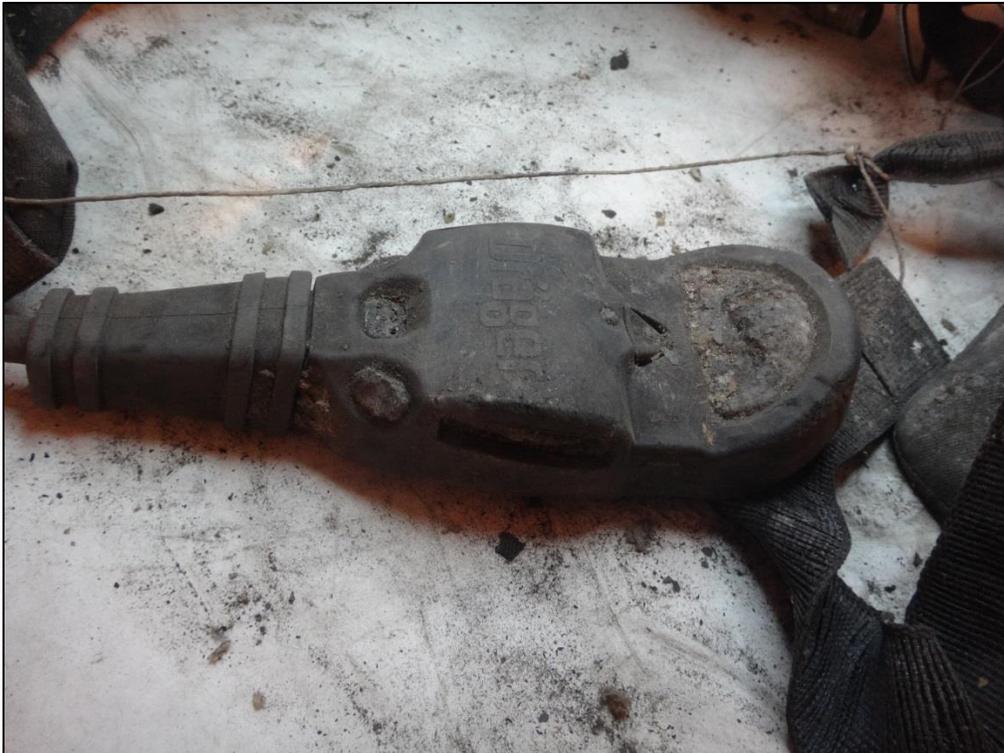
**Figure 24: Top view of PASS console.**

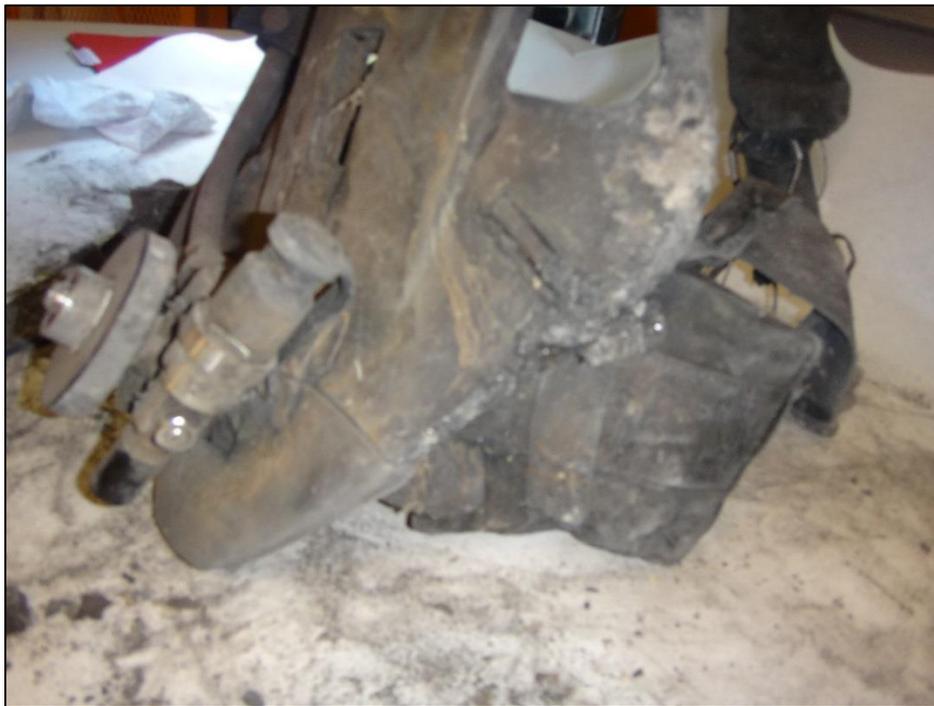
**Figure 30: Damage to pack at bottom right corner.**

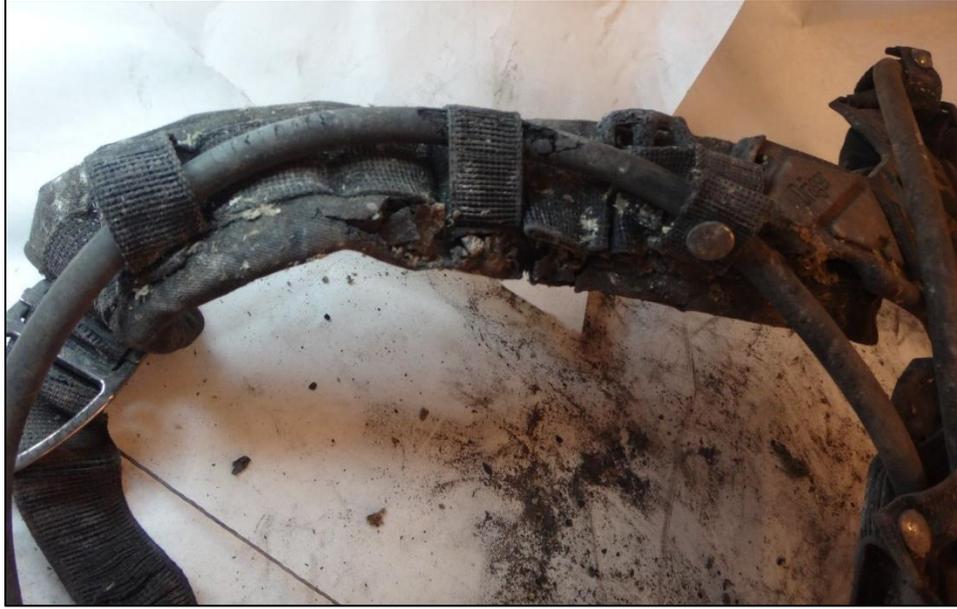
**Figure 31: Damage to left shoulder strap.**

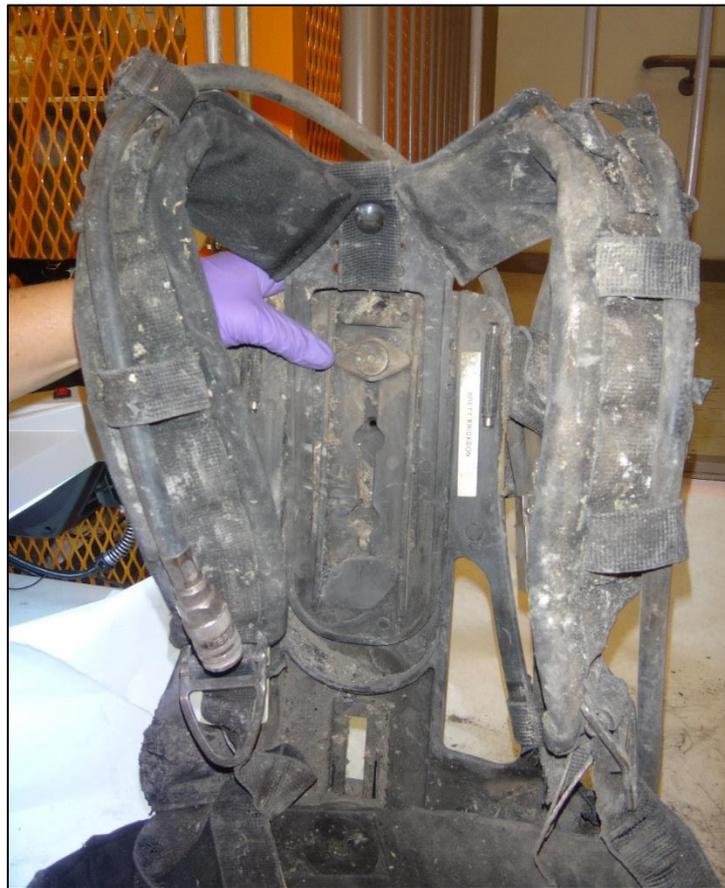
**Figure 32: Shoulder straps.**

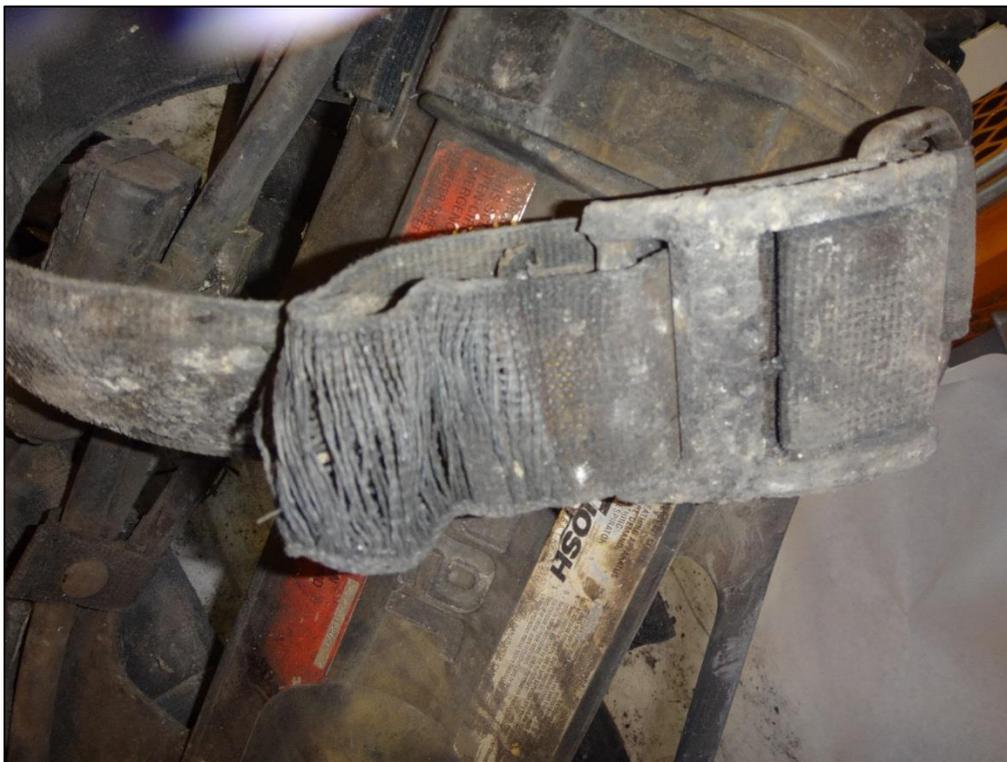
**Figure 34: Damage to cylinder strap.**

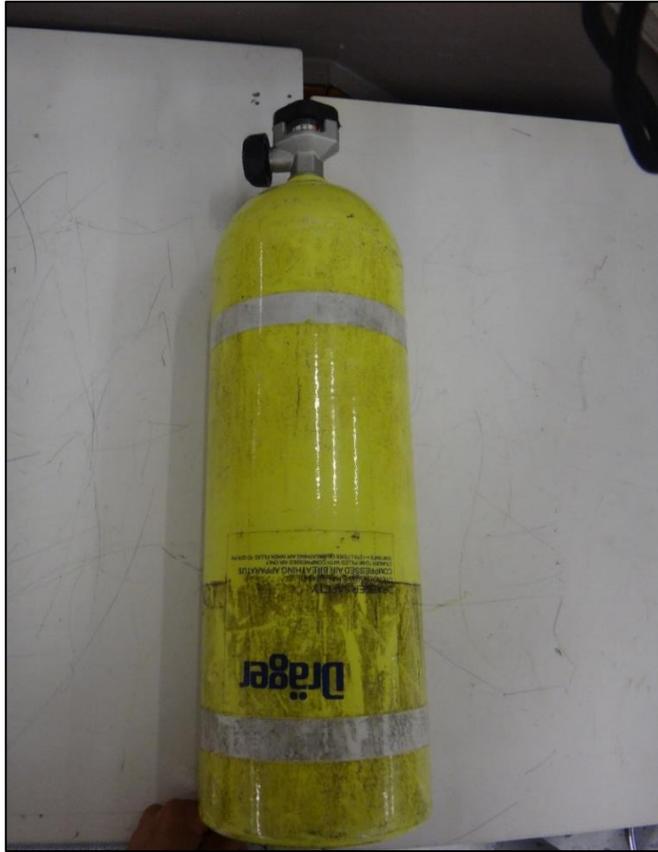
**Figure 35: Top view of cylinder.**
