RI 9655

**Geomechanics of Reinforced Cemented Backfill
in an Underhand Stope at the Lucky Friday Mine,
Mullan, Idaho**

**T.J. Williams, D.K. Denton, M.K. Larson, R.L. Rains, J.B. Seymour, and
D.R. Tesarik**

July 2001

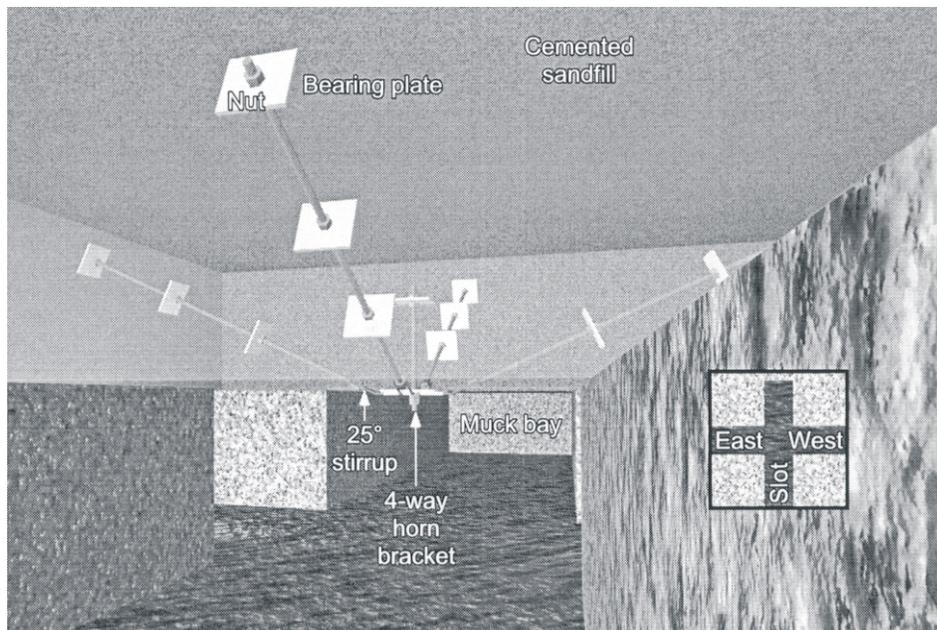
Figure 2.—Intersection truss system.

A four-way truss was installed at the center of the intersection in addition to the vertical rock bolts typically used as reinforcement. The truss was constructed using No. 7 Dywidag rock bolts having a minimum yield strength of 160 kN (36,000 lb). It consisted of one vertical rock bolt, four legs angled 15° to 20° from the horizontal, one four-way horn bracket, and four stirrup U-bolts bent upward at 25° from the horizontal. The horizontal legs consisted of two or three rock bolts joined together with couplings so that the ends of the legs lay outside the intersection into the east and west sides of the stope along the vein and into the slot and the muck bay (figure 2).

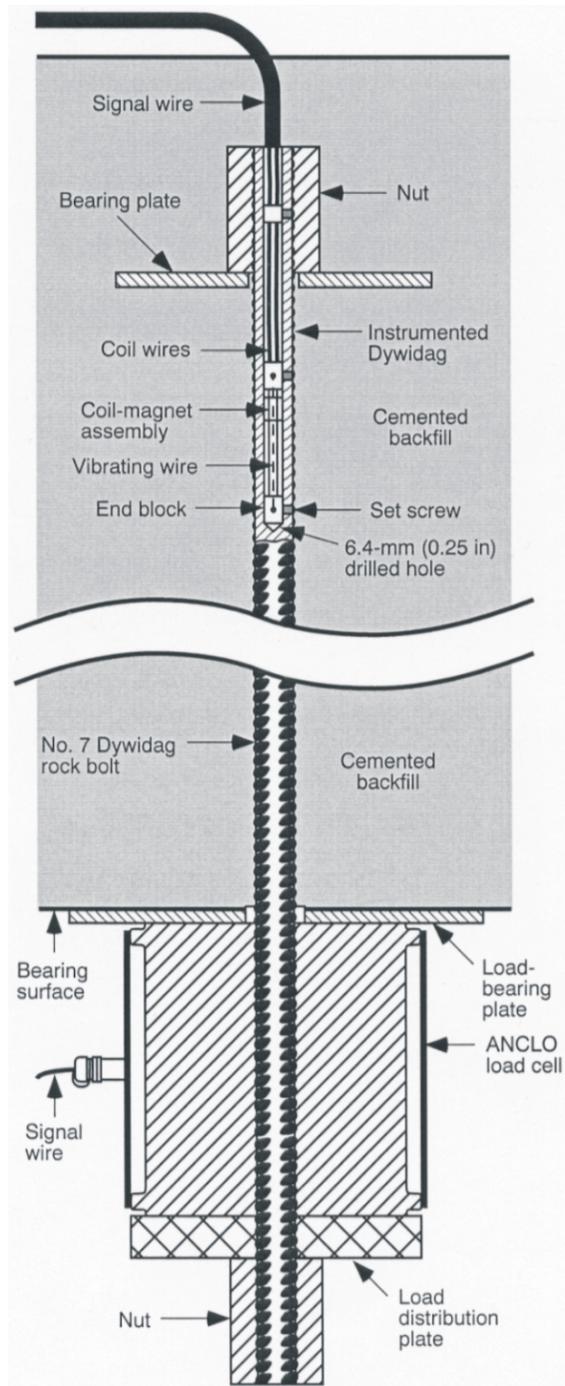
Figure 3.—Rock bolts instrumented with load cells.

Instrumented No. 7 Dywidag rock bolts were obtained from Roctest, Plattsburgh, NY, to measure induced load on the rock bolts used for backfill reinforcement. Roctest installed a vibrating-wire strain gauge and thermister in one end of each rock bolt. These instrumented rock bolts were placed at the ends of all the truss legs. They were also used to replace some of the vertical rock bolts throughout the stope. All instrumented

ALC10 rock bolt load cells were also obtained from Roctest to provide redundant readings on the vertical rock bolts and the truss. Load cells were the only instruments that could be used to obtain load readings at the junction of the stirrup and the horizontal legs at the truss bracket because blasting at this location would have destroyed the instrumented rock bolt wires. The load cells were installed on the lower end of instrumented rock bolts (figure 3) and on the truss legs after mining had passed. The load cells survived better than the instrumented rock bolts because the wires were not subjected to backfill deformation.

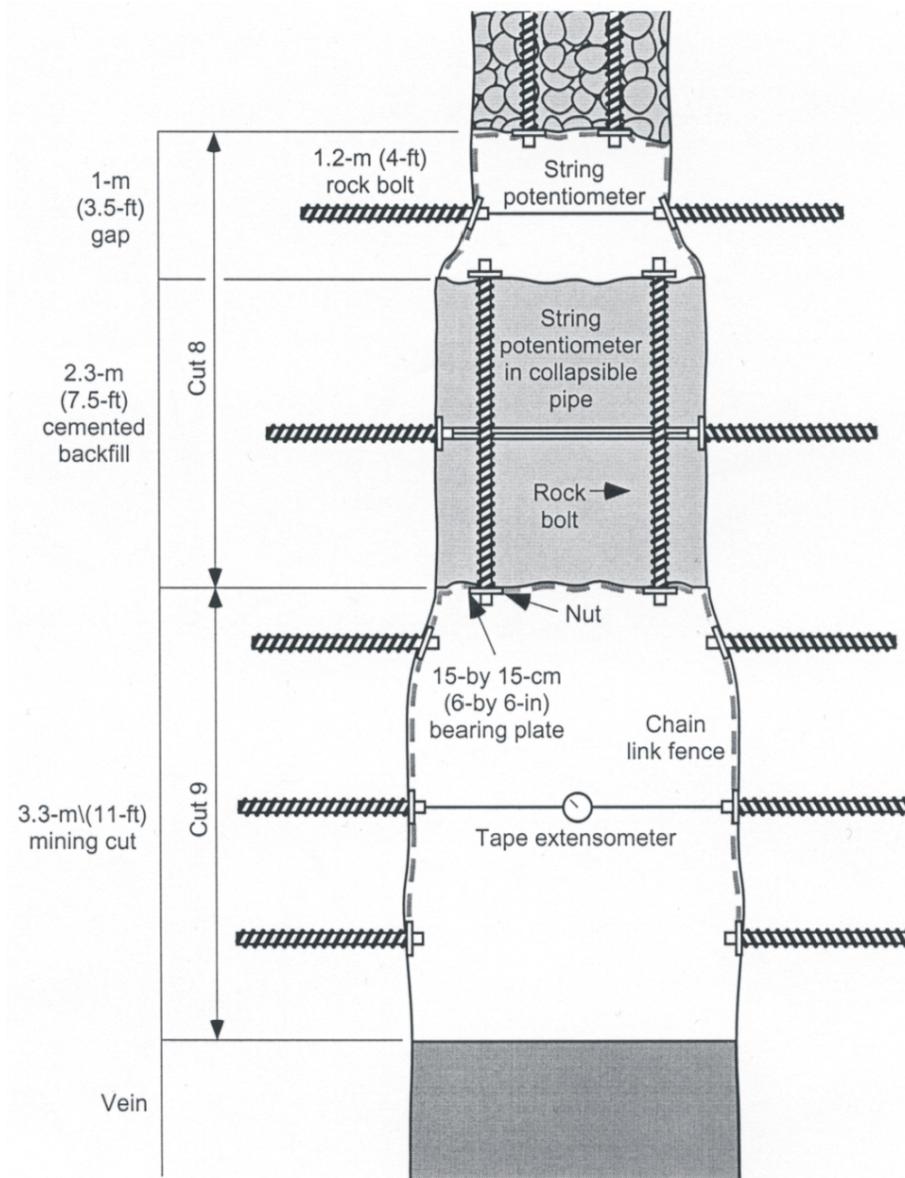
Figure 4.—Wall closure instrument locations.

At various locations, wall-to-wall closure was measured in three different vertical positions (figure 4). A closure plane in the 1-m (3-ft) gap above the backfill was measured with string potentiometers. Another closure plane across the backfill was measured with string potentiometers inside collapsible steel casings, and a closure plane in the new stope cut was measured with a tape extensometer. All closure readings were taken between 15- by 15-cm (6- by 6-in) bearing plates on 1.2-m- (4-ft-) long rock bolts to achieve as much accuracy as possible.

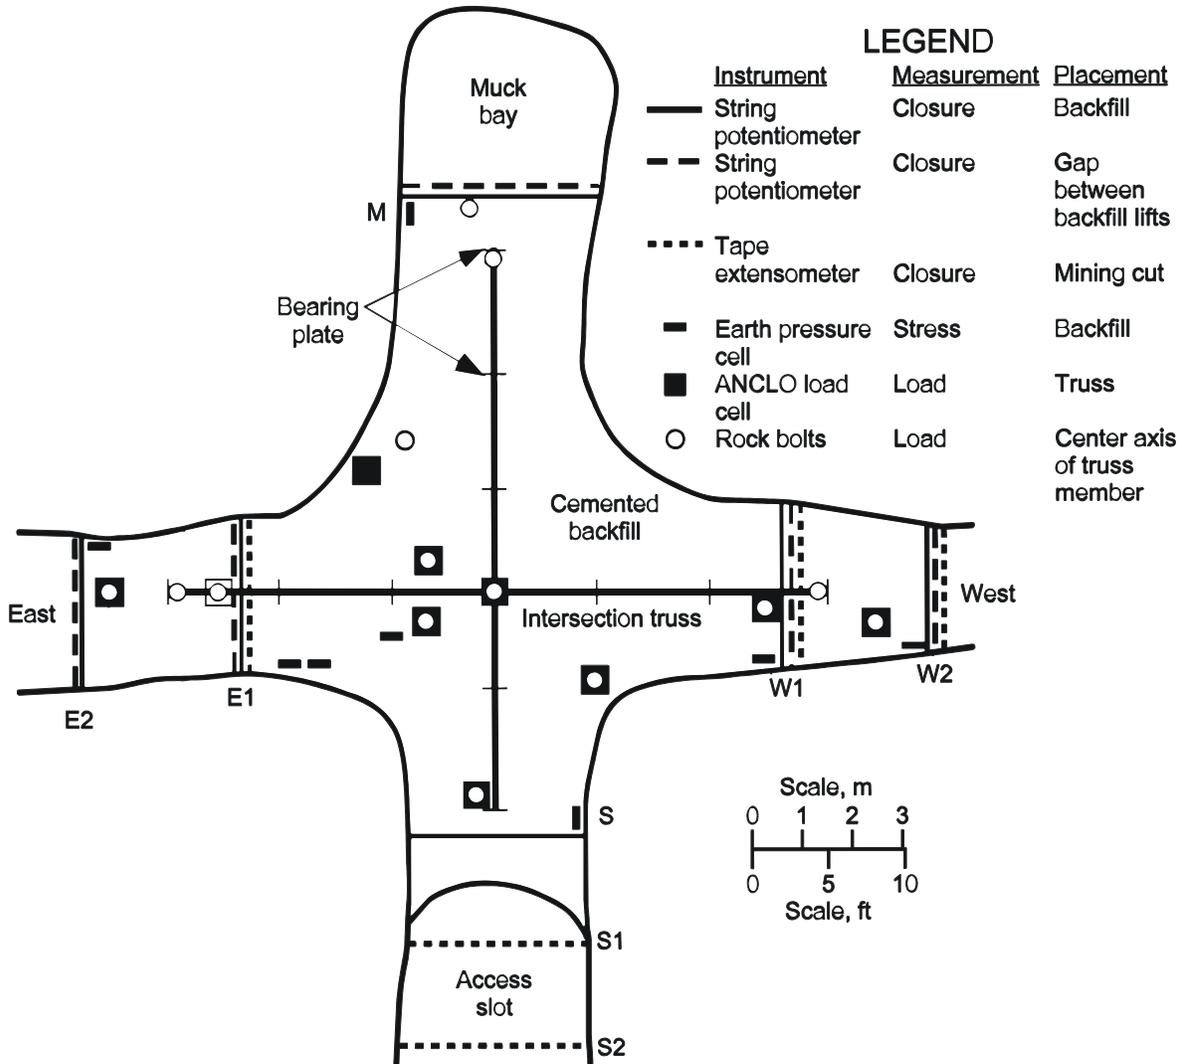
Figure 5.—Location of instruments in 5660-05-level intersection.

Figure 5 shows the location and types of instruments installed in the intersection.

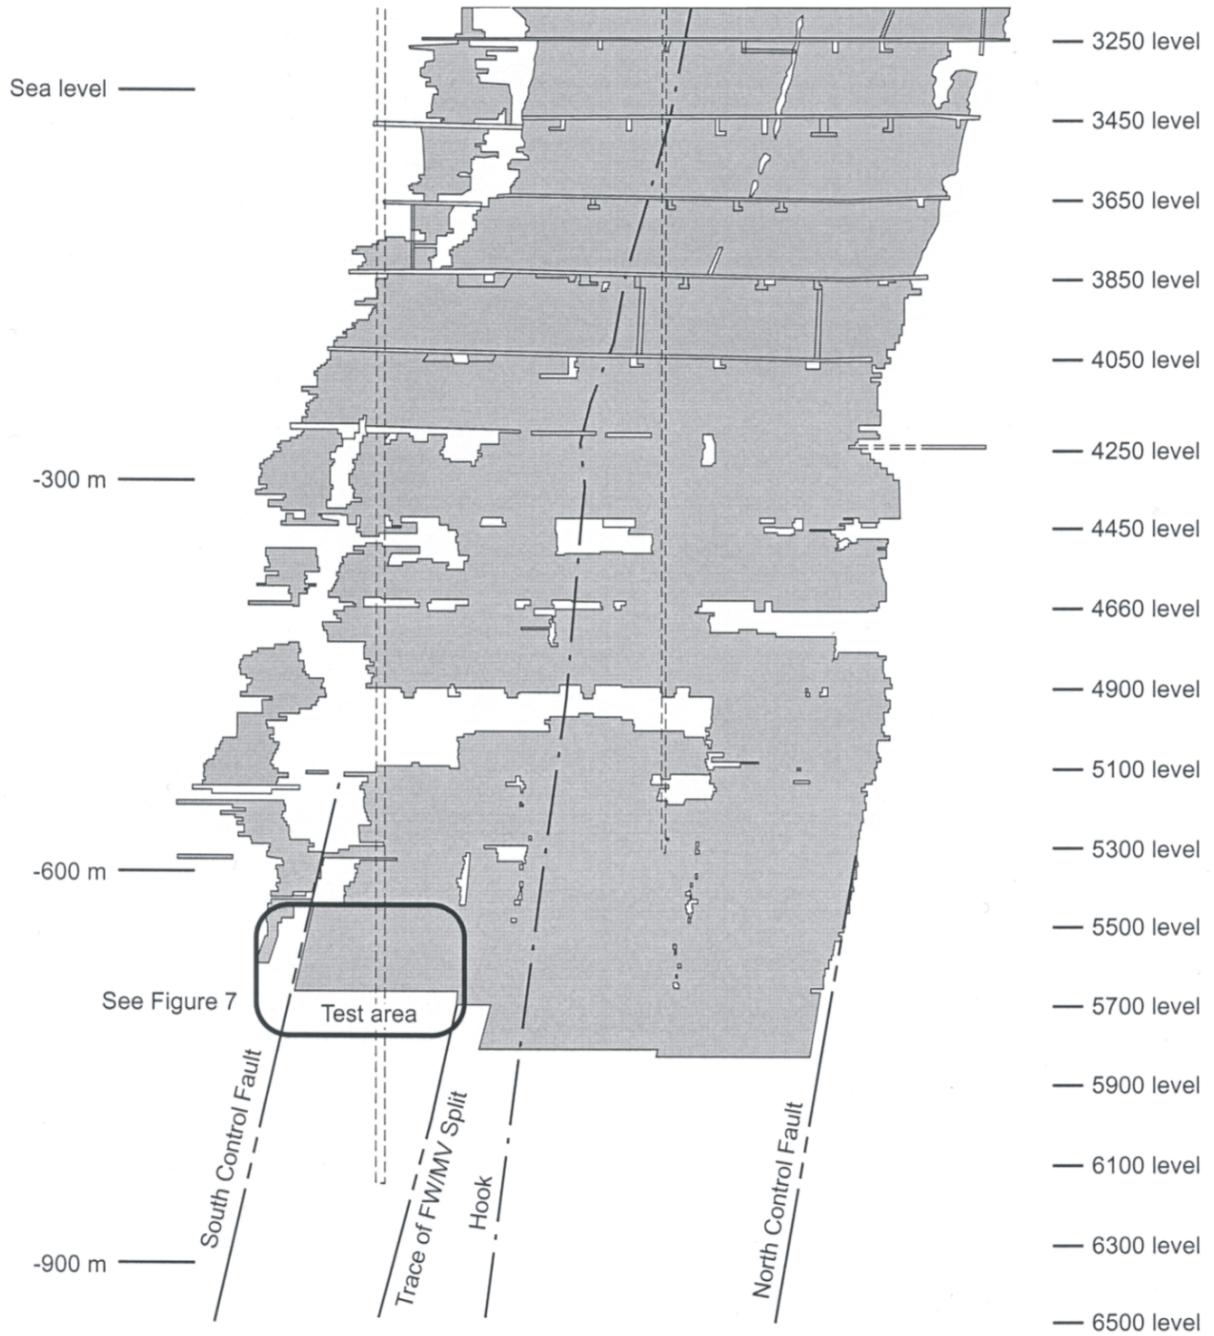
Figure 6.—Longitudinal projection of Lucky Friday Mine.

After the instruments were calibrated at SRL, they were installed in the mined-out cut 8 of the 5660-05 stope prior to placement of the backfill. Figure 6 is a longitudinal projection of the Lucky Friday Mine with the test stope location shown in the lower west corner. Figure 7 is an expanded view showing the cut sequence for the 5660 and 5750 sublevels and the location of the instrument site. On October 15, 1997, the intersection was backfilled with 2.3 m (7.5 ft) of cemented mill tailings so that the truss legs were completely covered. Because the stope was only filled for 2.3 m (7.5 ft) of its 3.3-m (11-ft) height, additional string potentiometers were installed wall-to-wall in the gap on October 16. The datalogger was then moved

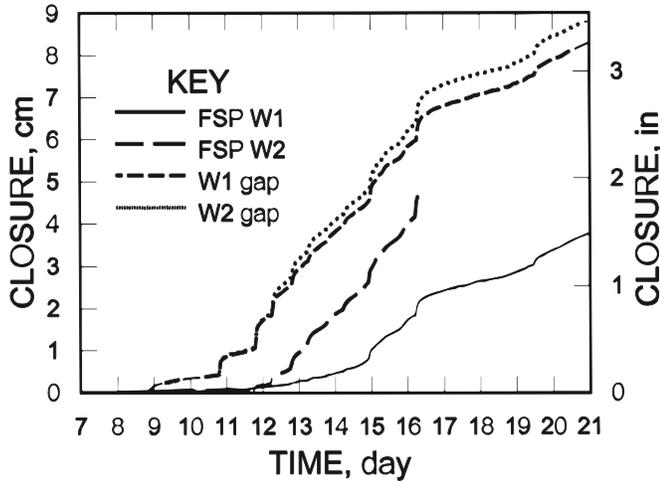
Figure 8.—Gap and backfill closure versus time.

before closure in the backfill (figure 8), a further indication that the backfill was supplying wall support. The amount of overall wall closure would probably be the same, but the backfill supplied enough support so that fractures in the stope walls closed before the backfill started to yield. There were no borehole closure extensometers in the walls, so this hypothesis could not be confirmed.

String pots placed in the backfill showed the vein walls had converged an average of 7.9 cm (3.1 in) during mining of cut 9 on the 5660 level, 8.9 cm (3.5 in) during mining of cut 1 on the 5750 level, and 8.0 cm (3.2 in) during mining of cut 2 on the 5750 level. At the same time, vein closure measured by string pots in the gap area averaged 14.0 cm (5.5 in) for cut 9 on the 5660 level, 11.5 cm (4.5 in) for cut 1 on the 5750 level, and 9.7 cm (3.8 in) for cut 2 on the 5750 level. Increased amounts of closure across the gap were caused by a lack of support for the walls in this area. Gap closure also began 1 or more days

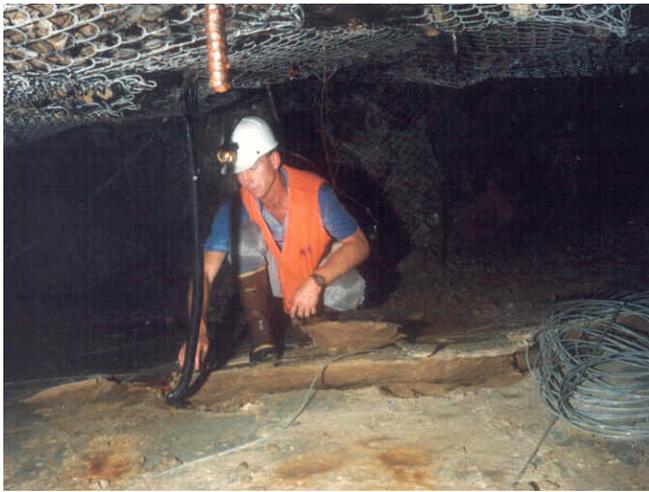
Figure 9.—Thrust-fault-type failure, November 4, 1997.

A thrust-fault-type of fracture (figure 9) was noticed at the top of the backfill while retrieving the CR10's data canister on November 4, 1997. The failure went across the intersection and into the east and west headings along the vein. Both 2- and 2.4-m- (6- and 8-ft-) long vertical rock bolts had been placed in

the area. Failure appeared to be above the 2-m (6-ft) rock bolts, but blocked by the 2.4-m (8-ft) rock bolts, the ends of which were just visible at the top of the fill.

This failure was caused by convergence of the vein walls on the backfill. At this time, there had been 2.5 to 7.6 cm (1 to 3 in) of horizontal closure across the vein in the backfill and 7.6 to 15 cm (3 to 6 in) in the gap above the instrumented backfill.

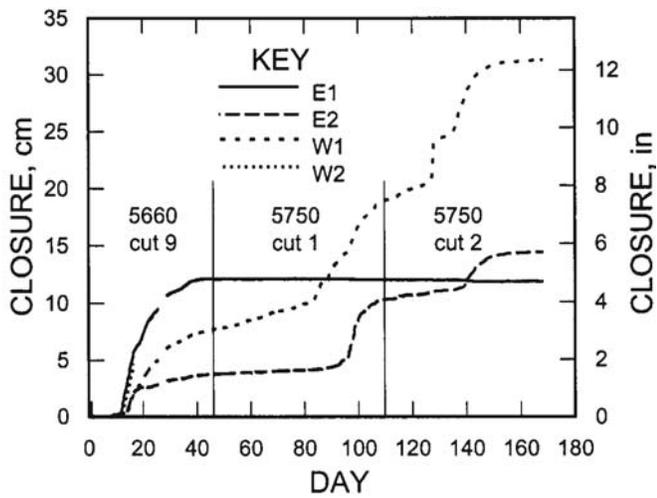
Figure 10.—Backfill closure as a function of time.

Fracturing of the backfill caused upward buckling that gradually reduced the gap between the backfills over time. Buckling continued until the initial 1-m (3.5-ft) vertical gap was reduced to less than 0.3 m (1 ft) before the backfill from cut 7 collapsed onto the instrumented cut 8 backfill. Table 1 is a summary of original stope widths, and table 2 shows closure readings for the three mining cuts. Figure 10 shows backfill closure as a function of time for three mining cuts. Total closure includes

some rapid closure as the cut was mined past the instruments and more gradual time-dependent closure resulting from all previous mining in the area.

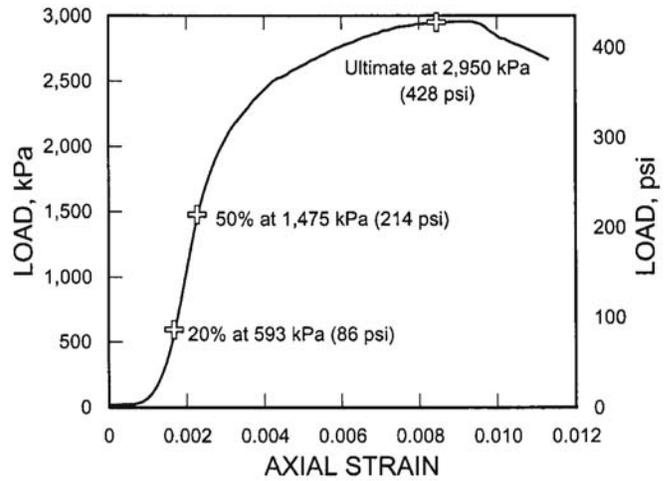
Figure 11.—Compressive test of cemented sandfill, stress/strain curve.

Movement of the platen head of the compression test machine was also recorded to determine an apparent modulus for the 7- and 28-day compressive tests. Figure 11 is an example of the stress-strain curve for the tests. The modulus for the samples is calculated between the 20% and 50% strength values because this is the straight line portion of the curve and most representative of the true response of the backfill. The equation used is —

$$\text{20-50 modulus} = \frac{(50\% \text{ strength} - 20\% \text{ strength})}{(50\% \text{ strain} - 20\% \text{ strain})}$$

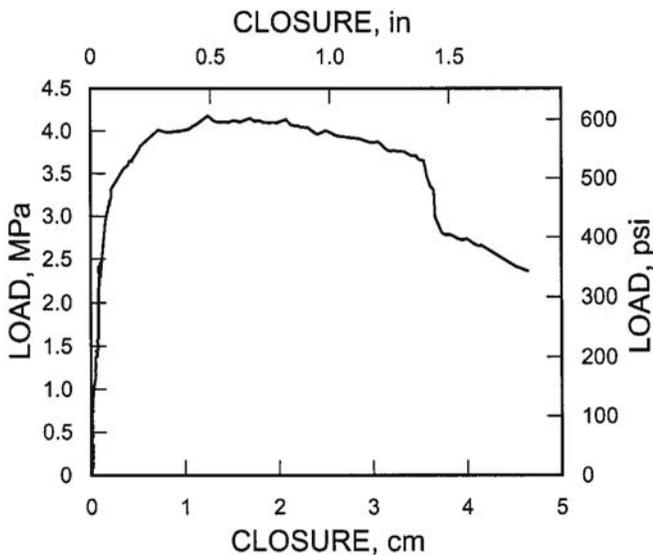
Figure 12.—Backfill closure versus backfill pressure, West 2.

Model 3500 earth pressure cells from Geokon, Inc., were placed in the cemented backfill to monitor pressure as the walls closed. The backfill pressure increased rapidly as wall closure commenced (figure 12). The readings peaked with mining of cut 9, after which backfill pressure dropped as each subsequent cut was completed. Peak pressures ranged from a low of 793 kPa (115 psi) in the intersection to 4178 kPa (606 psi) at West 2; the average across the vein was 2757 kPa (400 psi) at 15 days. The data collected in the mine were within the range of the data collected in the laboratory (7-day unconfined compressive strength of 2082 kPa [302 psi] and 28-day unconfined compressive of 3254 kPa [472 psi]).

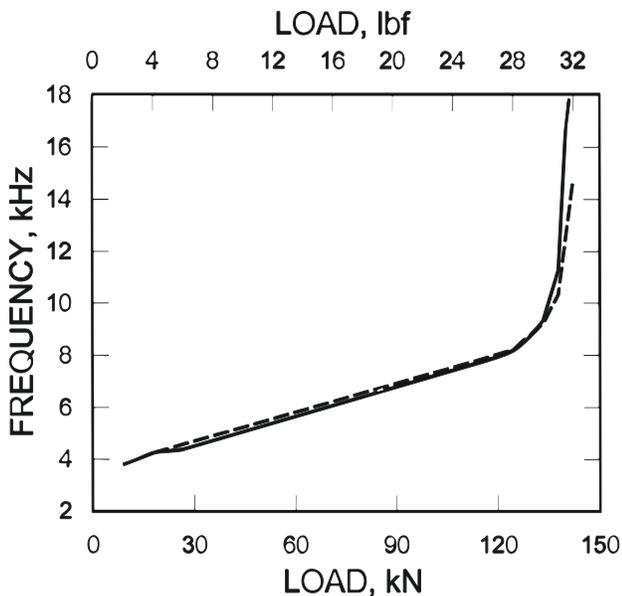
Figure 13.—Calibration curve showing relationship between frequency and load on instrumented rock bolts.

These tests showed that the hole drilled for the vibrating wire did not affect the yield strength of the bolt, but that it did reduce ultimate strength from 240 to 215 kN (54,000 to 48,450 lb). The slope of gauge response was linear between 8.9 and 124 kN (2000 and 28,000 lb) at 27 N/Hz (6 lb/Hz). Gauge response was then rapidly reduced to 2 N/Hz (0.45 lb/Hz). At 142 kN (32,000 lb), the gauges failed before the yield point of the rock bolts was reached. Figure 13 shows calibration load versus gauge response frequency for the bolts tested to failure. These tests showed that the vibrating-wire gauges installed in the end of the bolts were inadequate for this application and any future tests should use a gauge with a higher load range. The data were reanalyzed using this calibration curve.

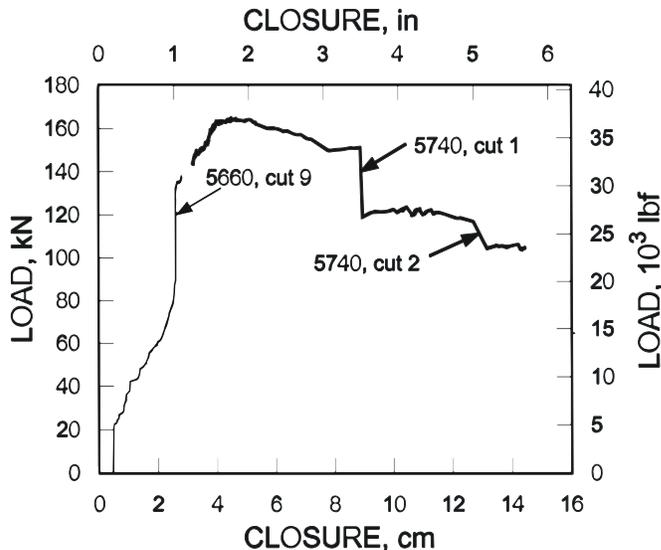
Figure 14.—Backfill closure versus rock bolt load, East 2.

Data from the rock bolt load cells indicated that the vertical rock bolts were under loads from 41 to 179 kN (9300 to 40,300 lb) after cut 9 was mined except in the muck bay, where loads ranged from 2.9 to 19.1 kN (660 to 4300 lb). Loads on the vertical rock bolts along the vein dropped as cuts were subsequently mined. This drop was probably a result of the continued breaking up of the backfill as the walls closed. Figure 14 shows the relationship of rock bolt load to backfill closure at East 2. The data indicate rock bolt load leveling off and

decreasing as closure continued following each mining cut. This drop was probably caused by backfill failure around the rock bolt bearing plates as the walls converged. Inspection of the bottom of the backfill revealed bags of broken backfill in the chain link fencing between the rock bolt plates. Visual observation of the top of the 2.4-m- (8-ft-) long vertical rock bolts also confirmed that the 15- by 15-cm (6- by 6-in) bearing plates resisted backfill deformation and transferred load to the rock bolt.

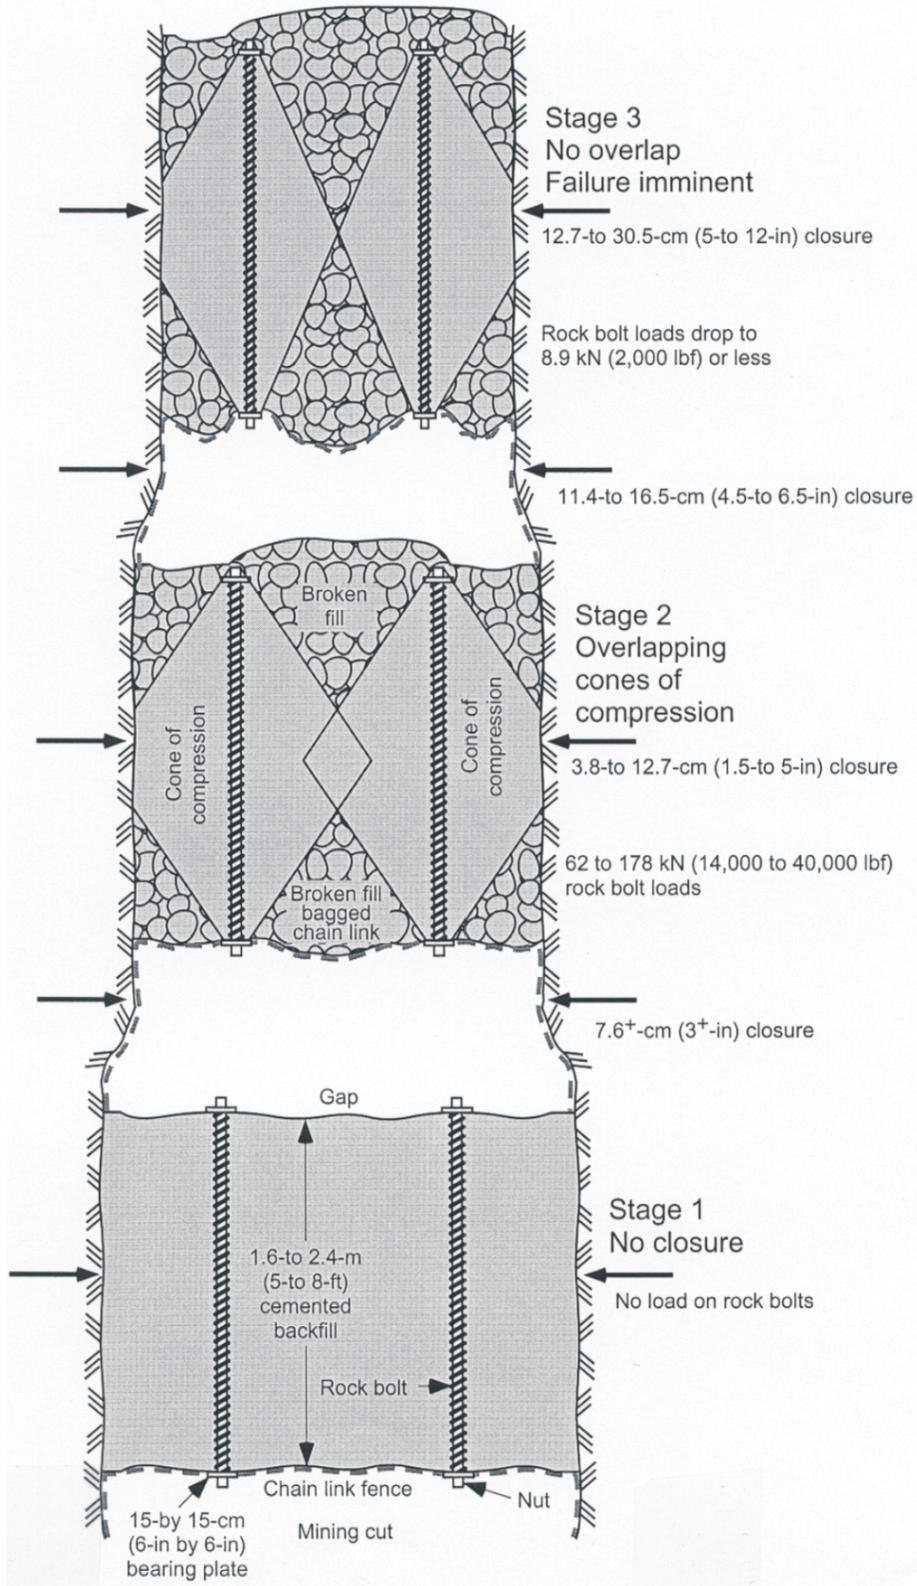
Figure 15.—Closure sequence in backfill.

Figure 15 is an idealized drawing of how the instrumented rock bolts interacted with the cemented backfill in the vein portion of the stope as mining progressed. This interpretation is based on conventional theories of rock bolt reinforcement that state that tensioned rock bolts create a self-supporting compressive arch across the opening (Lang 1961; Hoek and Brown 1980; Stillborg 1986; Brady and Brown 1993). The illustration is also based on visual observations, closure measurements, and load readings on the vertical rock bolts gathered during this project. Initially, in stage 1, there is no wall closure, pressure in the backfill, or load on the reinforcing rock bolts. Then forces in the backfill, created as the bearing plates resist backfill deformation caused by wall closure, form a cone of compression in the backfill (stage 2). The backfill is self-supporting until the backfill breakup progresses to the point where the overlap of the cones of compression between adjacent vertical rock bolts is eliminated (stage 3). The backfill then collapses because of gravity.

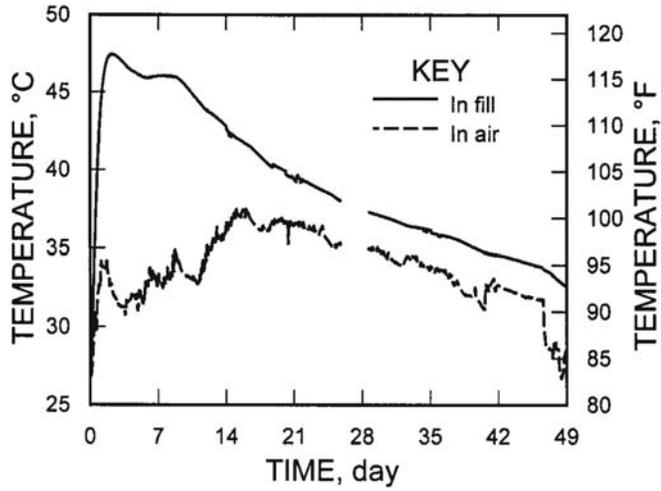
Figure 16.—Temperatures recorded on rock bolts in backfill and in mine atmosphere.

The instrumented bolts and two of the earth pressure cells had temperature sensors attached in case large temperature fluctuations required that calculations be made to compensate for these fluctuations. The sensors on the bolts were on the end of the bolt with the strain gauge, and the temperature readings reflected the position of the gauge with respect to the surface of the sandfill. The readings from the 2.4-m- (8-ft-) long rock bolts in the intersection were lower than the other readings because the ends of these bolts were exposed to the air. Figure 16 shows average temperatures for the bolts in the backfill and those in the intersection. The 47.2 °C (117 °F) in-fill temperature at day 2 was the highest temperature recorded in the backfill and stemmed from the heat of hydration of the cemented backfill. The 32.2 °C (90 °F) recorded on the IA, IB, and IC rock bolts was air temperature in the unventilated area above the backfill. The data show that no temperature compensation was required for the strain gauges because loads were significantly higher than the temperature compensation. The data also give an indication of the heat load to the ventilation system from the heat of hydration of the cemented backfill.

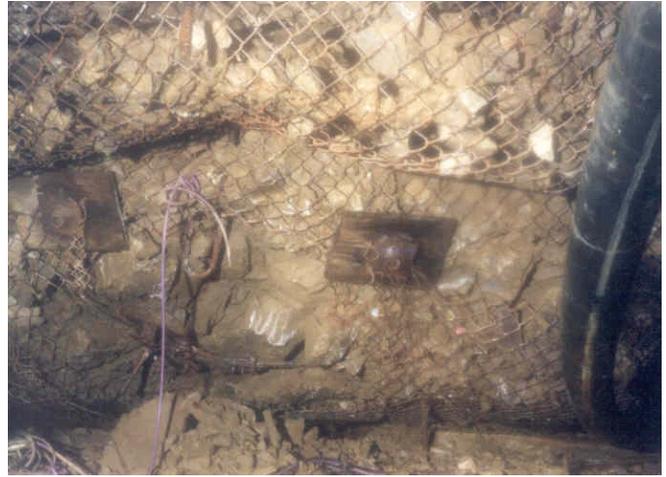
Figure 18.—Backfill failure at four-way bracket.

Visual inspection of the intersection on March 3 showed that the backfill in the northwest corner of the intersection had collapsed onto the backfill in cut 9, but that the truss was still above the backfill. It was not possible to determine how far the failure extended along the west side of the stope, but it is thought that, based on instrument response, failure was limited to the first 3 m (10 ft) of the west side. The 3-m- (10-ft-) long cap placed here probably stopped further collapse, but the area was not accessible to confirm this belief. The weight of the backfill from cut 7 on top of the instrumented backfill and continued wall closure from mining in cut 2 on the 5750-05 level caused the intersection to collapse. The collapse was not hazardous to miners because there were two intact backfilled cuts between the collapse and the active mining area.

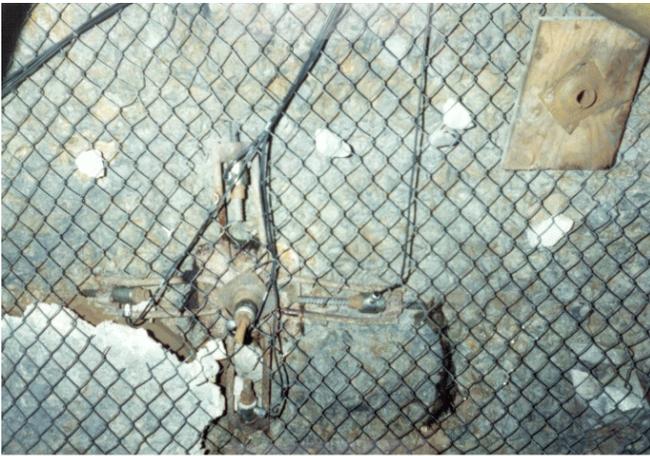
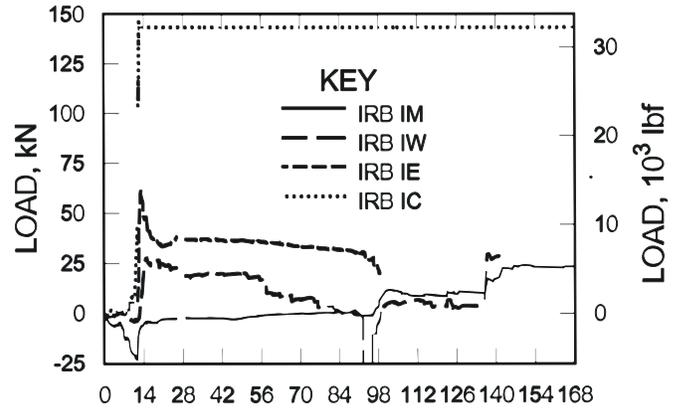
Figure 19.—Data from instrumented bolts in truss.

At day 136, the two remaining instrumented rock bolts on the muck bay leg and the west leg also recorded sudden increases in load similar to, but of a lower magnitude than, those of the load cells at the truss bracket. Readings from the instrumented rock bolt on the west truss leg stopped on day 142 after cut 2 from the 5750 level had mined under. Figure 19 is a graph of data for all three mining cuts.

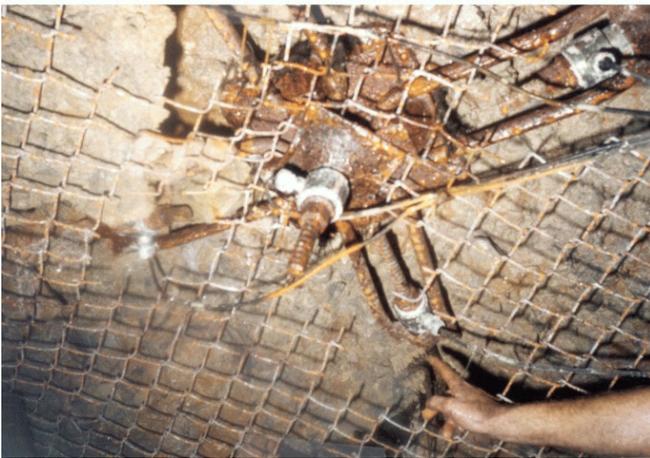
Figure 17.—Load cells at truss four-way bracket.

Immediately after installation on day 14 and during mining of cut 9 on the 5660 level, the load cell on the vertical rock bolt in the center of the truss took on loads to 116 kN (26,000 lb), while the load cells on the horizontal leg showed loads from 0.4 to 33.4 kN (100 to 7500 lb) (figure 17). Loads on the horizontal legs remained fairly constant until day 87, at which time cut 1 from the 5750 level was being mined past the instrument locations 6 m (20 ft) below.
