Results of In-Mine Research in Support of the Investigation of the Sago Mine Explosion

Report of Investigations 9678

**By Kenneth L. Cashdollar, Eric S. Weiss, Samuel P. Harteis, P.E.,
Michael J. Sapko, and John E. Urosek, P.E.**

DEPARTMENT OF HEALTH AND HUMAN SERVICES
Centers for Disease Control and Prevention
National Institute for Occupational Safety and Health
Pittsburgh Research Laboratory
Pittsburgh, PA

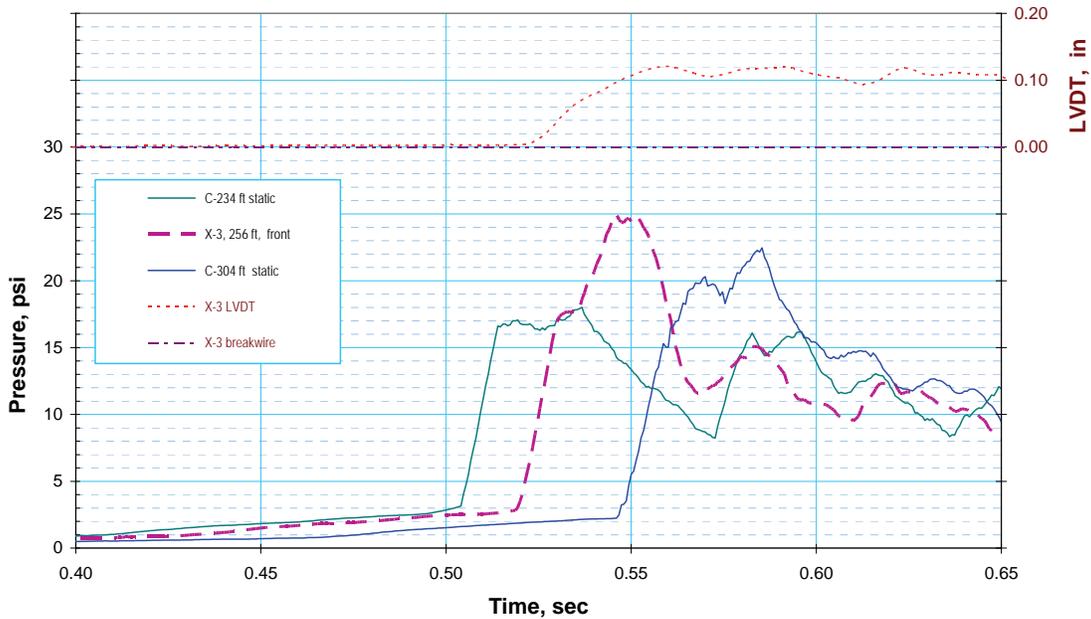
the figure shows the seal displacement as measured by the LVDT on the back of the seal. The maximum recorded movement during the explosion was 0.12 in. Since the seal did not fail, there was no change in the breakwire signal.

Figure 9.—Pressures and LVDT displacement at the Omega block seal in X-3 during Test 1 (LLEM #501).

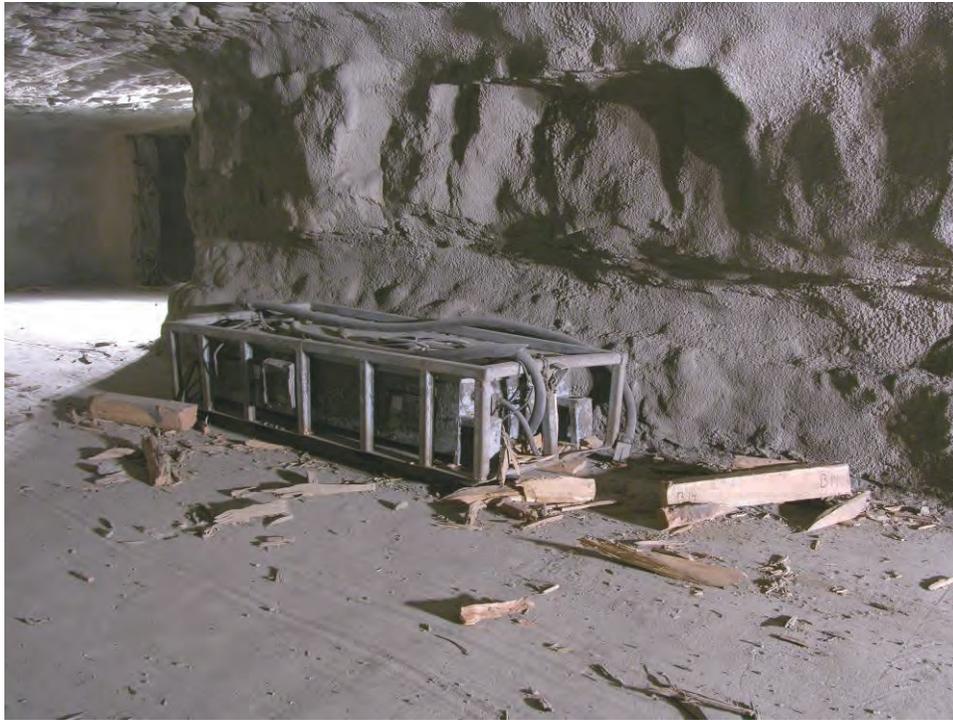
The recorded explosion pressure at the battery charger location was 6–7 psi, and the dynamic pressure was 0.8 psi. The length of the charger was 7.5 ft. The explosion pressure would equalize from the inby to the outby end of the charger at the speed of sound. Therefore, the pressure would equalize in about 7 ms. If the pressure pulse rose from about 0 psi to its maximum value in less than 7 ms, then the inby end of the charger would have been subjected to a differential pressure that was equal to the maximum explosion pressure at that location. For Test 1, the explosion pressure loading at this location rose to its maximum value in less than 7 ms. Therefore, the inby end of the charger was subjected to a pressure loading of 6–7 psi while the outby end was still at ~0 psi. The dimensions of the end of the charger were 40 in wide by 22.5 in high, giving a cross-sectional area of 900 in². The ~6.5-psi pressure loading on that area would result in a total force of ~5,900 lb on the charger for a few milliseconds. The 0.8-psi dynamic pressure would continue to act on the charger for a longer time period. The battery charger moved 22 ft during Test 1. The final charger position and some of the wood debris from the cribs are shown in Figure 12.

Figure 12.—Battery charger and debris from the wood cribs near X-7 after Test 1 (LLEM #501).

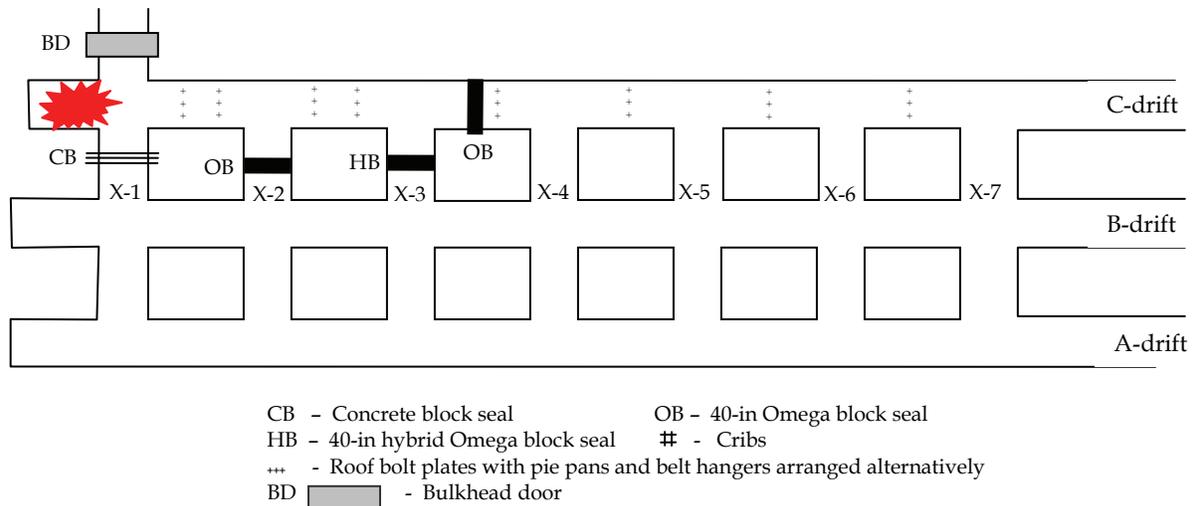
The solid-concrete-block seal in X-1, the 2001-design Omega block seal in X-2, and the hybrid Omega block seal in X-3 had survived the previous LLEM explosion test and were left in place for the second test. A new 2001-design Omega block seal was installed across C-drift at about 320 ft from the face. The details of the test procedure and seal description can be found in Appendix A under “Test No. 2 Protocol.” Additional details of the C-drift seal construction can be found in Appendix B, section 3. A schematic of the test setup is shown in Figure 14.

Figure 14.—Setup for Test 2 (LLEM #502).

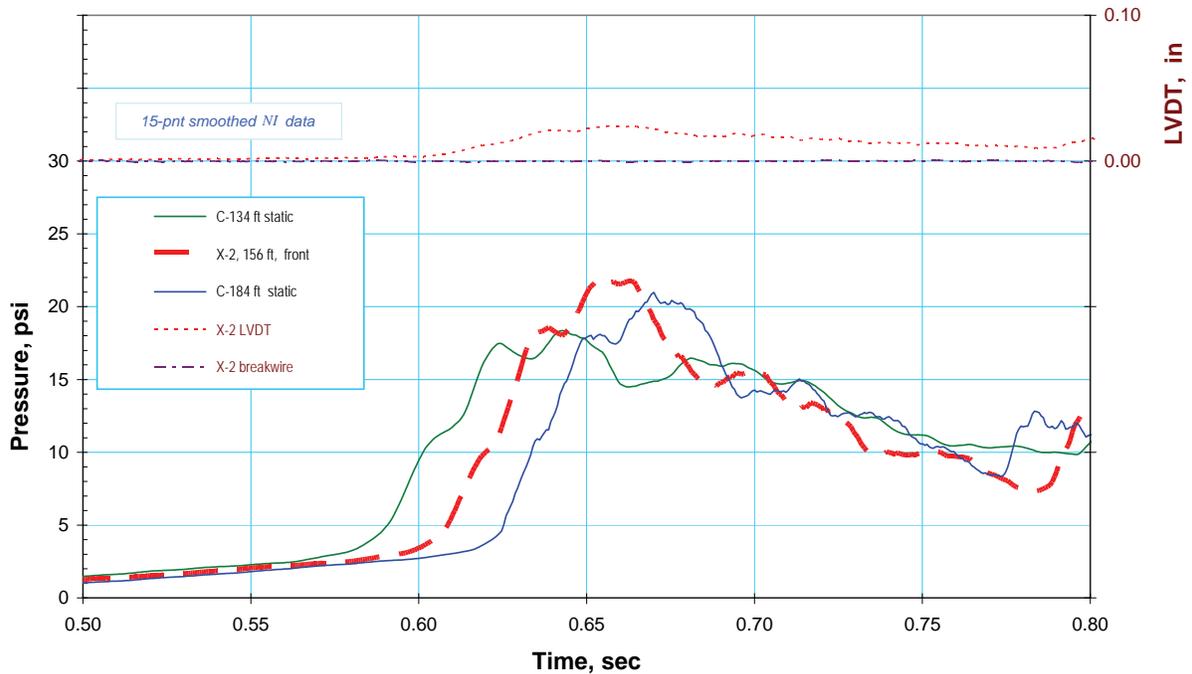
In this test, the Omega block seal in X-2 survived, but the seals in X-3 and C-drift were destroyed by the higher pressures. Figure 15 shows the pressure loading at the seal in X-2 along with the quasi-static pressure at the wall of C-drift inby (134 ft) and outby (184 ft) the seal. The pressure transducer at the seal was located approximately in the middle front of the seal at 156 ft from the face of C-drift. All of the data were averaged over 10 ms. The pressure loading at the seal was 22 psi, similar to the value during the first test. The curve at the top of the figure shows the seal displacement as measured by the LVDT on the back of the seal. The maximum recorded movement during the explosion was 0.03 in. Since the seal did not fail, there was no change in the breakwire signal.

Figure 15.—Pressures and LVDT displacement at the Omega block seal in X-2 during Test 2 (LLEM #502).

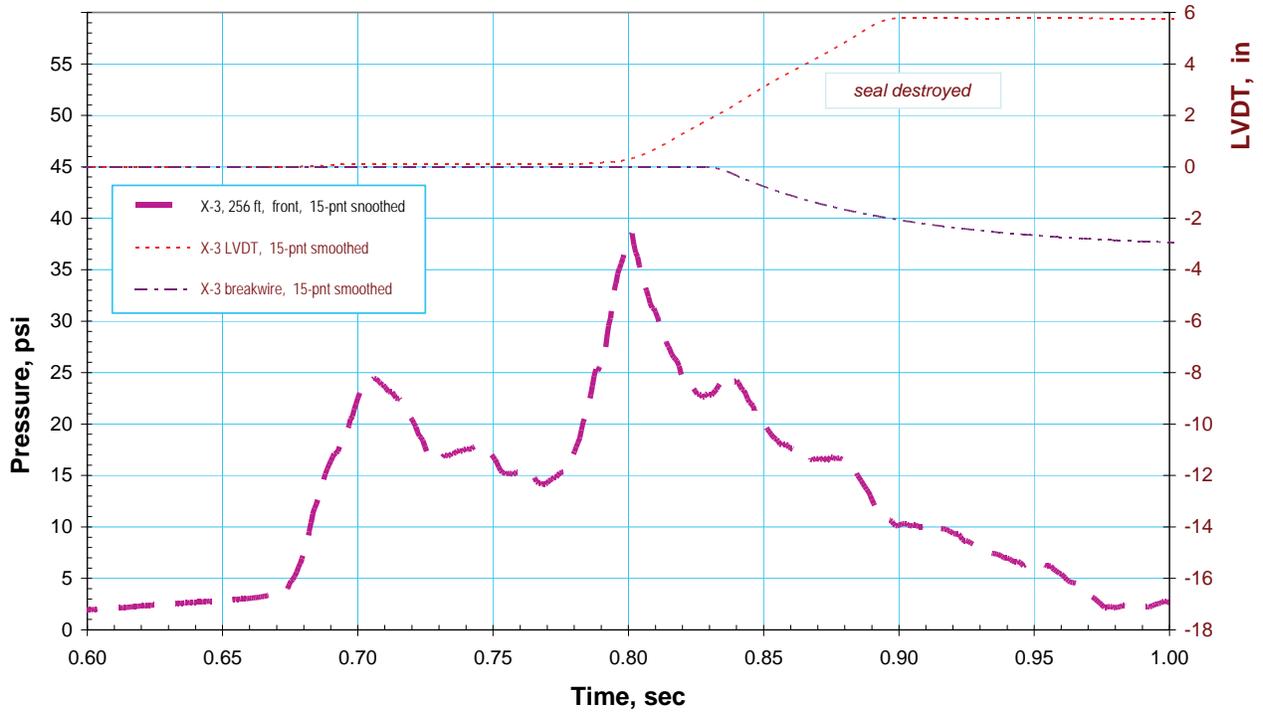
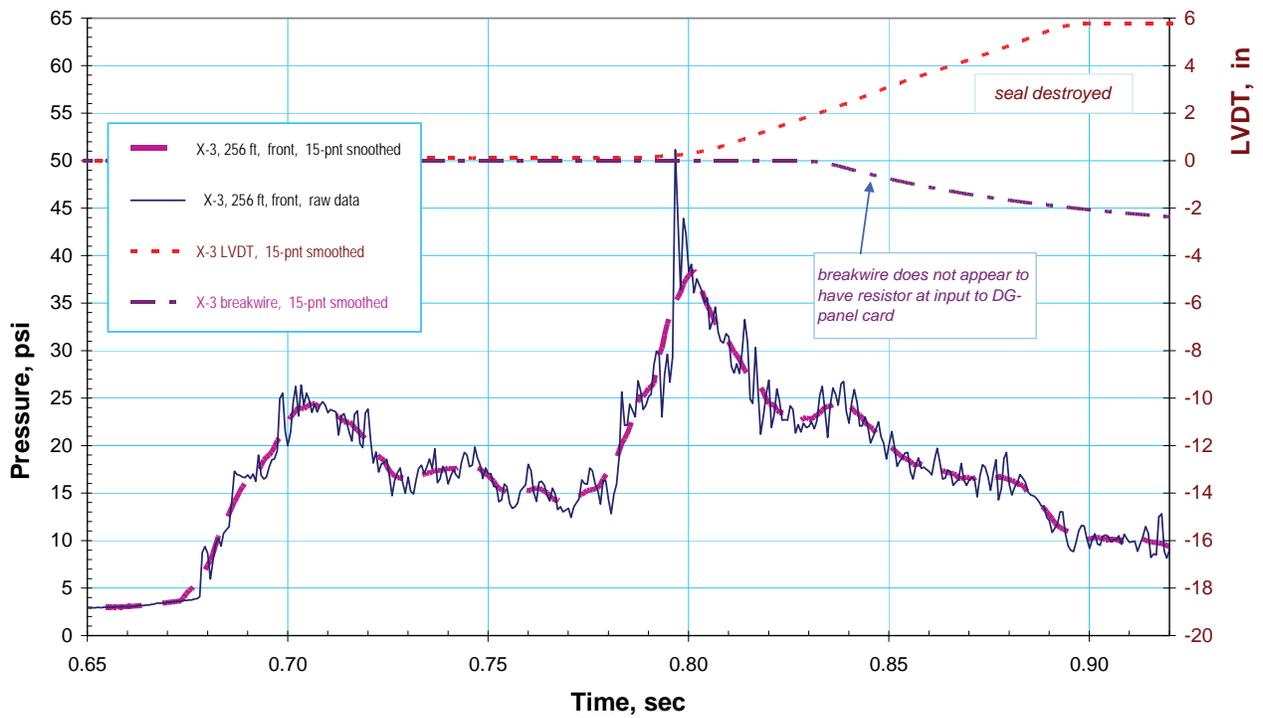
Figure 16.—Pressures and LVDT displacement at Omega block seal in X-3 during Test 2 (LLEM #502).

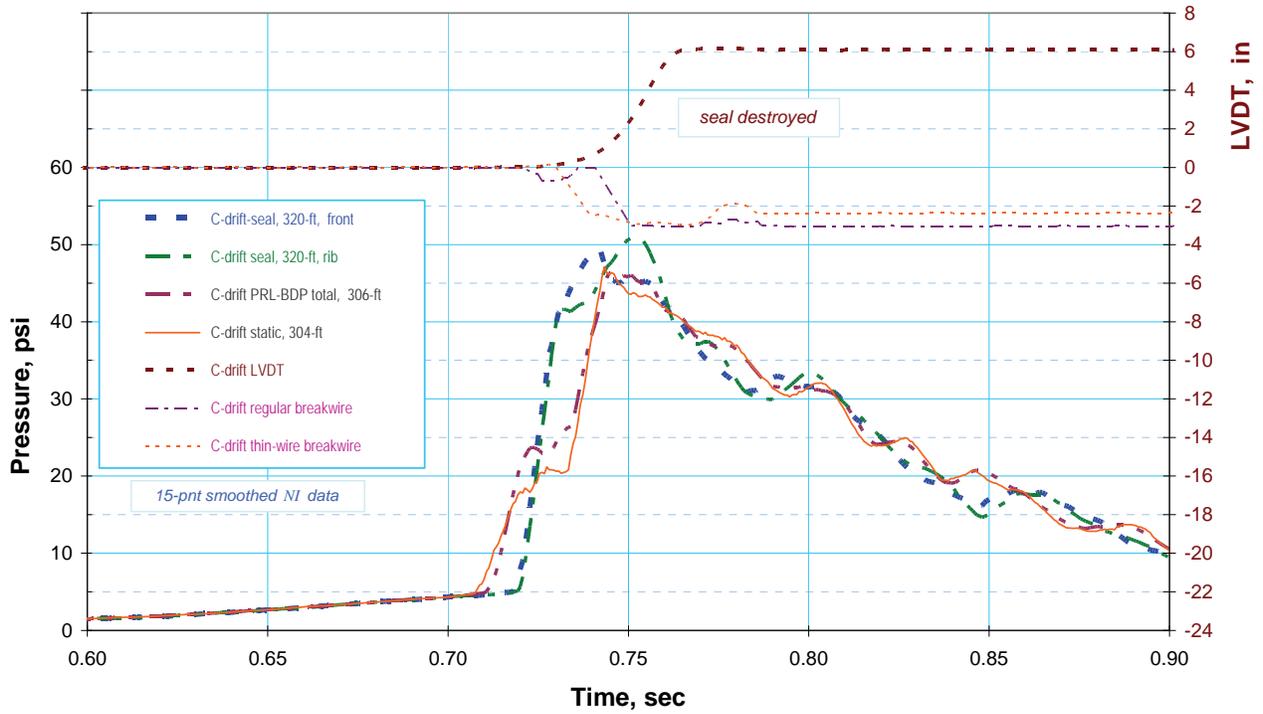
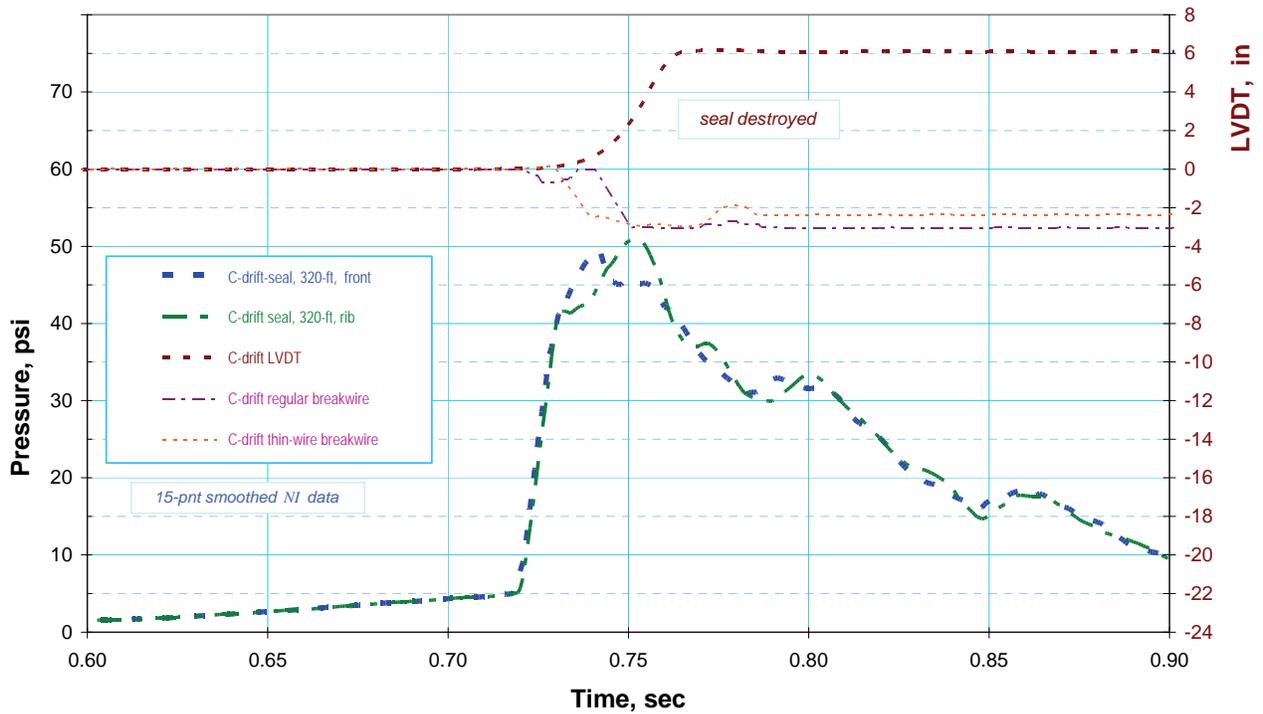
The top graph of Figure 17 shows the pressure loading at the middle front of the seal at 320 ft in C-drift and the quasi-static pressure loading as measured perpendicular to the entry near the rib at the edge of the seal. Also shown are the quasi-static pressure at the wall of C-drift at 304 ft and the total explosion pressure measured by the BDP at 306 ft. All of the data were averaged over 10 ms. The bottom graph of Figure 17 only shows the data from the two pressure transducers at the seal. The smoothed pressure loading at the seal was 49.5 psi at the front center and 51 psi at the rib. The peak pressure loadings from the 1,500-Hz raw data (not shown in Figure 17) were 61 psi at the front center and 53 psi at the rib. The recorded seal movement during the explosion was >6 in as the seal was destroyed. The two breakwire signals showed that the wires broke as the seal was destroyed near the time of peak pressure loading at ~0.73–0.75 sec.

Figure 17.—Pressures and LVDT displacement at C-drift Omega block seal during Test 2 (LLEM #502).

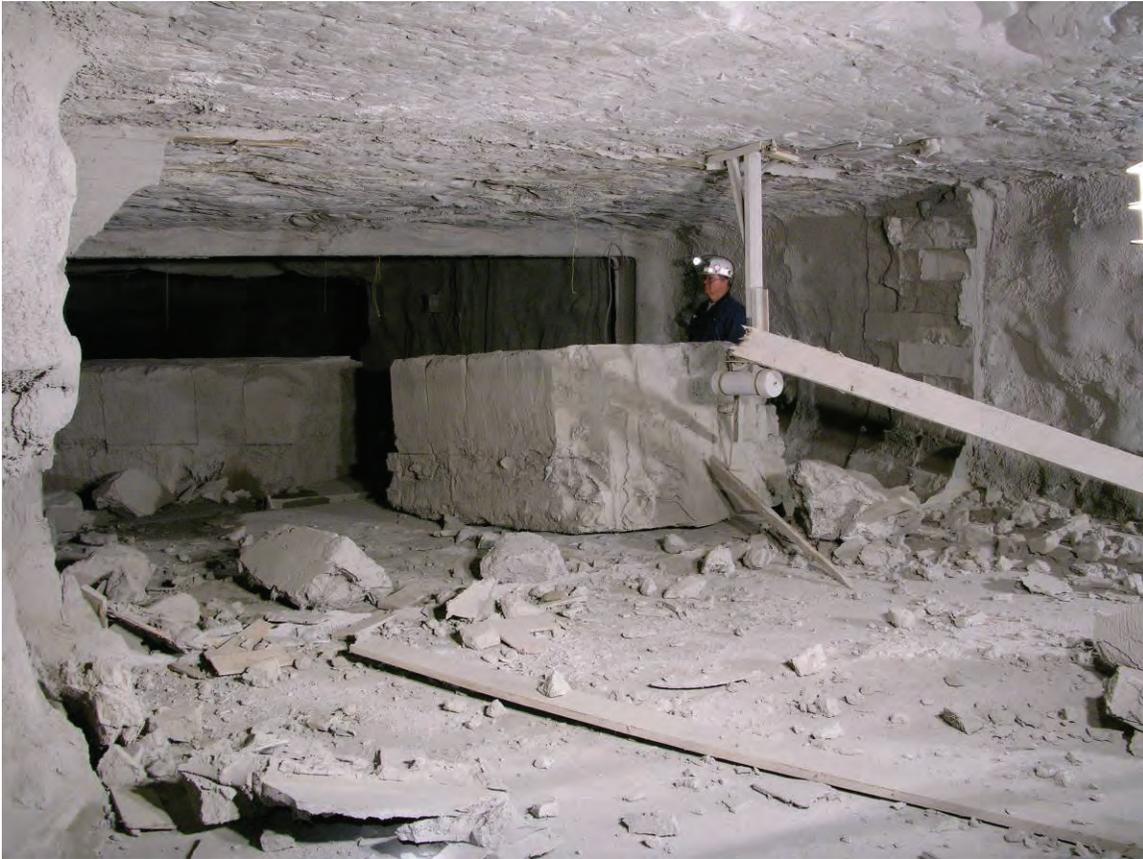
Figure 18.—Remains of X-3 seal viewed from C-drift after Test 2 (LLEM #502).

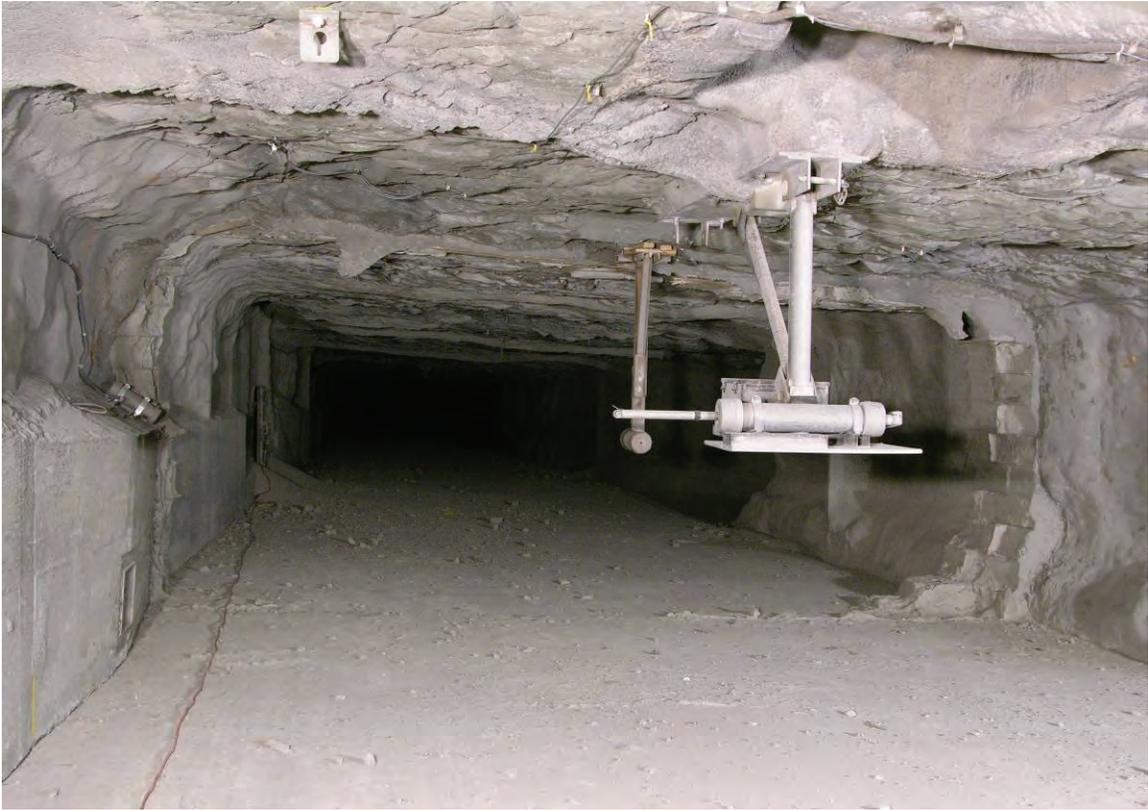
Figure 19.—Postexplosion view looking outby from original seal position in C-drift.

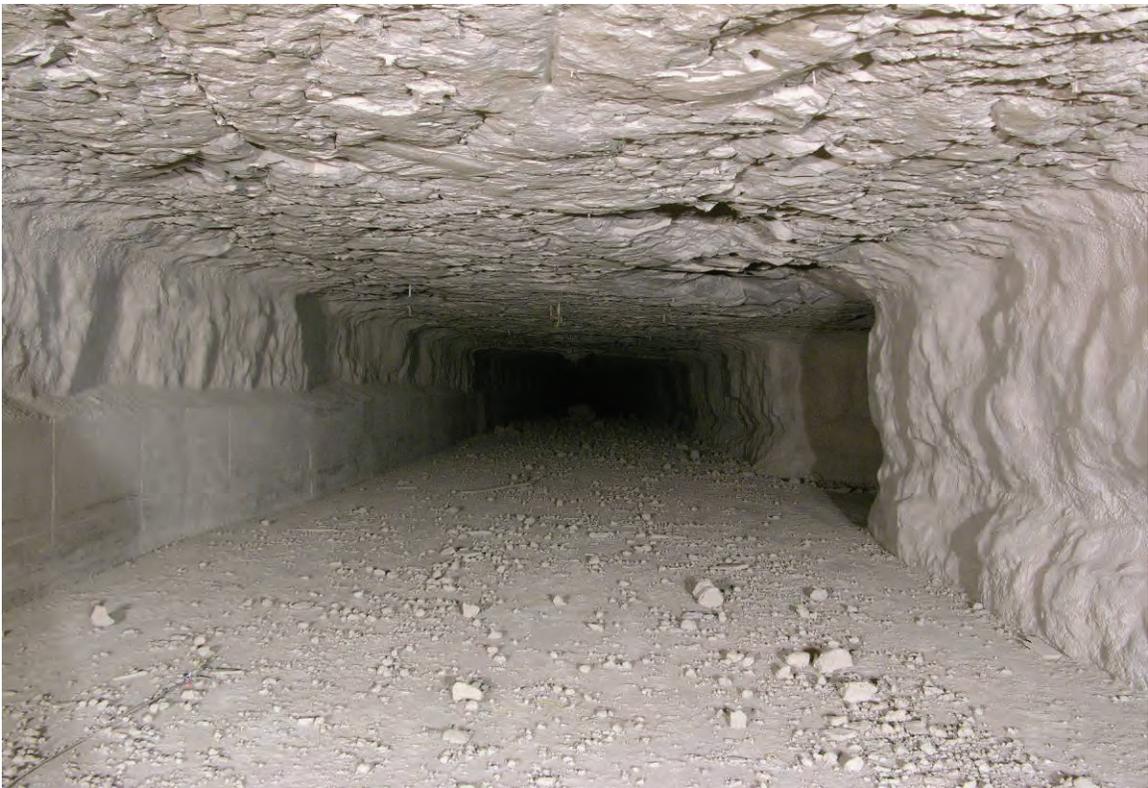
Figure 20 shows the view looking outby from the DG panel at 403 ft. Even at this distance, the seal debris consists only of small pieces. Larger pieces of debris from the C-drift seal are seen in Figures 21–22, which show the views looking outby from X-6 at 547 ft and X-7 at 647 ft, respectively.

Figure 20.—Postexplosion view looking outby from 403 ft after Test 2 (LLEM #502).

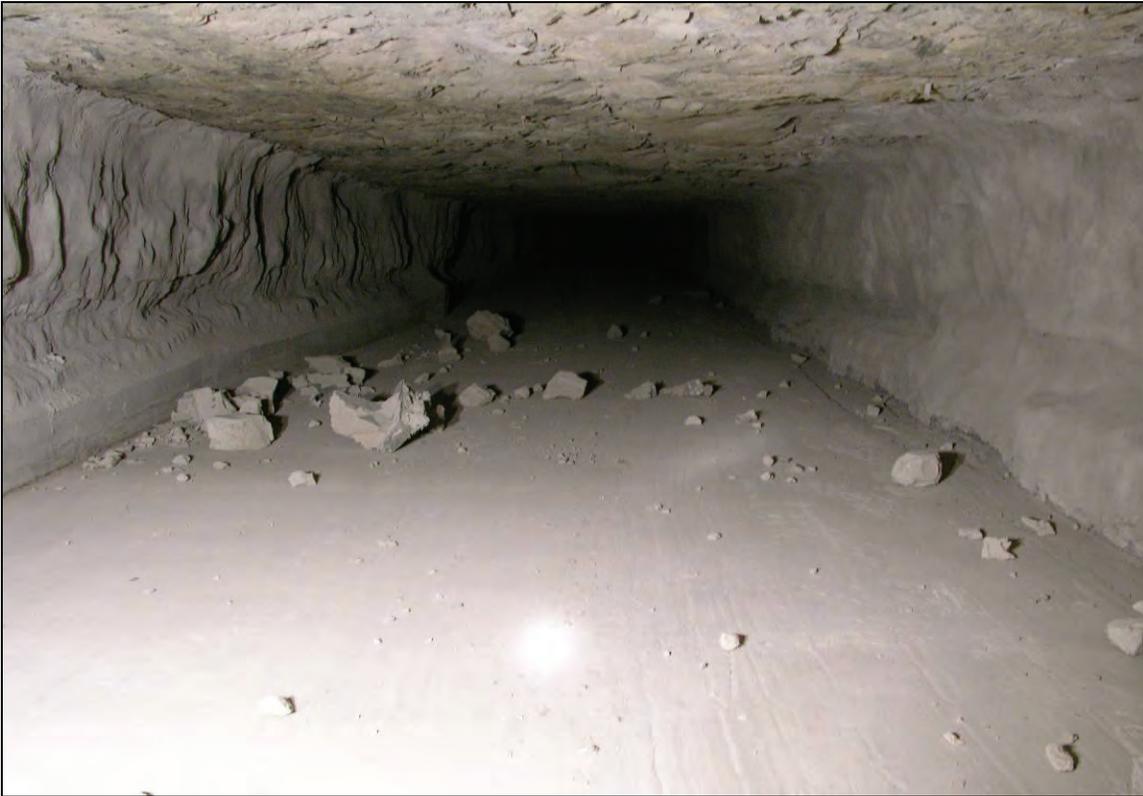
Figure 23.—Debris after Test 2 (LLEM #502) looking outby from 850 ft.

Figure 23 shows the seal debris at a position looking outby at a distance of ~850 ft from the face or ~530 ft from the original C-drift seal position. The farthest the debris traveled during Test 2 was ~824 ft from the original C-drift seal location, as noted in Table 5. There were no wood cribs for this test.

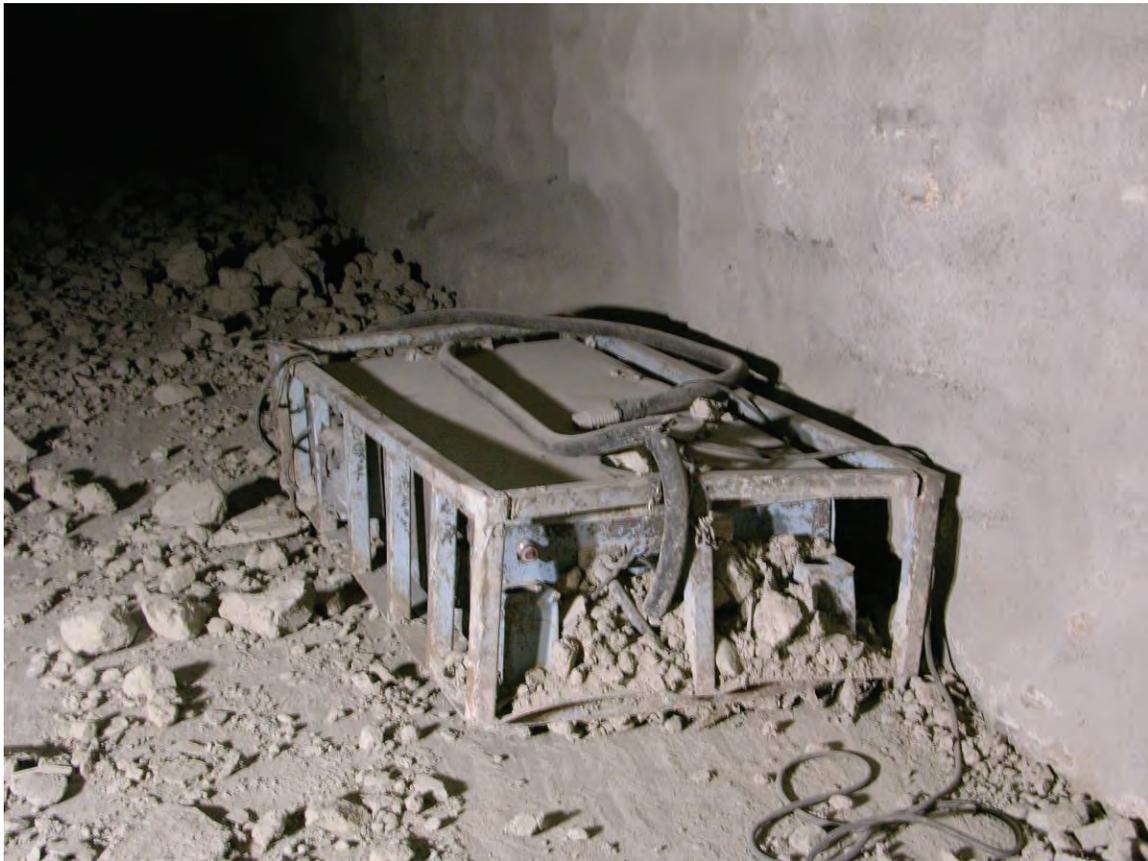
For Test 2 (LLEM #502), the 1,560-lb battery charger was placed at 688 ft from the face of C-drift or 365 ft from the outby face of the C-drift seal. The charger moved ~79 ft during this explosion. Figure 24 shows the final location of the battery charger near 770 ft surrounded by debris from the seal. The total explosion pressure at the 604-ft BDP was 3.8 psi and the dynamic pressure was 0.3 psi. The quasi-static wall pressure at 757 ft was 2.8 psi. The pressure loading at the charger location would have been ~3.5 psi. As for Test 1, the pressure pulse rose to its peak recorded value in less than 7 ms. Therefore, the inby end of the charger would have been subjected to the maximum explosion pressure loading while the outby end was still at ~0 psi. Based on the cross-sectional area of 900 in² for the end of the charger and the pressure loading of ~3.5 psi, the total force would have been ~3,100 lb for a few milliseconds. The ~0.3-psi dynamic pressure would have continued to act on the charger for a longer time period. In addition to the air pressure, the battery charger was also hit by debris from the seal, as evidenced in Figure 24.

Figure 24.—Final location of battery charger at ~770 ft.

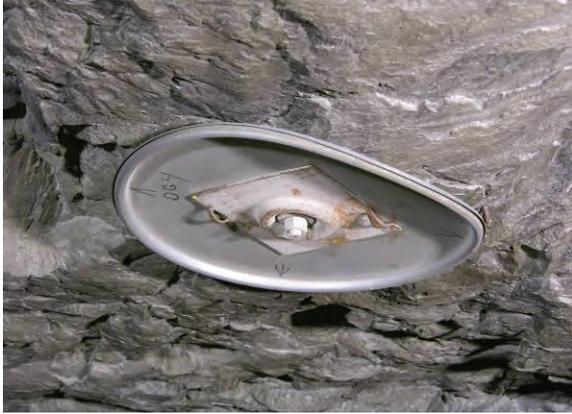
Some of the roof plates were damaged during the Test 2 explosion, as shown in Figure 25. On the left side of the figure, the plates are shown from inby of the plates, looking outby. On the right side of the figure, the plates are viewed looking across the entry from the DG-panel side. The round plate at 184 ft was slightly bent during the explosion. The round plate at 234 ft from the face was the only one that was severely bent during the explosion. There was little or no obvious damage to the other round plates, square plates, and belt hangers.

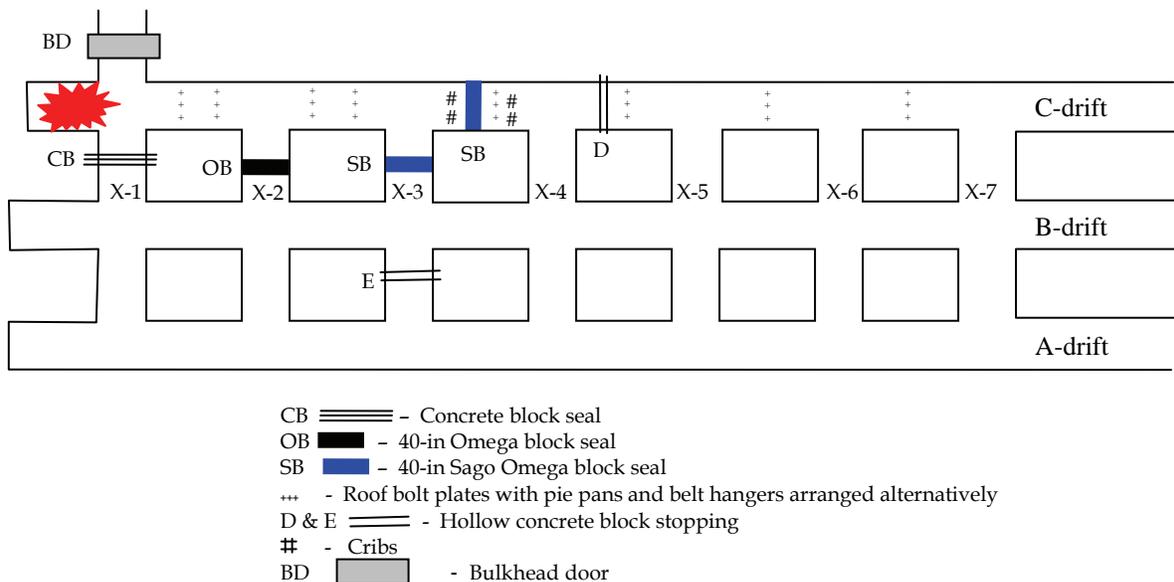
The solid-concrete-block seal in X-1 and the 2001-design Omega block seal in X-2 had survived the previous LLEM explosion tests and were left in place for the third test. New Sago nominal 40-in Omega block seals were installed in X-3 and in C-drift at about 320 ft from the face. The intent of Test 3 was to determine if an improperly constructed 40-in-thick Omega block seal (as constructed at the Sago Mine) could meet the regulatory requirement of 20 psi. The new Sago Omega block seals were installed in a manner similar to the previous hybrid Omega block seal in X-3 during Test 1, except the dry layer of BlocBond on the floor was 1.5 in thick (instead of 0.25 in thick) and each course of blocks was positioned completely across the crosscut before applying the properly mixed BlocBond to the top of that course and forcing the BlocBond into the vertical joints using only gloved hands. Each block course was alternated to stagger the block joints. Additional details of the seal construction procedures can be found in Appendix A under “Test No. 3 Protocol” and in Appendix B, sections 4 and 5. Figure 26 shows a schematic of the test setup; the new seals are shown in blue. Wood cribs were also constructed both inby and outby the seal in C-drift, as shown in Figure 26. A hollow-block stopping was constructed outby the C-drift seal at ~384 ft (point D in Figure 26). Another hollow-block stopping was constructed in X-3 between A- and B-drifts (point E in Figure 26). Roof plates that had been damaged in the previous explosion were replaced for this test.

Figure 26.—Setup for Test 3 (LLEM #503).

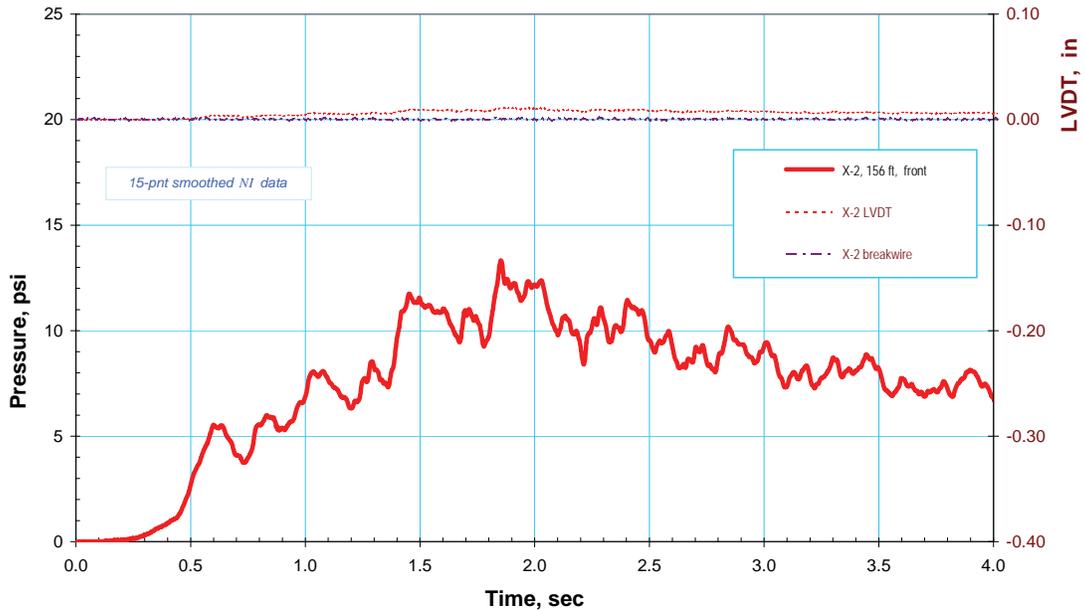
pressure pulse reflected back and forth between the face and the C-drift seal at 320 ft. This is more obvious in Figure 28 for X-3. The smoothed pressure loading at the X-2 seal was 13.5 psi. At the X-3 seal, there were two pressure transducers—one mounted horizontally and one vertically, as shown in Figure 3. The pressure loading at the X-3 seal was slightly less than 16 psi for both transducers. The maximum recorded LVDT movement during the explosion was 0.01 in for the X-2 seal and 0.04 in for the X-3 seal. Since the seals did not fail, there were no changes in the breakwire signals.

Figure 27.—Pressures and LVDT displacement at the X-2 seal during Test 3 (LLEM #503).

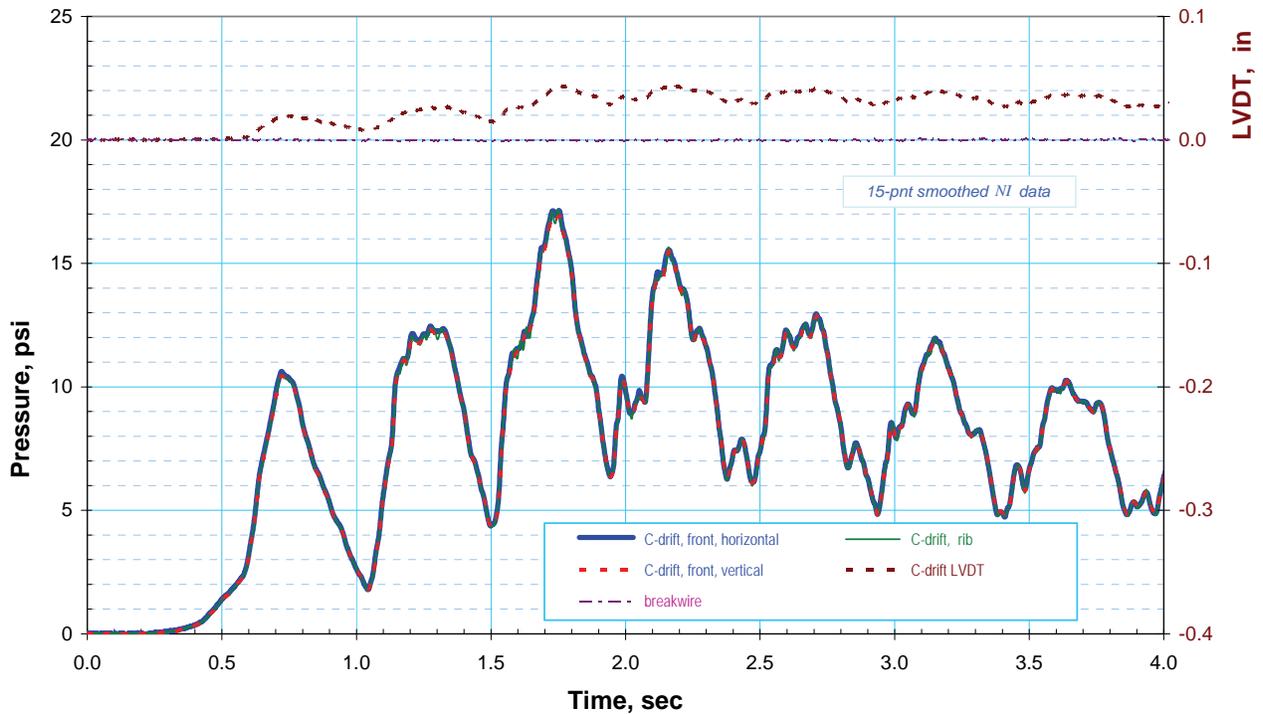
Figure 29.—Pressures and LVDT displacement at the C-drift seal during Test 3 (LLEM #503).

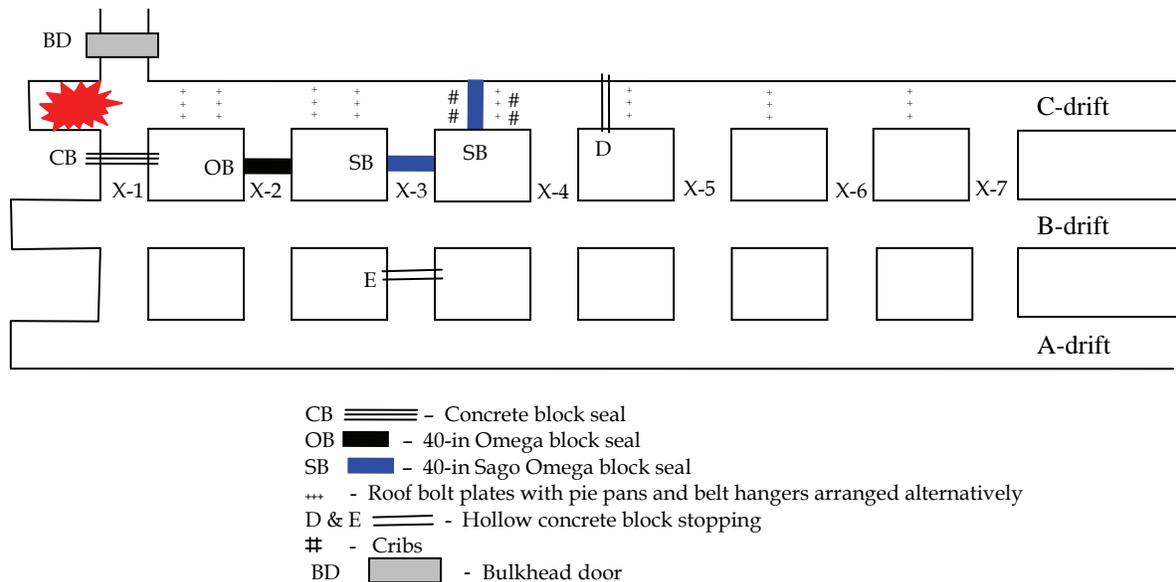
All three seals, the wood cribs, and the hollow-block stoppings had survived the previous LLEM explosion test and were left in place for the fourth test. Since the peak explosion pressures in Test 3 were under 20 psi, the intent of Test 4 was to increase the pressure slightly above Test 3 to determine if an improperly constructed 40-in-thick Omega block seal (as constructed at the Sago Mine) could meet the regulatory requirement of 20 psi. Figure 30 shows a schematic of the test setup, which was almost the same as for the previous test. For Test 4, the same 47-ft-long zone of ~10% CH₄ in air was used, but the ignition point was moved from 35 to 28.5 ft from the face of C-drift to achieve slightly higher pressures than for Test 3. Additional details of the test procedure can be found in Appendix A under “Test No. 4 Protocol.”

Figure 30.—Setup for Test 4 (LLEM #504).

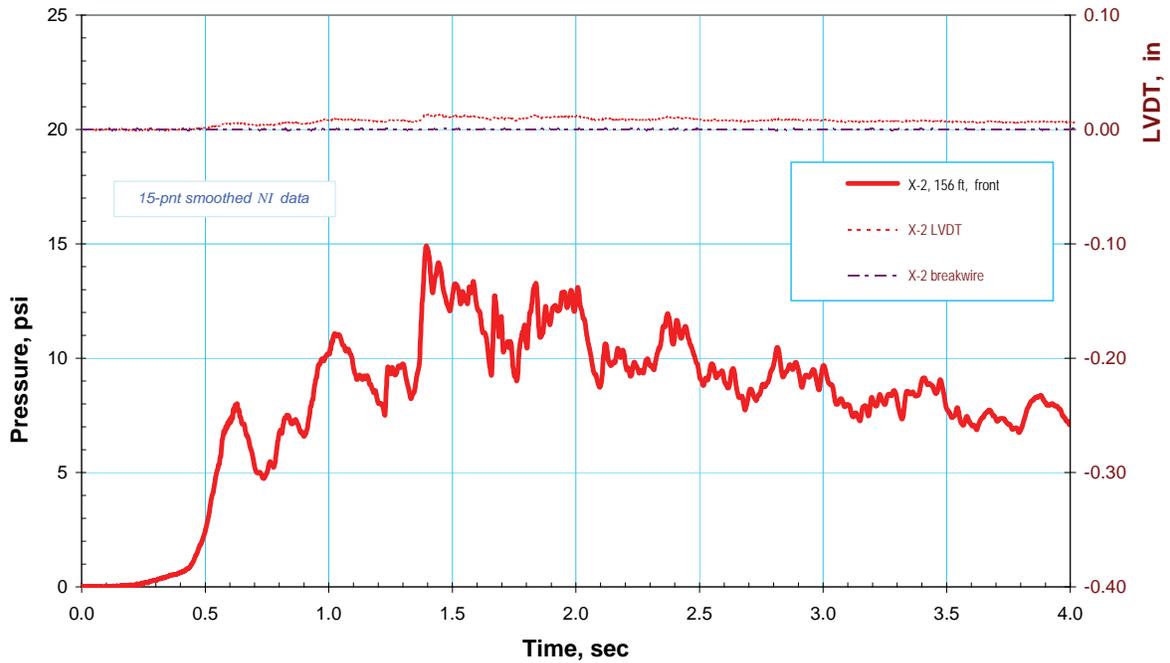
pulse reflecting back and forth between the face and the C-drift seal, similar to Figure 32. The LVDT data in the upper part of the figure show that the seal moved about 0.07 in during the explosion.

Figure 31.—Pressures and LVDT displacement at the X-2 seal during Test 4 (LLEM #504).

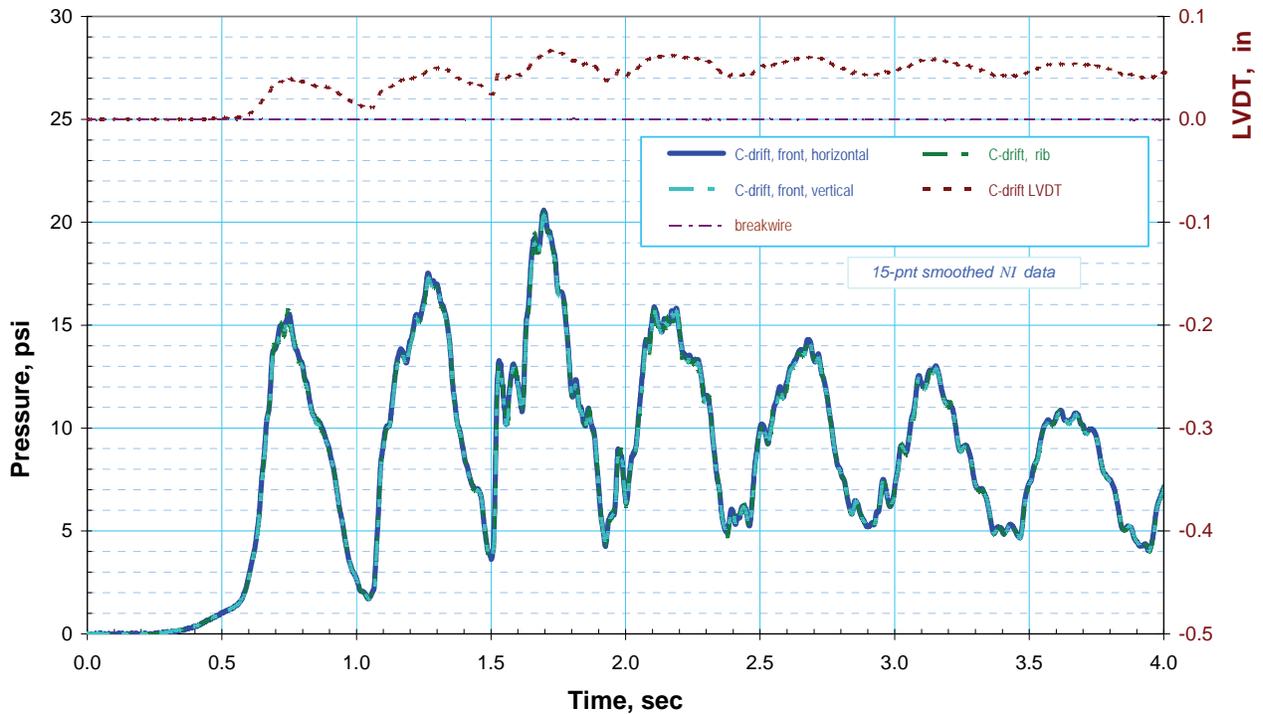
Figure 33.—Pressures and LVDT displacement at the C-drift seal during Test 4 (LLEM #504).

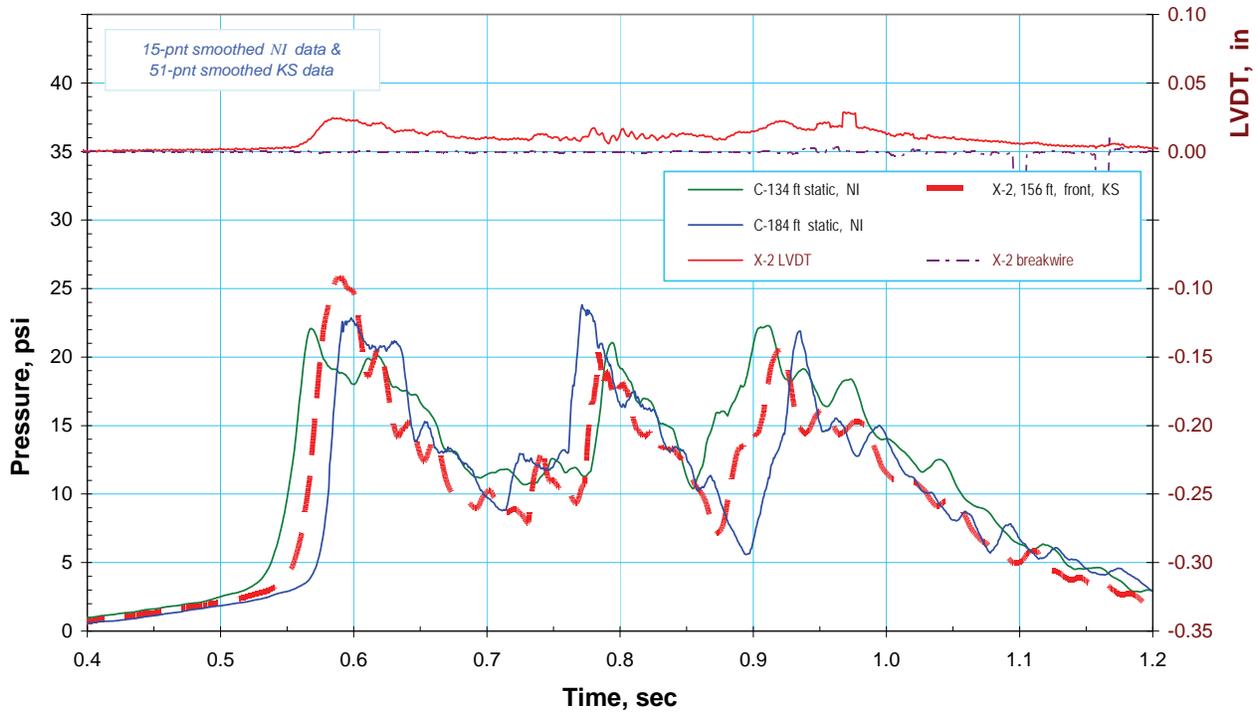
In this test, the Omega block seal in X-2 survived, but the Omega block seals in X-3 and C-drift were destroyed by the higher pressures during Test 5. Figure 35 shows the pressure loading at the seal in X-2 along with the quasi-static pressure at the wall of C-drift inby the seal at 134 ft and outby the seal at 184 ft. The pressure transducer at the seal was located approximately in the middle front of the seal at 156 ft from the face of C-drift. Most of the data are from the NI data acquisition system. The pressure data at the X-2 seal are from the KS data acquisition system because there was a problem with that channel on the NI system during this test. All of the data were averaged over 10 ms. The pressure loading at the X-2 seal was 26 psi. The maximum recorded LVDT movement during the explosion was 0.03 in. Since the seal did not fail, there was no change in the breakwire signal.

Figure 35.—Pressures and LVDT displacement at the X-2 seal during Test 5 (LLEM #505).

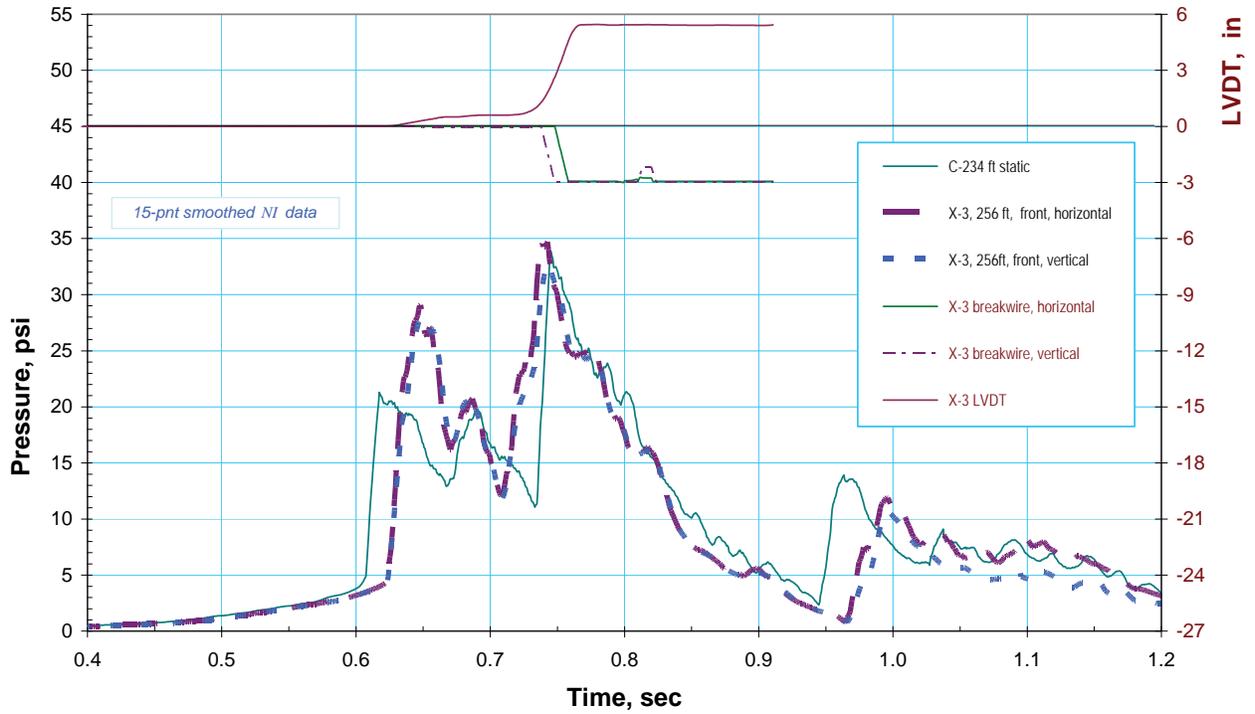
Figure 36.—Pressures and LVDT displacement at the X-3 seal during Test 5 (LLEM #505).

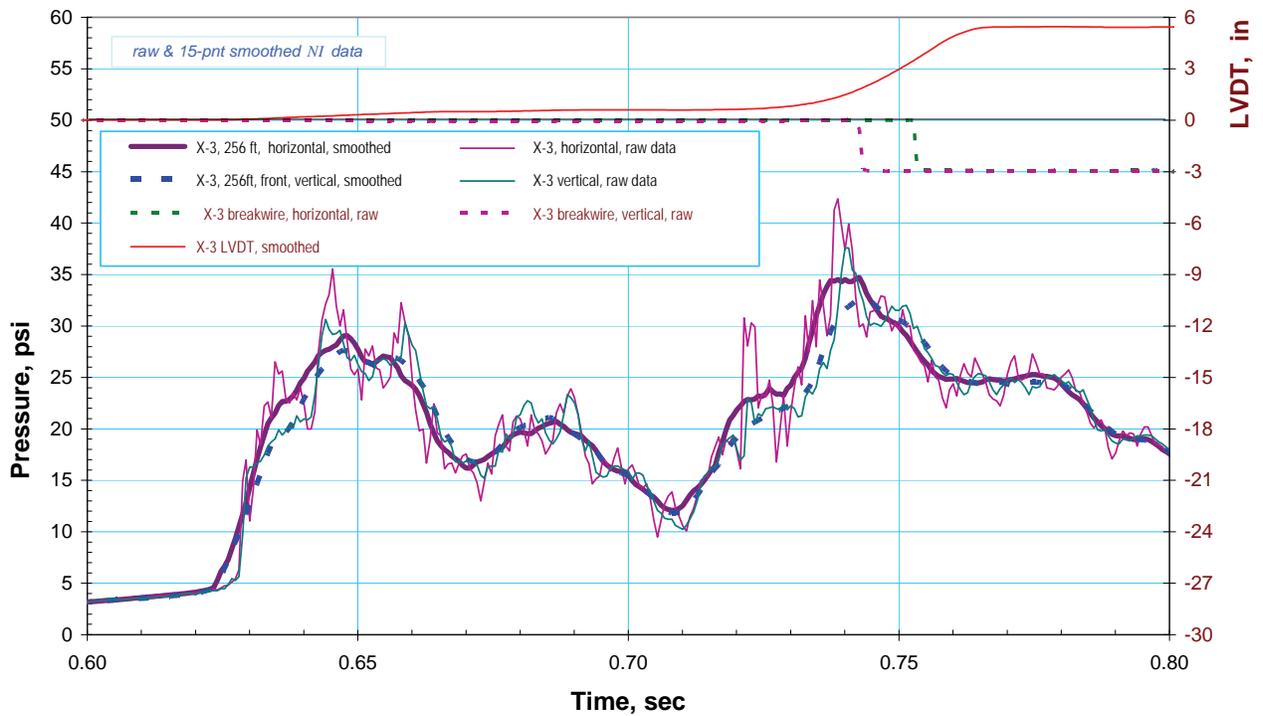
Figure 37 shows the pressures from the NI data acquisition system at the X-3 seal on an expanded time scale. Both the raw data at 1,500 samples per second and the smoothed data (15-point smoothing or 10-ms average) are shown. The averaged pressure loading for the horizontal transducer was 34.7 psi. The peak pressure loading from the raw data for the horizontal transducer at the X-3 seal was ~42 psi, but it lasted only about 1 ms. The averaged pressure loading for the vertical transducer at the X-3 seal was 32.8 psi. The peak pressure loading from the raw data for this vertical transducer at the X-3 seal was ~38 psi, but it lasted only about 1 ms. The curve at the top of the figure shows the seal displacement as measured by the LVDT on the back of the seal. The maximum recorded movement during the explosion was >6 in as the seal was destroyed. The breakwire raw data at the top of Figure 37 are shown as the dotted curves that almost instantaneously drop below the baseline; the units are arbitrary. The breakwire signals showed that the wires broke at 0.743–0.753 sec after ignition.

Figure 37.—Pressures and LVDT displacement on an expanded time scale for the X-3 seal during Test 5 (LLEM #505).
