Results of In-Mine Research in Support of the Investigation of the Sago Mine Explosion

Report of Investigations 9678

**By Kenneth L. Cashdollar, Eric S. Weiss, Samuel P. Harteis, P.E.,
Michael J. Sapko, and John E. Urosek, P.E.**

DEPARTMENT OF HEALTH AND HUMAN SERVICES
Centers for Disease Control and Prevention
National Institute for Occupational Safety and Health
Pittsburgh Research Laboratory
Pittsburgh, PA

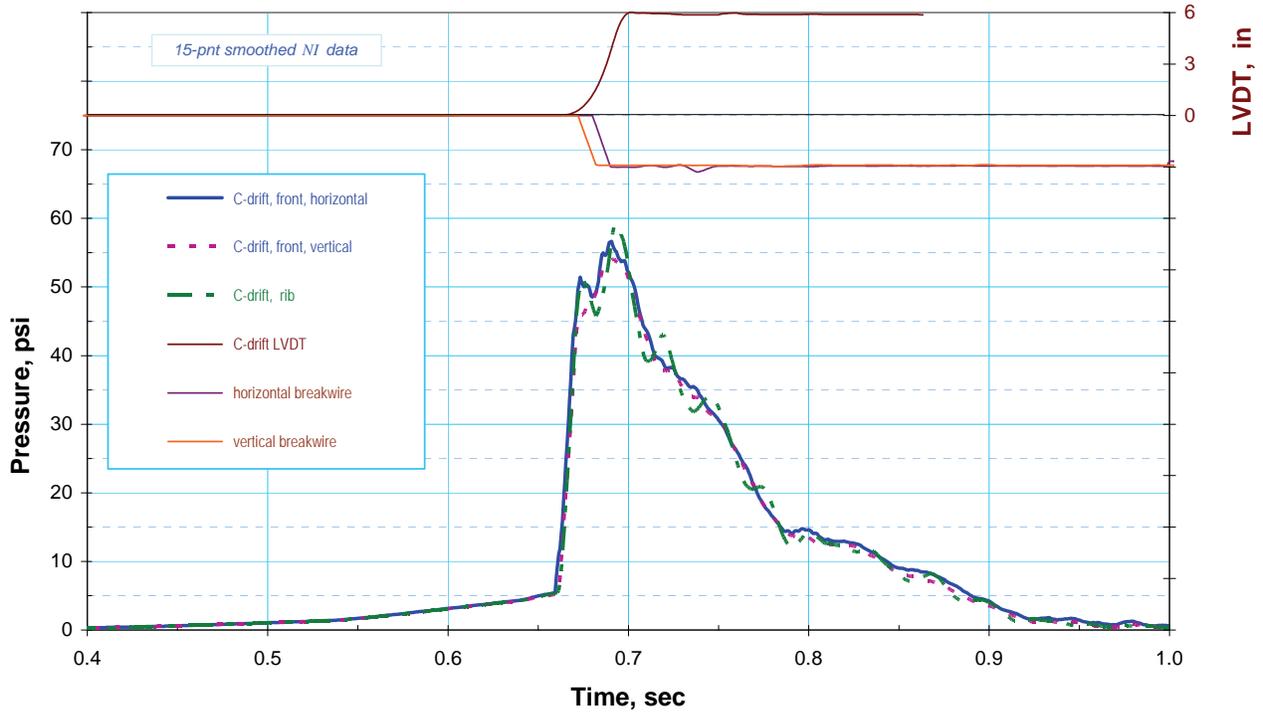
Figure 38 shows NI data from three pressure transducers at the C-drift seal at 320 ft from the face. Two transducers were near the middle of the seal—one mounted horizontally and one vertically, as shown in Figure 3. A third transducer was mounted on the rib perpendicular to the entry. The total measured explosion pressure loadings at all three transducers were similar, as shown in the figure. The LVDT and breakwire data show that the seal broke near the time of peak pressure loading.

Figure 38.—Pressures and LVDT displacement at the C-drift seal during Test 5 (LLEM #505).

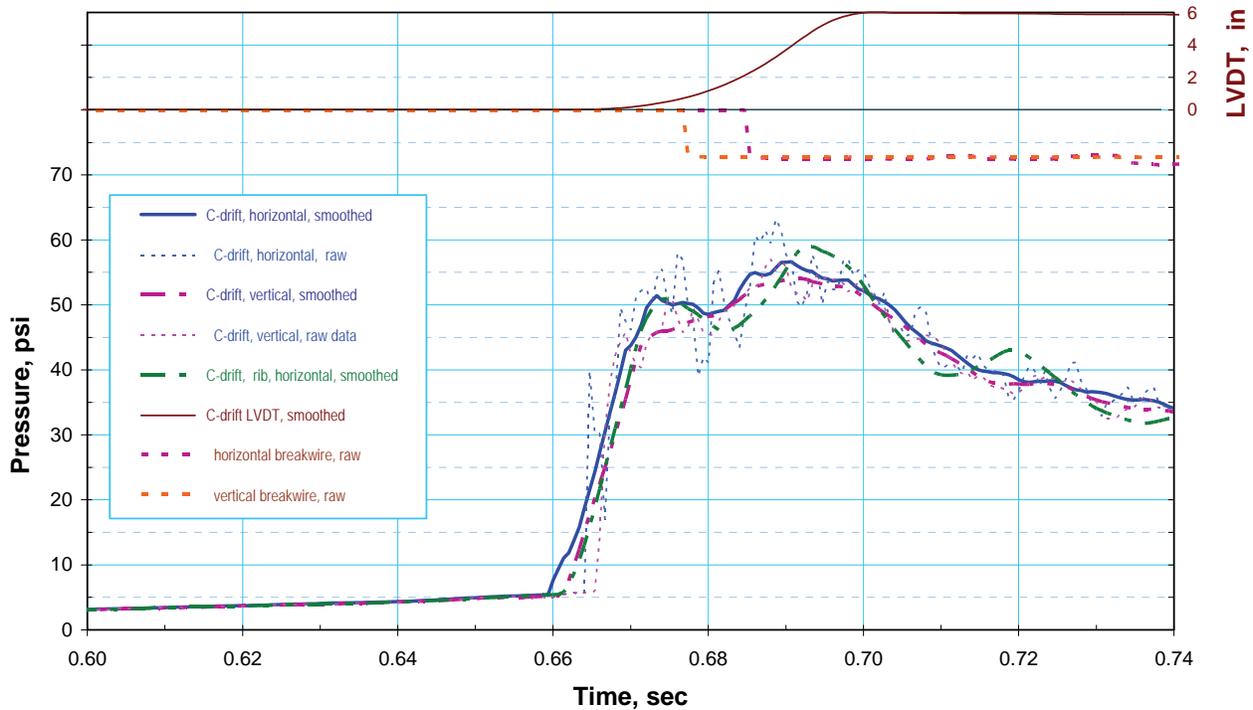
Figure 39 shows the pressures from the NI data acquisition system at the seal on an expanded time scale. Both the raw data at 1,500 samples per second and the smoothed data (15-point smoothing or 10-ms average) are shown. The smoothed pressure loading for the horizontal transducer was 56.6 psi. The peak pressure loading from the raw data for the horizontal transducer was ~63 psi, but it lasted only about 1 ms. The smoothed pressure for the vertical transducer was 54.1 psi. The peak pressure loading from the raw data for the vertical transducer was ~57 psi, but it lasted only about 1 ms. The smoothed pressure loading at the rib was 59.1 psi, and the peak value from the raw data was ~63 psi. The LVDT data in the upper part of the figure show that the seal moved >6 in as the seal was destroyed. The two breakwire signals (from the NI raw data) both show a sharp discontinuity as the wires broke at 0.677–0.685 sec.

Figure 39.—Pressures and LVDT displacement on an expanded time scale at the C-drift seal during Test 5 (LLEM #505).

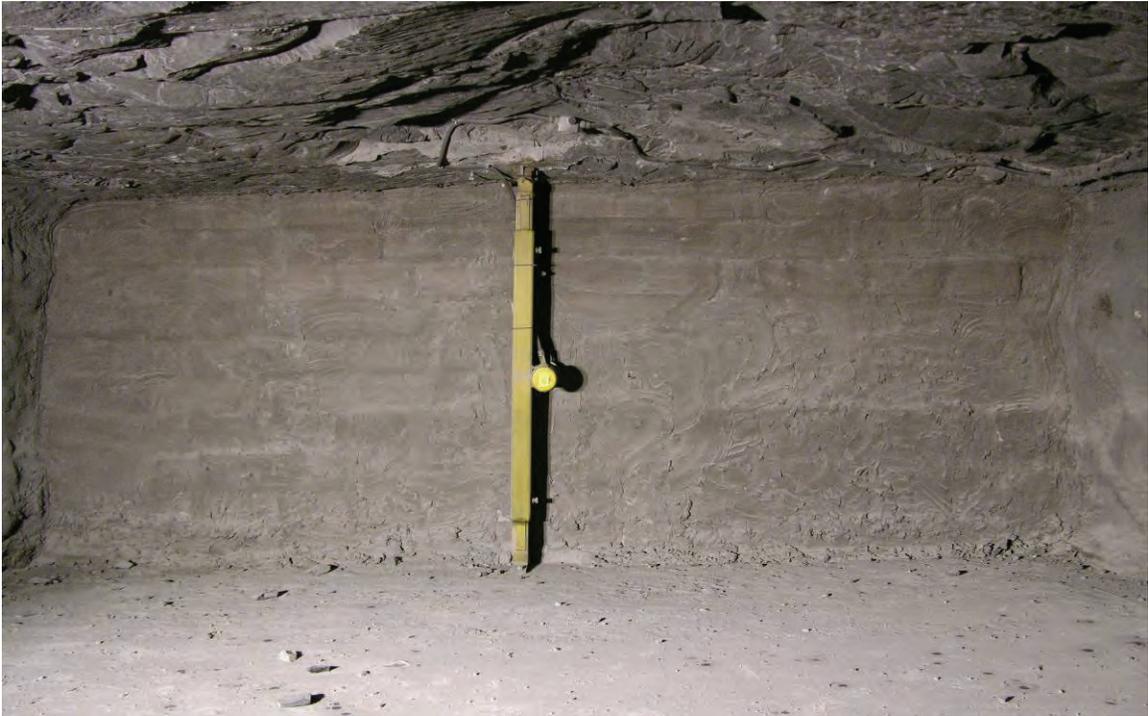
Figure 40 shows the seal in X-2 that survived Test 5 (LLEM #505). The air leakage data are in Table C-8 in Appendix C. The X-2 seal passed the leakage test. The seals in X-3 and C-drift were destroyed during the test and therefore not measured for air leakage.

Figure 40.—Seal in X-2 that survived Test 5 (LLEM #505).

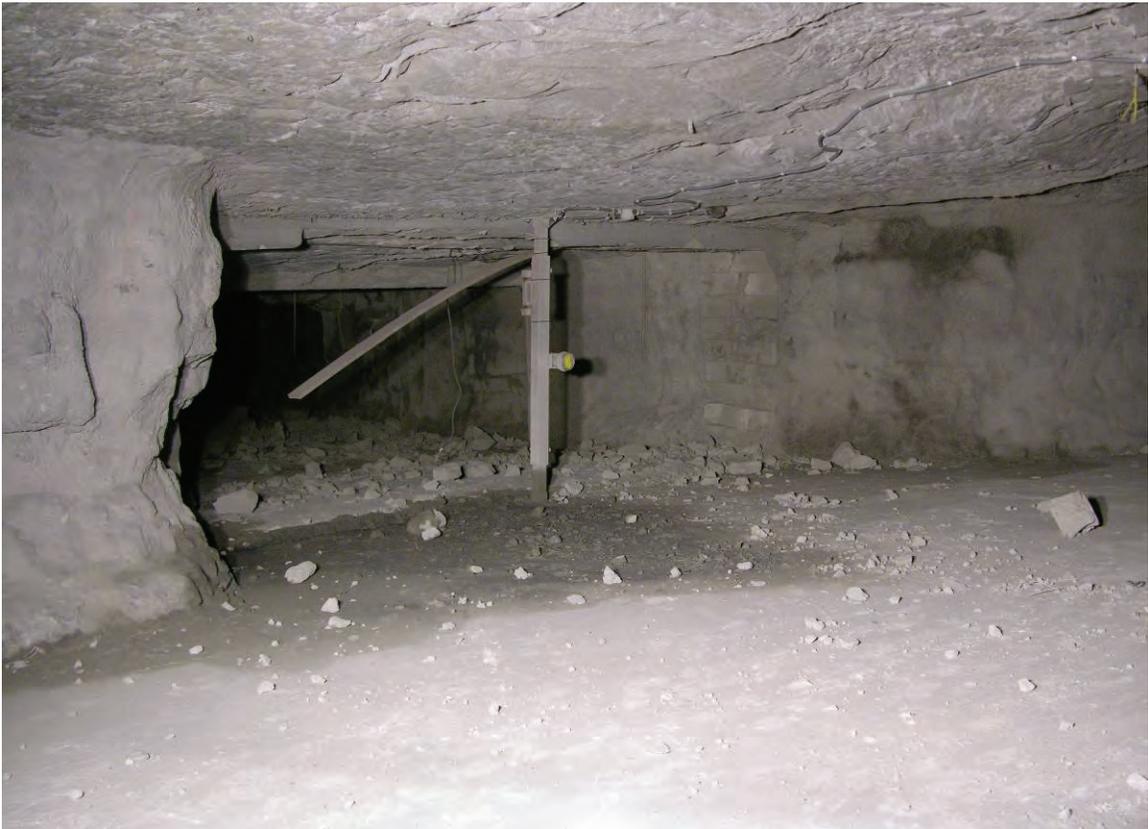
Figures 41–42 show the remains of the X-3 seal that was destroyed during Test 5 (LLEM #505). Figure 41 shows the view looking toward the original X-3 seal position from slightly outby in C-drift. Very little debris can be seen in C-drift. The vertical post holding the pressure transducers is still intact. The original seal position was just behind the pressure transducer post. The long board hanging from the roof in the figure was one of the header boards for the seal. Figure 42 shows the view looking directly into X-3 from C-drift. A large amount of debris can be seen beyond the original seal location and extending into the B-drift intersection. Figure 43 shows additional debris from the X-3 seal piled against the stopping between A- and B-drifts. There is also debris beyond the stopping into A-drift. The left side of the stopping was mostly destroyed, but the right side remained intact. The pressure transducer post in front of the stopping also survived. Figure 44 shows the debris from the X-3 seal and stopping piled against the far wall of A-drift.

Figure 41.—Debris from X-3 seal after Test 5 (LLEM #505) viewed from C-drift.

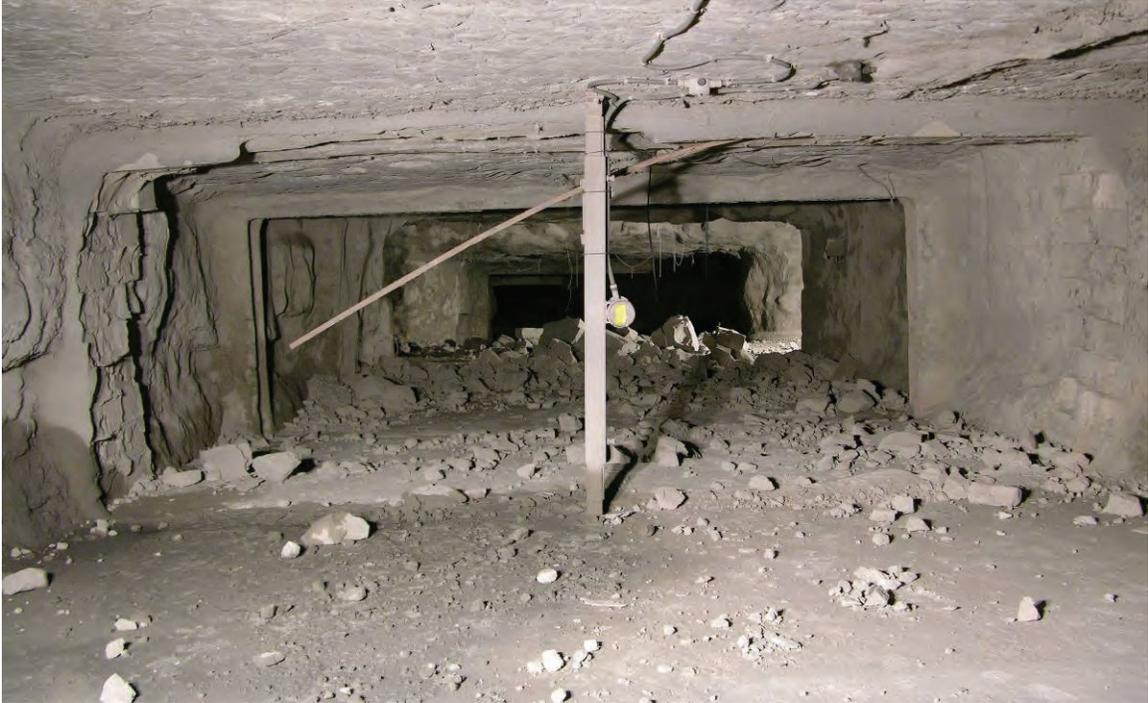
Figure 42.—Debris from X-3 seal after Test 5 (LLEM #505) looking into X-3 toward B-drift.

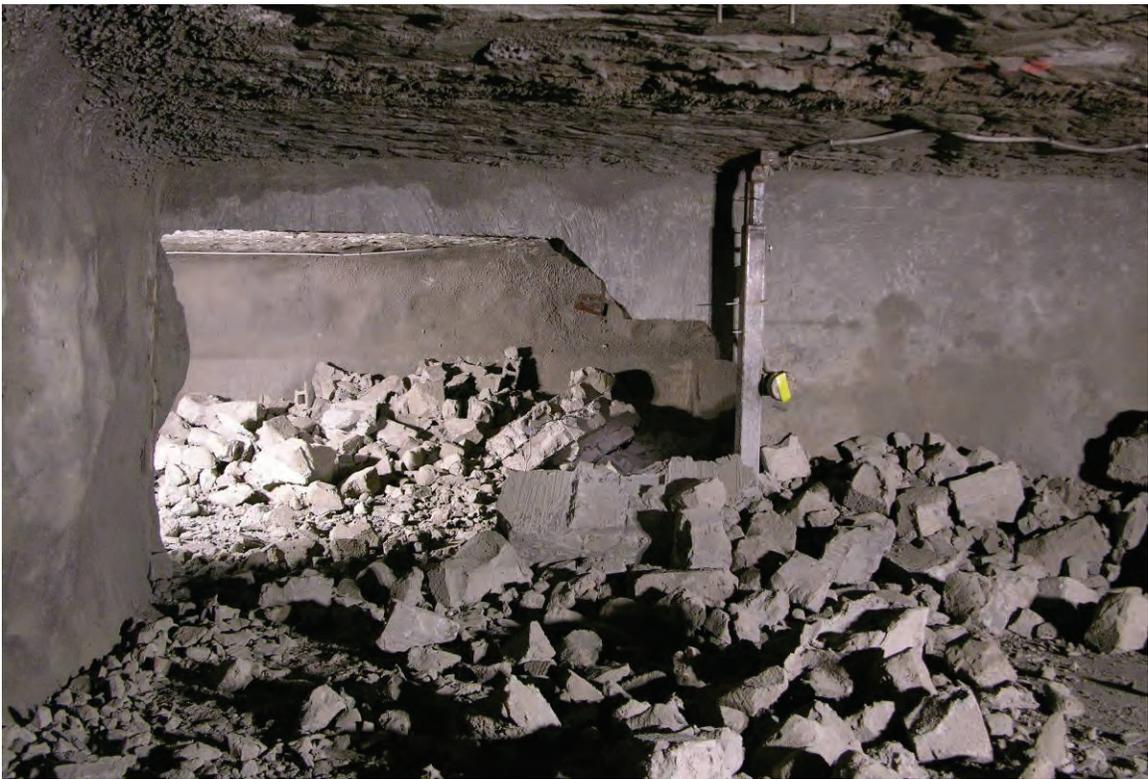
Figure 43.—Debris from the X-3 seal at the X-3 stopping location after Test 5 (LLEM #505).

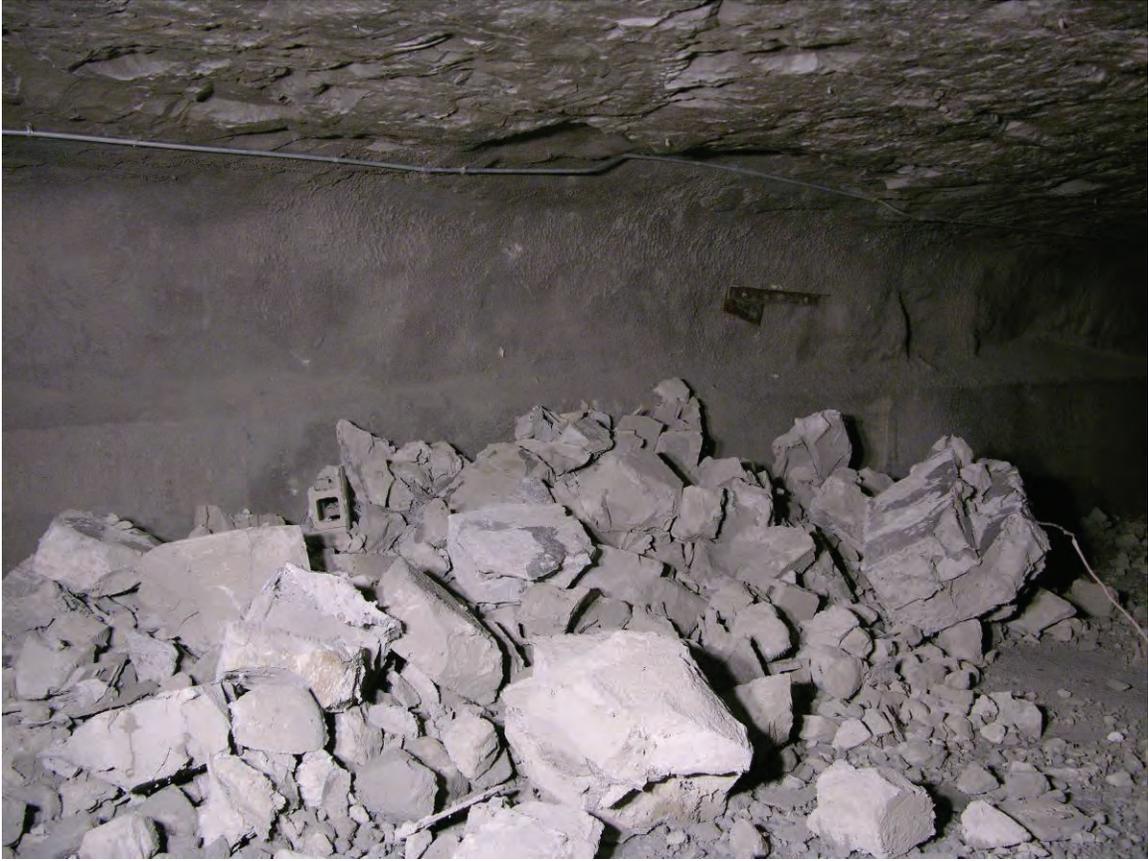
Figure 44.—Debris from the X-3 seal and stopping piled against the far wall of A-drift after Test 5 (LLEM #505).

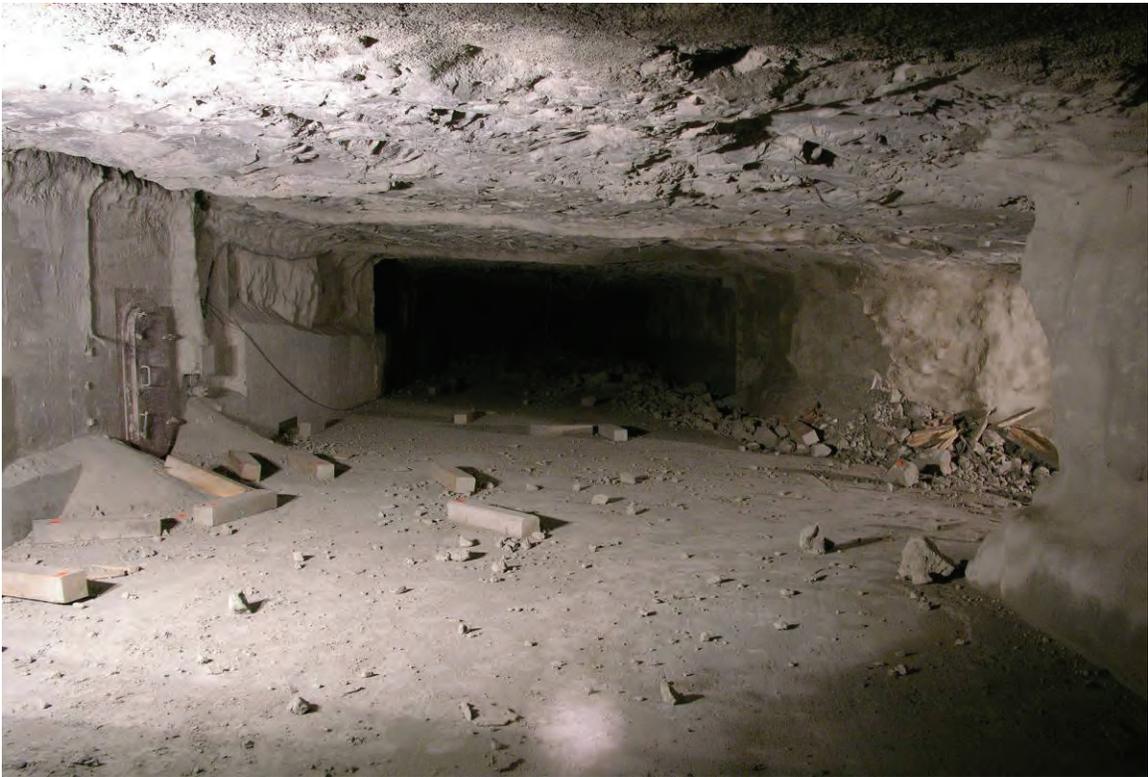
Figure 46 shows the view looking outby toward X-4 at 355 ft. Wood blocks and small pieces of seal debris are seen in the photo. Some debris was carried into X-4 by the explosion. Figure 47 shows the view looking outby from the DG panel at 403 ft. At this distance, large amounts of wood and seal debris were found. Figure 48, looking outby from X-6 at 547 ft, also shows large amounts of debris from the wood cribs, C-drift seal, and C-drift stopping.

Figure 46.—Debris in C-drift after Test 5 (LLEM #505) looking outby toward X-4 (right side of photo) at 355 ft.

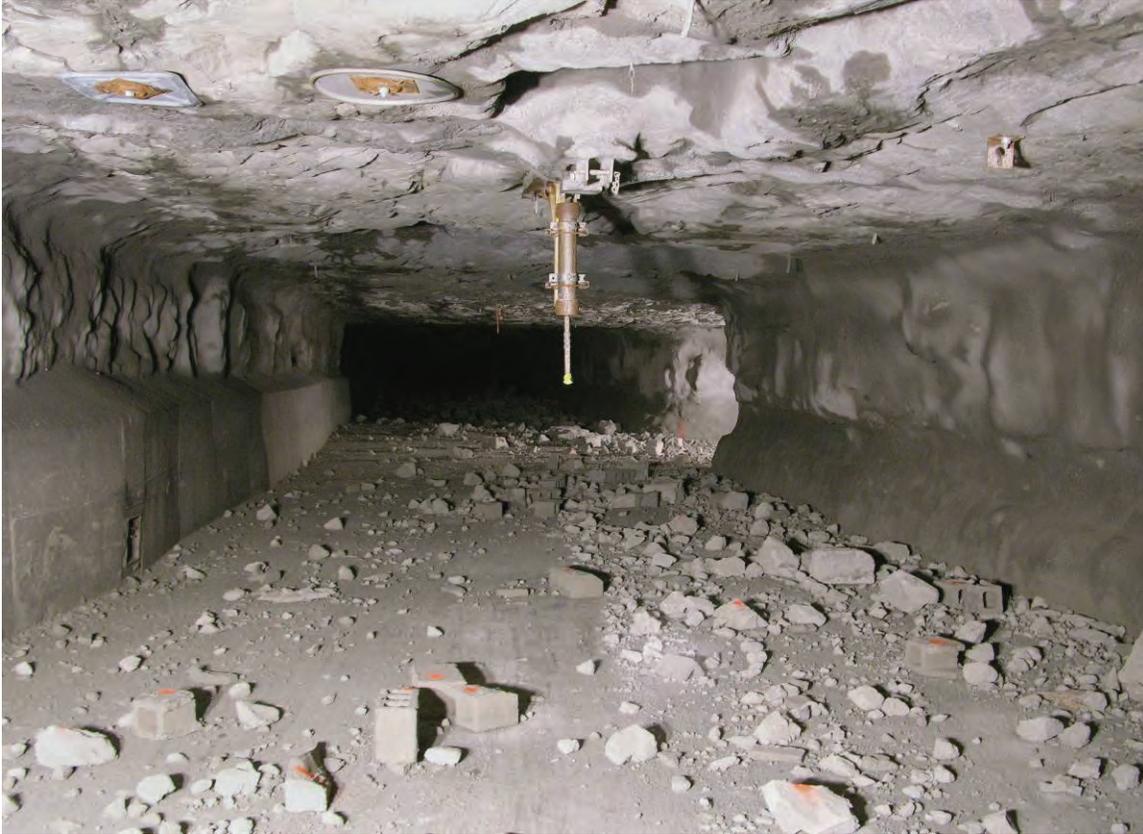
Figure 49 shows the seal debris at a position looking outby from a distance of ~600 ft from the face or ~280 ft from the original seal location. In the distance is X-7 at 647 ft. Pieces of Omega blocks from the seal and pieces of hollow concrete blocks from the stopping can be seen in the photo.

Figure 49.—Debris in C-drift after Test 5 (LLEM #505) looking outby from ~600 ft.

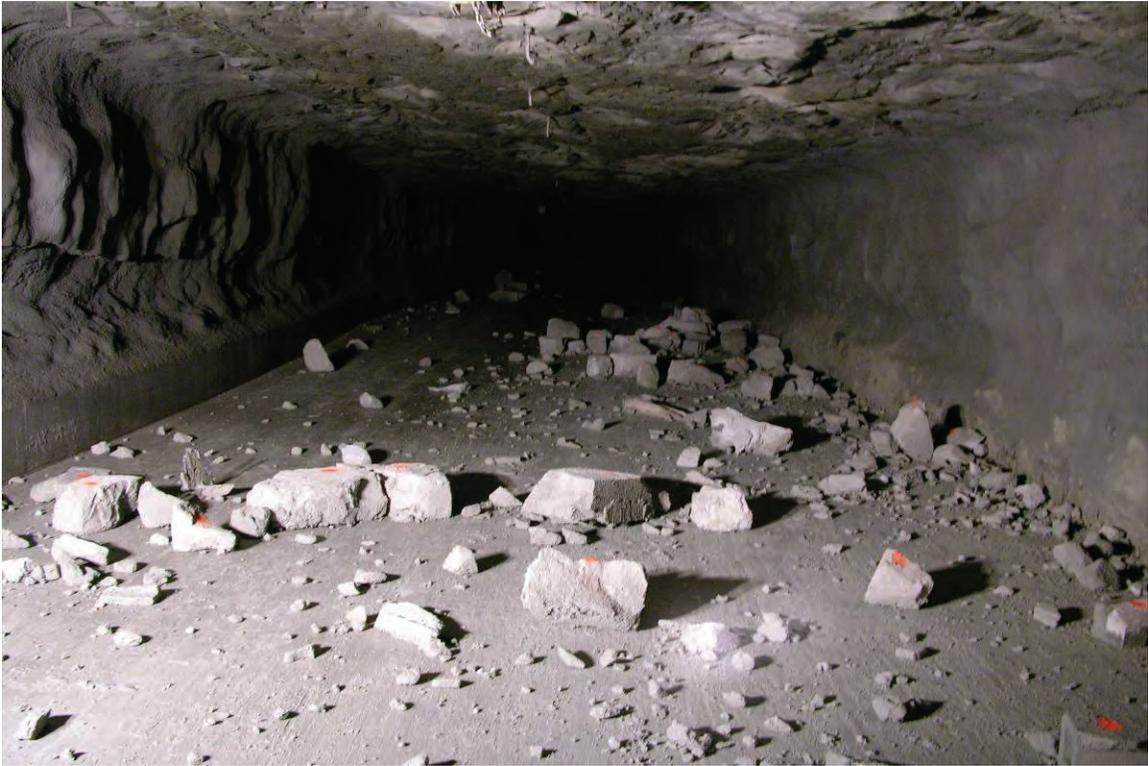
Figure 50 shows the seal debris looking outby in C-drift from the DG panel at 757 ft from the face or ~435 ft from the original seal location. There are numerous large pieces of seal debris in the photo. Figure 51 shows the debris at ~850 ft after Test 5. There are still some large pieces of seal debris at this location. In the upper right of the photo is a carbon monoxide sensor box hanging from the roof. There was no apparent damage to the sensor box during the explosion.

Figure 50.—Debris in C-drift after Test 5 (LLEM #505) looking outby from 757 ft.

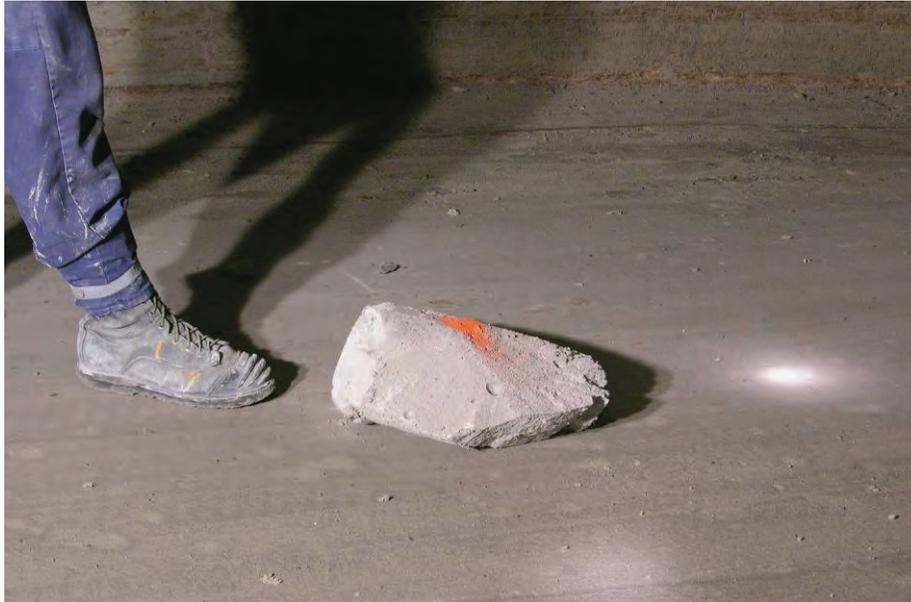
Figure 52 shows the last piece of seal debris at ~880 ft. During Test 5 (LLEM #505), pieces of Omega blocks traveled as far as 556 ft from the original C-drift seal location, as noted in Table 9 and shown in Figure 52. Debris from the C-drift stopping traveled ~460 ft from the original stopping location. Debris from the wood cribs traveled ~437 ft. These values were measured from the postexplosion surveys.

Figure 52.—Debris in C-drift after Test 5 (LLEM #505) at ~880 ft.

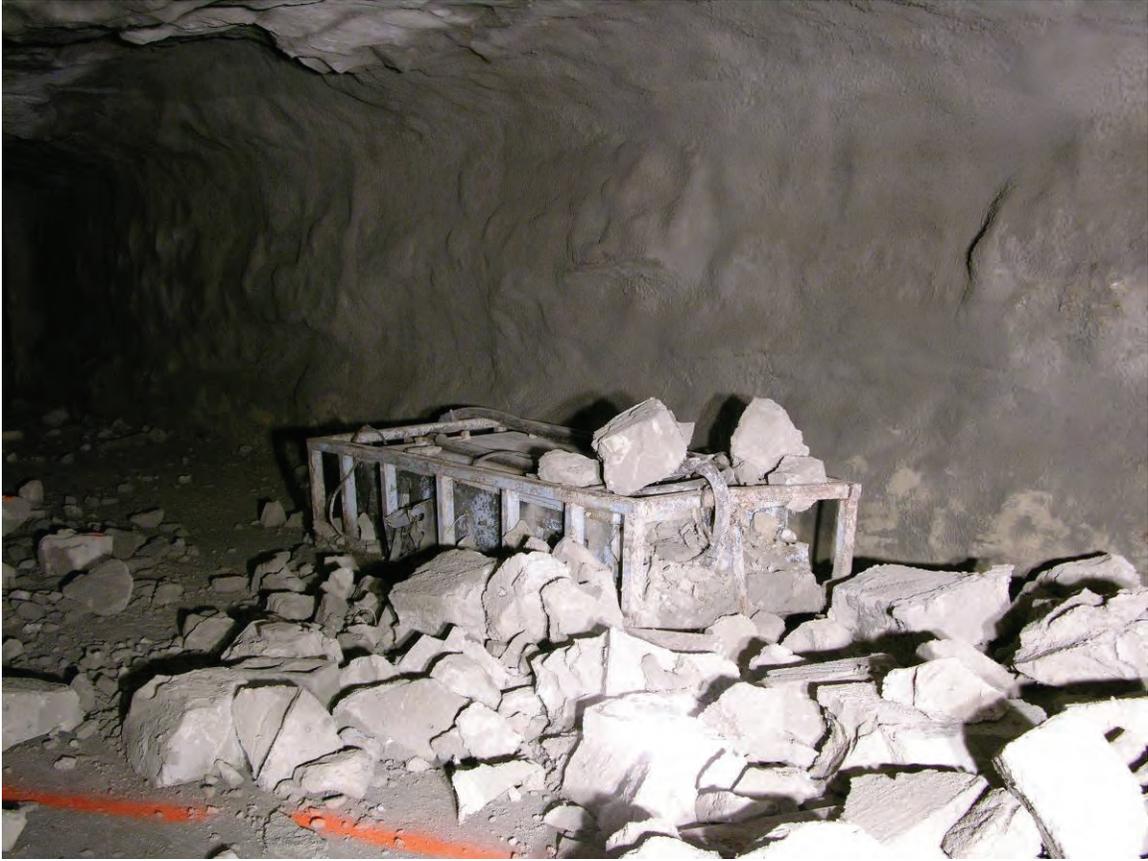
For Test 5 (LLEM #505), the 1,560-lb battery charger was placed at 688 ft from the face of C-drift or 365 ft from the outby face of the C-drift seal. Figure 53 shows the final location of the battery charger after the test, with large amounts of seal debris. The charger moved 30 ft during this explosion. The total explosion pressure at the 604-ft BDP was 2.7 psi, and the dynamic pressure was 0.2 psi. The quasi-static wall pressure at 757 ft was 2.6 psi. The pressure loading at the charger would have been ~2.5 psi. However, for Test 5 the pressure pulse took much longer than 7 ms to reach its maximum value. Therefore, for this test, the maximum differential pressure loading from the inby to outby end of the charger was only ~0.33 psi. The cross-sectional area of 900 in² and differential explosion pressure loading of ~0.33 psi would result in a total force of ~300 lb for a few milliseconds. The 0.2-psi dynamic pressure (~180-lb force) would have continued to act on the charger for a longer period of time. In addition to the air pressure, the battery charger was also hit by debris from the seal, stopping, and wood cribs, as evidenced in Figure 53.

Figure 53.—Final location of battery charger near 720 ft after Test 5 (LLEM #505).

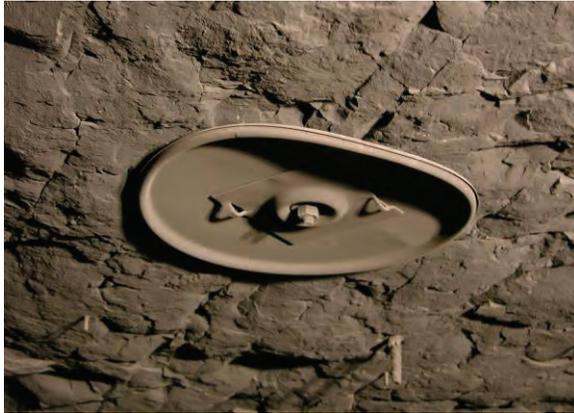
Some of the roof plates were damaged during the Test 5 explosion, as shown in Figures 54–55. On the left side of the figures, the plates are shown from inby of the plates, looking outby. On the right side of the figure, the plates are viewed looking across the entry from the DG-panel side. There was only a slight bending of the round plate at 84 ft. The round plates at 134, 184, and 234 ft from the face were severely bent during the explosion. At 304 ft, the round plate was slightly bent, but there was no obvious damage to the square plate. There was only some minor impact damage to the round plate at 403 ft, but no obvious damage to the square plate. However, the belt hanger at 403 ft was significantly bent, as shown in Figures 56–57. These views are looking across the entry toward the DG panel; therefore, outby is to the right in these photos. This belt hanger was probably damaged by flying debris because the inby belt hangers were not damaged even though they were exposed to greater explosion pressures. There was little or no obvious damage to the other round plates, square plates, and belt hangers throughout C-drift.

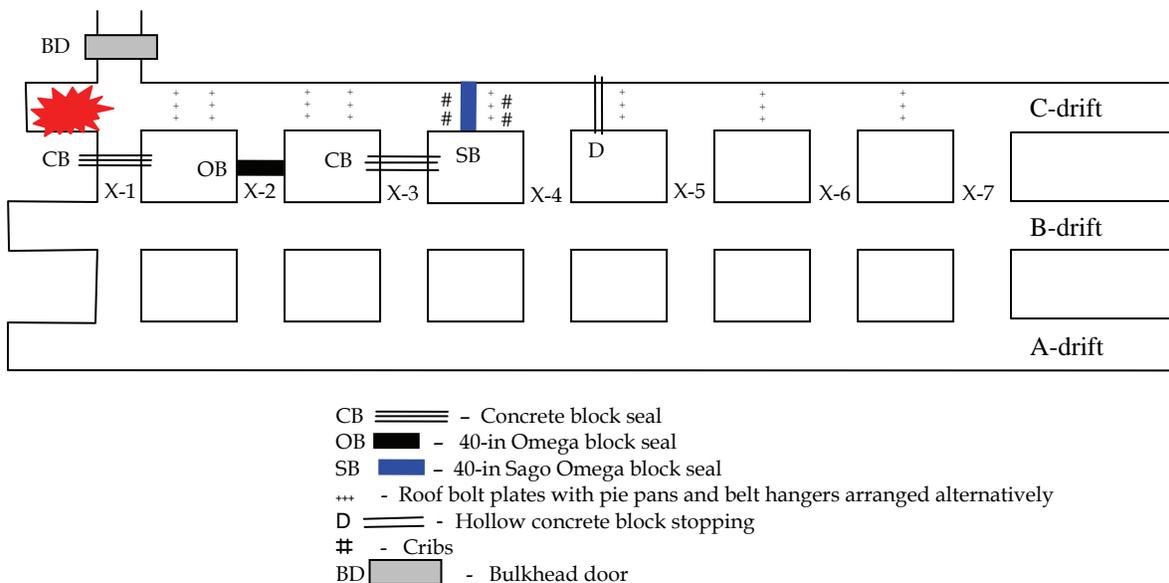
The 2001-design Omega block seal in X-2 had survived the previous LLEM explosion tests and was left in place for the sixth and final test. A new solid-concrete-block seal was installed in X-3. This new 16-in-thick solid-concrete-block seal with a 32-in-thick center pilaster was constructed in a manner similar to the solid-concrete-block seal in X-1 for Test 1, except the X-3 seal used Type S mortar (not BlocBond) and was coated on both sides with Quikrete B-Bond sealant. Additional details on the construction of this seal can be found in Appendix B, section 6. A new Sago nominal 40-in Omega block seal was installed in C-drift about 320 ft from the face. This seal was built in a manner similar to the seals built for Test 3, except that it was built with Omega blocks from the Sago Mine. Additional details can be found in Appendix A under “Test No. 6 Protocol” and in Appendix B, section 7. Figure 58 shows a schematic of the test setup with the new Omega seal shown in blue. Wood cribs were also constructed both inby and outby the seal in C-drift, as shown in Figure 58. A hollow-block stopping was constructed outby the C-drift seal at ~384 ft. Any of the roof plates or belt hangers that had been damaged in the previous explosion were replaced for this test. Additional details of the test procedure can be found in Appendix A under “Test No. 6 Protocol.”

Figure 58.—Setup for Test 6 (LLEM #506).

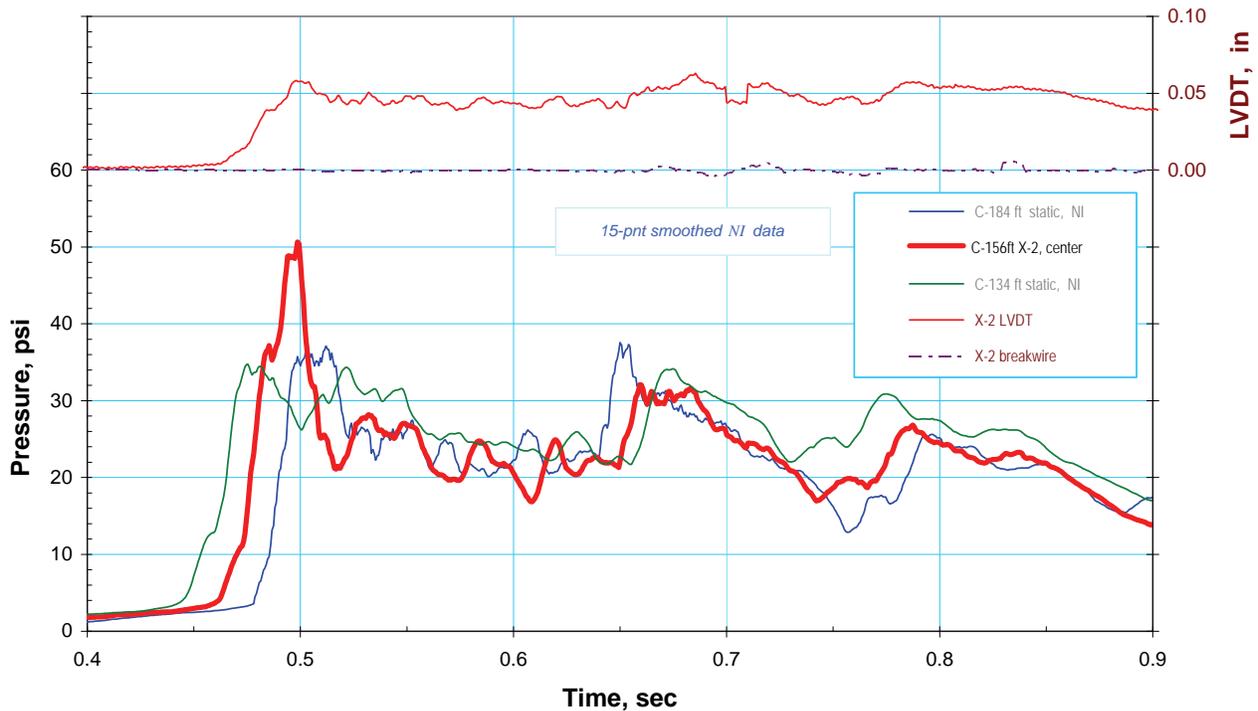
Figure 59.—Pressures and LVDT displacement at the X-2 seal during Test 6 (LLEM #506).

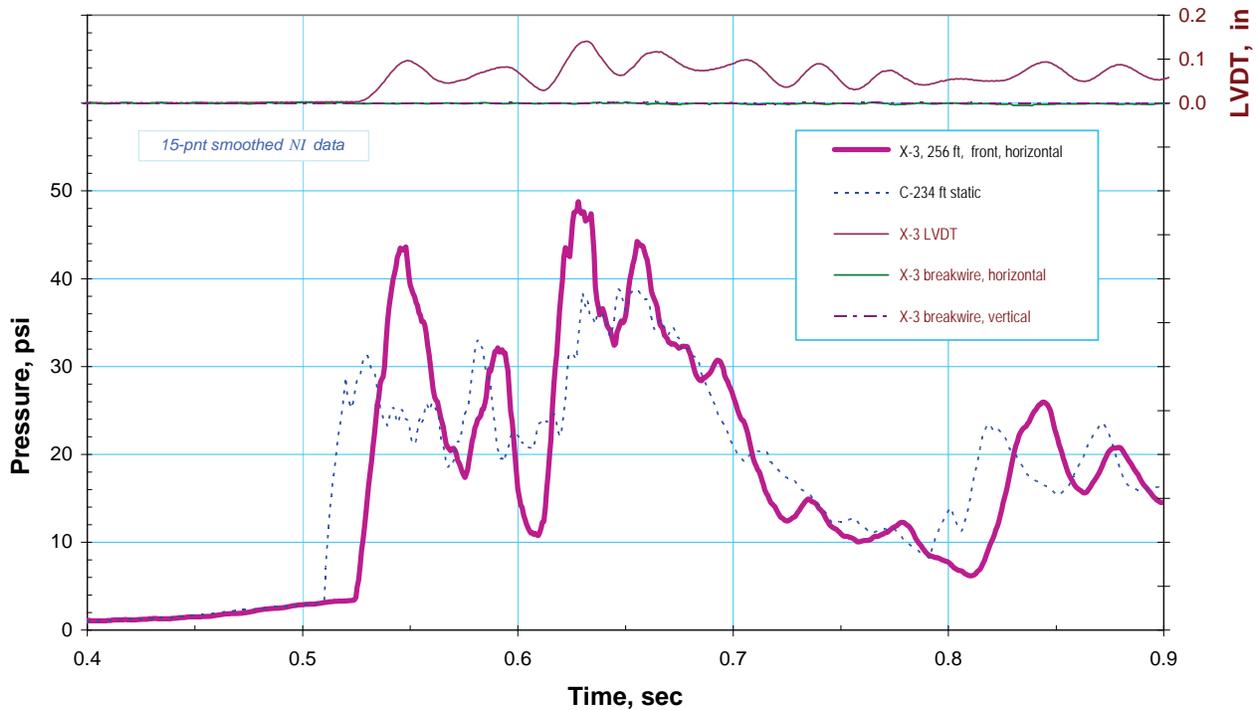
Figure 60.—Pressures and LVDT displacement at the X-3 seal during Test 6 (LLEM #506).

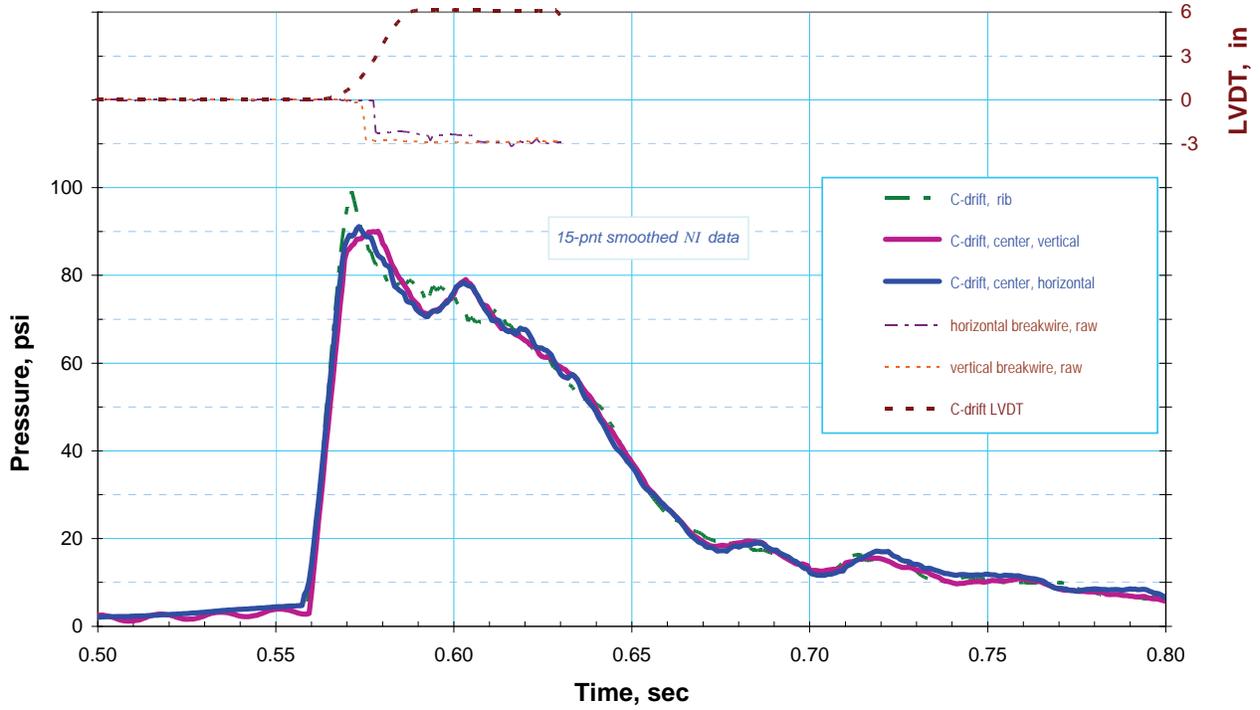
Figure 61.—Pressures and LVDT displacement at the C-drift seal during Test 6 (LLEM #506).

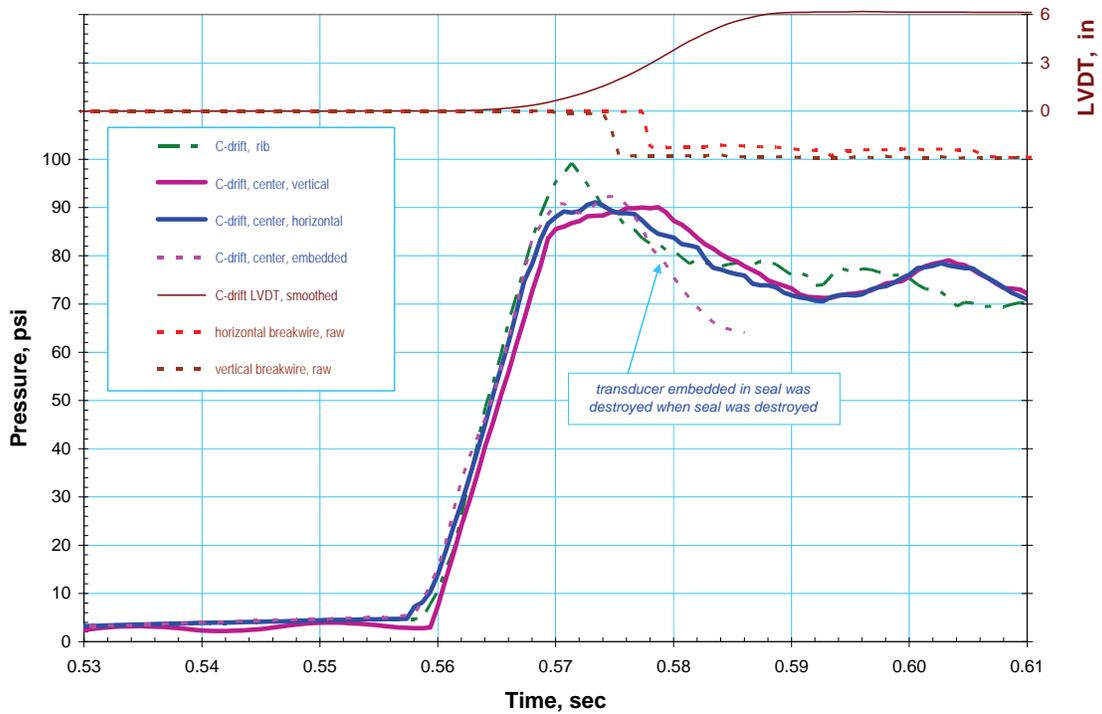
Figure 62.—Pressures and LVDT displacement on an expanded time scale at the C-drift seal during Test 6 (LLEM #506).

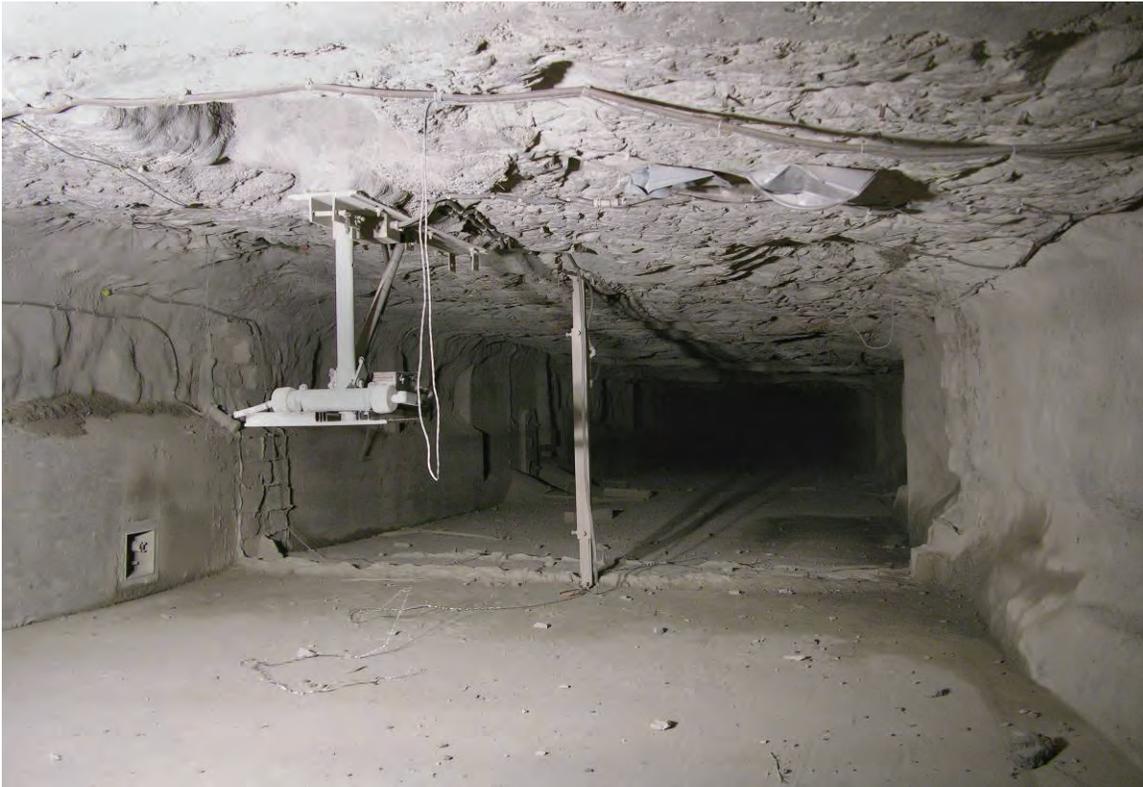
The debris from the C-drift seal was thrown a long distance down the drift. Figure 65 shows the postexplosion view looking outby near the original seal position in C-drift. Near the center is the pressure transducer post. The original seal location was just behind this post. The vertical transducer is still attached to the back of the post, but the horizontal transducer was broken from the post during the explosion. The BDP at 306 ft is in the left center of the photo. Only a few wood blocks and small pieces of seal debris are seen on the floor outby the original seal position.

Figure 65.—Postexplosion view in C-drift looking outby toward original seal location at 320 ft after Test 6 (LLEM #506).

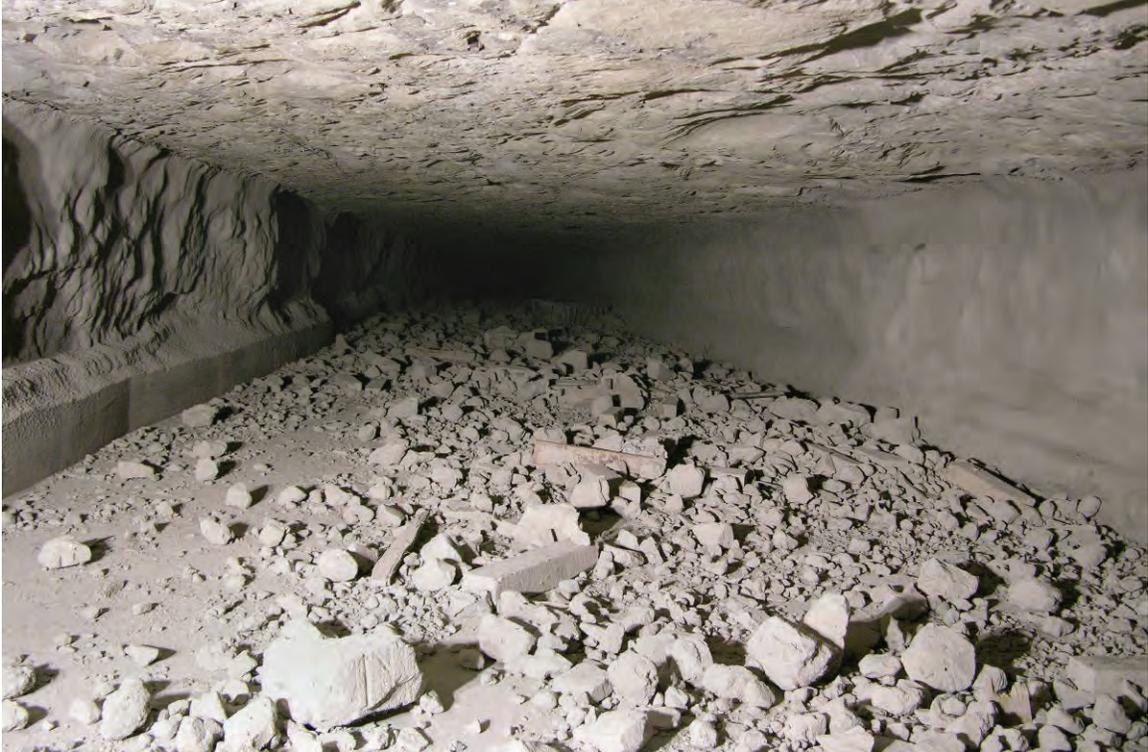
Figure 72 shows a photo of the postexplosion debris looking outby in C-drift from ~950 ft from the face or ~630 ft from the original seal location. At this distance, large amounts of wood and seal debris were found.

Figure 72.—Debris after Test 6 (LLEM #506) looking outby from ~950 ft.

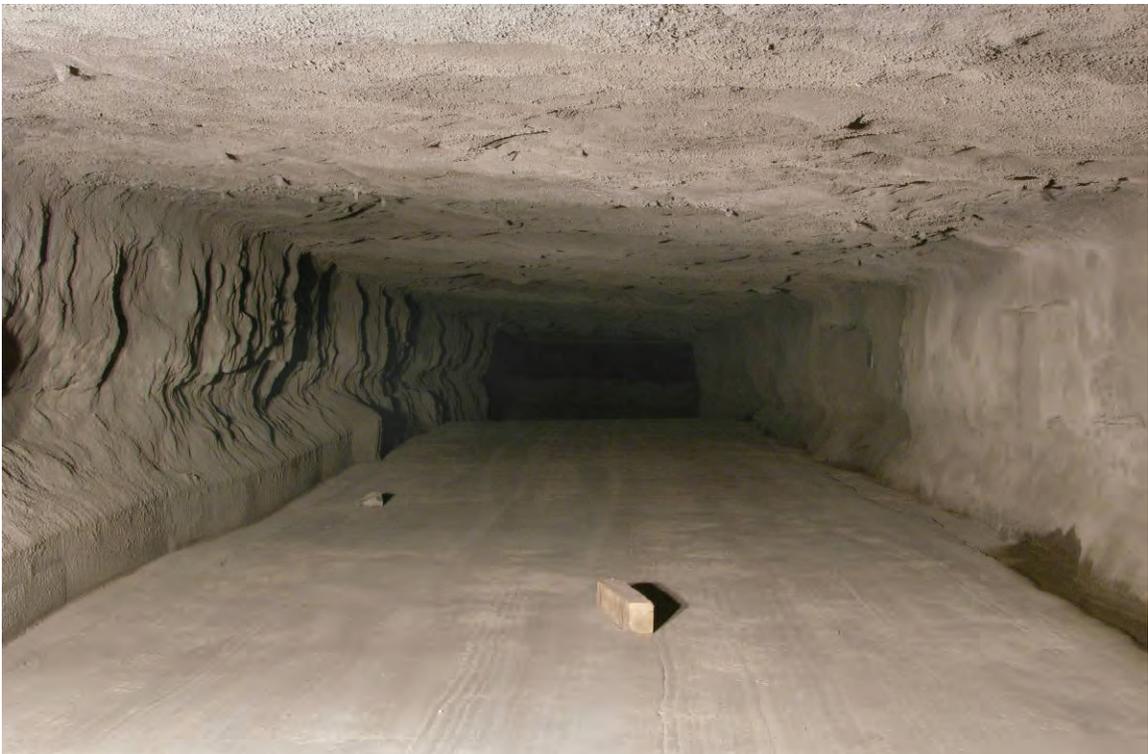
Figure 76.—Debris in C-drift after Test 6 (LLEM #506) looking outby from ~1,440 ft.

During Test 6 (LLEM #506), pieces of Omega blocks traveled as far as ~917 ft from the original C-drift seal location, as noted in Table 11. A piece of BlocBond mortar traveled ~1,168 ft from the original seal location (see Figure 76). Debris from the C-drift stopping traveled ~748 ft from the original stopping location. Debris from the wood cribs that were originally inby the C-drift seal traveled ~606 ft. Debris from the wood cribs that were originally outby the seal traveled ~1,139 ft (see Figure 76). These distances were measured from the postexplosion surveys.

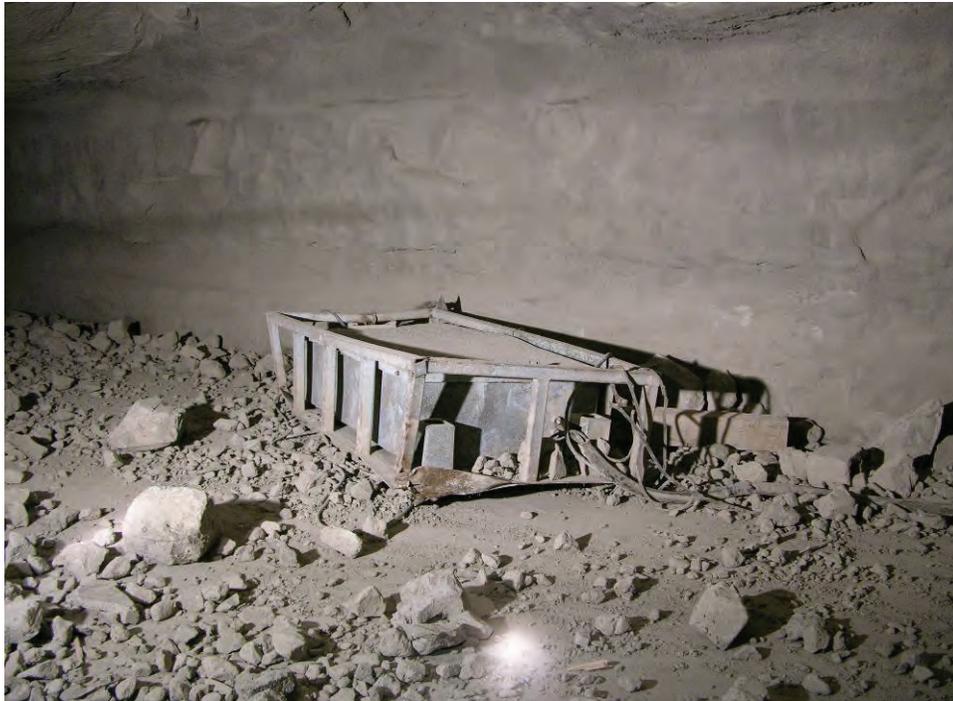
Figure 77.—Final position of battery charger after Test 6 (LLEM #506).

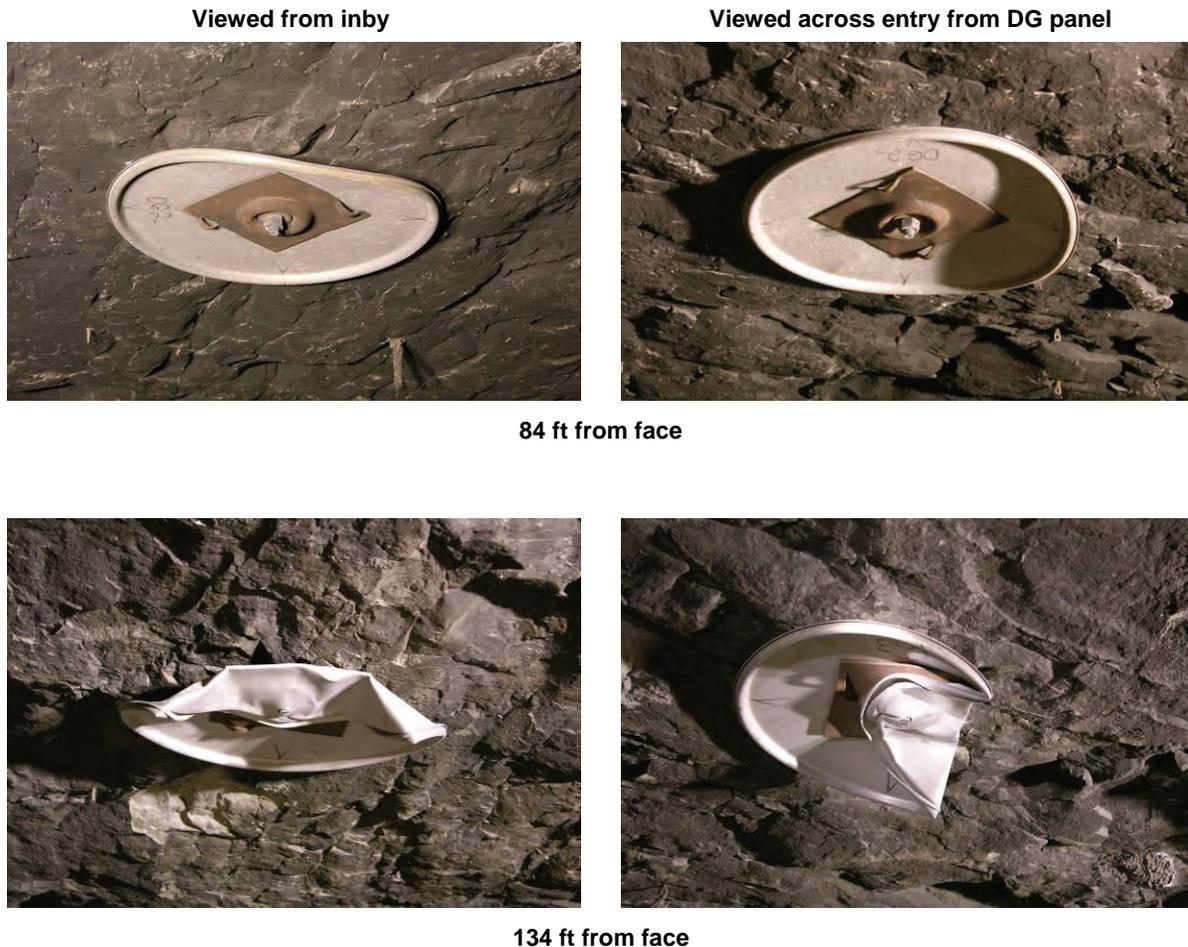
Some of the roof plates were damaged during the Test 6 explosion, as shown in Figures 78–80. On the left side of the figures, the plates are shown from inby of the plates, looking outby. On the right side of the figure, the plates are viewed looking across the entry from the DG-panel side. There was only a slight bending of the round plate at 84 ft. The round plate at 134 ft from the face was severely bent during the explosion, but the square plate had no obvious damage.

Figure 78.—Roof plates at 84 and 134 ft from the face after Test 6 (LLEM #506).
