Results of In-Mine Research in Support of the Investigation of the Sago Mine Explosion

Report of Investigations 9678

**By Kenneth L. Cashdollar, Eric S. Weiss, Samuel P. Harteis, P.E.,
Michael J. Sapko, and John E. Urosek, P.E.**

DEPARTMENT OF HEALTH AND HUMAN SERVICES
Centers for Disease Control and Prevention
National Institute for Occupational Safety and Health
Pittsburgh Research Laboratory
Pittsburgh, PA

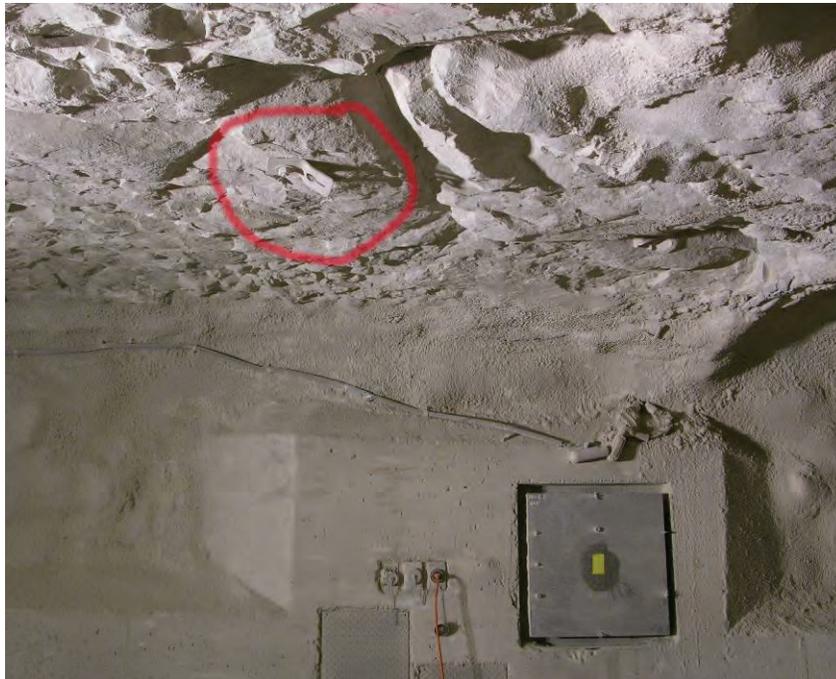
The belt hanger at 403 ft was significantly bent, as shown in Figures 81–82. This was similar to the damage to this belt hanger during Test 5. These views are looking across the entry toward the DG panel. Therefore, outby is to the right in these photos. This belt hanger was probably damaged by flying debris because the inby belt hangers were not damaged even though they were exposed to greater explosion pressures. The belt hanger seemed to have a small amount of residue from the impact of an Omega block. For this test, the carbon monoxide sensor box was hung from the roof at ~800 ft from the face or ~475 ft from the seal. There was no apparent damage to the sensor box during the explosion.

Figure 81.—Belt hanger (circled in red) near DG panel at 403 ft.
