Role of fault slip on mechanisms of rock burst damage, Lucky Friday Mine, Idaho, USA

B. G. WHITE & J. K. WHYATT

Spokane Research Laboratory, National Institute for Occupational Safety and Health, Spokane, WA, USA

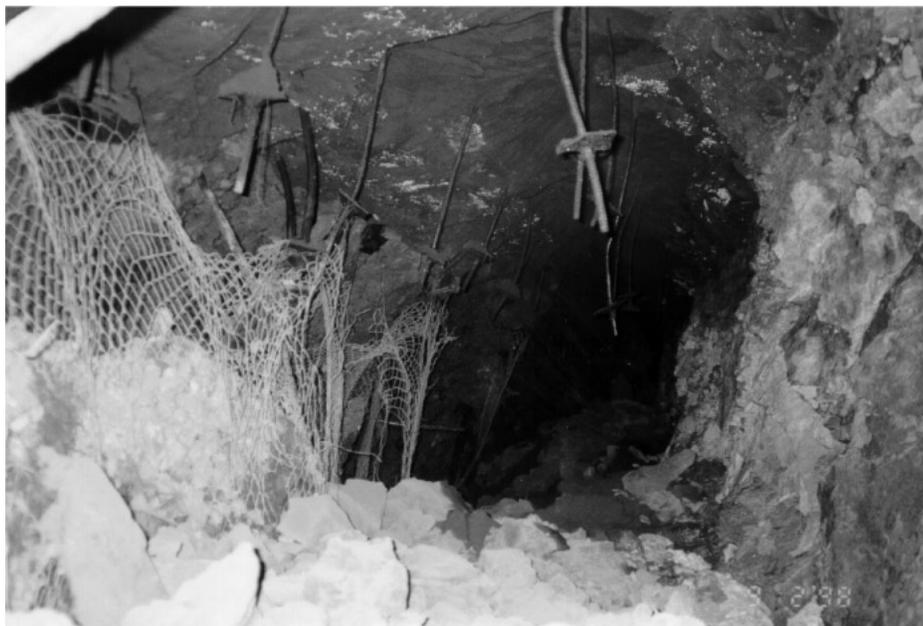
Figure 2. Rock burst damage in the 5750-05 stope. Note that both ribs, as well as the overhead sandfill, were damaged in this event.

Rock burst damage may affect ribs, the cemented sandfill, or the abutment, and may involve several of these locations in the same event (Figure 2). A common pattern of damage is one that affects the lower footwall rib and adjacent abutment and the diametrically opposite upper hanging wall rib adjacent to the sandfill. In these cases, damage in the hanging wall frequently extends a short distance up along the side of the sandfill. Such diametrically symmetrical damage is frequently seen at the mine and resembles

A rock burst extensively damaged the 5750-05 stope on August 28, 1998 (Figure 2), in a Richter-magnitude 3.1 seismic event. Rock was expelled from both ribs, and the overhead cemented sandfill failed to an average depth of 1 m for a distance of about 25 m along the length of the stope. As is common, the event occurred during blasting. Bedding slip believed to have taken place during this event could be documented by offsets in marks painted across exposed argillite interbeds in the access ramp. A 2-cm slip was found 30 m from the stope, and a 13-cm slip (Figure 9B) was found 27 m from the stope. Possibly even greater slip took place, but this can not be confirmed because some rock on one side of the larger slip detached from the rib and may have moved independently of the substrate. Evidence of slip could not be seen on any other argillite interbeds, but many paint marks were destroyed by raveling during the event. Thus, the minimum net slip in the event was 15 cm.

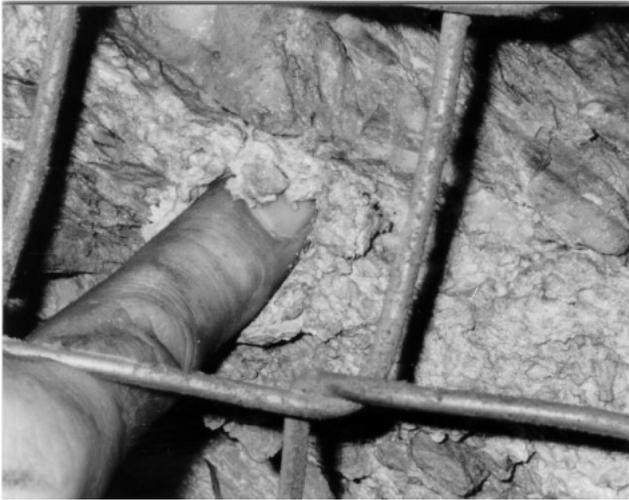
Figure 4. Soft, white gouge due to slip along argillite interbed

Several types of recurrently seen structures are believed to indicate mining-induced wall rock movement. These structures include mining-induced thrust faults or shear ruptures; disrupted, mining-induced extension fracture zones; and bedding plane faults containing a distinctive, soft white gouge. The presence of the white gouge (Figure 4) in structures that are believed, for other reasons, to have been caused by mining and the absence of the white gouge at locations away from the vein suggest that the gouge originated from mining-induced slip.

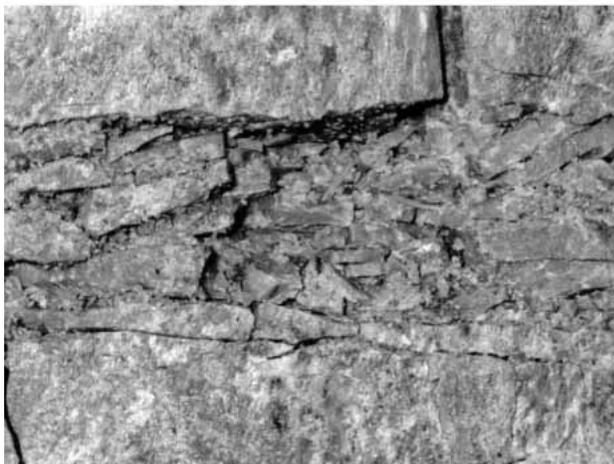
Figure 6. Disrupted zone formed by shearing within 4-cm-wide zone of closely spaced mining-induced extension fractures in stope walls.
