Personal Protective Equipment Conformity Assessment Studies and Evaluations

Evaluation of a Self-Contained Breathing Apparatus Involved in Near Miss During Live Fire Training with a Recruit at a State Academy

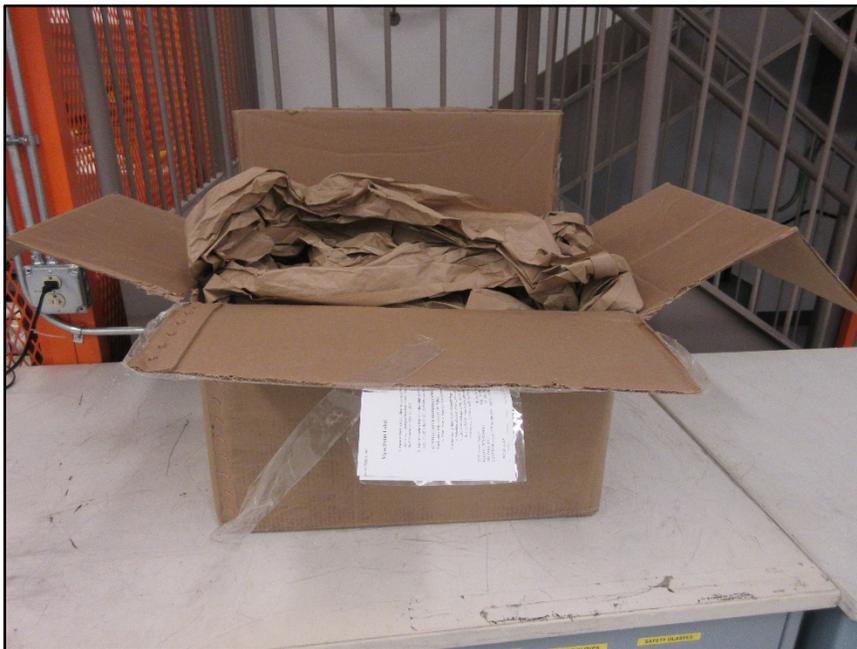
Figure 1: SCBA as received.
