# PPE CASE

## Personal Protective Equipment Conformity Assessment Studies and Evaluations

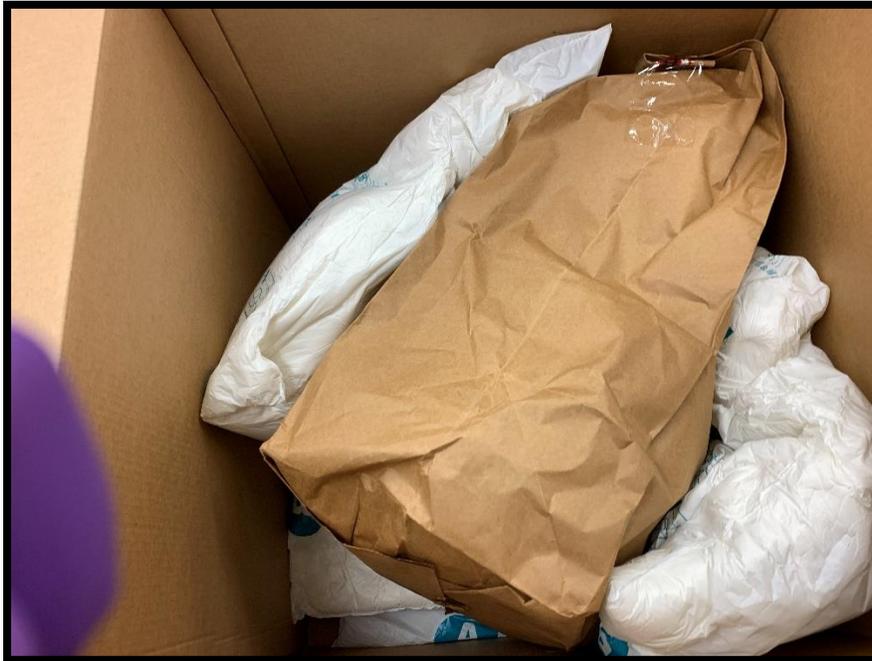
**Figure 1: Packaged SCBA as received.**

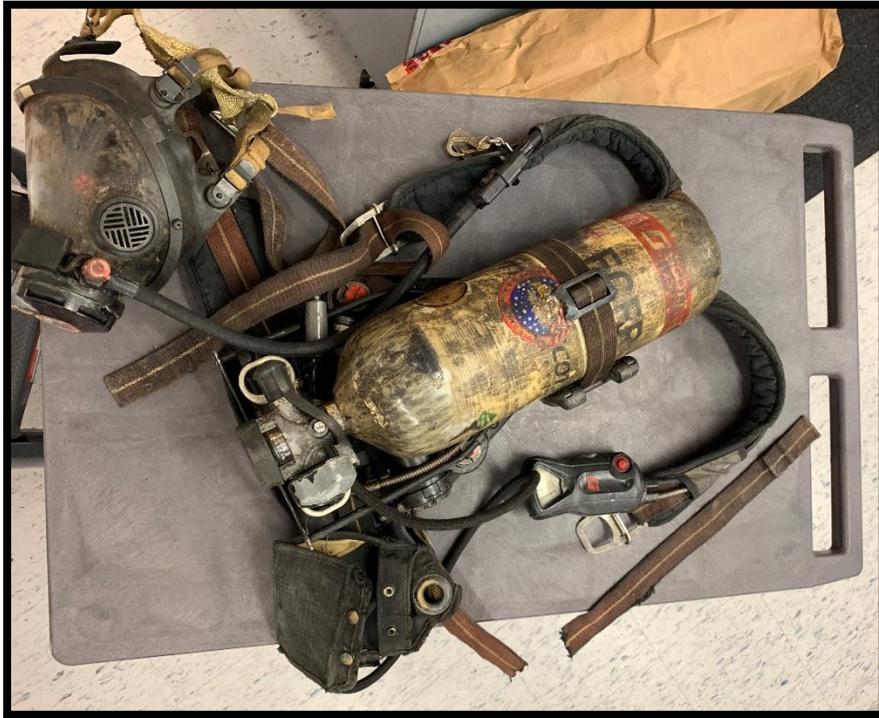
**Figure 2: Unpackaged SCBA as received.**

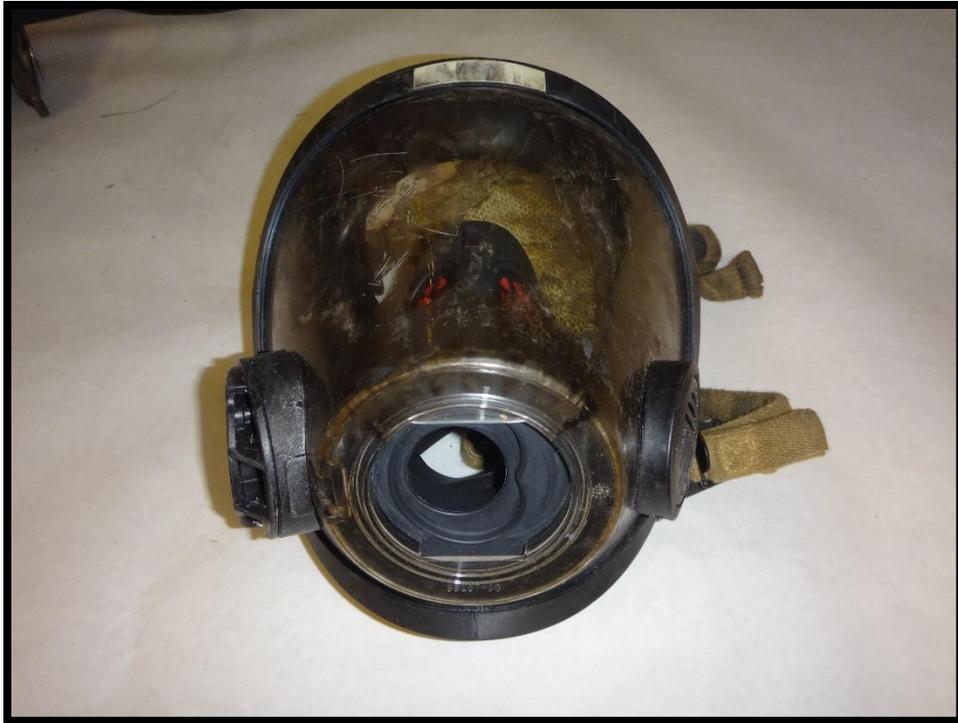
**Figure 3: Front of facepiece.**

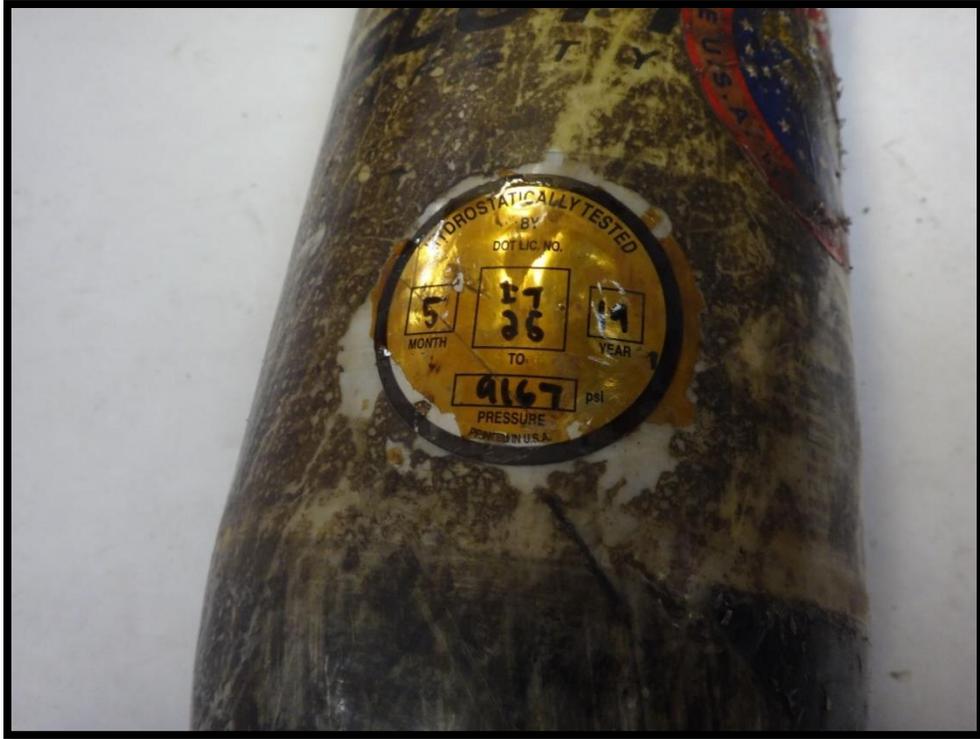
Figure 21: Cylinder hydrostatically tested label.
