Evaluation of a Self-Contained Breathing Apparatus for Potential Contribution to a Fatal Event in the Fire Service

Houston, Texas Fire Department Request for Scott® Safety Air-Pak® 4.5, 4500 psi unit with NIOSH Approval Number TC-13F-212CBRN (August 15, 2016)

NIOSH Task Number 20842

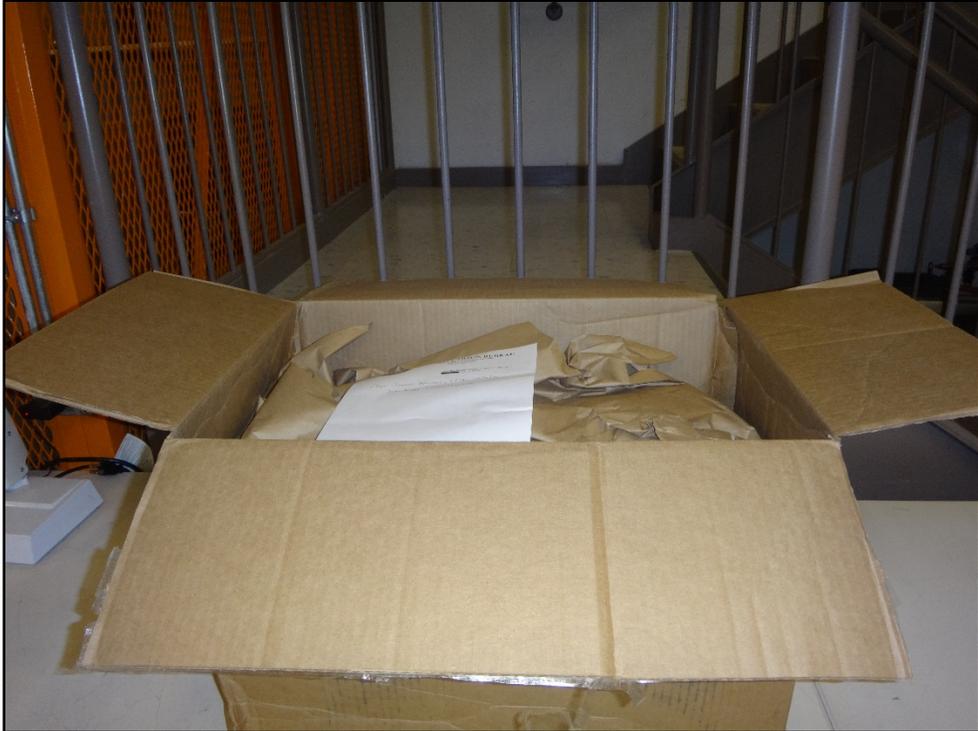
Figure 1: Cardboard box containing SCBA as received

The SCBA was received in a cardboard box (refer to **Figures 1-2** in **Appendix III**)

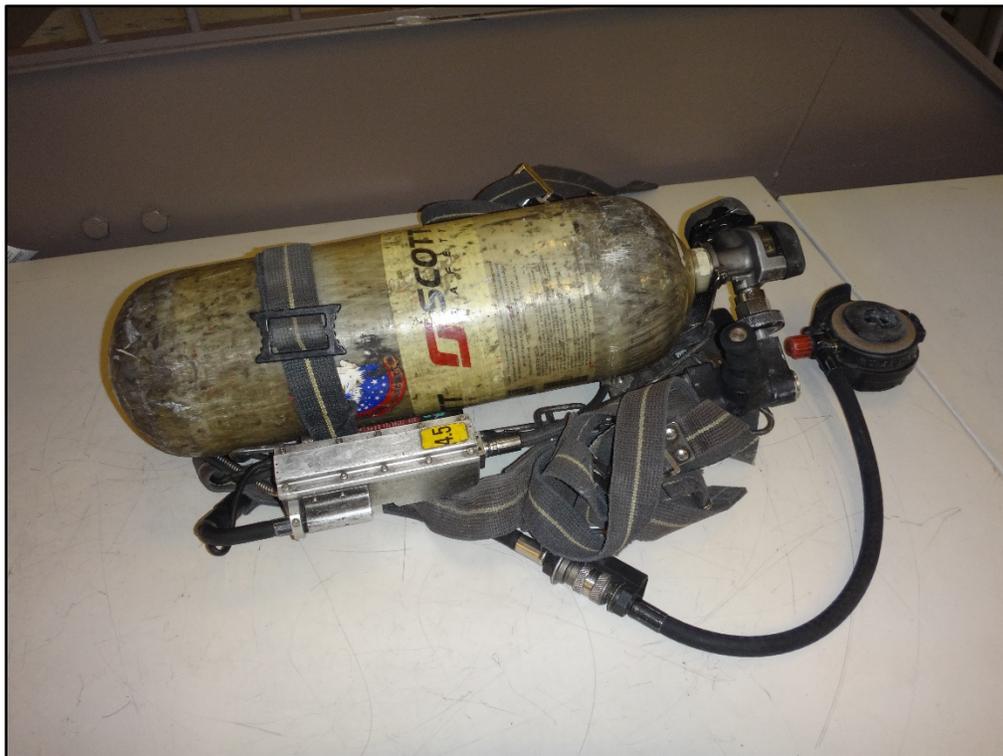
Figure 2: Overview of unit out of bag

- Cylinder included and empty
- Bypass in the “on” position
- Donning switch on, regulator inactive
- No facepiece included

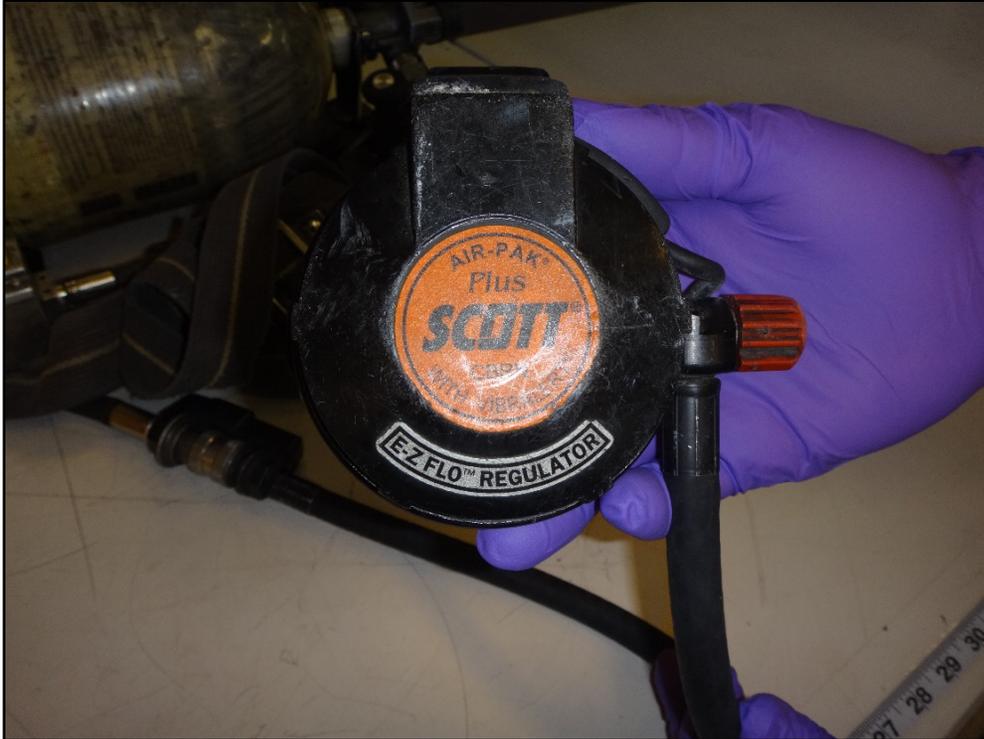
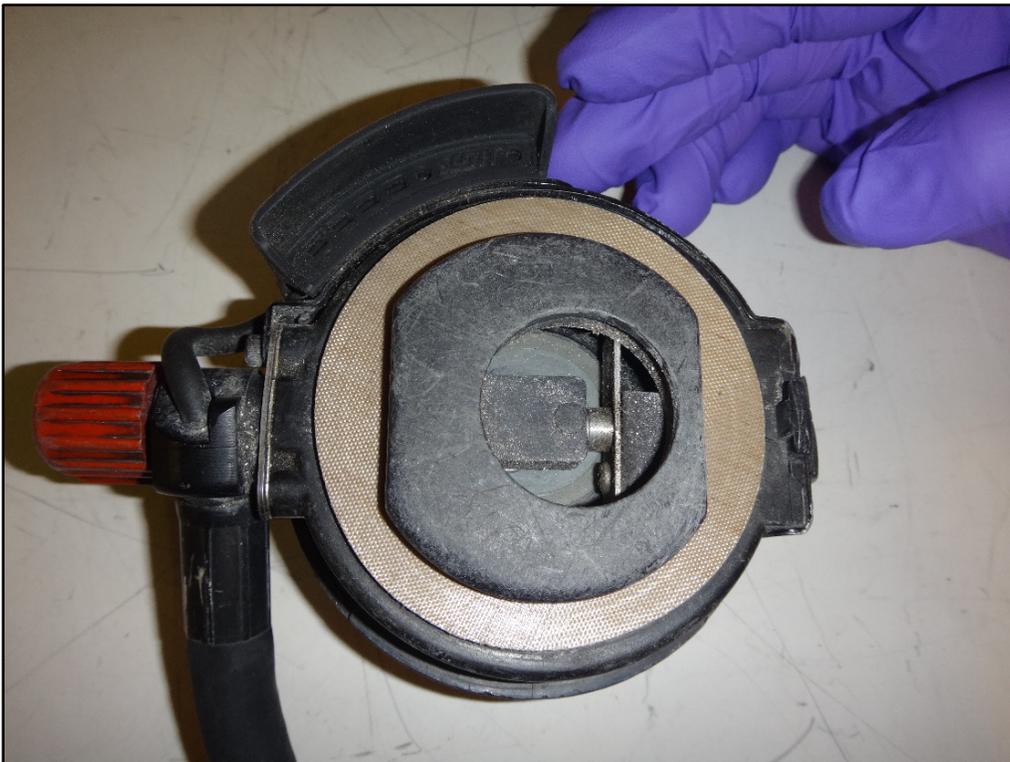
MMR with Heads up Display (HUD): (refer to **Figures 3-4** in **Appendix III**).

Air-Pak® plus CBRN with Vibralert and E-Z Flo regulator.

- Overall condition is good, some scrapes
- Outer case is good with stickers present
- Donning switch and cover are in fair condition
- Secured to low pressure line
- Bypass in the on position
- Bypass knob normal wear and tear
- Inside flange has scratches
- Sealing area mostly clean
- Locking assembly does function

Figure 3: Mask mounted regulator

Figure 4: Inside flange, Mask mounted regulator

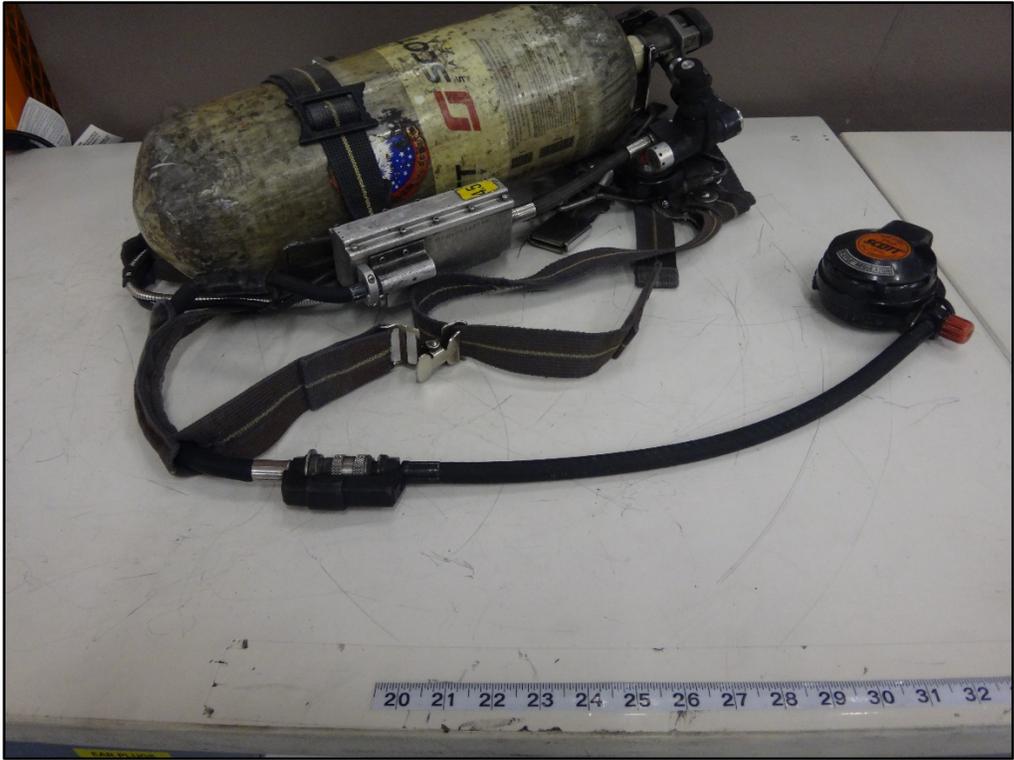
Low Pressure Line: (refer to **Figures 5** in **Appendix III**).

- Overall condition is good, no rips or tears
- Secured at all attachments points
- Quick disconnect in good condition and functions
- Line runs through the shoulder strap to the reducer

Figure 5: Low pressure hose

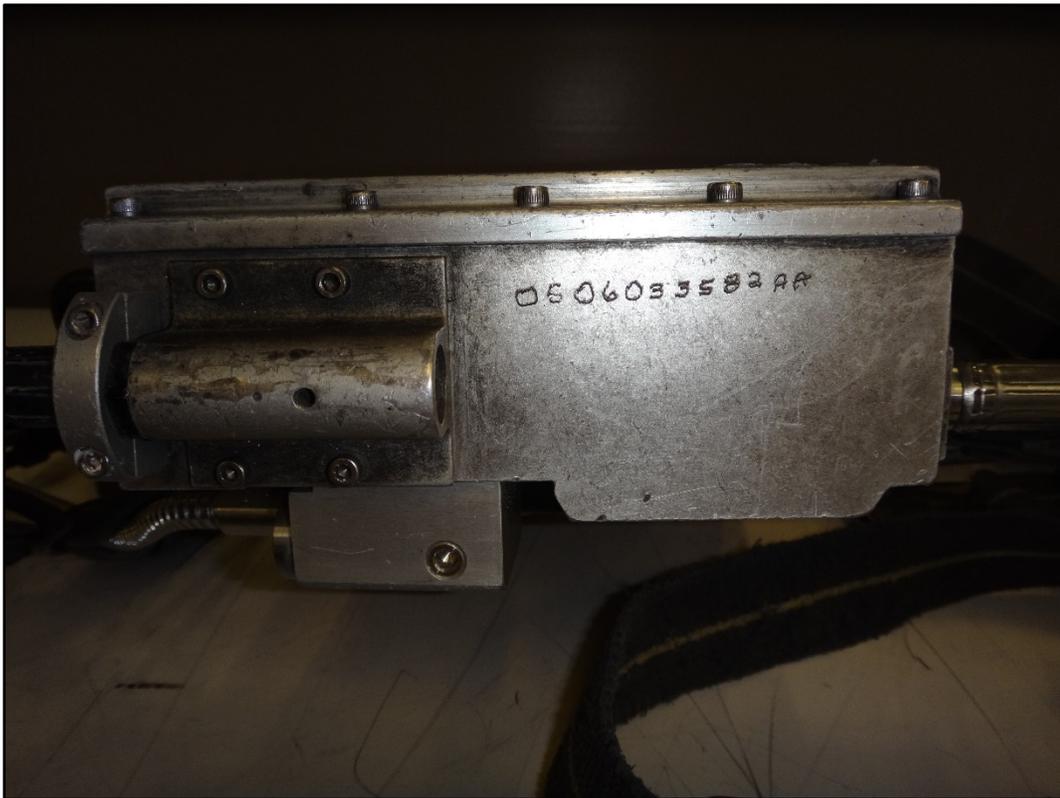
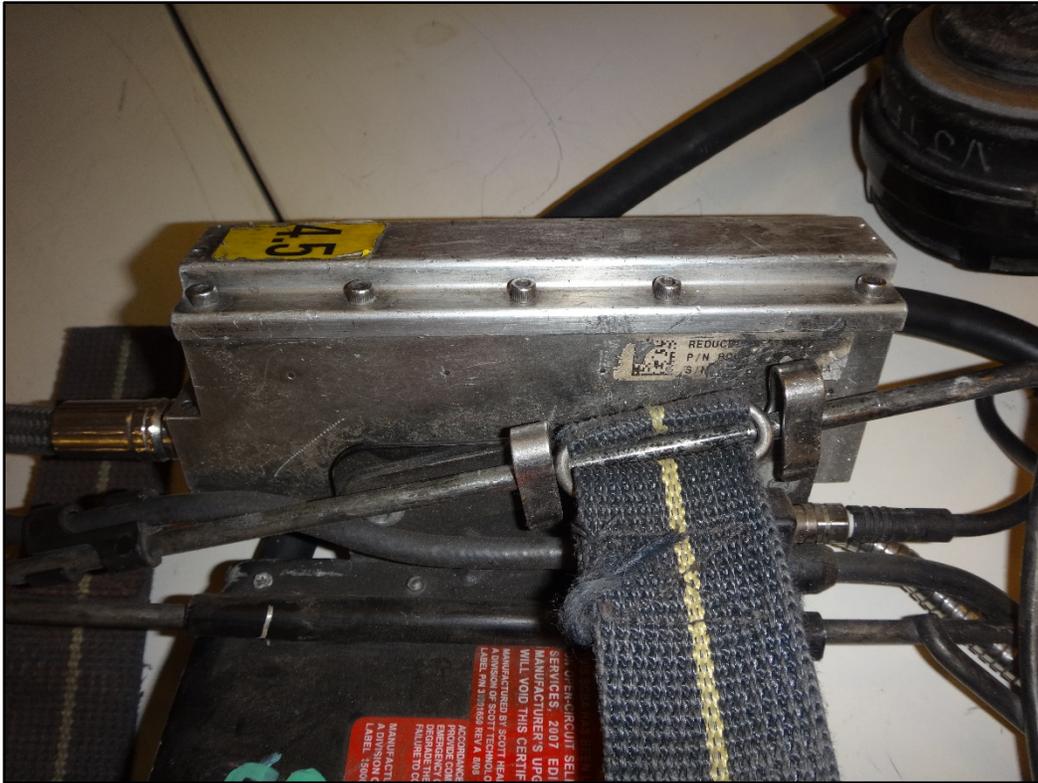
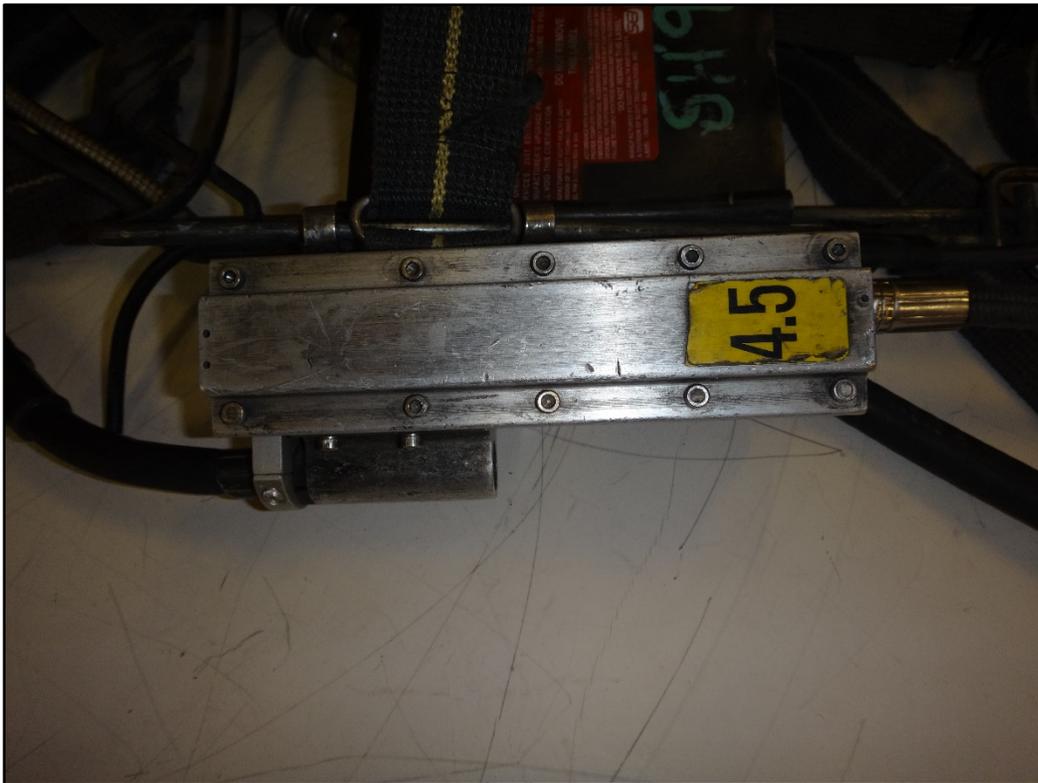
4.5 Pressure Reducer Assembly: (refer to **Figures 6-8** in **Appendix III**).

P/N: Present but unreadable Marking: 4.5 sticker, SN engraved: 0606033582AA

- Overall condition is good, pretty clean
- All airline connections are secure

Figure 6: Pressure reducer assembly

Figure 7: Interior view of pressure reducer assembly

Figure 8: Top view of Pressure reducer assembly

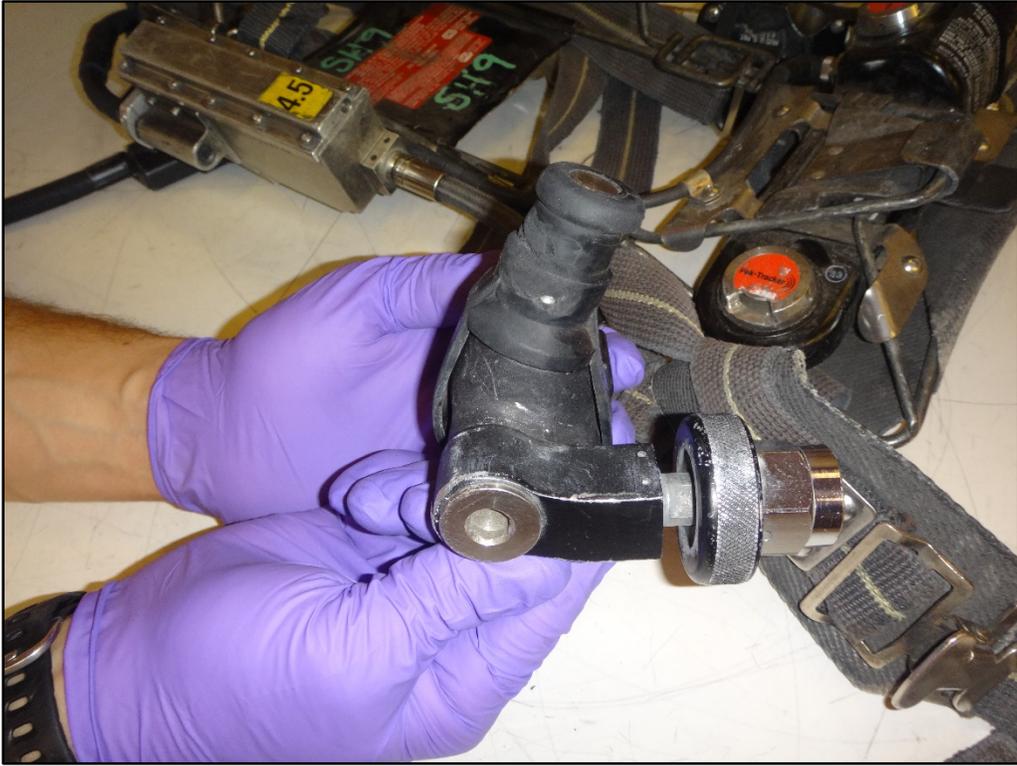
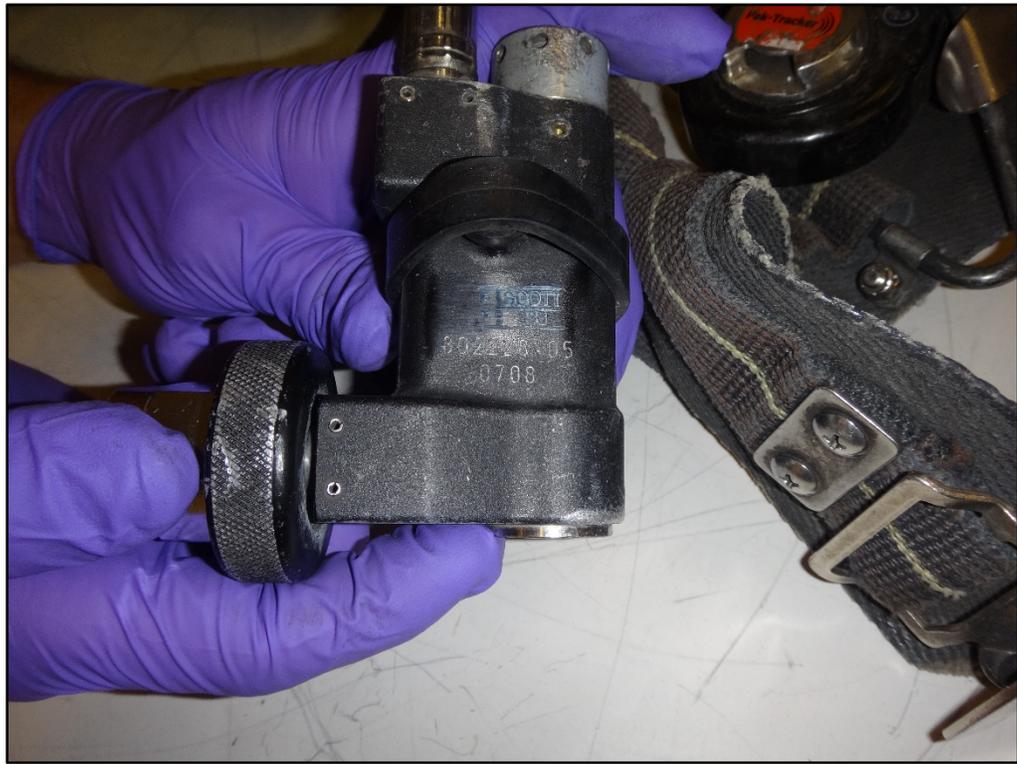
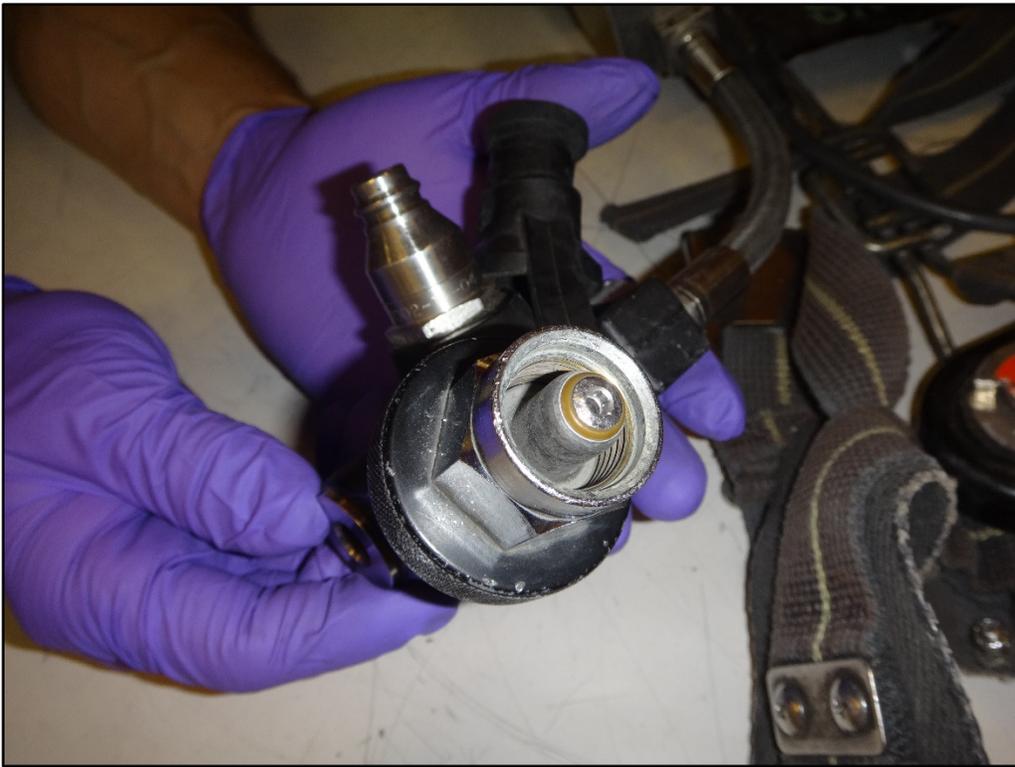
High Pressure Line & Cylinder Attachment: (refer to **Figures 9-11** in **Appendix III**).

Cylinder Attachment P/N: 802228-05
for

- Overall condition is good, some scratches
- Cylinder attachments thread clean, threads on and off, “O” ring in place
- Quick fill and cover in good shape #ETN FD17-1002-10-04

Figure 9: Cylinder attachment overview and relief valve

Figure 10: Cylinder attachment identifying markings

Figure 11: Quick fill port on cylinder attachment and overview of threads

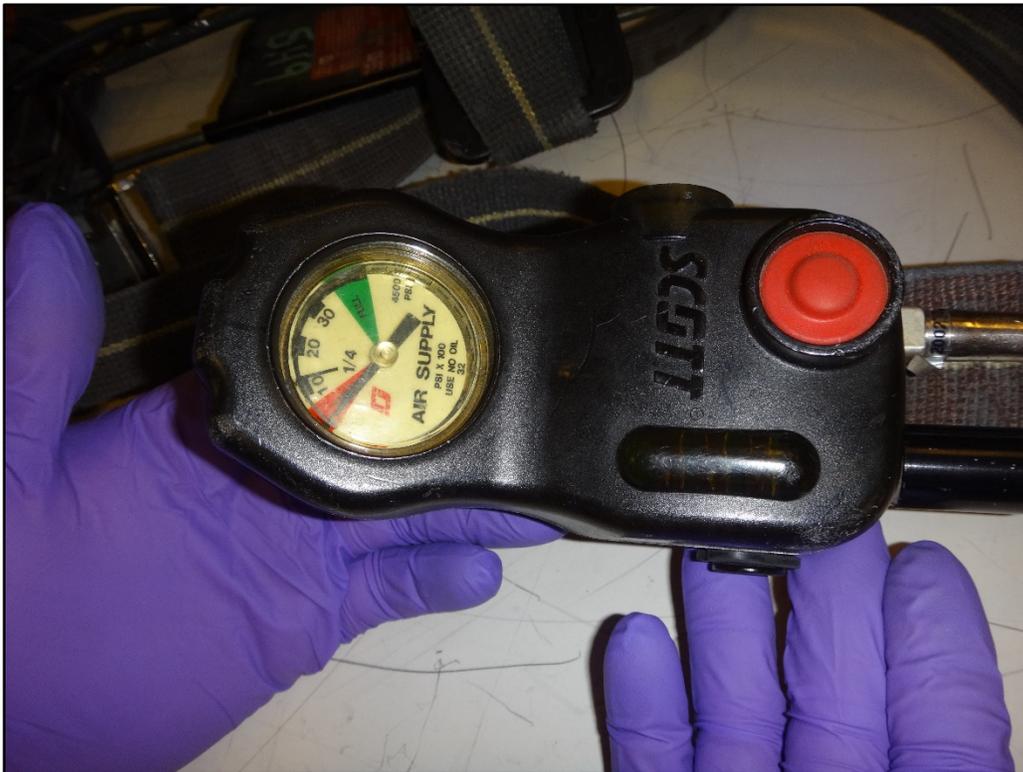
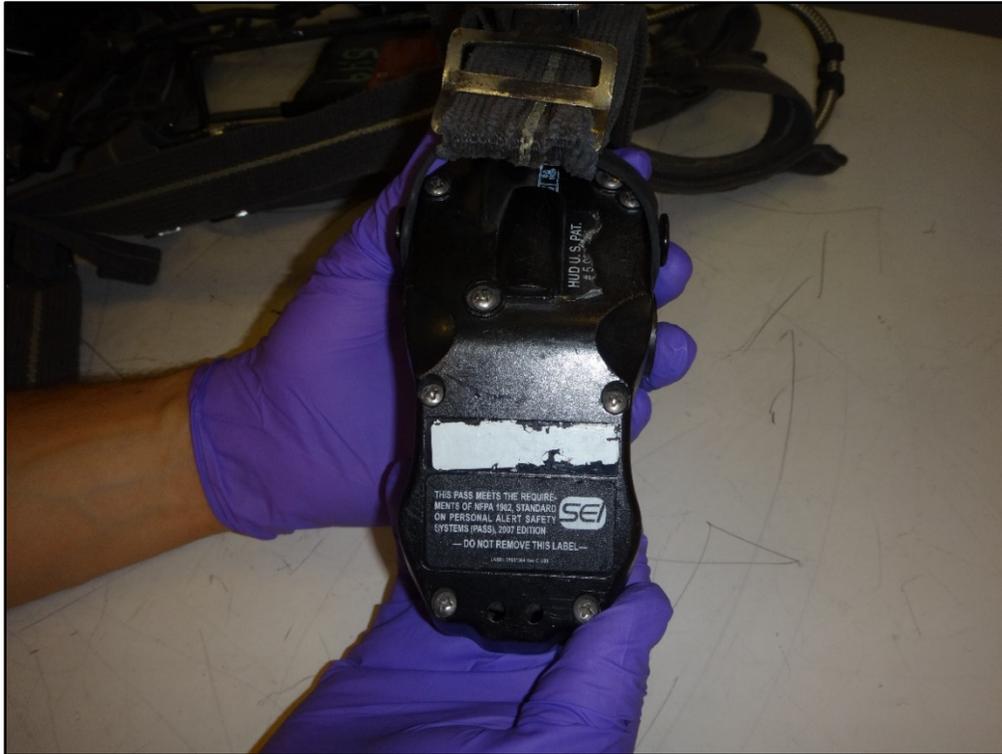
Console Assembly PASS: (refer to **Figures 12-13** in **Appendix III**).

- Overall condition is good, clean

- Lines in good shape – pressure/electrical
- Gauge lens is readable
- Protective casing slightly dirty
- Rubber attachment strap present, attached to the PASS console and shoulder strap
- SEI Label attached: NFPA 1982, 1998 edition

Figure 12: PASS console

Figure 13: Back of PASS console, SEI label

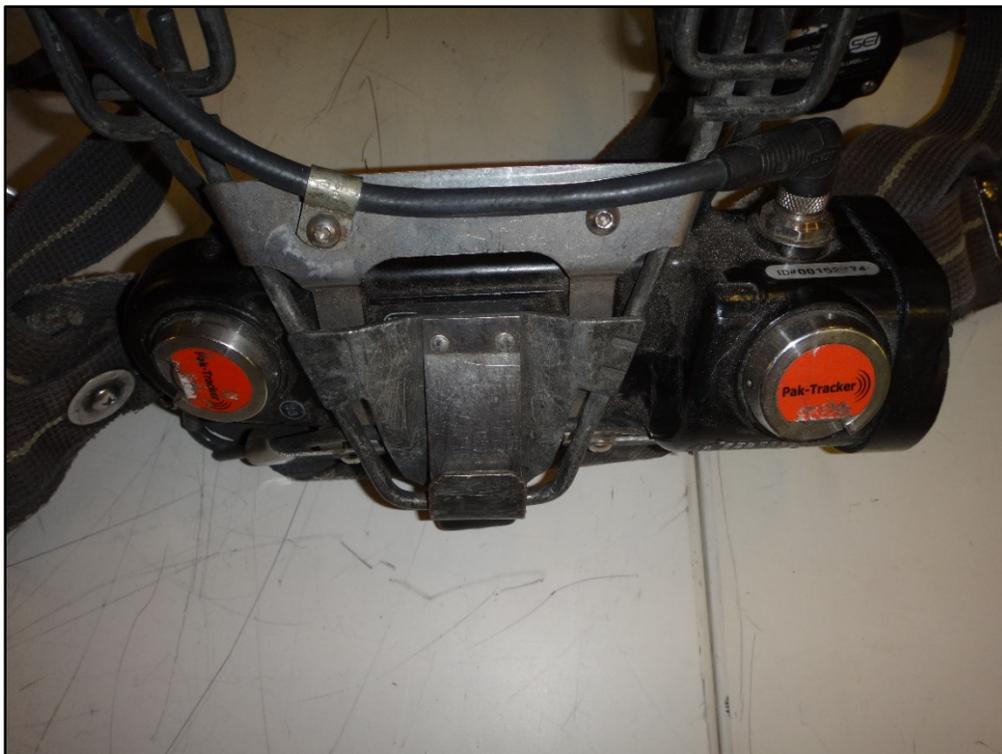
PASS Control Module: (refer to **Figures 14-15** in **Appendix III**).

- Overall condition is good
- Held securely to backframe
- Wire connection connected to PASS device
- Wire held secure to backframe and runs to console assembly

Figure 14: PASS control module

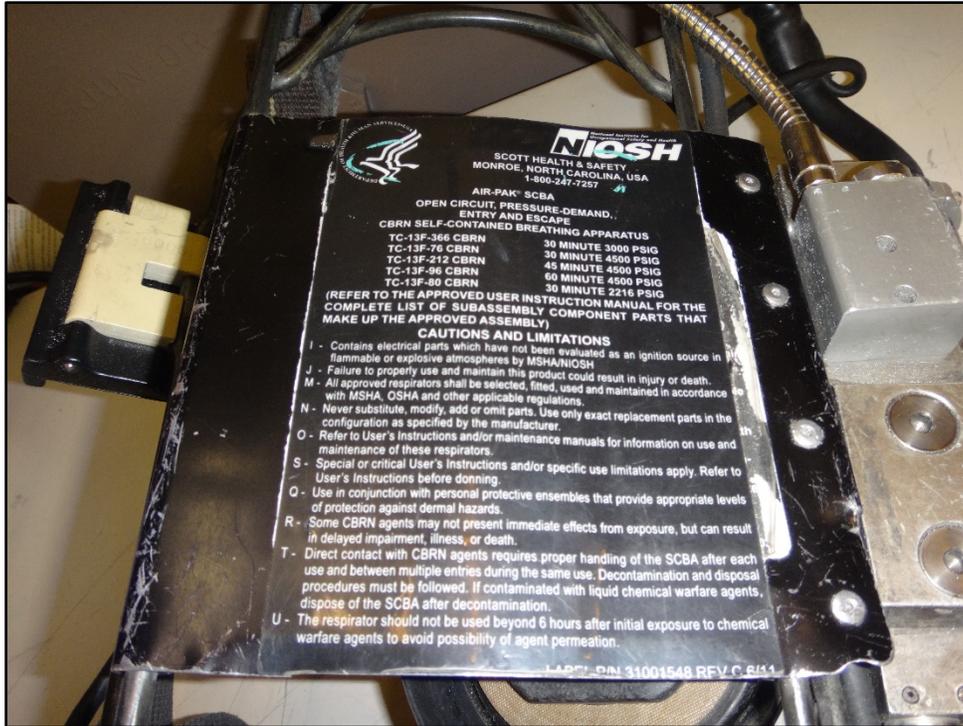
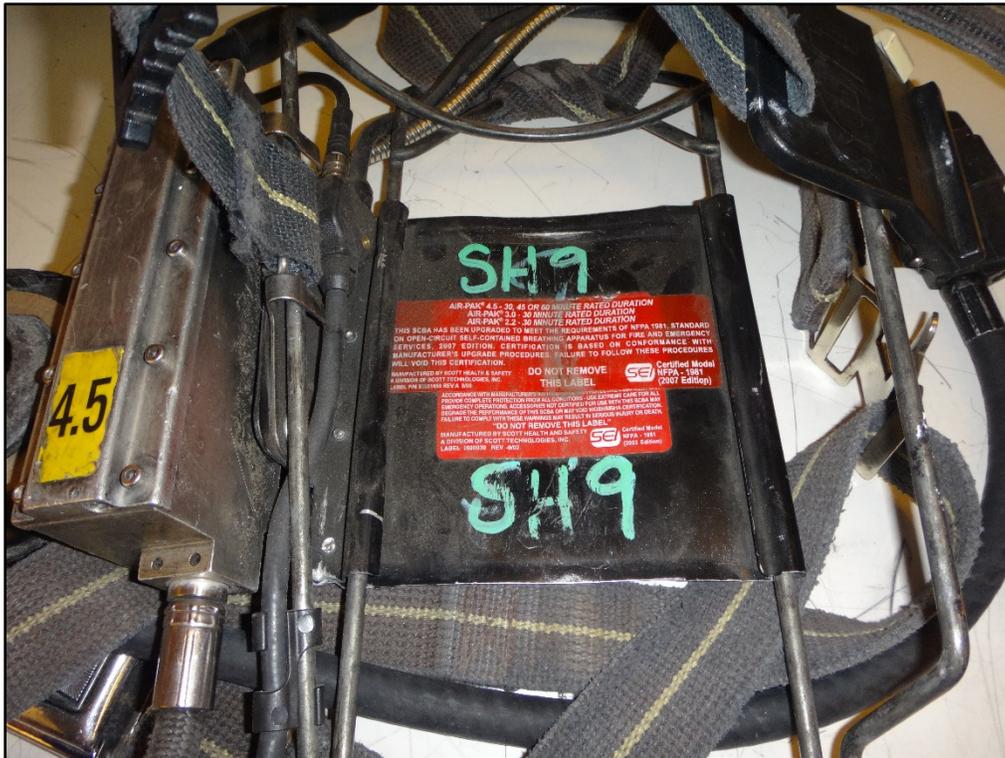
Backframe Assembly: (refer to **Figures 16-18** in **Appendix III**).

SEI Label attached, NFPA 1981, 2007 Edition

- Overall fair condition, no bends/cracks in wire frame
- Shoulder straps were attached to the frame
- Cylinder strap and latch are in fair condition, dirty
- Cylinder strap adjuster functional
- Cylinder strap and latch is dirty but functional
- E73-2 marked on back frame
- CBRN label present
- NIOSH label present, TC-13F-212CBRN

Figure 17: Labels inside of pack

Figure 18: Labels on back frame

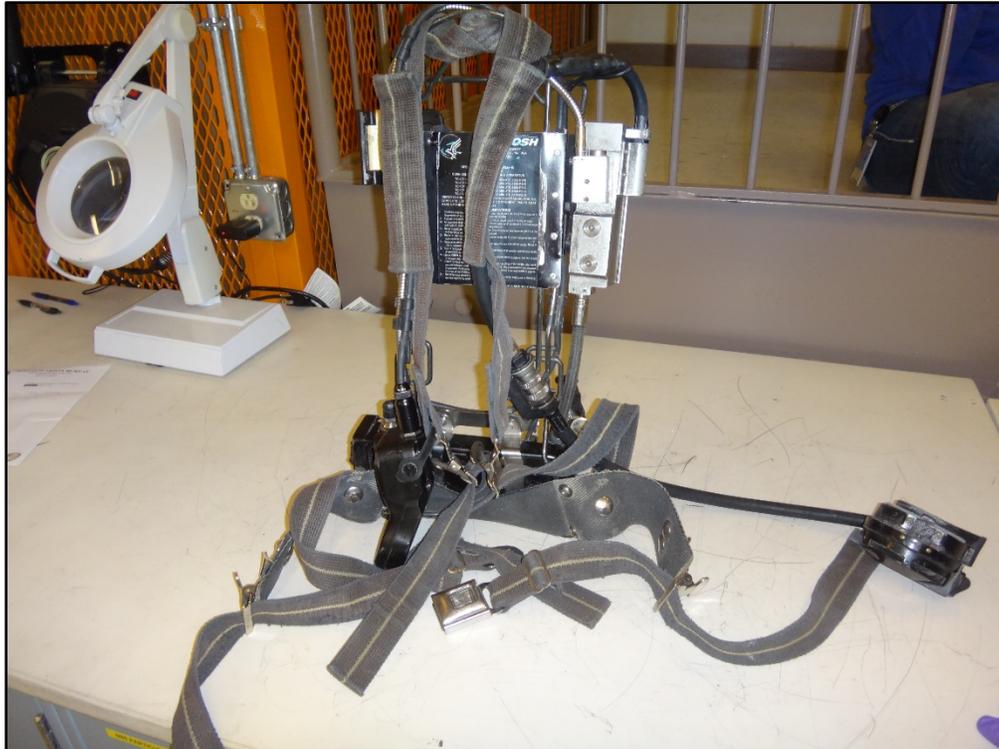
Straps & Buckles: (refer to **Figure 19** in **Appendix III**).

- Overall strap condition is good
- Both shoulder straps attached at the top of the back frame
- Hose lines and wires pass through shoulder straps
- All adjustable buckles move and hold in place
- Waist area buckle latches and releases
- Right side waist strap worn
- Lumbar strap in good condition with some dirt and minimal fraying at attachment points on either side of the pad

Figure 19: Overview of straps and buckles

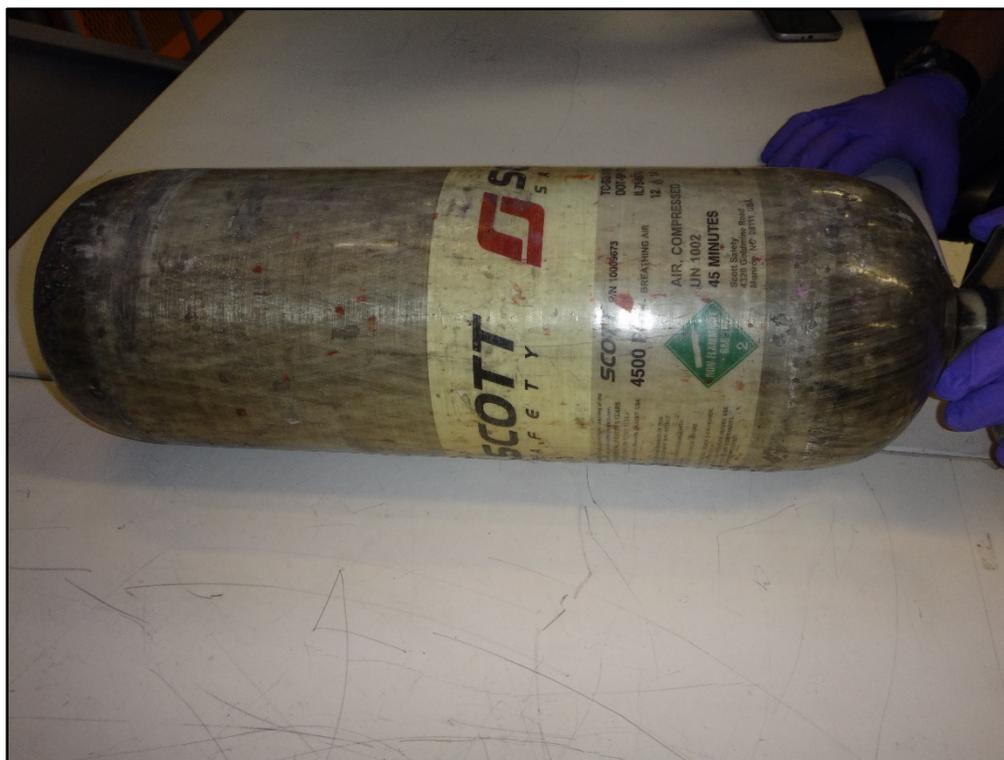
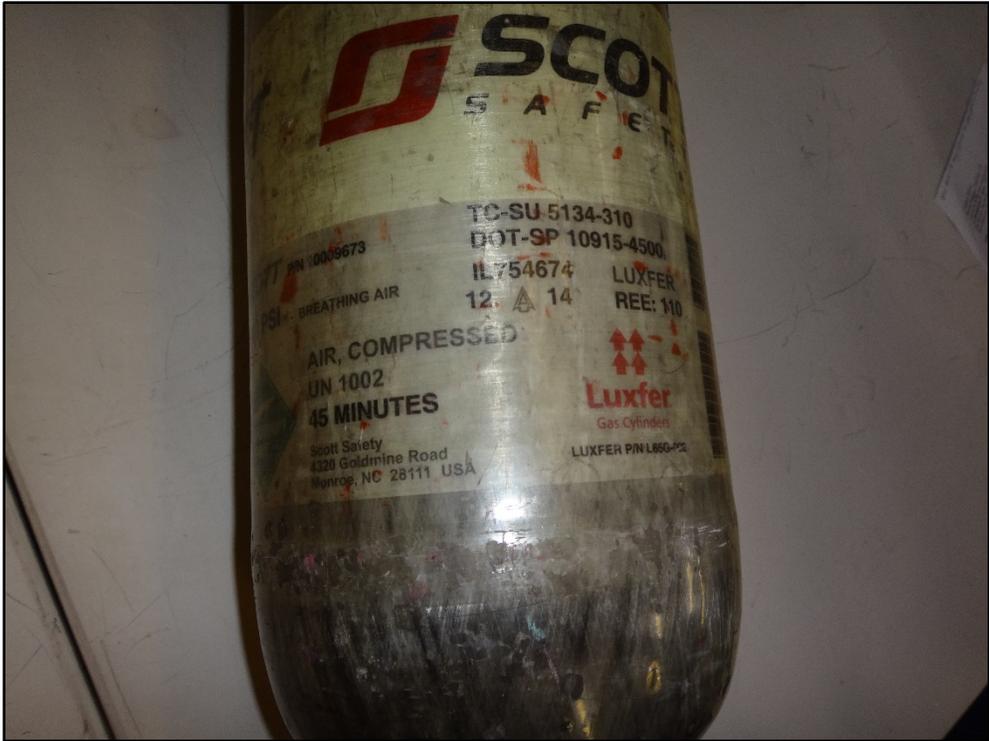
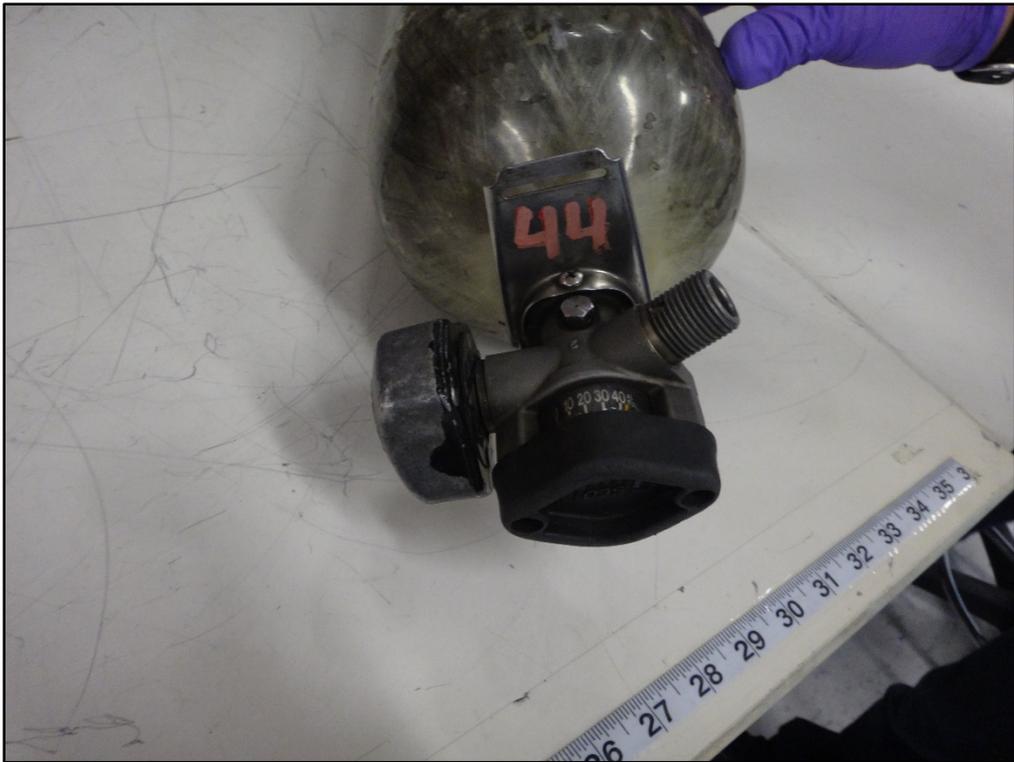
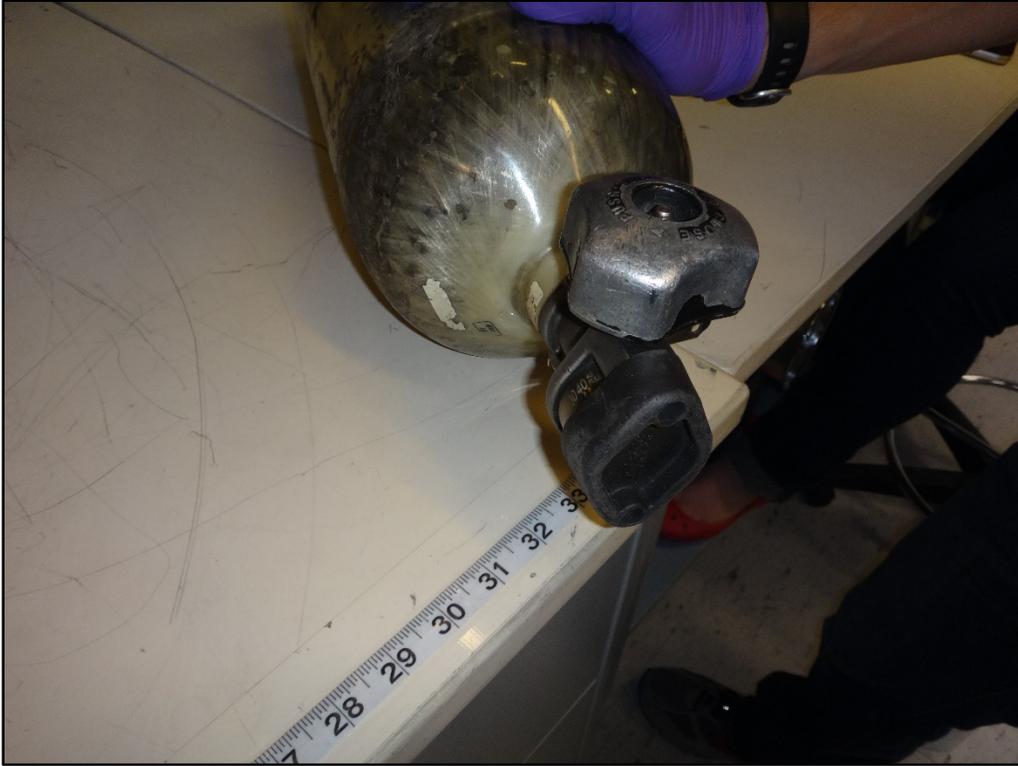
Cylinder & Valve Assembly: (refer to **Figures 20-23** in **Appendix III**).

- Overall condition is fair to good as there are some surface scratches and dirt present
- Gauge is readable
- Threads are okay, some corrosion
- As received cylinder valve fully closed with no air remaining
- Rubber bumper at base on cylinder valve is in good condition

Figure 20: Overview of cylinder

Figure 21: Overview of cylinder label

Figure 22: Cylinder gauge is readable

Figure 23: Overview of top of cylinder
