Personal Protective Equipment Conformity Assessment Studies and Evaluations

Evaluation of Two Self-Contained Breathing Apparatus Involved in a Near Miss in the Fire Service

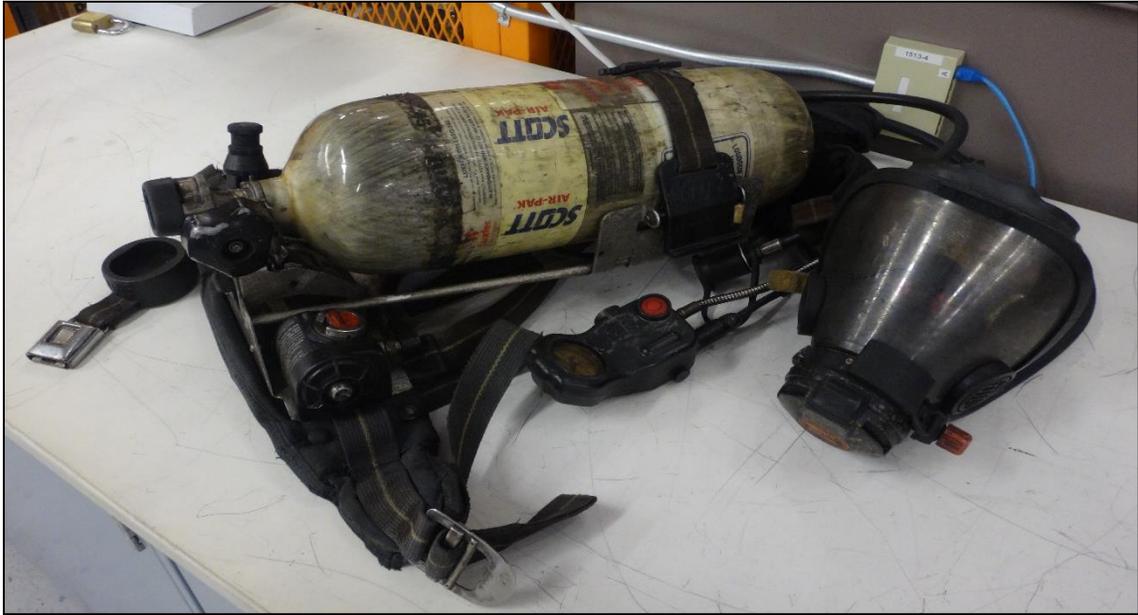
Figure 1: All components of SCBA 60105 unit to be examined.

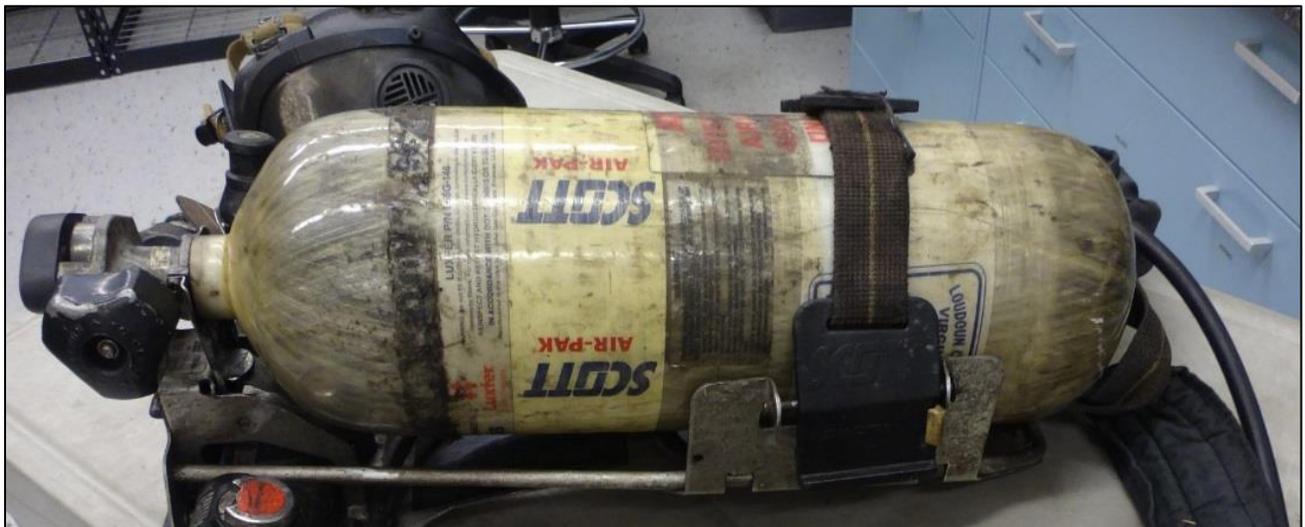
Figure 25: Overall condition of cylinder.

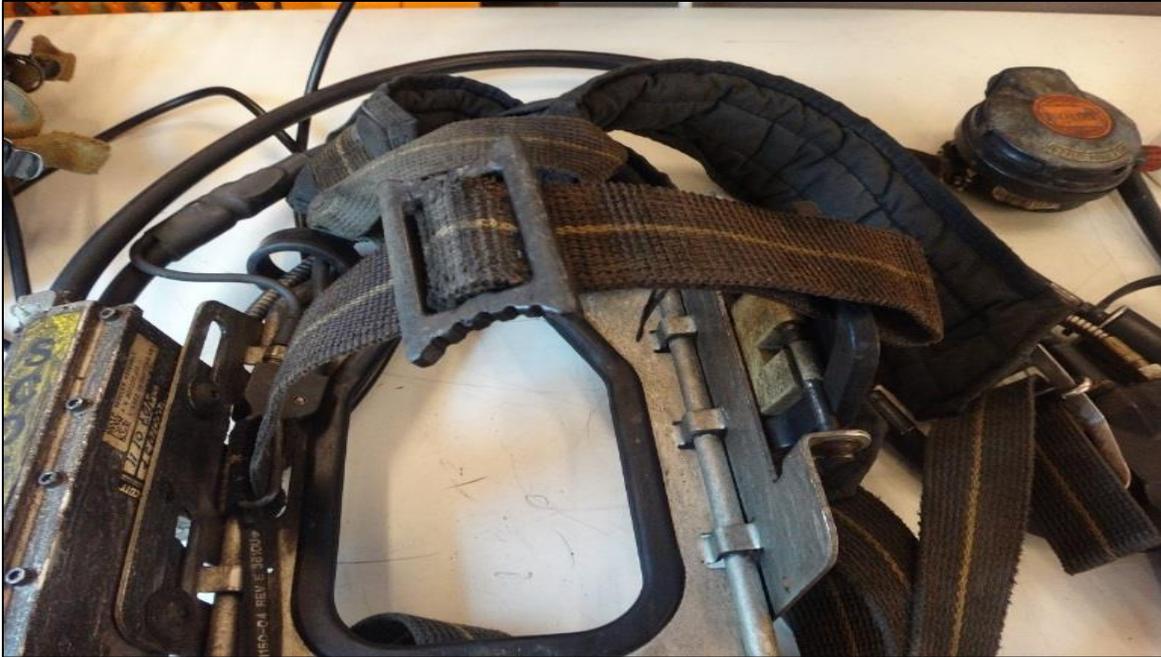
Figure 26: Cylinder strap.

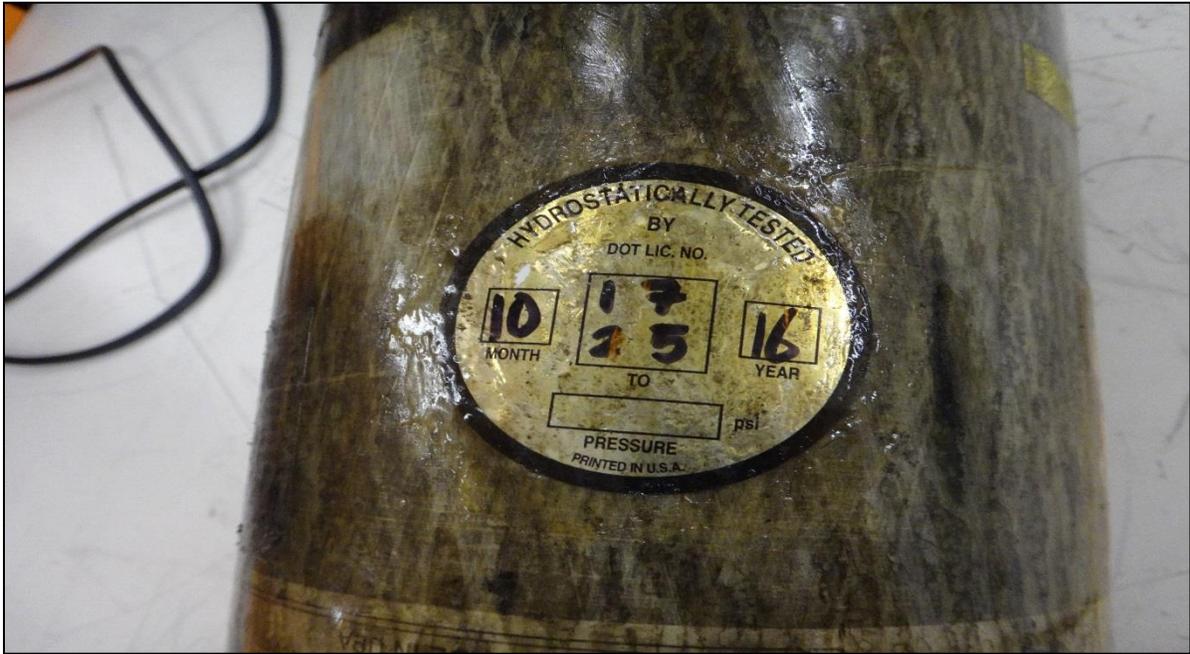
Figure 53: Hydrostatic test date sticker.

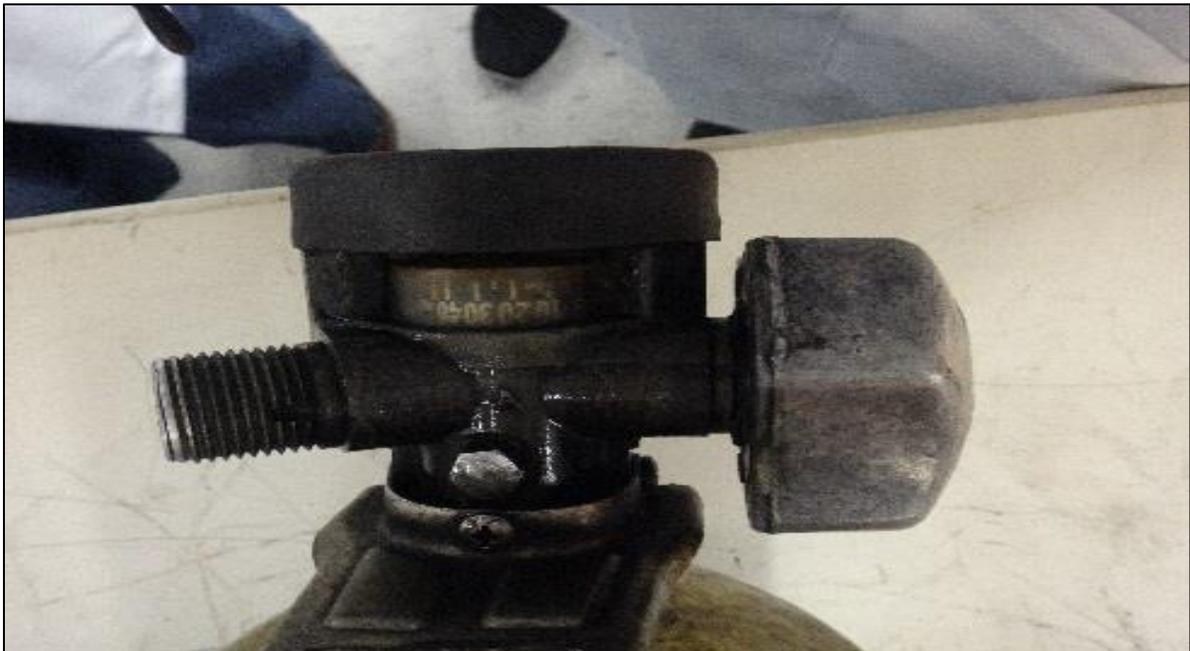
Figure 54: Cylinder gauge is readable, view of threads.
