Personal Protective Equipment Conformity Assessment Studies and Evaluations

Evaluation of a Self-Contained Breathing Apparatus Involved in a Fatality While Operating at a Structure Fire

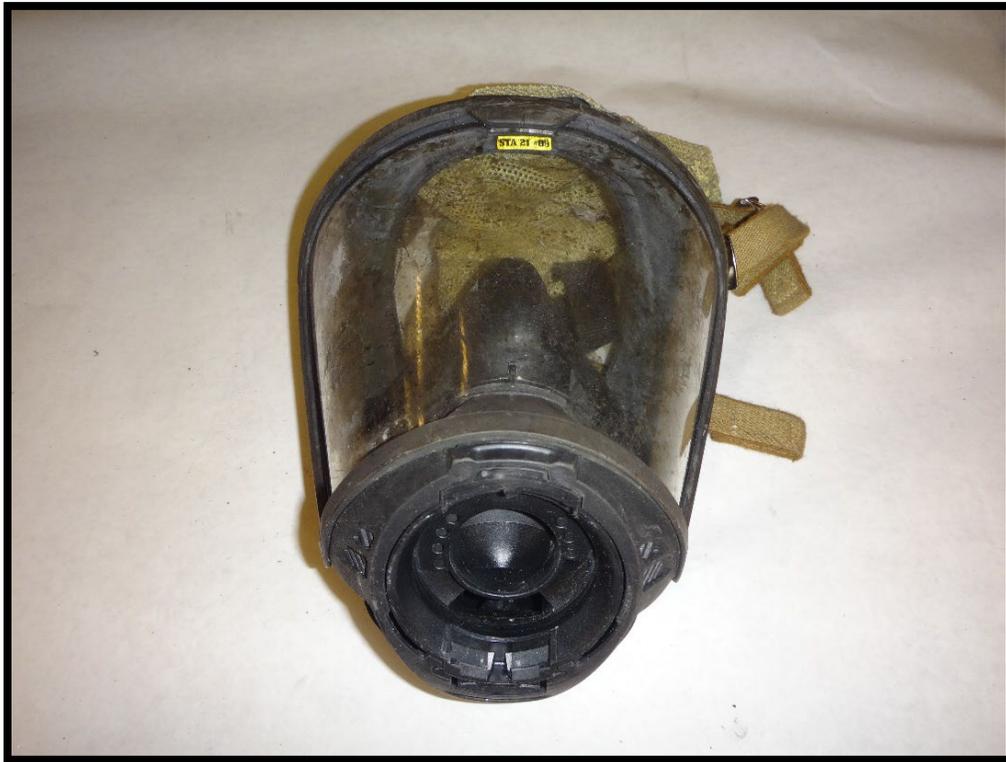
Figure 3: Front of facepiece

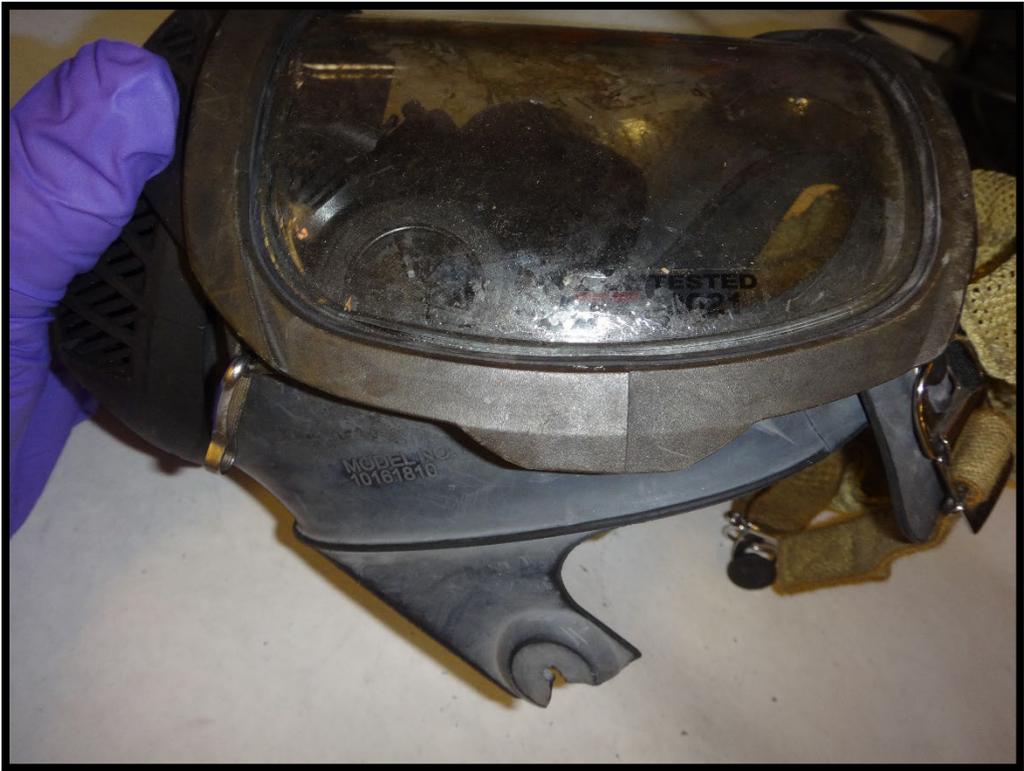
Figure 6: Bottom left lug broken on facepiece

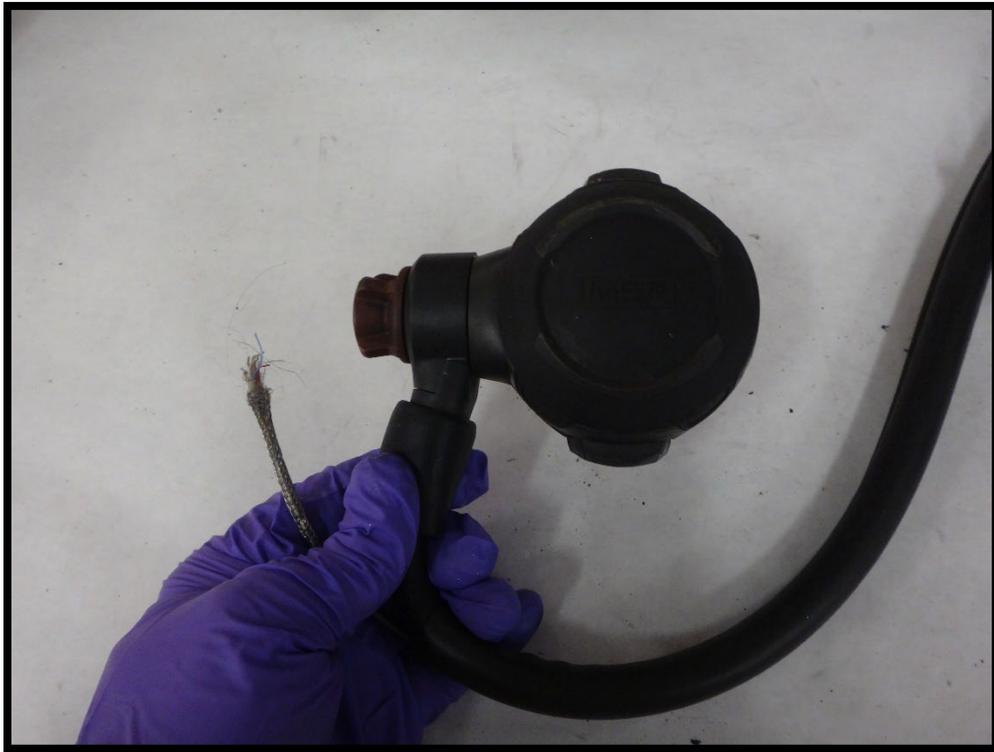
Figure 7: Mask-mounted regulator with HUD wire not connected
