Personal Protective Equipment Conformity Assessment Studies and Evaluations

Evaluation of a Self-Contained Breathing Apparatus Involved in a Fatality While Operating at a Structure Fire

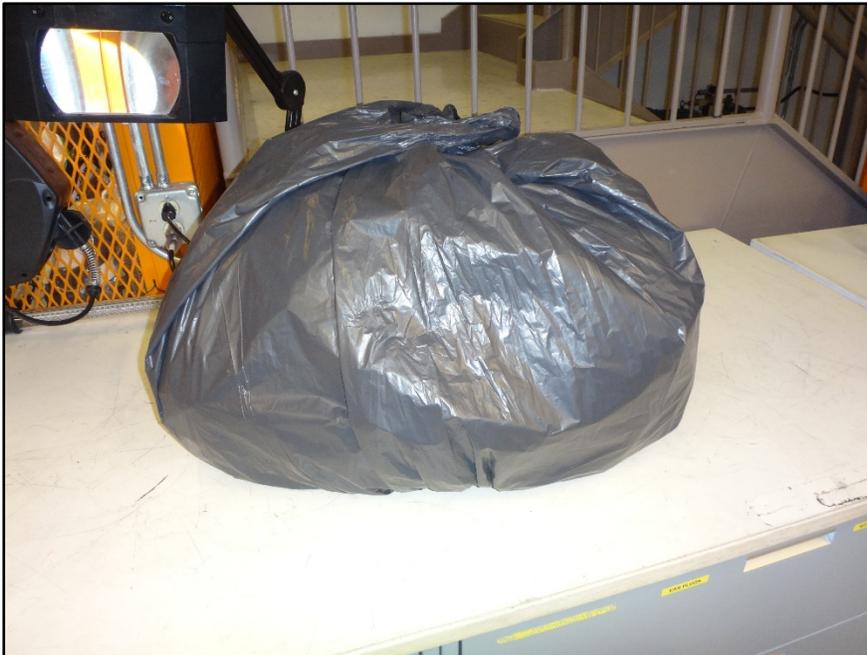
Figure 1: SCBA as received.

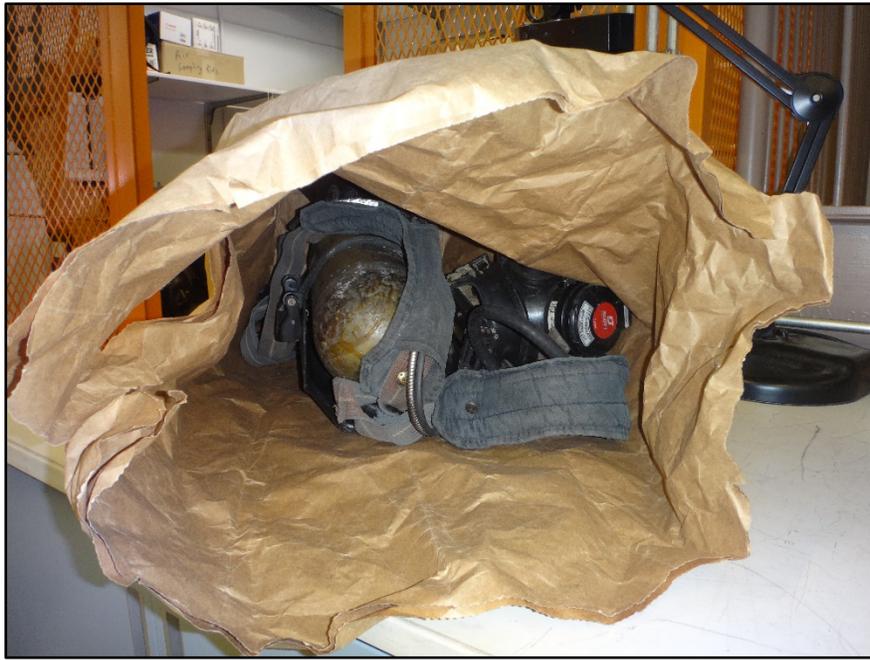
Figure 2: SCBA as received
