Personal Protective Equipment Conformity Assessment Studies and Evaluations

Evaluation of Two Self-Contained Breathing Apparatus for Potential Contribution to a Fatal Event in the Fire Service

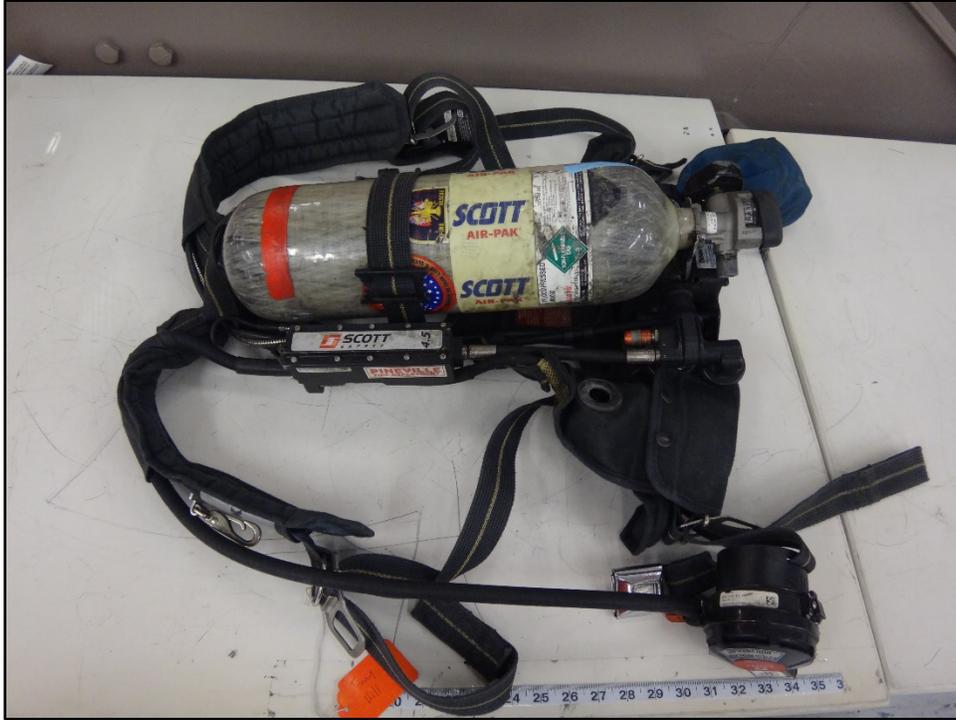
Figure 1: Overview of SCBA unit as received

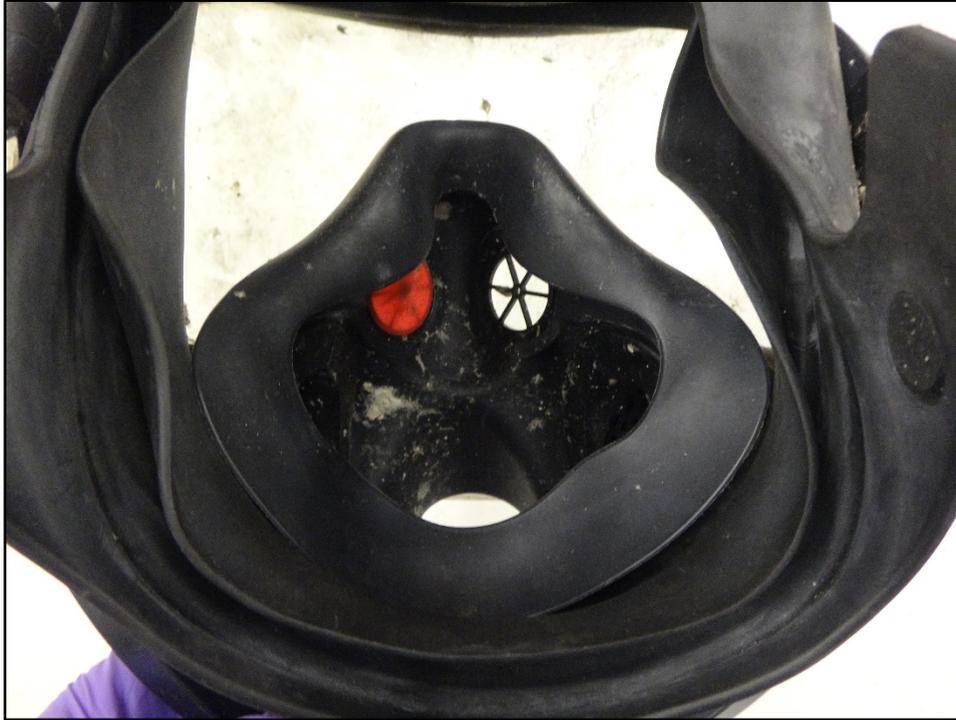
Figure 3: Inside view, missing exhalation valve

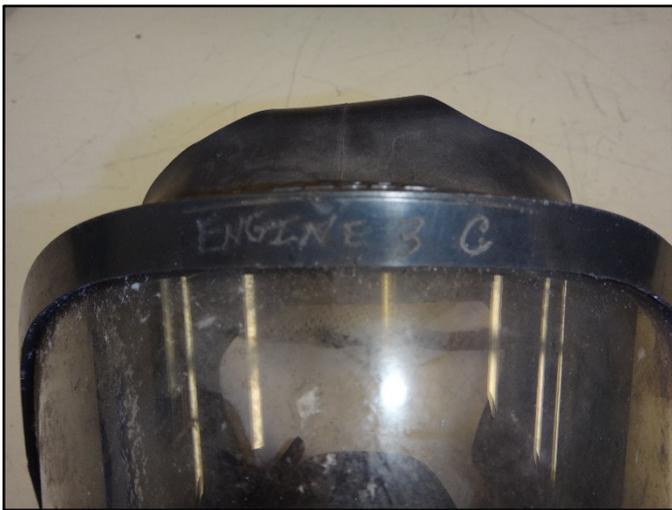
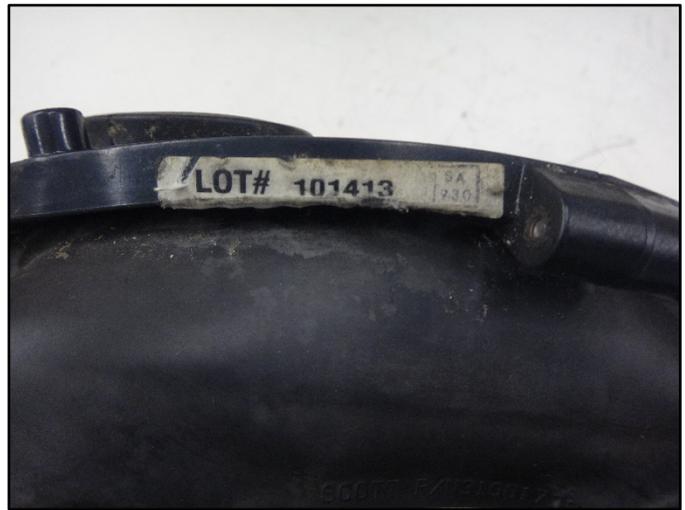
Figure 4: Outside identifying markings

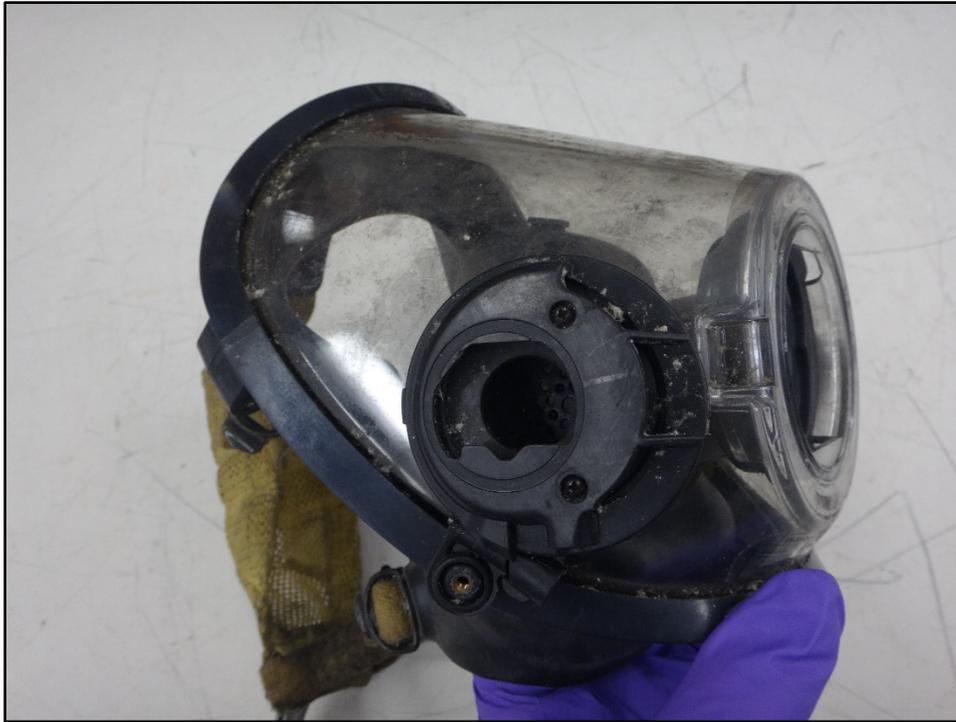
Figure 5: Missing voice amplifier

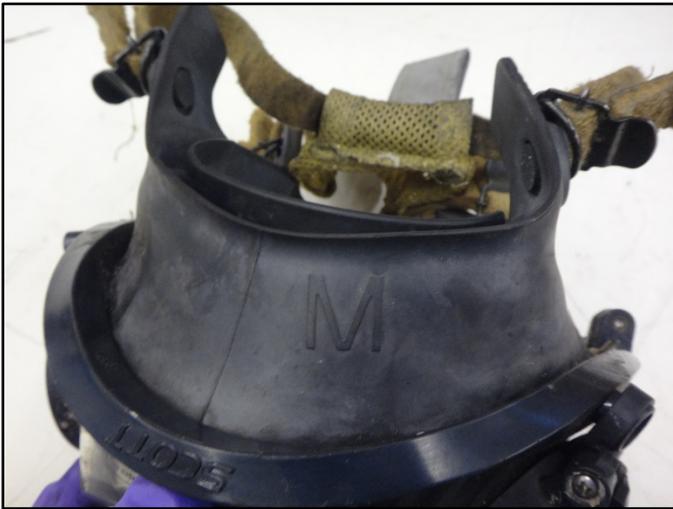
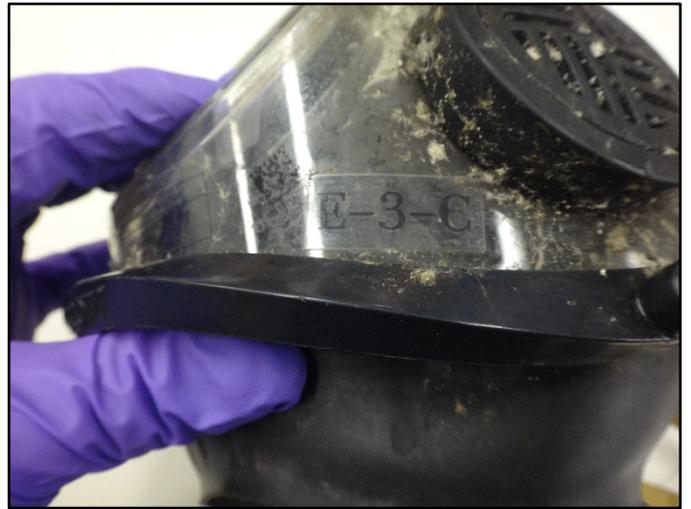
Figure 6: Identifying size/markings
