### **Evaluation of a Self-Contained Breathing Apparatus Involved in a Near Miss in the Fire Service**

#### **Rock Creek Idaho Fire Department Request for a Sperian TITAN™ unit**

# NIOSH Task Number 21014

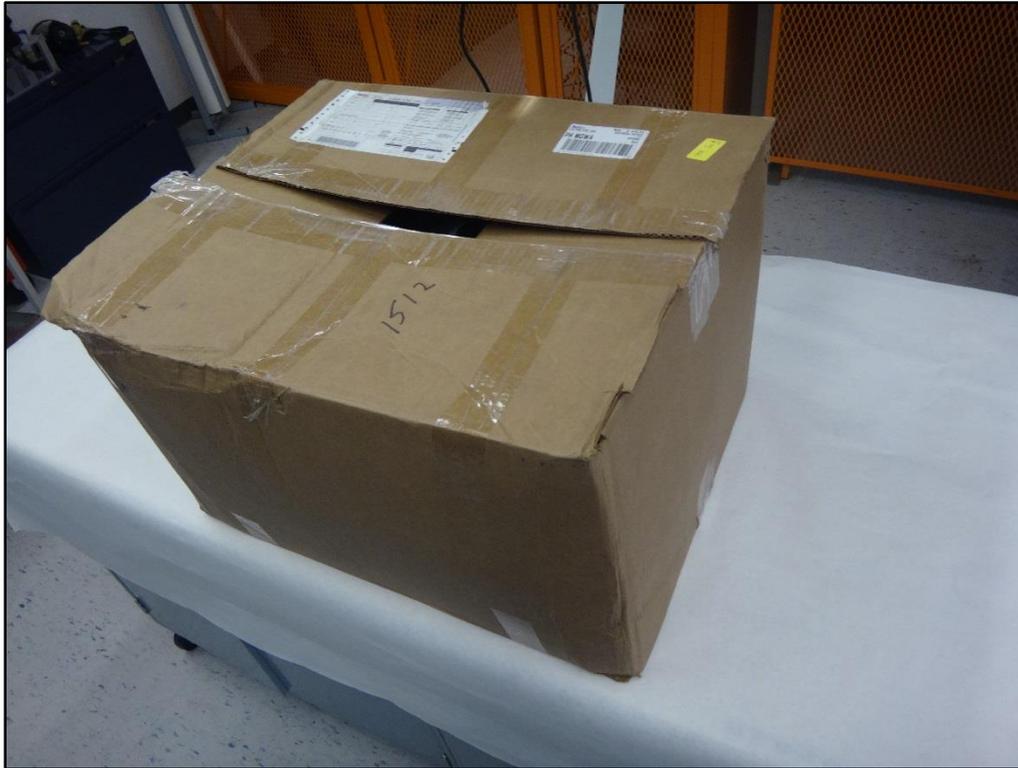
The SCBA was received in a cardboard box (refer to **Figures 1 and 2** in **Appendix III**).

**Figure 1: Cardboard box containing SCBA as received.**

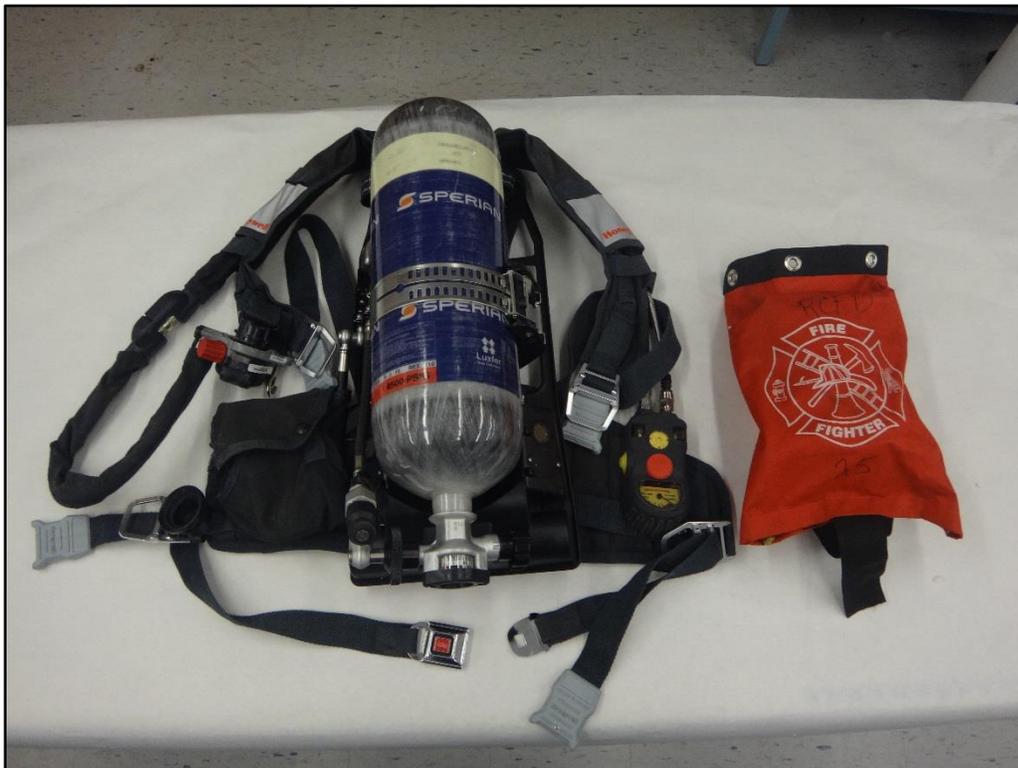
- SCBA unit and cylinder were in a cardboard box with packing materials, facepiece was also included, in a separate fire department bag.
- Cylinder received empty and open.
- Bypass was closed.
- Mask mounted regulator (MMR) was attached to waist belt with the donning switch in the off position and inactive.

**Figure 2: SCBA and facepiece out of box.**

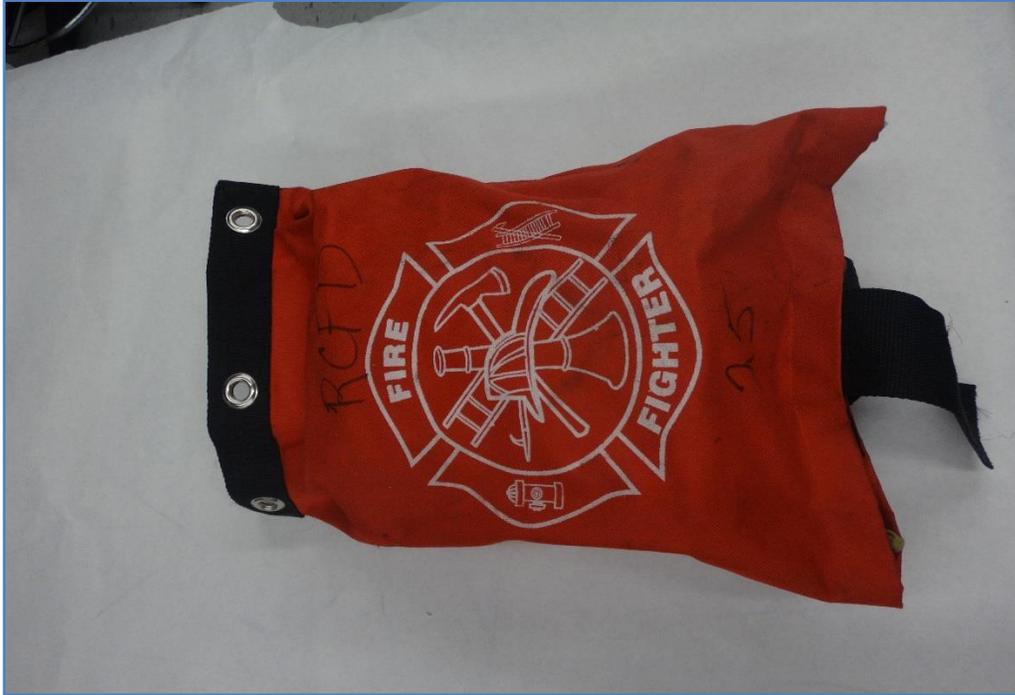
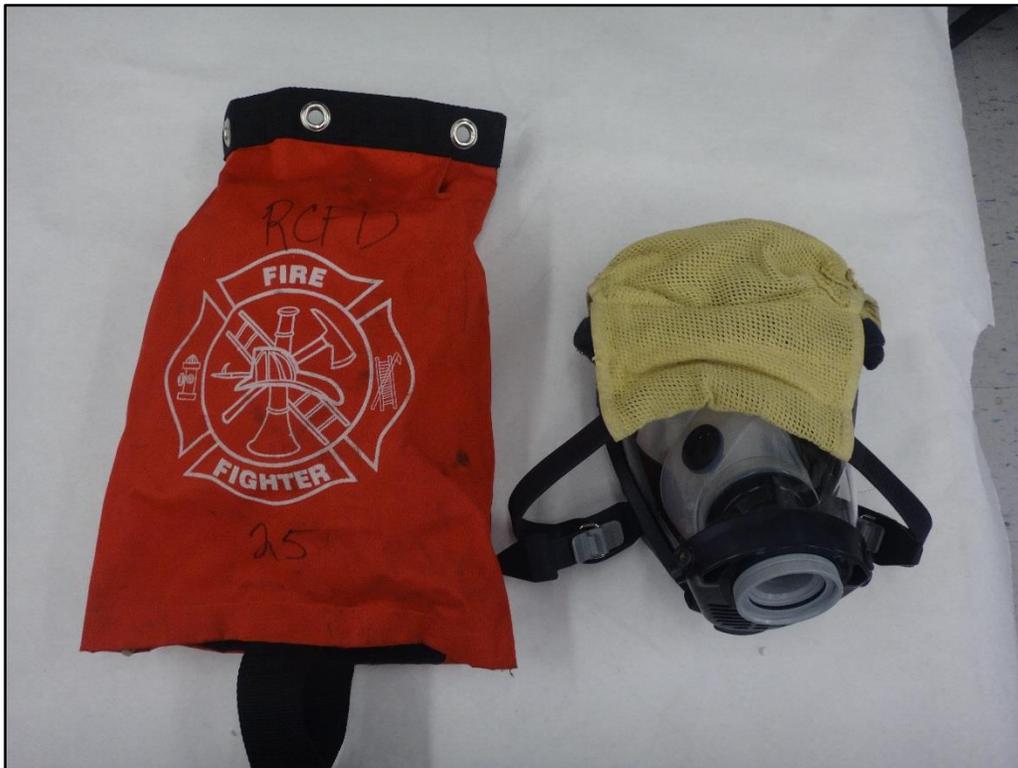
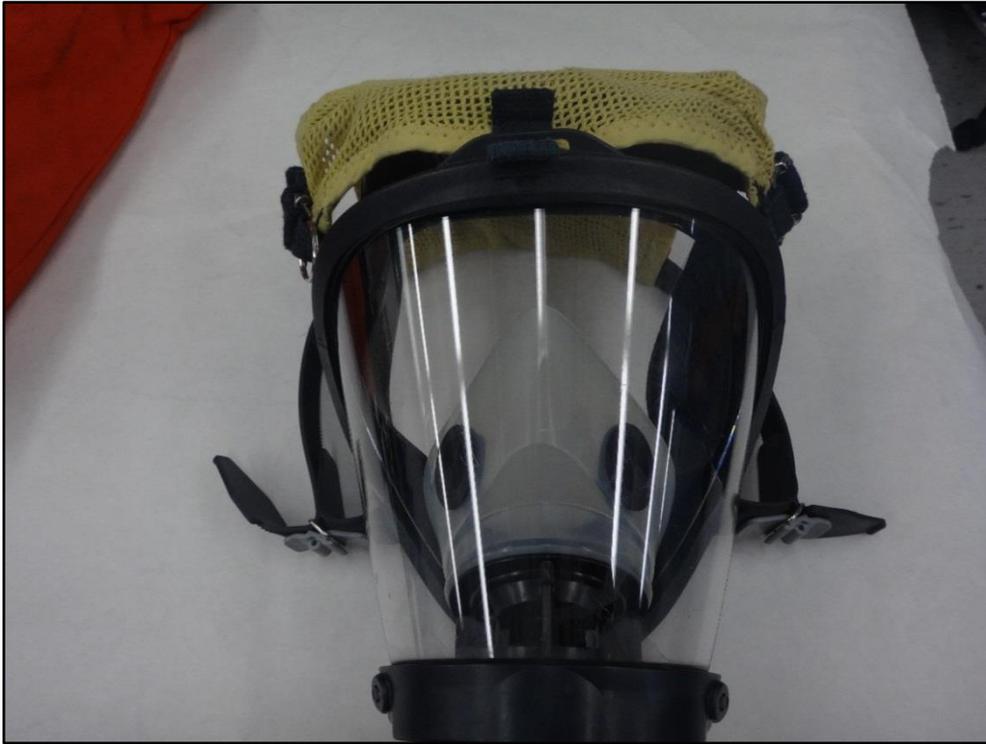
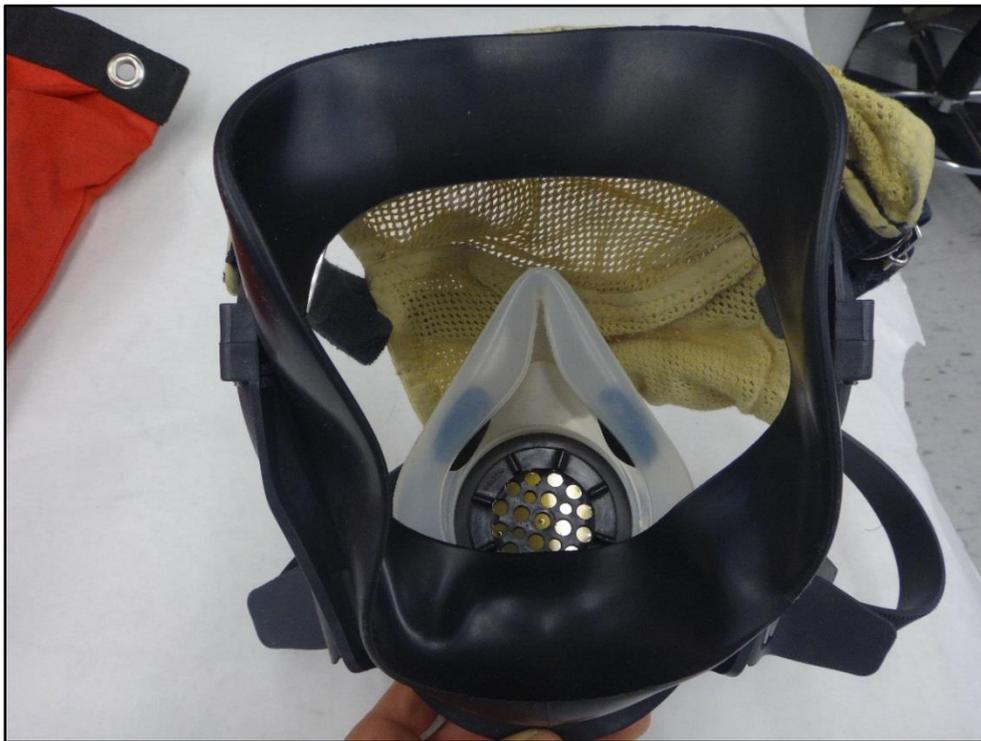
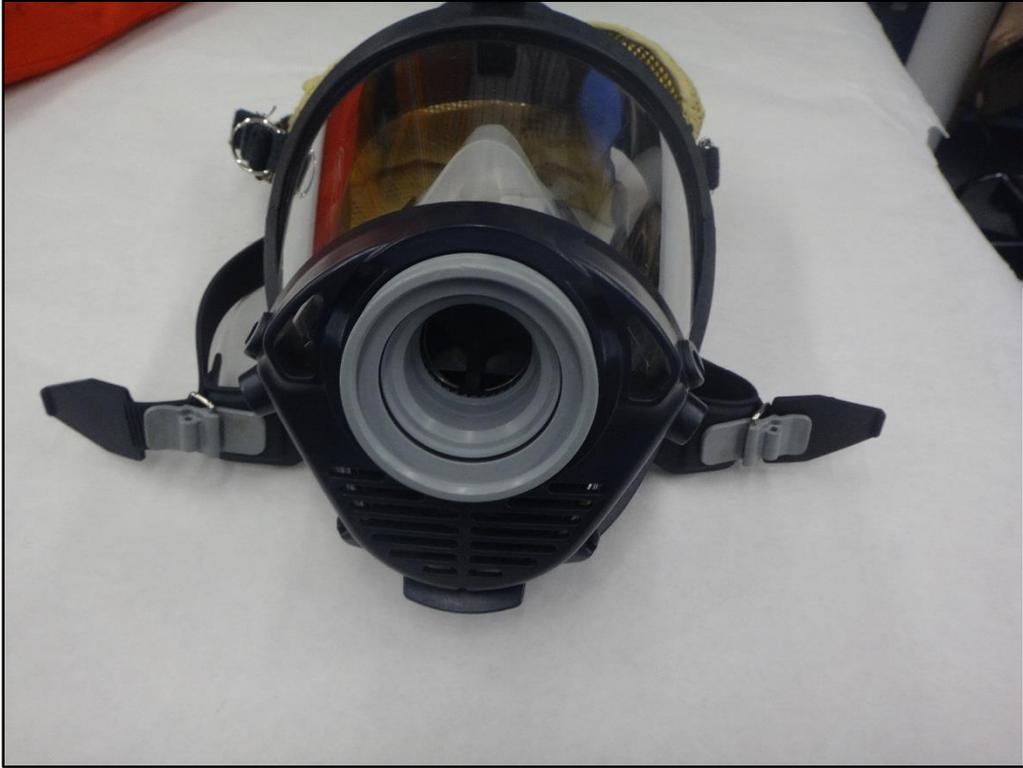
#### 1. Facepiece: (refer to **Figures 3 - 7** in **Appendix III**)

- Overall condition very good.
- Facepiece housed in a red Rock Creek Fire Department bag with “25” marked on it.

- Lens good with no scratches.
- Hairnet good.
- Hairnet straps good, straps moved freely held in place, and held securely to facepiece.
- Attachment points for straps good.
- The facepiece skirt in excellent condition.
- Regulator interface area good, with no debris.

**Figure 3: Facepiece in bag.**

**Figure 4: Facepiece out of bag.**

**Figure 5: Top view of facepiece.**

**Figure 6: Inside view of facepiece, skirt, and nosecup.**

**Figure 7: Bottom view of facepiece.**

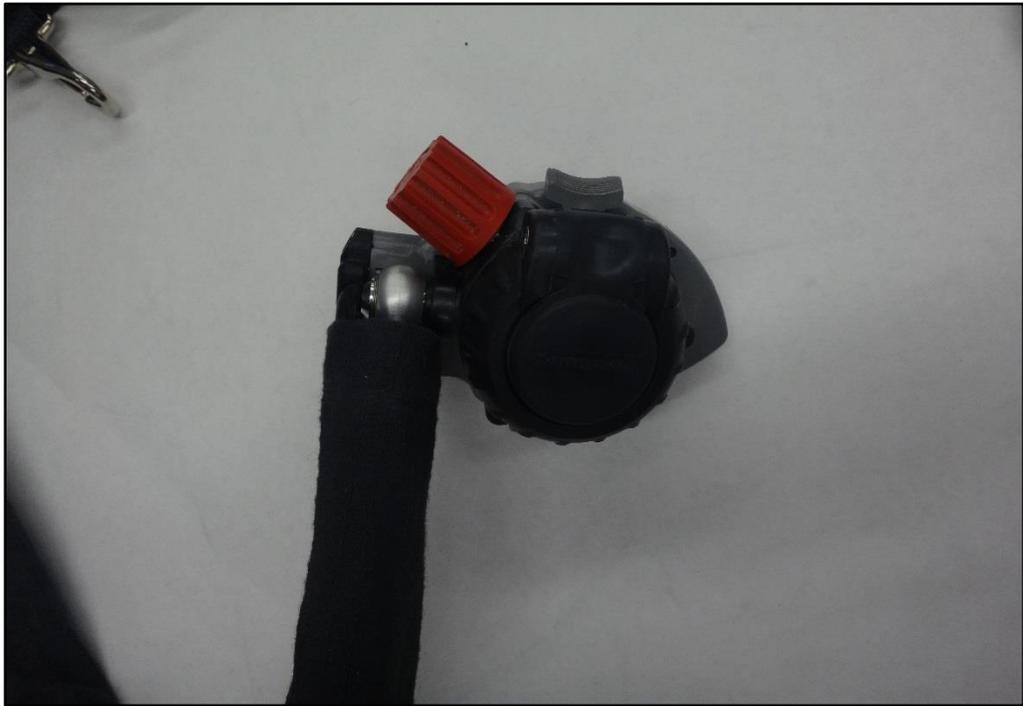
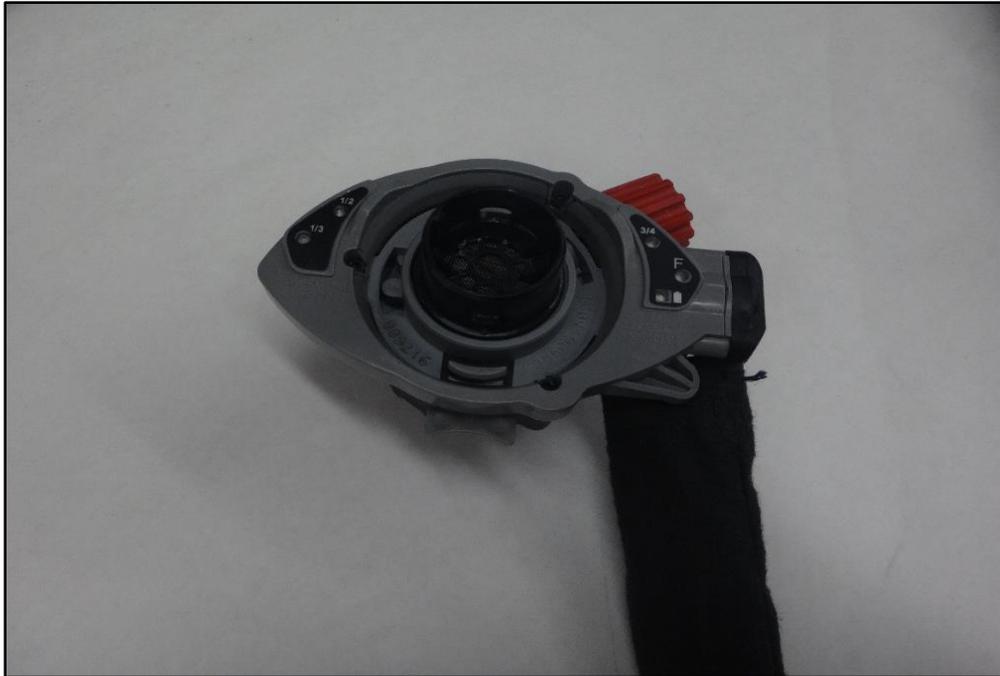
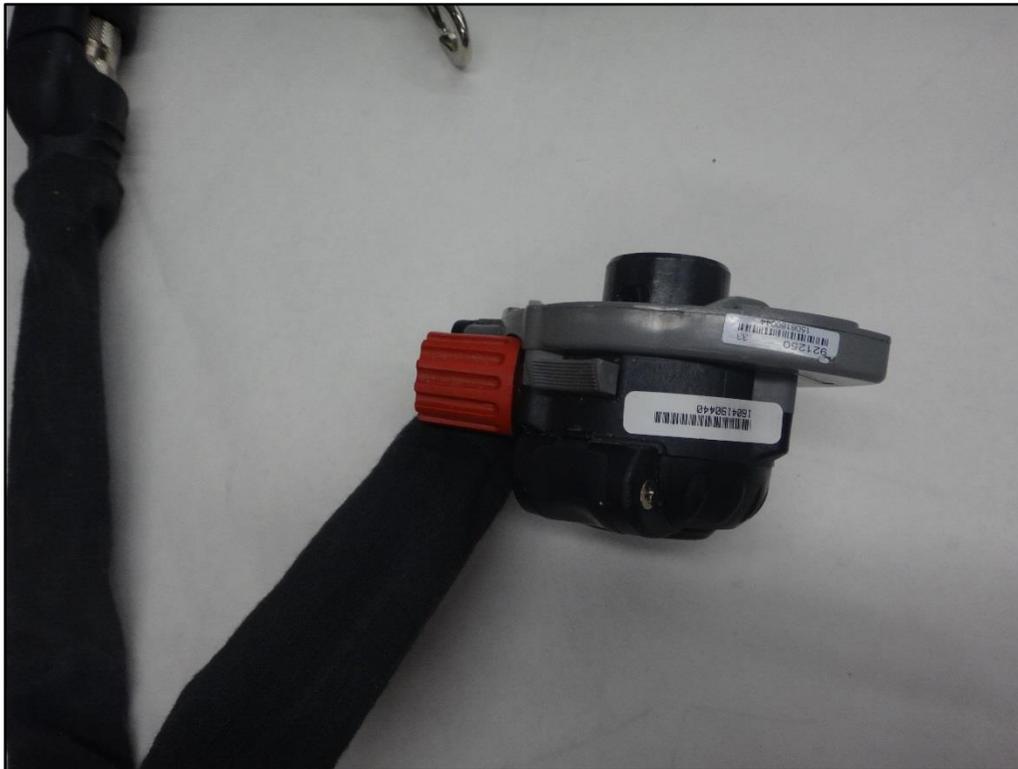
**2. Mask Mounted Regulator (MMR): (refer to **Figures 8 - 10** in **Appendix III**)**

- Overall condition good, with no sign of heat damage.
- Outer case in good condition and front label legible.
- Donning switch in good condition.
- Quick Disconnect present and attached.
- Bypass open, bypass knob in excellent shape.
- Inside flange had minimal scratches, clean.
- Sealing area mostly clean and in excellent shape.
- Regulator could be attached and removed.
- Locking assembly functioned.

**Figure 8: Top view of MMR.**

**Figure 9: Bottom view of MMR.**

**Figure 10: MMR side view and labels.**

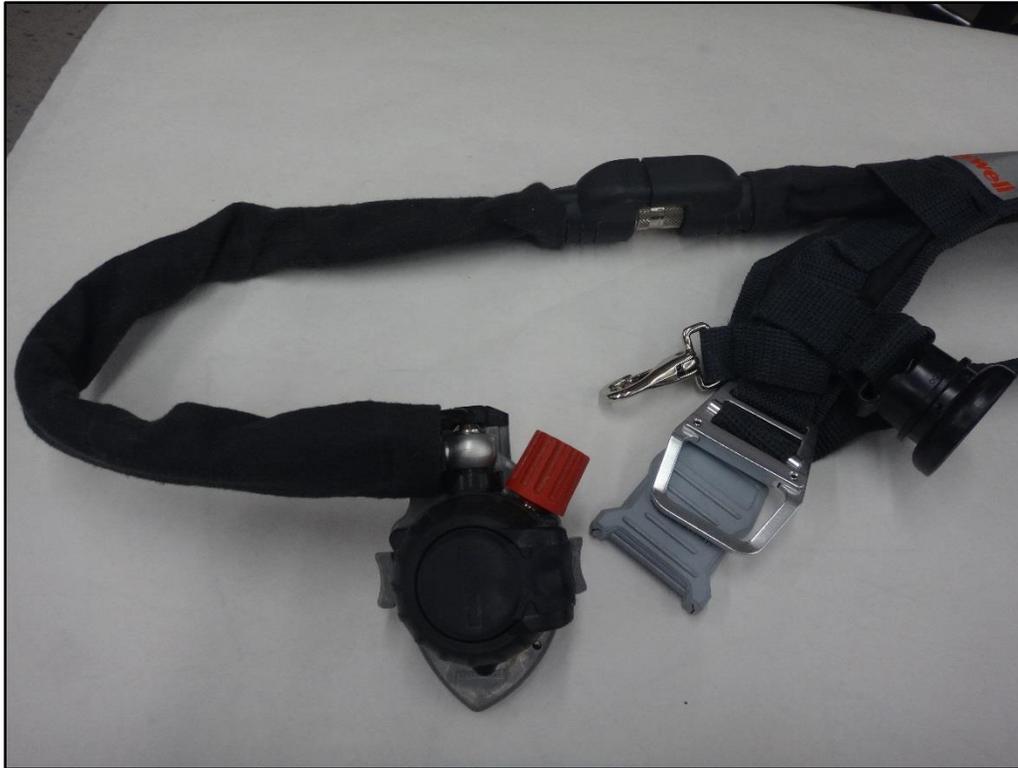
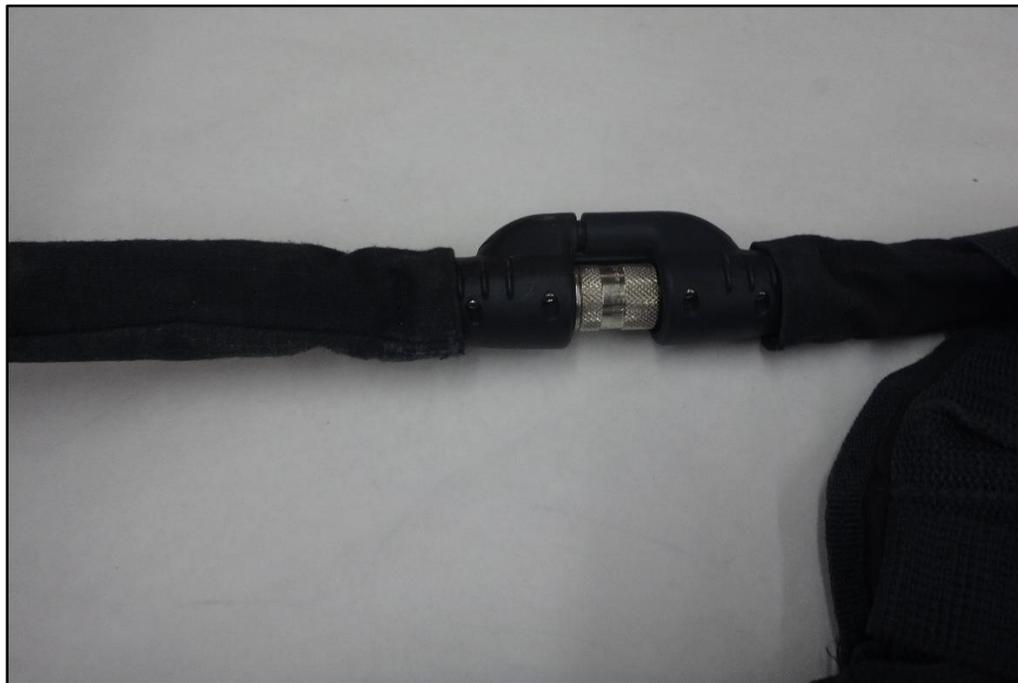
**3. Low Pressure Regulator Hose: (refer to **Figures 11 and 12** in **Appendix III**)**

- Overall condition excellent.
- Attached to unit at Quick Disconnect
- Quick Disconnect in good condition and functioned.
- Line ran through the shoulder strap to the pressure reducer.

**Figure 11: Low pressure line.**

**Figure 12: Quick Disconnect on low pressure line.**

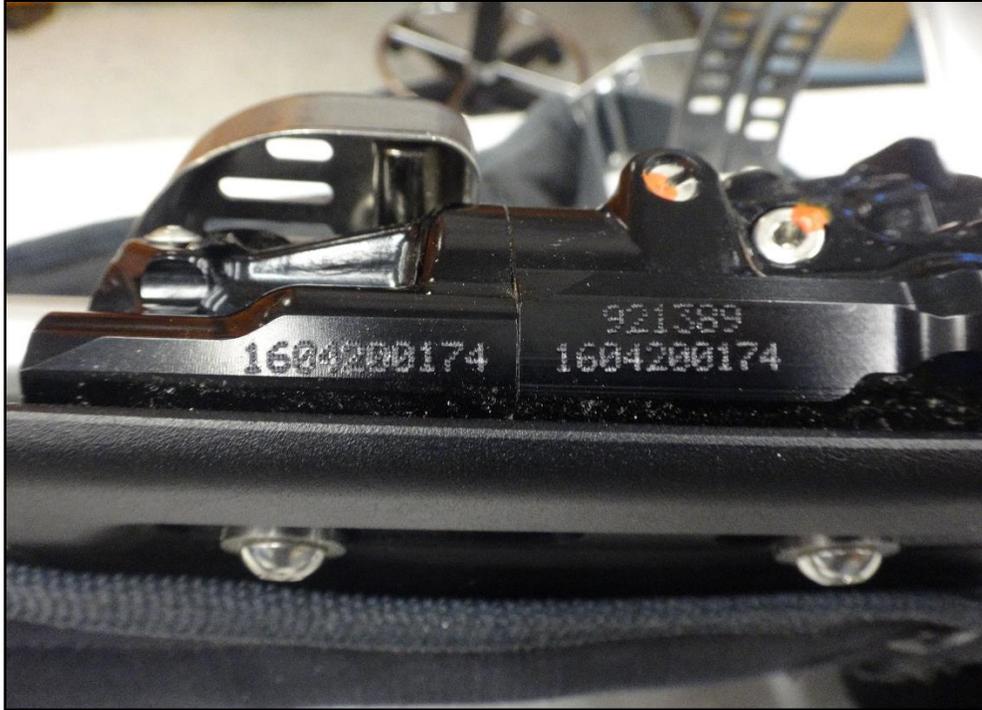
**4. Pressure Reducer Assembly: (refer to **Figures 13 - 15** in **Appendix III**)**

- Overall condition good.
- All air-line connections secured with no sign of heat damage.
- Low pressure line and dual manifold assembly were in pouch and in good condition.

**Figure 15: Side view of pressure reducer with markings.**

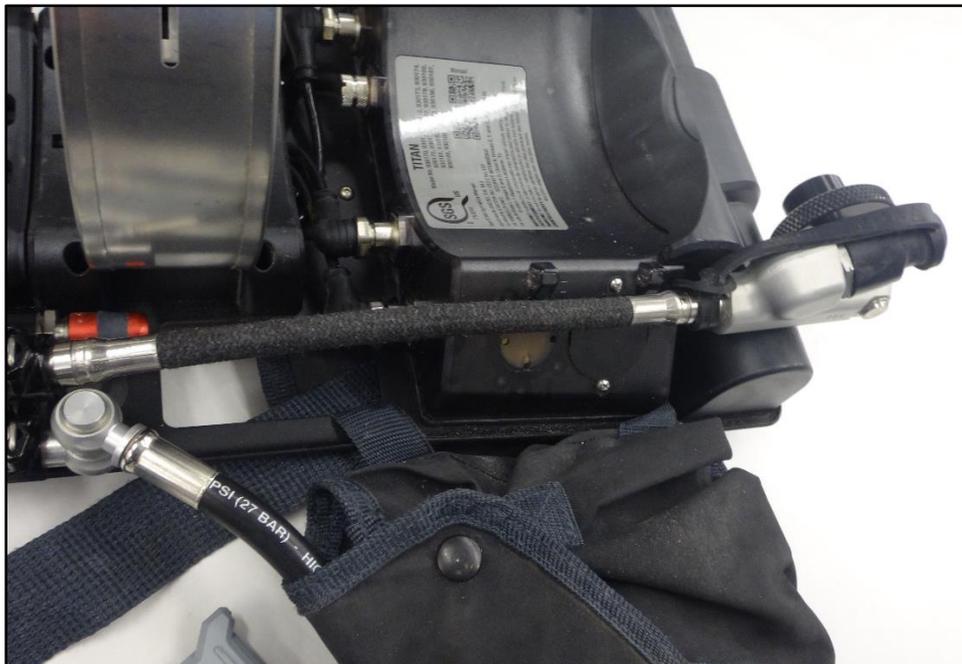
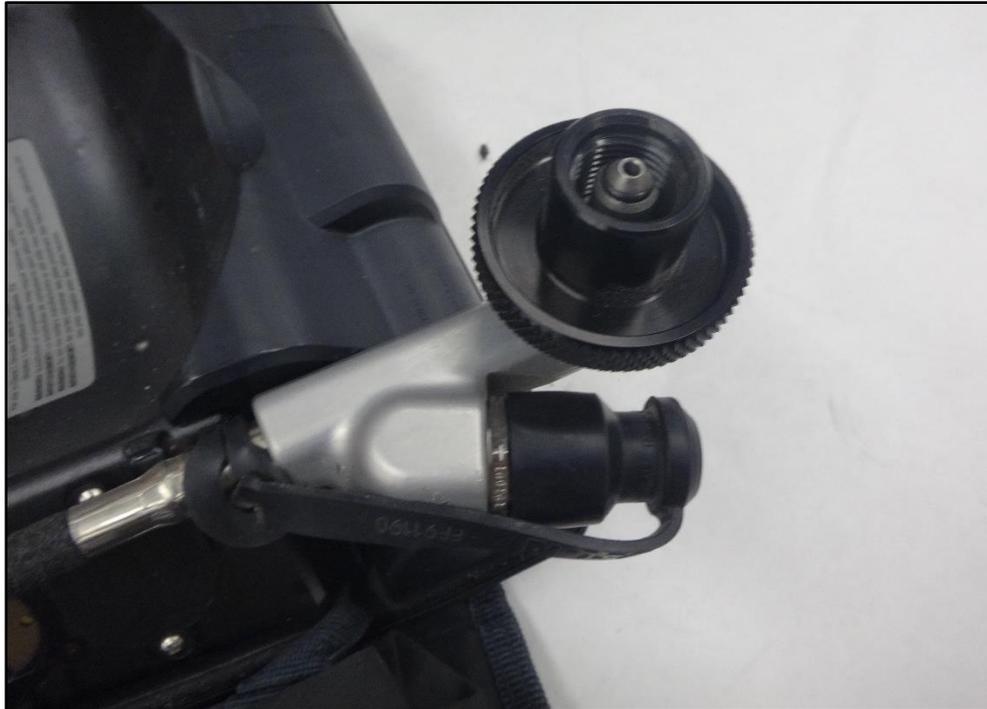
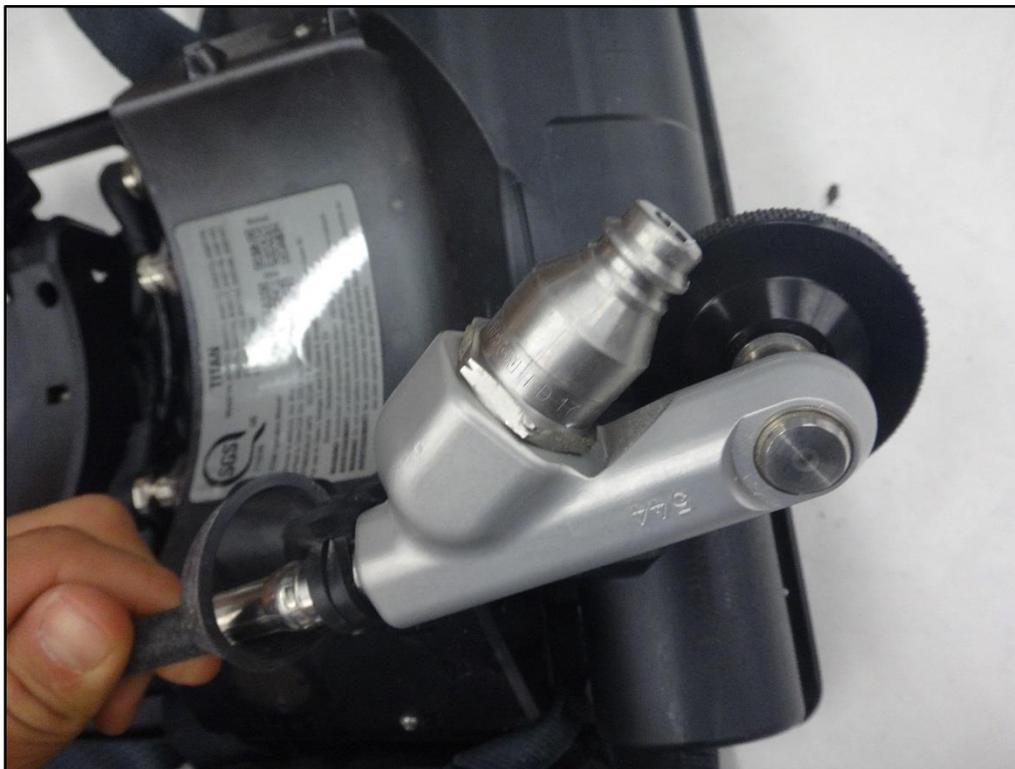
**5. High Pressure Hose and Cylinder Attachment: (refer to **Figures 16 - 18** in **Appendix III**)**

- Overall condition good.
- Cylinder attachment thread clean, threads on and off, and “O” ring was in place.
- Quick-Fill cover in good condition, connection clean.

**Figure 16: High pressure line.**

**Figure 17: Cylinder attachment and threads.**

**Figure 18: Quick-Fill port.**

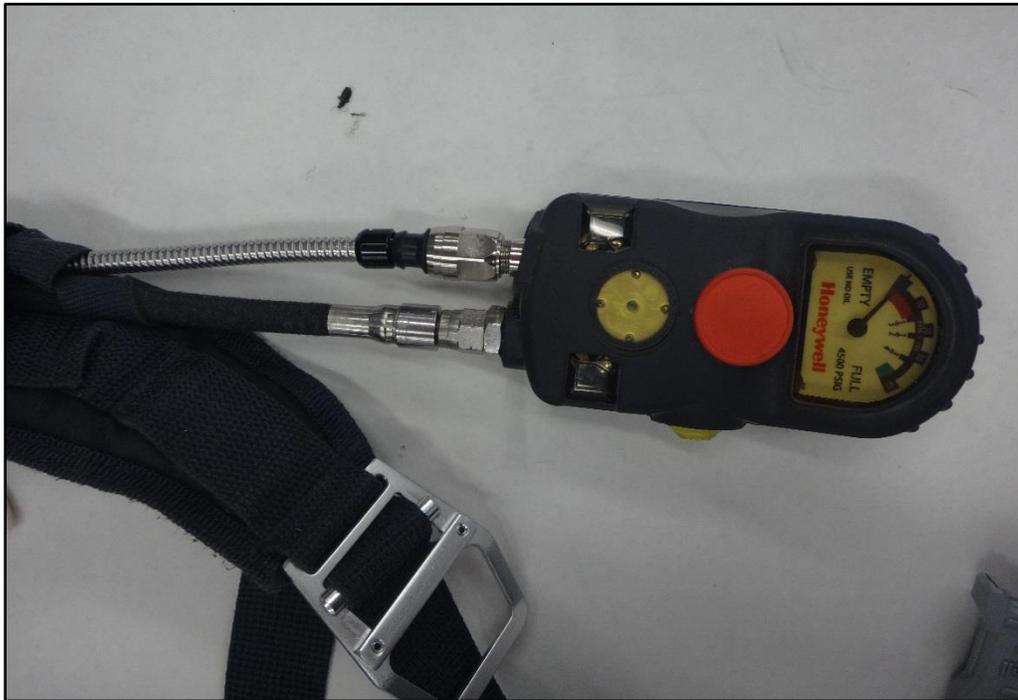
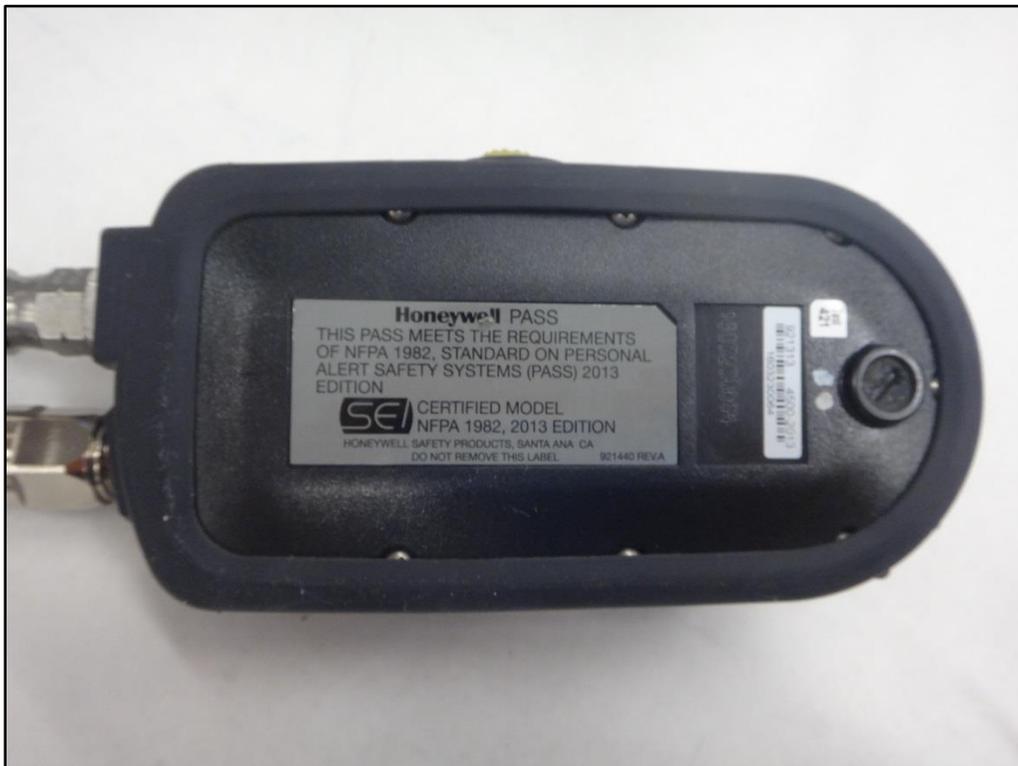
**6. Console Assembly PASS: (refer to **Figures 19 and 20** in **Appendix III**)**

- Overall condition good.
- Pressure and electrical lines in good condition.
- Gauge lens good and readable.
- Protective casing good.
- Rubber attachment strap present, attached to the PASS console and shoulder strap.
- SEI label present.

**Figure 19: PASS console.**

**Figure 20: Back view of PASS console.**

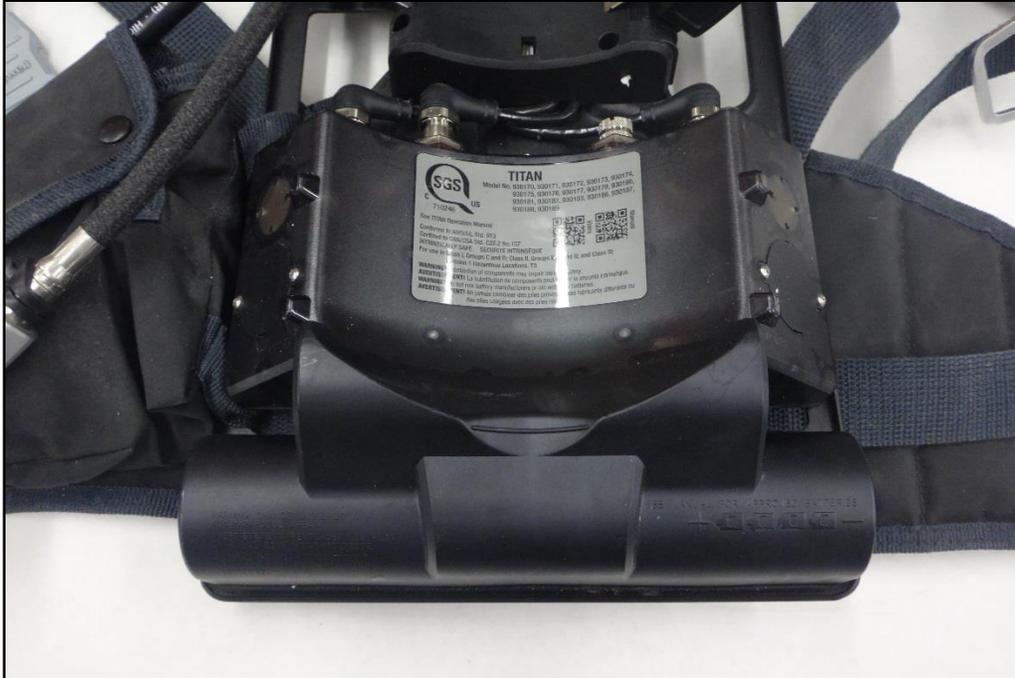
**7. PASS Control Module: (refer to **Figure 21** in **Appendix III**)**

- Overall condition good.
- Held securely to backframe.
- Wire connection connected to PASS.
- Wire held secure to backframe and ran to console assembly.

**Figure 21: PASS control module.**

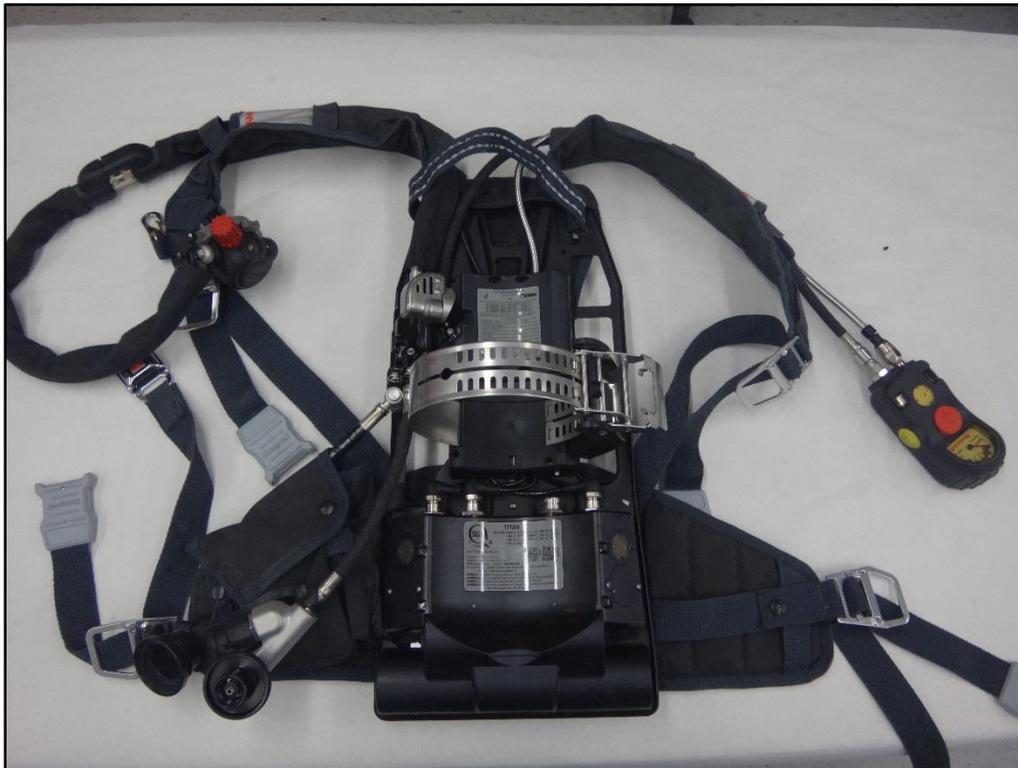
**8. Backframe Assembly: (refer to **Figures 22 - 24** in **Appendix III**)**

- Overall good condition, no bends/cracks in wire frame, or plate.
- Shoulder straps attached to the frame.
- Cylinder strap latch in excellent condition and functioned.

**Figure 22: Top view of backframe.**

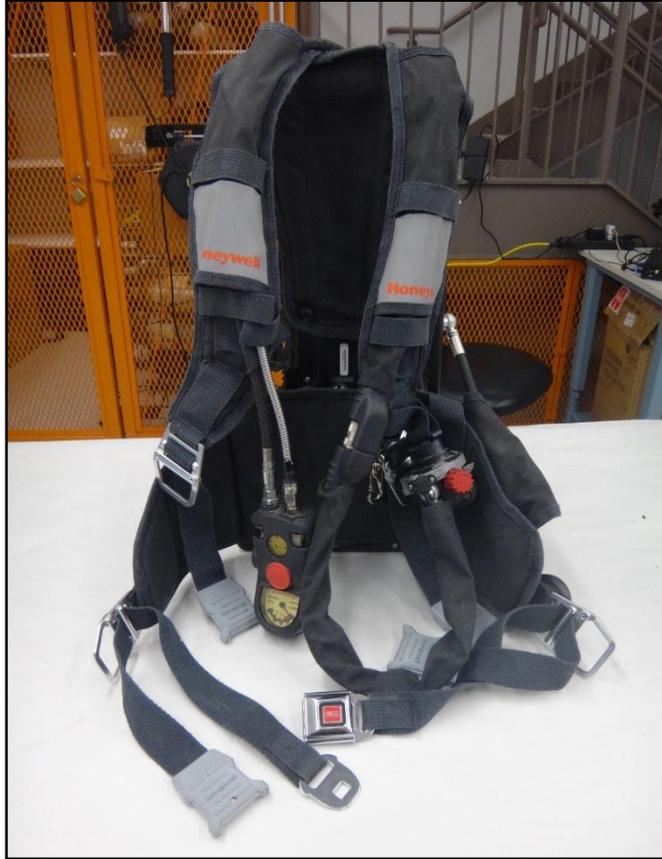
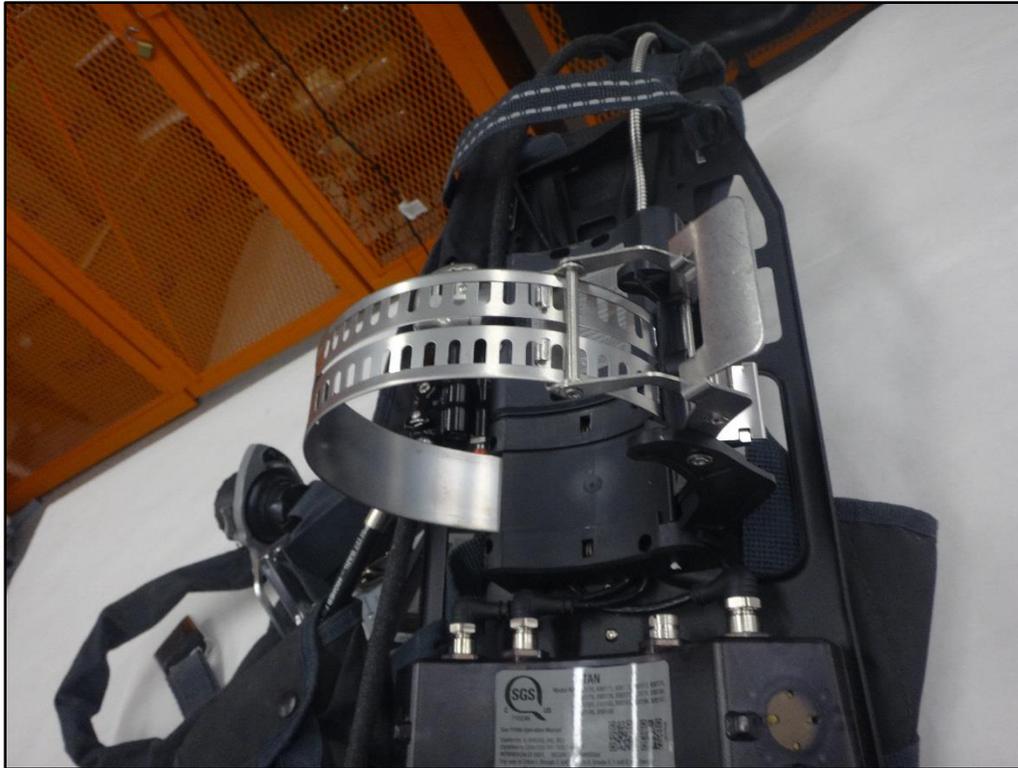
**9. Straps and Buckles: (refer to **Figure 25 and 26** in **Appendix III**)**

- Overall strap condition in excellent condition.
- Both shoulder straps attached at the top of the backframe.
- Hose lines and wires passed through shoulder straps.
- All adjustable buckles moved and held in place.
- Waist area buckle latched and released.
- Lumbar strap in good condition.

**Figure 25: View of all straps and buckles.**

**Figure 26: Cylinder strap.**

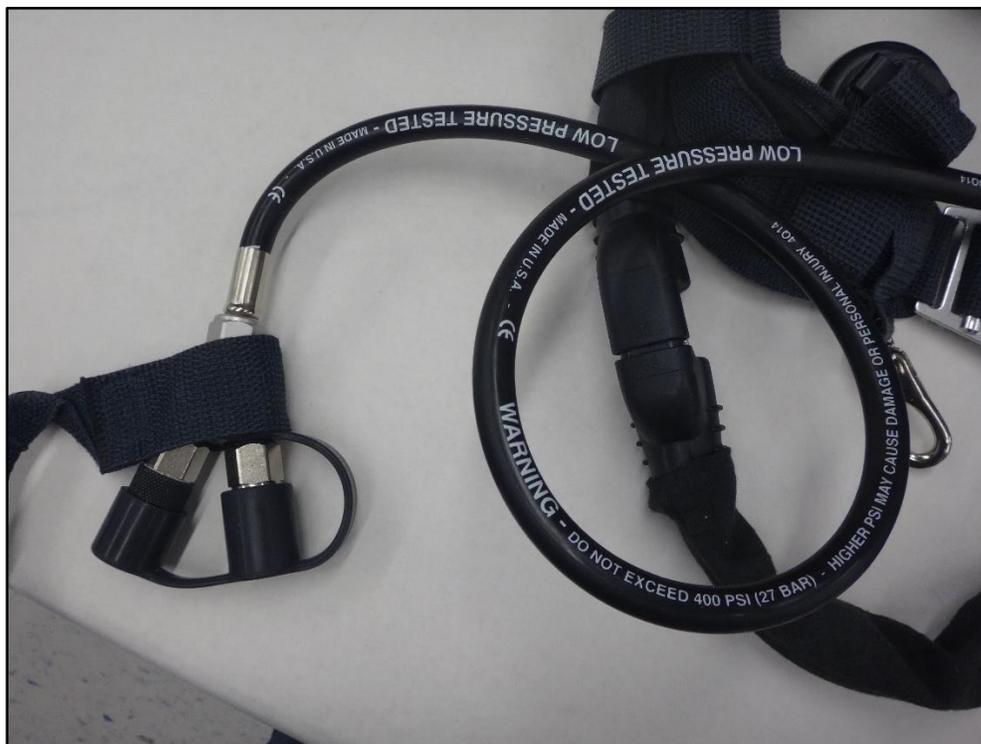
**10. Auxiliary Hose: (refer to **Figure 27** in **Appendix III**)**

- Overall condition good and rubber protective boots in good shape.
- Straps attached to covers and cylinder attachment assembly.
- Fittings clean.

**Figure 27: Auxiliary hose out of pouch.**

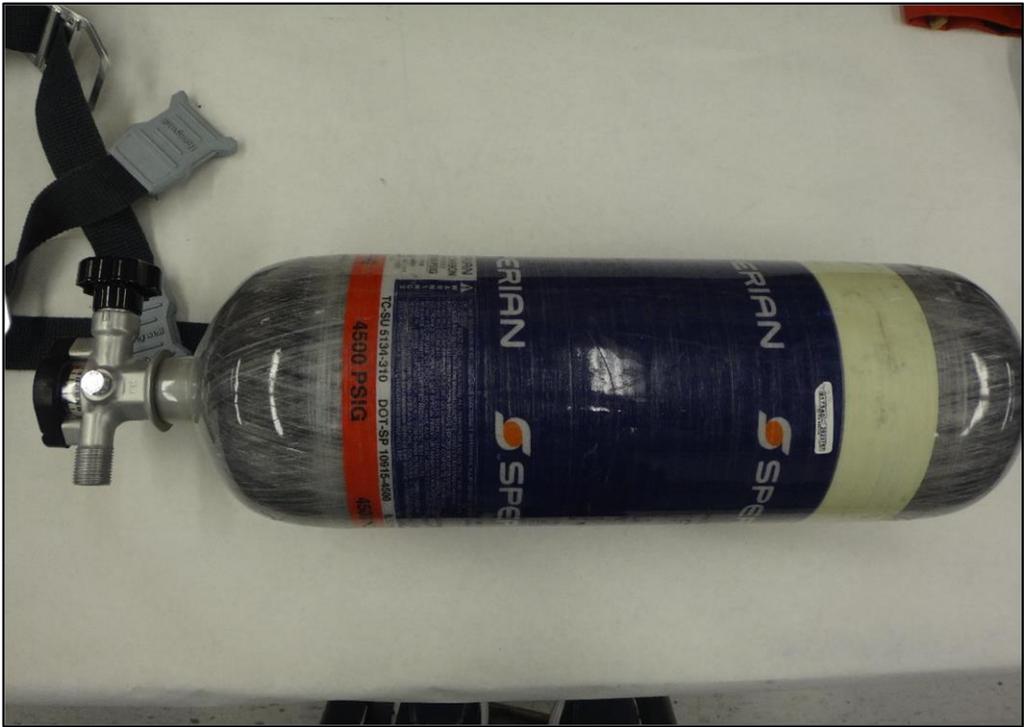
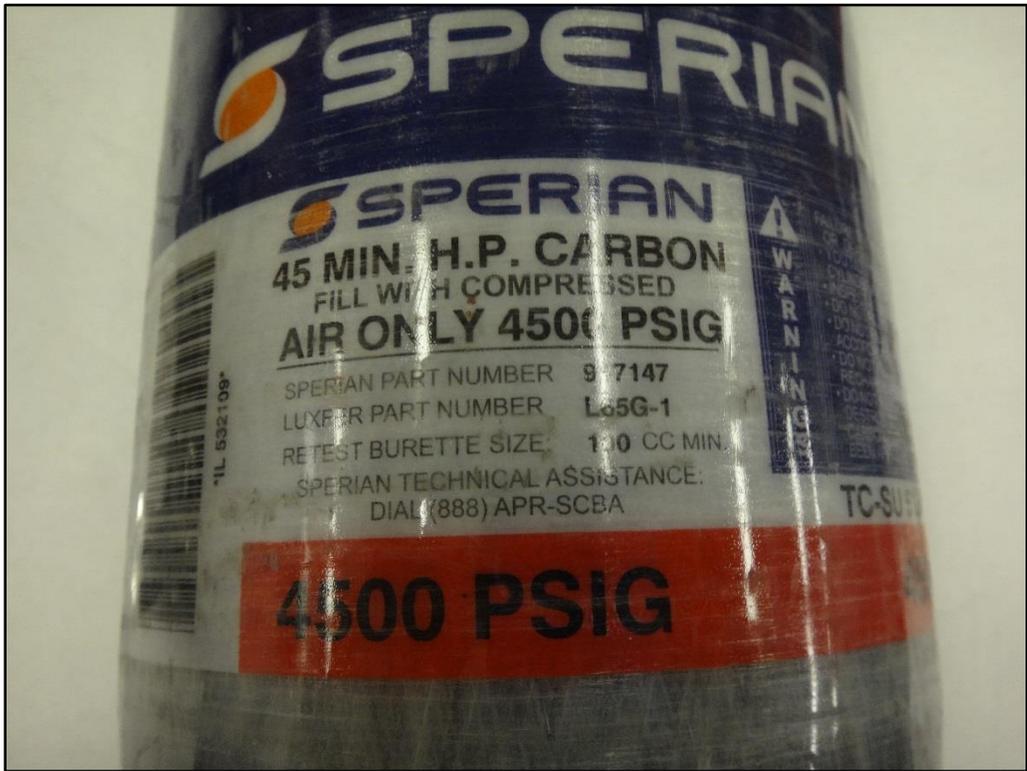
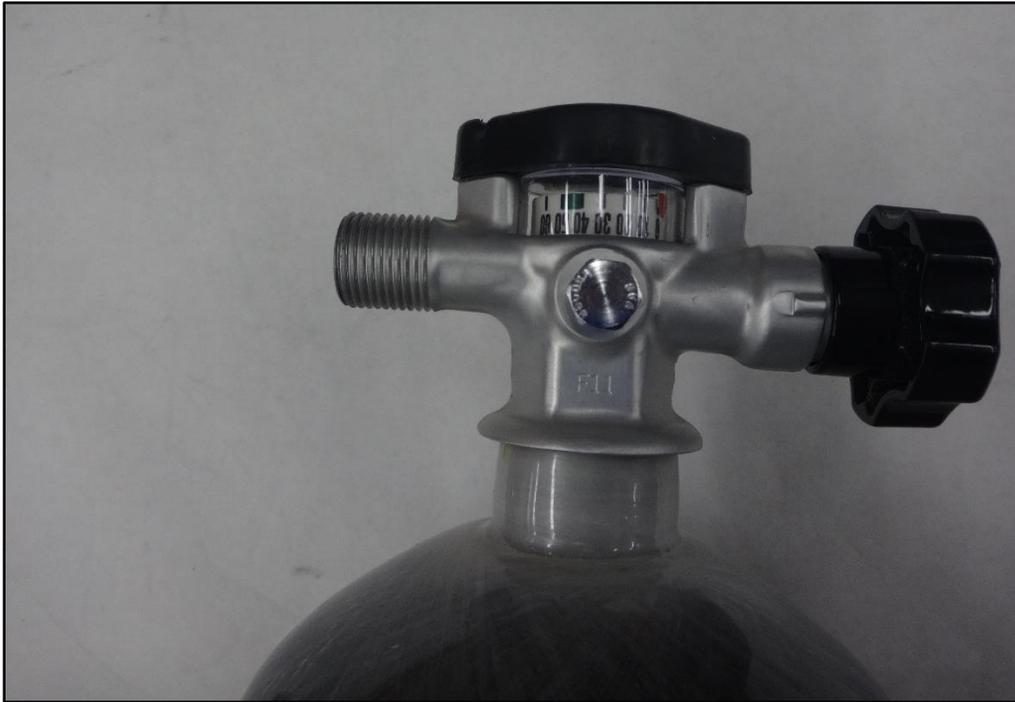
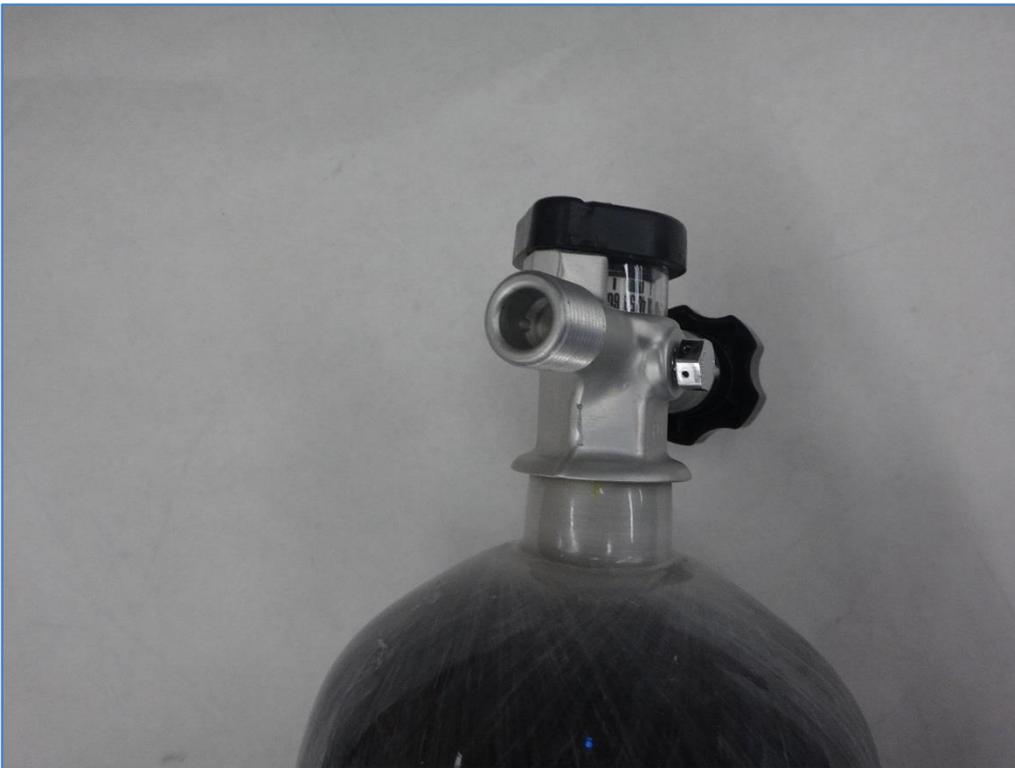
**11. Cylinder and Cylinder Valve Assembly: (refer to **Figures 28 - 31** in **Appendix III**)**

- Overall condition good.
- Gauge was readable.
- Threads clean, but some were damaged.
- As received, the cylinder was empty with valve open.
- Rubber bumper at base of cylinder valve in excellent condition.
- Markings on stem: F11, 715, 1601250206.

**Figure 28: Top view of cylinder.**

**Figure 29: Cylinder label.**

**Figure 30: Cylinder gauge and threads.**

**Figure 31: Cylinder threads.**

If this unit is to be placed back in service, the SCBA must be repaired, tested, cleaned and any damaged components replaced and inspected by a qualified service technician, including testing and other maintenance activities as prescribed by the schedule from the SCBA manufacturer. Typically a flow test is required on at least an annual basis, at a minimum.
