Personal Protective Equipment Conformity Assessment Studies and Evaluations

Evaluation of a Self-Contained Breathing Apparatus Involved in a Fatality While Operating at a Structure Fire

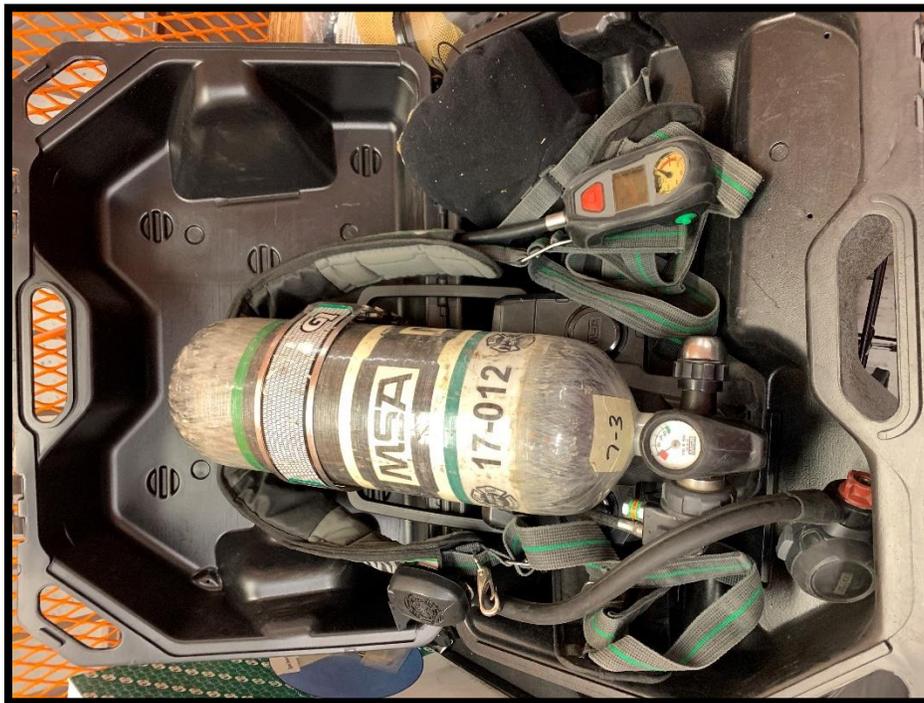
Figure 1: SCBA as received
