RI 9660 REPORT OF INVESTIGATIONS/2003

Evaluation of Systems to Monitor Blind Areas Behind Trucks Used in Road Construction and Maintenance: Phase 1

Todd M. Ruff

February 2003

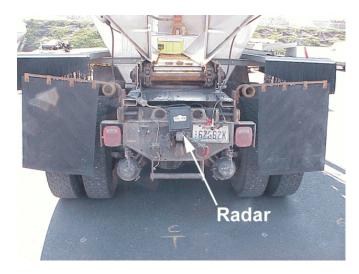
Initially, the radar unit was mounted on the sanding truck's hitch plate area on the right side of the hitch at a height of 86 cm (34 in). The alarm display was mounted on the back of the truck so the state of the display could be easily recorded during tests. Because the radar system's presence-sensing abilities do not require motion, false alarms occurred in a clear area because the system sensed the nearby hitch. False alarms also occurred when the unit was moved to a position just above the hitch (figure 6). Because of the size of the radar antenna and its sensitivity to any nearby metal, the antenna could not be mounted on the hitch plate or frame and was reinstalled at the center of the sand hopper at a height of 188 cm (74 in) (figure 7). The radar was tilted downward 20° to improve detection of a person close to the truck. At this mounting position, no false alarms occurred when the truck was moved in reverse in a clear area.

To determine the detection zone for a person, the test subject walked toward the rear of the sanding truck and recorded where reliable detection occurred (figure 8). The test subject then remained stationary while the truck was moved slowly (3-5 km/hr [2-3 mile/hr]) in reverse. No significant changes were seen in the detection zone. The range for both scenarios was 7.6 m (25 ft), and the width of the detection zone was adequate to detect a person standing 30 to 60 cm (1 to 2 ft) away from the outer edge of the rear tires. However, at this mounting

Figure 6.—Preview radar system temporarily mounted above hitch on sanding truck.

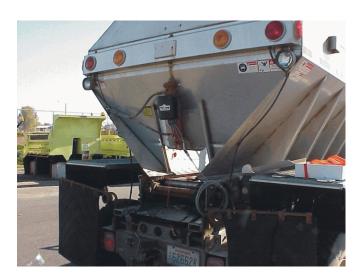
Figure 7.—Preview radar system mounted on sand hopper.

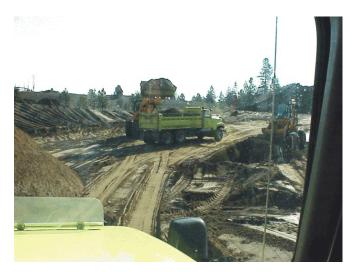
Most of the tests were conducted at a site where the ground was being leveled for the relocation of high-capacity power lines in preparation for a new highway (figure 16). The haulage road surface and material being moved consisted mostly of sand. Moisture content of the sand varied according to weather, but a water truck kept most of the haulage roads damp to reduce dust. The dump truck was loaded by a front-end loader and then driven to the dump area. Each truck traveled between 50 and 70 round trips in a workday. Truck drivers' comments on the radar system are summarized below.

- The radar system was useful in that it prompted the driver to check the camera system's video monitor, but most often the alarms were caused by items that posed no danger, e.g., sand piles or other equipment of which the driver was already aware.
- Very few false alarms were heard, i.e., alarms generated for no apparent reason.
- The radar system was reliable in detecting and displaying an approximate distance to the sand pile when backing to the dump point.
- The mounting bridge caused the loader operator to slow down to avoid hitting the bridge during loading.

Figure 16.—Summer test site.

• The mounting bridge was too high and would not pass under the asphalt loading bin in later tests. This truck could not be used for paving projects.

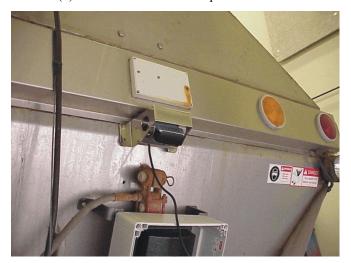
The camera system had similar problems as the radar when driving on the road during the winter months. Ice, snow, and mud build-up on the camera caused several problems. Initially, the motorized lens shield on the camera was left in the open position for forward and reverse gears. This was requested so the driver could monitor vehicles behind the truck during sanding and plowing operations. After the first few days of operation, it was necessary to change this configuration so the lens shield closed when the truck was in forward gear, allowing the camera view to be activated only in reverse. This was because (1) mud and snow build-up on the lens occurred

Figure 17.—Clarion camera mounted on back of sand hopper.

because (1) mud and snow build-up on the lens occurred quickly in forward gear (figure 18), obstructing the camera view, and (2) glare from headlights distracted the driver during night operations. After this change was made, the camera system operated reliably on warmer days. However, in snowy conditions, ice and snow quickly covered the camera when traveling forward. This caused the lens shield to become frozen in the closed position, making the camera unusable even in reverse. After a few days of operating under these conditions, the lens shield mechanism failed and was stuck in the closed position even after snow and ice were cleared from the camera. A heated camera enclosure or some other method to keep snow and ice from building up on the camera would be required before using this system on a sanding truck.

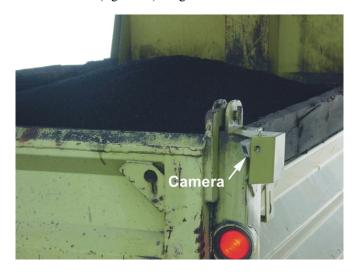
The Intec camera was permanently mounted on the right side of the dump box just above the highest taillight at a height of 2.2 m (87 in) and a downward tilt angle of 20° (figure 21). The video monitor was mounted on a pedestal between the seats in the cab (figure 22). Figure 20 shows the FOV of the

Figure 21.—Final installation of Intec camera on dump truck.

camera for both a standing and a crouching person. Tests were conducted during the summer months at patching/paving jobs and during other various road construction and maintenance activities. No evaluation forms were turned in, but driver interviews were held in which the drivers commented that the system worked well and was effective in monitoring the rear blind area. However, they also commented that the view from the camera was sometimes confusing because the camera did not point in the same direction that the truck traveled when in reverse.

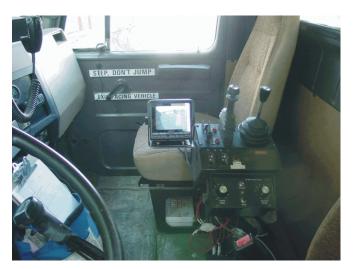
Figure 22.—Intec monitor installed in truck cab.

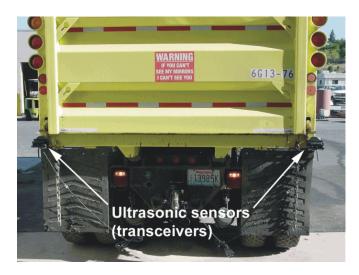
As suggested by the manufacturer, the two sensors were temporarily mounted on the lower corners of the dump truck's box (just below the tailgate hinge points) as shown in figure 23. The alarm was situated at the rear of the truck for easy viewing for these initial tests. Several problems were seen with this mounting configuration, including the potential for damage to the sensors when material flowed through the tailgate and the lack of continuous detection of a crouching person behind the truck, as shown by the dashed lines in figure 24.

Figure 23.—Hindsight sensors mounted on dump box for short-term test.

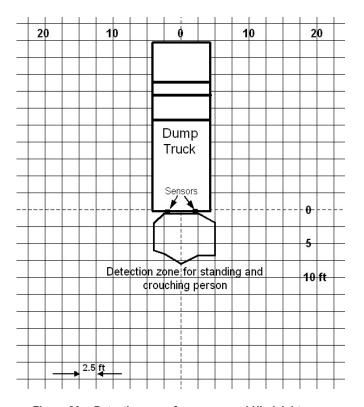
An alternative mounting position for the sensors was tested (figure 25). This placed the sensors on the hitch plate and closer together, which resulted in a more continuous detection zone for a person, as seen in figure 26. The total range of the system was 2.4 m (8 ft), and detection covered most of the width of the truck except the corners of the dump box. The system did not generate false alarms in a clear area on asphalt, and the mud flaps were not detected. Despite the short detection range, long-term tests on a dump truck were conducted.

Figure 26.—Detection zone for person and Hindsight sensors mounted on hitch plate.
