Evaluation of a Self-Contained Breathing Apparatus

Involved in a Near Miss in the Fire Service

Birmingham Alabama Fire Department Request for a Scott® Safety Air-Pak® Model 4.5 unit

NIOSH Task Number 21002

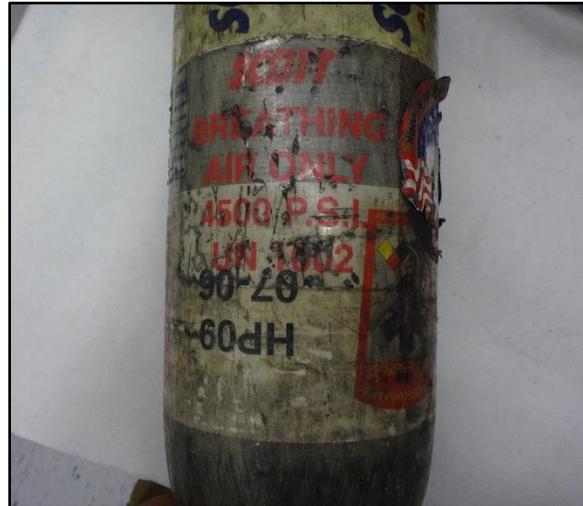
Figure 25: Identifying information on cylinder.

- Overall condition fair but scratched.
- Gauge was legible.
- Threads in good condition.
- As received, cylinder was empty with valve fully closed.
- Rubber bumper at base of cylinder valve was in good condition.
