RI 9656

Self-Contained Self-Rescuer Field Evaluation: Seventh-Phase Results

**Self-Contained Self-Rescuer Field Evaluation:
Seventh-Phase Results**

March 2002

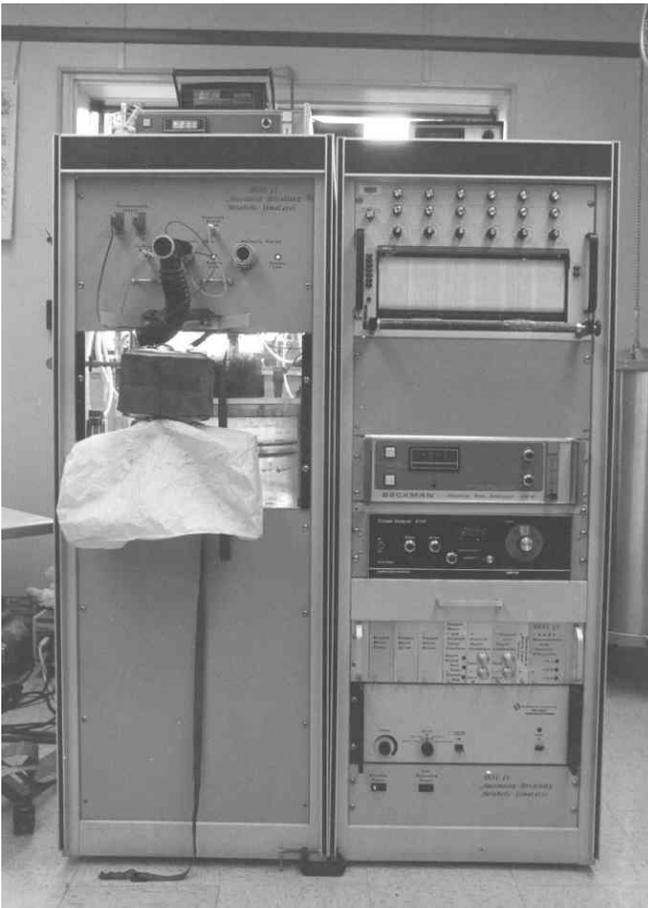
Figure 1.—Breathing and metabolic simulator.

This study involves testing approximately 100 SCSRs in each phase. This report describes findings in the seventh phase of testing from May 1999 to August 2000. Previous reports describe phases 1 through 6 [Kyriazi et al. 1986; Kyriazi and Shubilla 1992, 1994, 1996, 2000]. Ninety percent of the apparatus were tested on a breathing and metabolic simulator (BMS) (figure 1) and 10% on human subjects on a treadmill.

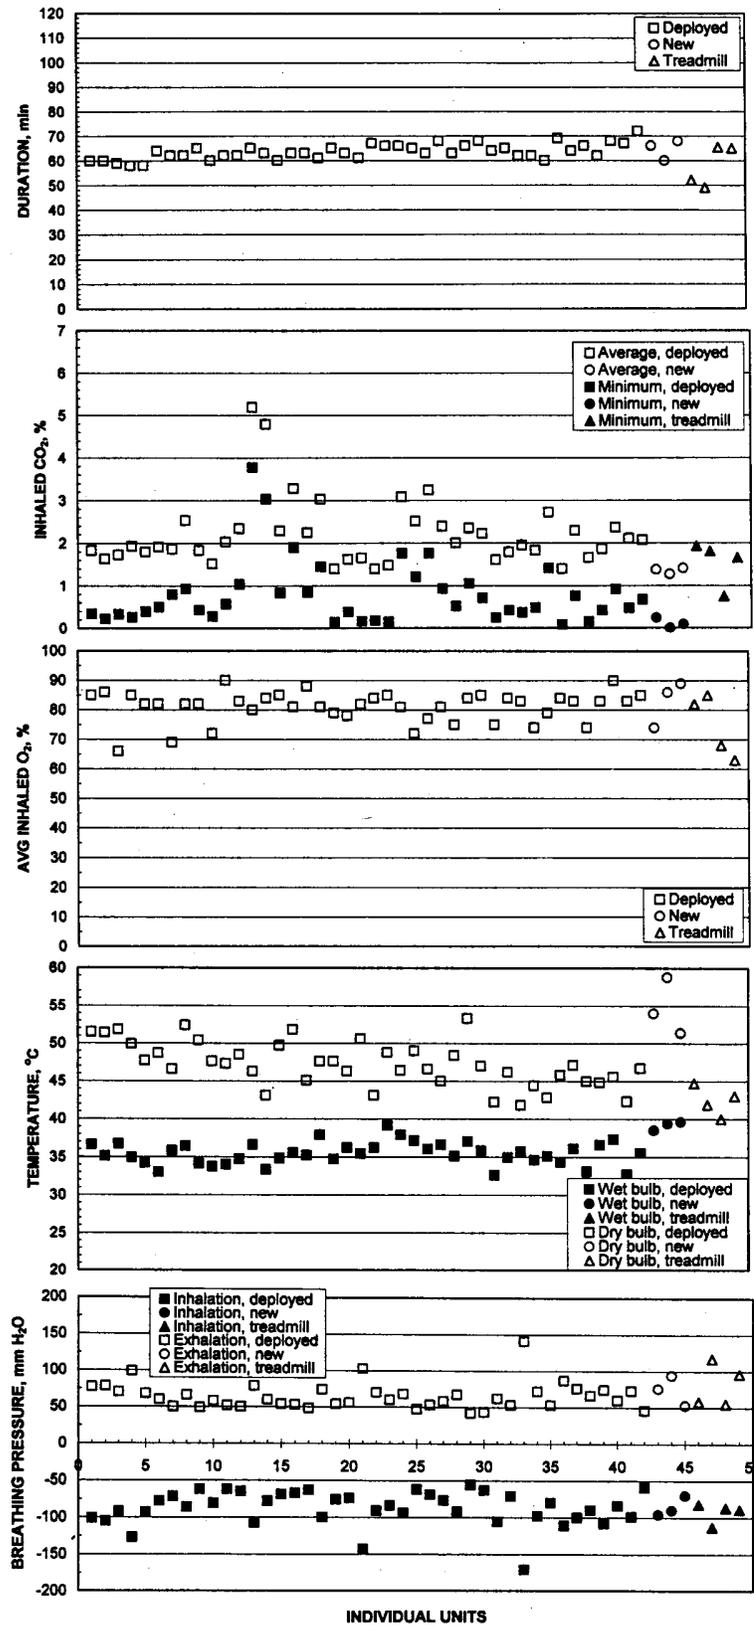
Figure 7.—CSE SR-100 test results.

Experience with each model of apparatus is discussed separately. The minute-average values of the monitored stressors were averaged over the entire test duration and are presented graphically (figures 7-11) for each apparatus by stressor. The values for new units tested on the BMS can be compared with those for deployed units tested on the BMS and, to some extent, with those for deployed units tested on human subjects on a treadmill, which are plotted afterward. Because human subjects may differ from each other and from the BMS in terms of CO₂ production rate, ventilation rate, and respiratory frequency, all of which affect apparatus duration as well as all of the monitored stressors, treadmill tests cannot be considered equivalent to the BMS tests even though the O₂ consumption rate is the same. Missing data points for wet-bulb temperature indicate equipment malfunction or inability to instrument apparatus.

As in the previous two phases, the Wilcoxon rank-sum test [M=3; N=21] for average inhaled CO₂ showed a significant difference between new and deployed units, with deployed units having higher values than new ones (table 3). CSE's noise test, developed to detect bed degradation, was not being used at the mines during the collection of all the apparatus in this phase of testing. Therefore, some apparatus were collected that had noise levels that would have required them to be removed from service. They were tested anyway to see how they performed. In general, the higher the decibel level, the higher the CO₂ level; however, the correlation coefficient was only 0.51 in this phase versus 0.85 for 17 apparatus tested in the previous phase. We have no explanation for this disparity at present but, for the apparatus tested here, only when decibel levels were under 34 was one guaranteed that average inhaled CO₂ levels would remain under 4% during the life of the unit (figure 12).

Table 4 shows that 15 of 42 apparatus tested on the BMS experienced CO₂ breakthrough before expenditure of the O₂ supply; 11 of these occurred before 60 min. None of the new units experienced premature breakthrough. The response to high inhaled levels of CO₂ will be increased ventilation rates in most users. Increased ventilation rates will result in higher breathing pressures experienced by the user. Breathing resistance in the SR-100 increases rapidly toward end-of-life even in new apparatus, and elevated CO₂ levels will only add to this.

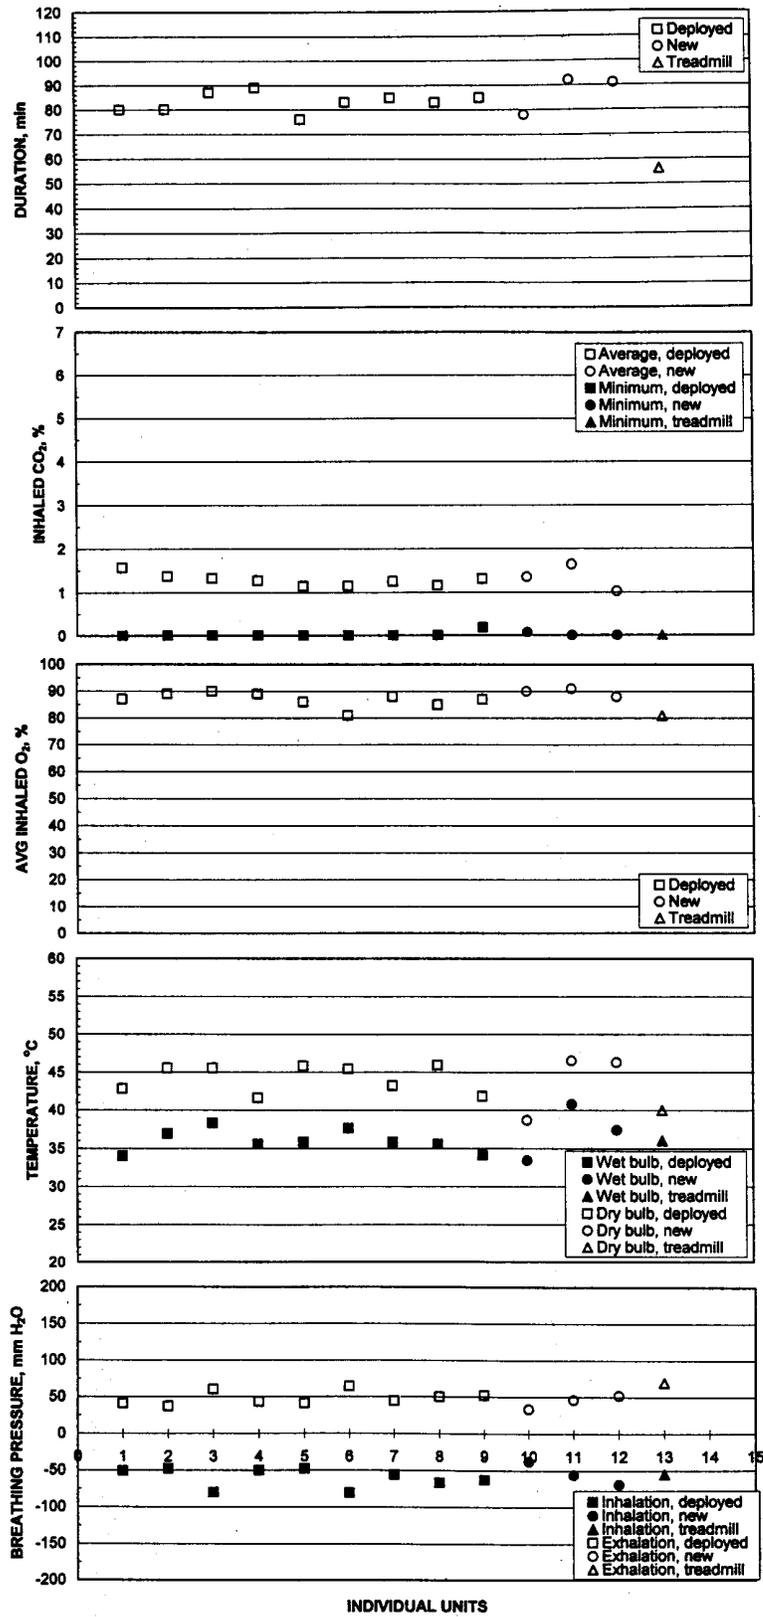
Figure 8.—Draeger OXY K-Plus test results.

The Wilcoxon rank-sum tests [M=3; N=9] for the Draeger show that new units could not be distinguished from deployed units in any measured parameter.

No deployed or new units experienced CO₂ breakthrough.

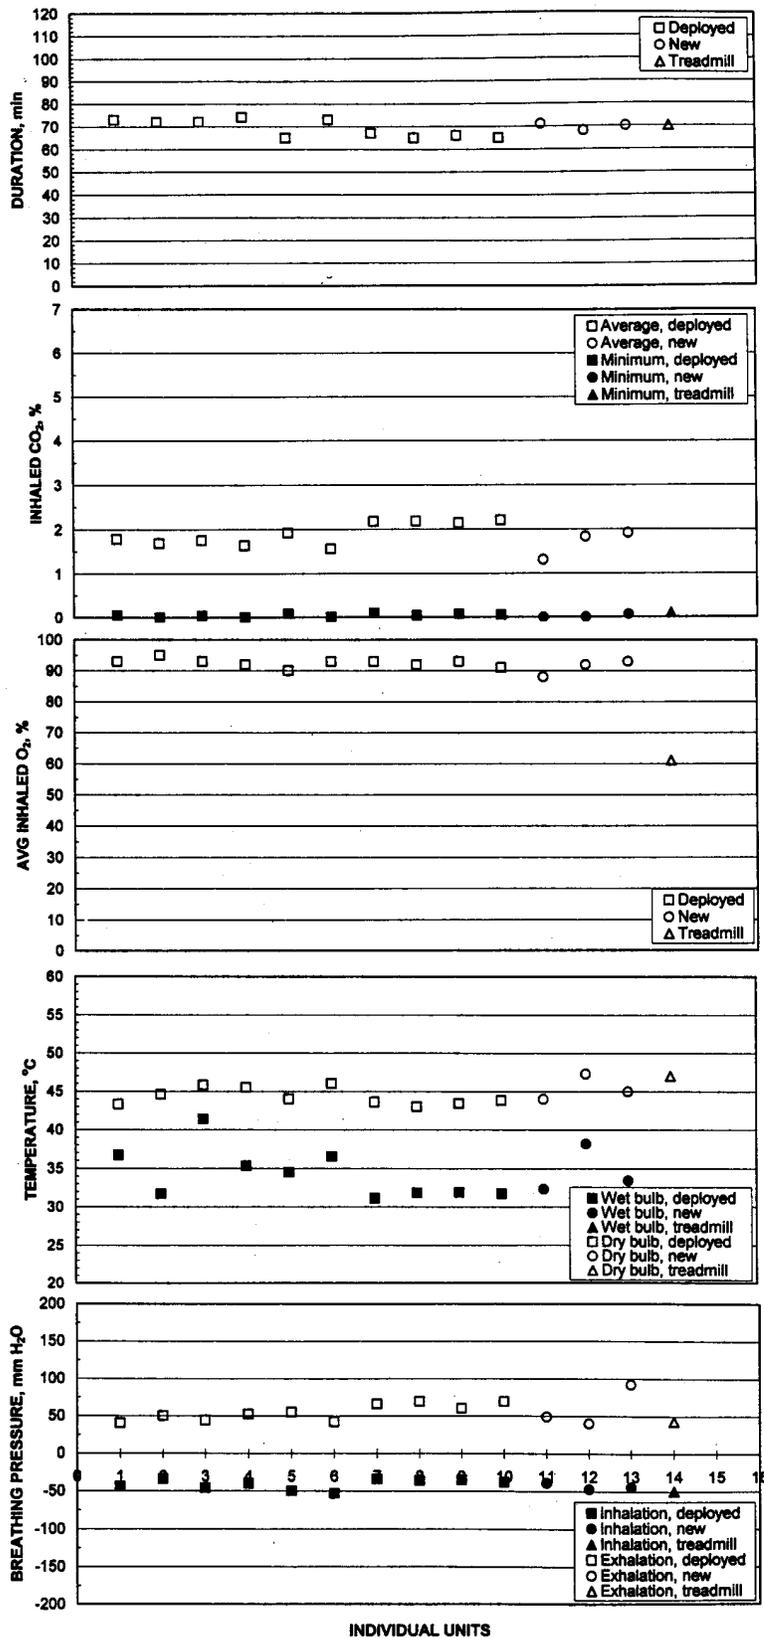
Figure 9.—MSA Life-Saver 60 test results.

The low oxygen level during the treadmill test (figure 9) was caused by a poorly fitting nose clip on the human test subject.

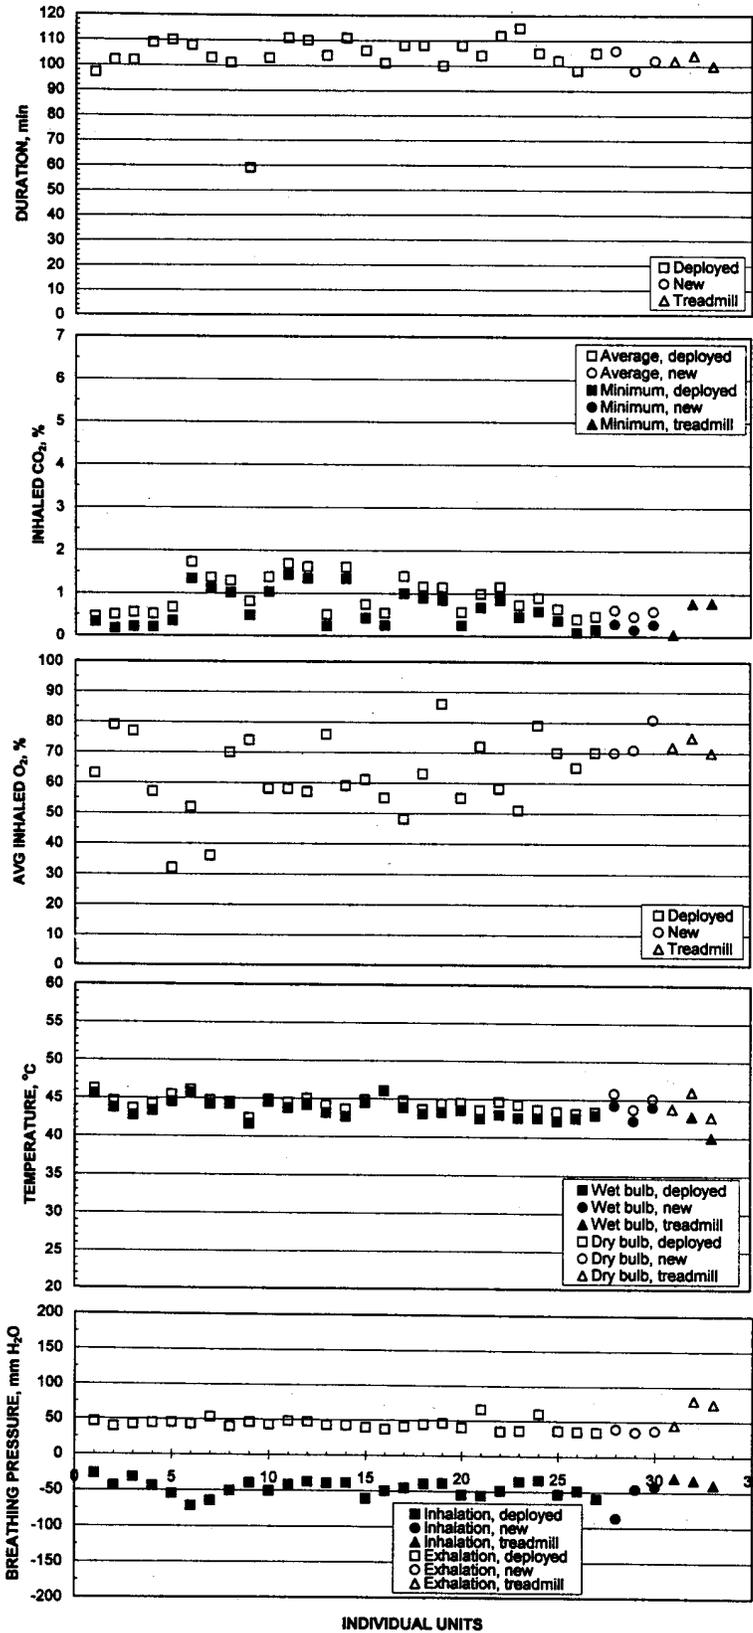
Figure 10.—Ocenco EBA 6.5 test results.

The large range of average inhaled O₂ level test averages is due to the difference in the apparatus O₂ regulator flow rates, which ranged in this phase from 1.53 to 1.93 L/min ATPD. The O₂ concentration in a breathing circuit will rise if the O₂ supply rate is higher than the O₂ consumption rate.

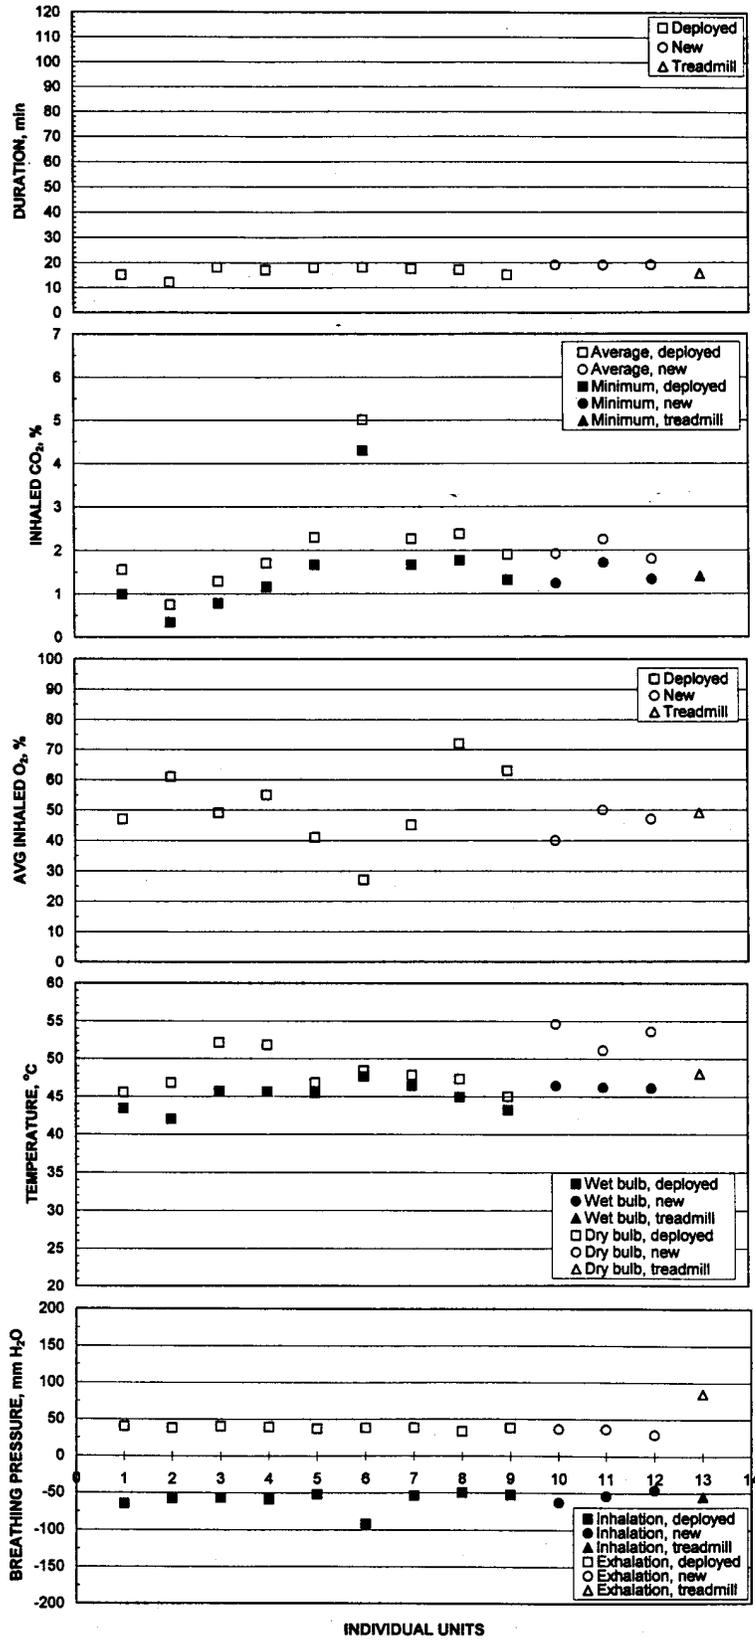
Figure 11.—Ocenco M-20 test results.

Four deployed and all three of the new apparatus experienced average inhaled CO₂ levels of 4% before exhaustion of the O₂ supply (table 5). In all but one instance, however, the depletion of the O₂ supply was only 1 min or less away. One apparatus experienced CO₂ breakthrough at minute 5 with a final duration of 18 min, at which time the average inhaled CO₂ had reached 7.5%. This unit also had a noticeable quantity of lithium hydroxide (LiOH) in the breathing bag and a lower-than-normal O₂ flow rate, as evidenced by continuous demand valve use. The continuous use of the demand valve would have been of no

The Wilcoxon rank-sum test [M=3; N=9] revealed that durations for deployed units were statistically significantly lower than those for new units. This could be caused by gas leakage
