Tech News

Milestones in Mining Safety and Health Technology

No. 560

The Saturn LED Area Light Provides Improved Illumination for Greater Roof Bolter Safety

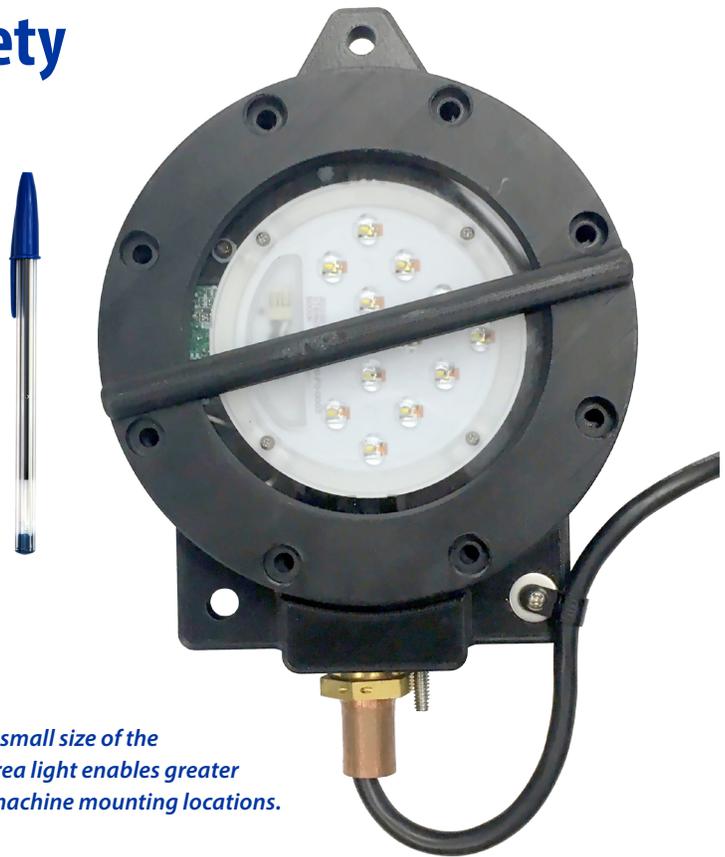
Figure 1: The small size of the Saturn LED area light enables greater flexibility in machine mounting locations.

glare and increasing floor illumination to improve the ability of miners to see floor tripping hazards. A secondary objective was to reduce the size of the lighting to give more flexibility for mounting the lighting on roof bolters—thus, new mounting locations could potentially provide better illumination of hazards. The Saturn LED area light (Figure 1) takes up only one-third the volume compared to existing lights used on roof bolters, and it has a useful life of about 30,000 hours in contrast to the existing

lighting life of about 8,000 hours from traditional lighting. The longevity of the Saturn reduces the likelihood of maintenance-related injuries and reduces maintenance costs.

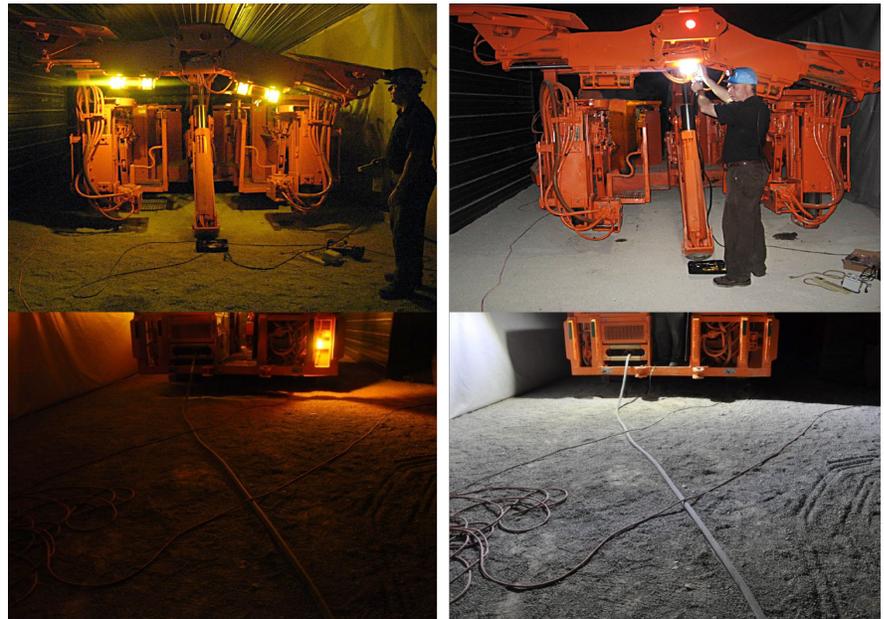
Figure 2: *The existing illumination provided by traditional lighting for a roof bolter (left). The improved illumination provided by the NIOSH-developed Saturn LED area light (right).*

The unpublished results of the study indicated significant reductions of discomfort glare and major improvements in detecting trip hazards when using the Saturn LED area light (Figure 2). Discomfort glare was improved up to three levels (from level 5 to 8). The De Boer 9-level rating scale for discomfort glare ranges between level 9 (just noticeable) and level 1 (unbearable). The mean trip hazard detection time for the oldest age group (> 50 yrs. old) was improved 58% with the Saturn LED area light.
