**RI 9659**

# **Evaluation of Explosion-Resistant Seals, Stoppings, and Overcast for Ventilation Control in Underground Coal Mining**

**By Eric S. Weiss, Kenneth L. Cashdollar,  
and Michael J. Sapko**

December 2002

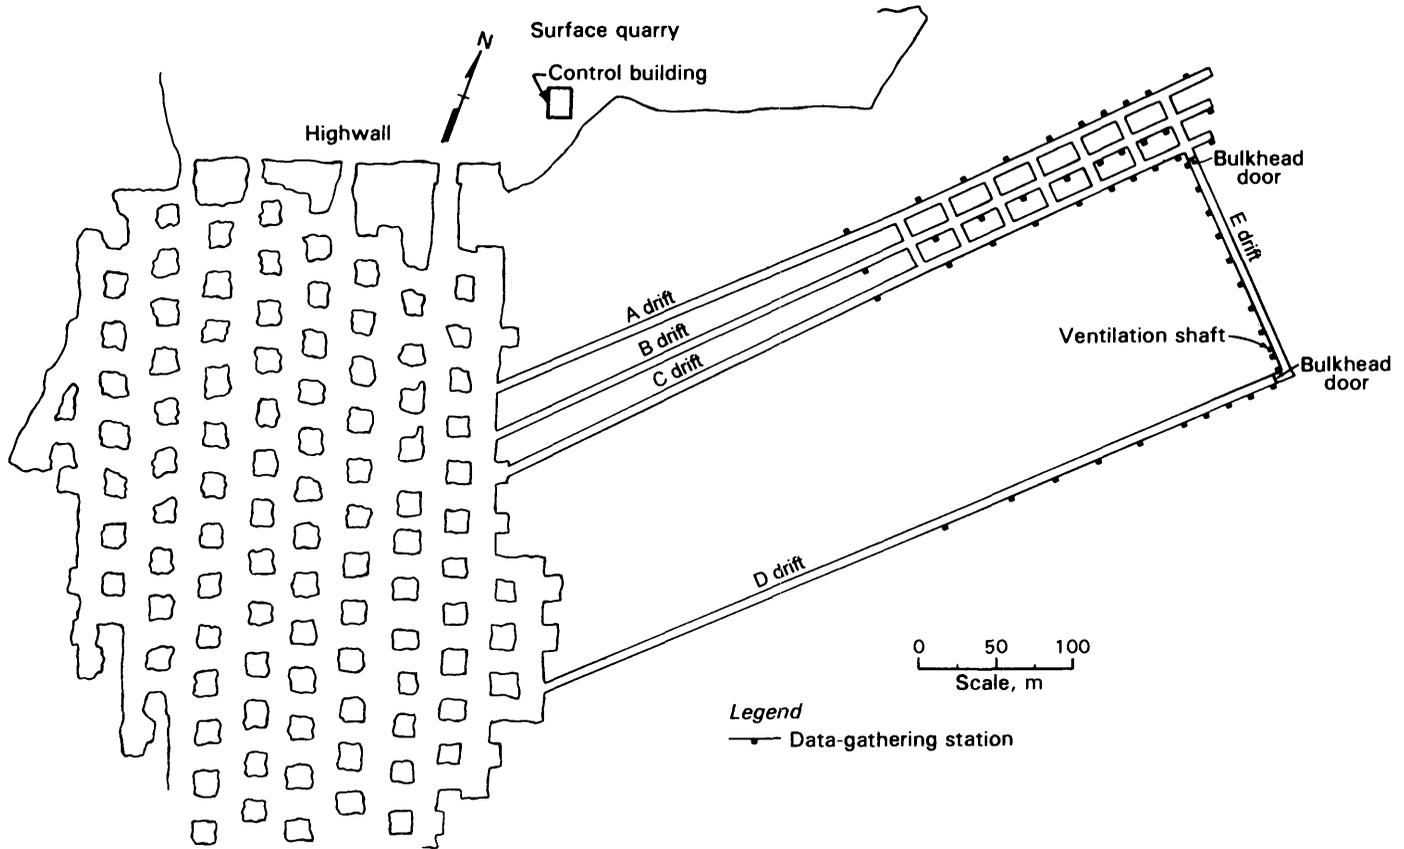
Figure 1.—Plan view of the Lake Lynn Experimental Mine.

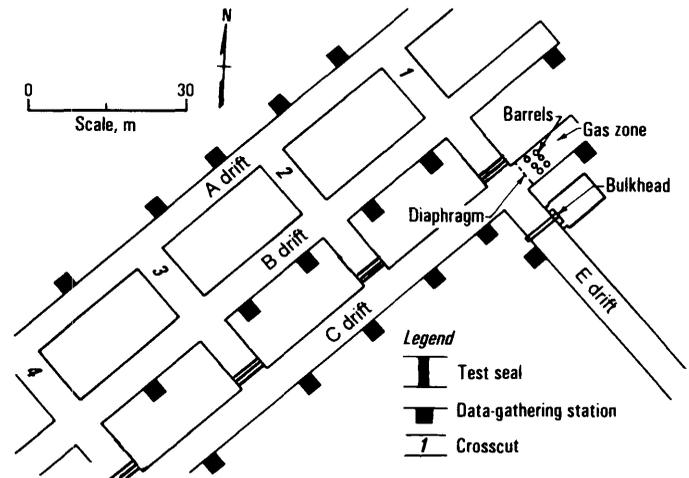
Figure 2.—Seal test area in the LLEM.

Figure 2 shows a closeup view of the seal test area in the multiple-entry section of the LLEM. All of the seals and stoppings were built in the crosscuts between B- and C-drifts. The roof in one section of crosscut 3 had been enlarged previously to ~2.8 m high to more closely represent those of typical Australian and some U.S. underground coal mines [Weiss et al. 1999]. The roof in the intersection of B-drift and crosscut 3 was enlarged during this series of tests to accommodate the overcast design. Details on the designs for the seals, stoppings, and overcast are found in the "Construction" section for each of the three programs found later in this report.

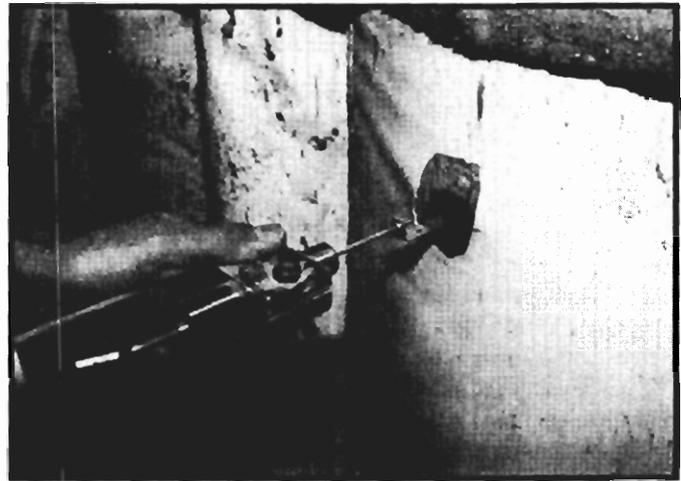
Figure 3.—LVDT attached to a seal.

An additional type of sensor was used during the Barclay Mowlem and Packsetter seal evaluation programs: linear variable differential transducers (LVDTs) to measure movement of the seals. The LVDT is shown attached to the back (B-drift side) of a seal in figure 3.<sup>5</sup> The Schlumberger Industries LVDTs provide a reliable method for precision measurement of linear displacement in the direction of the wall movement, perpendicular to the plane of the seal or overcast wall or deck. The LVDT is calibrated by varying the position of the core (the thin rod extending out from the cylindrical housing in figure 3) by known distances and then measuring the corresponding output voltages. Each LVDT was attached to an aluminum housing that was clamped to a steel post behind the seal, as shown in

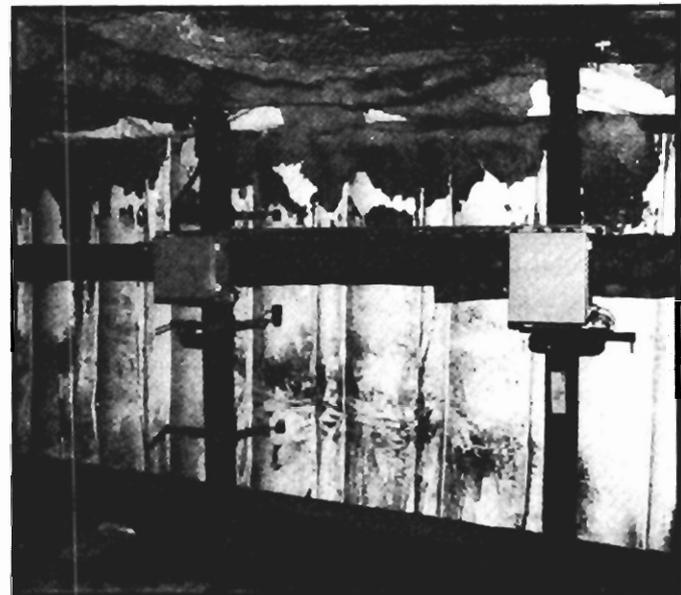
Figure 4.—Support posts and instrumentation on the back side of a seal.

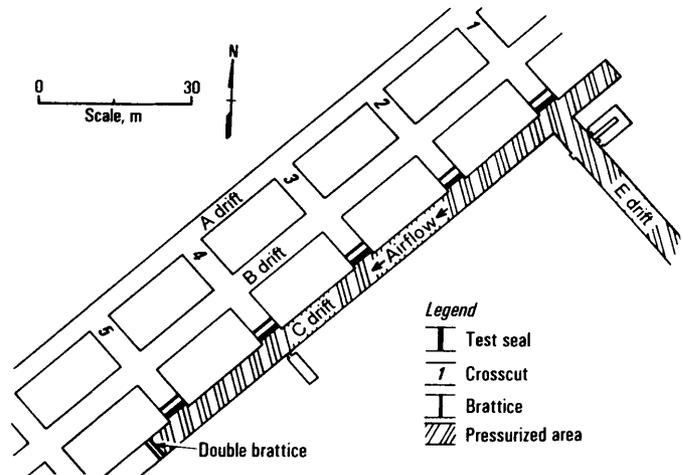
Figure 5.—Pressurized entry for leakage determination rates across the seals.

On the B-drift side of each seal and stopping design, a diaphragm of brattice cloth was installed across each crosscut (figure 5). A typical brattice with a 465-cm<sup>2</sup> opening near the

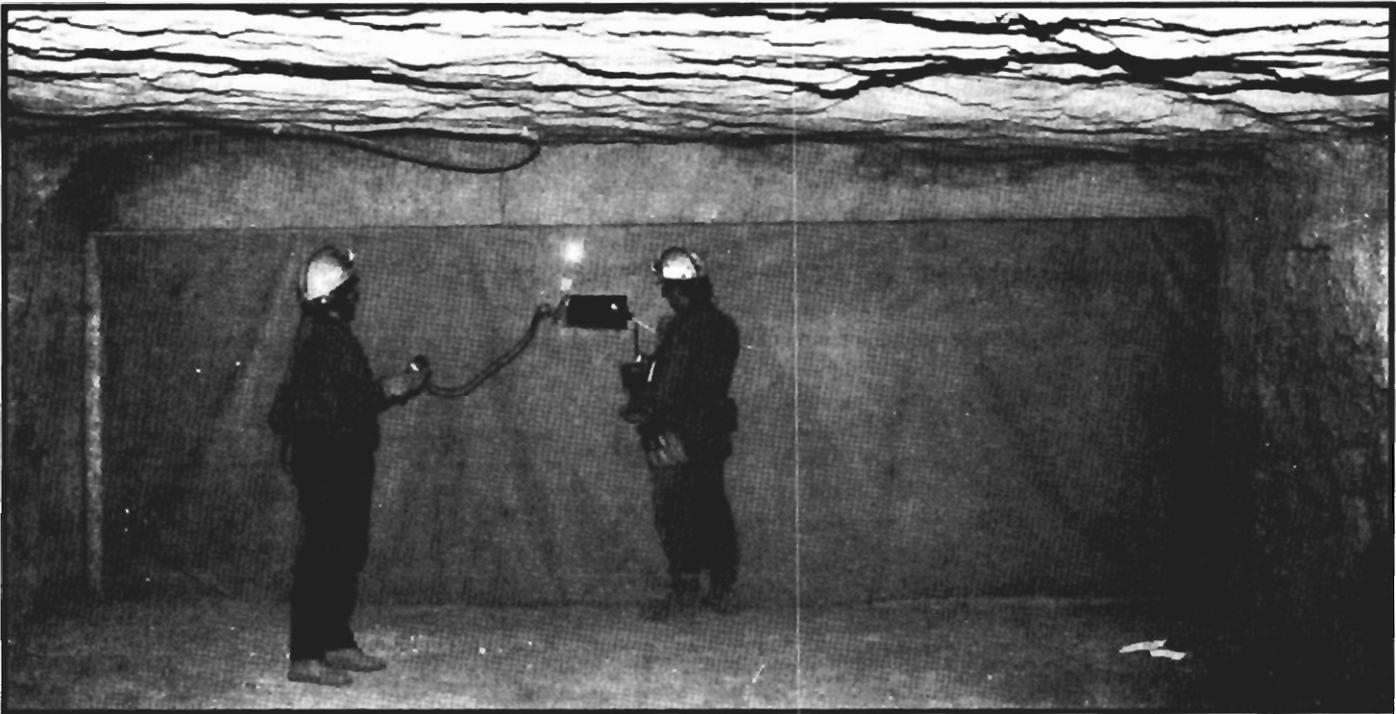
Figure 6.—Brattice in place for seal leakage test.

center is shown in figure 6. For the Barclay Mowlem overcast air leakage tests, three diaphragms were constructed: one inby the overcast in B-drift, one outby the overcast in B-drift, and one in the crosscut between A- and B-drifts. The 465-cm<sup>2</sup> center opening was only on one of these brattices. A vane anemometer was used to monitor the airflow through these openings on the brattices to determine the leakage rates through each design (figure 6). During construction of the seals, stoppings, and overcast, a copper tube was positioned through each of these structures with one end of the tube extending out on either side. This tube served as a way of measuring the air pressure exerted by the fan on each structure. During these air leakage tests, a pressure gauge was attached to the copper tube on the B-drift side to monitor the differential pressure across the structure.

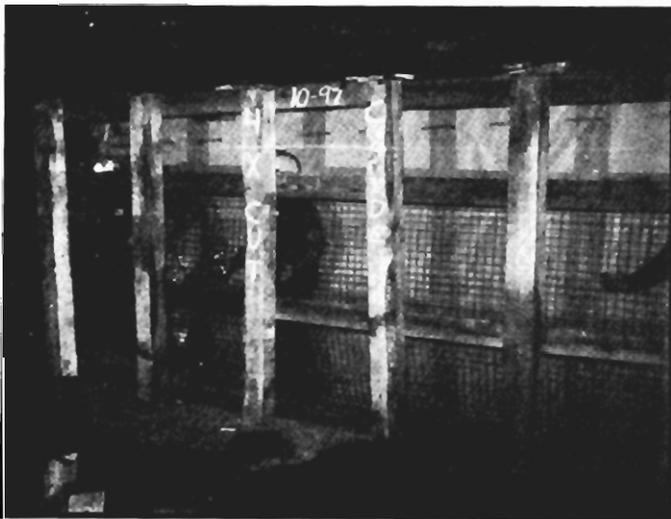
Figure 7.—Construction of the wood and brattice cloth form walls used to contain the pumpable cementitious grout slurry.

As with the previously evaluated pumpable cementitious seal designs, these new HeiTech designs used a similar wooden framework and brattice liner to contain the cementitious slurry. Before installing these form walls, the concrete mine floor of the LLEM was roughened. (In a coal mine installation, the mine floor must be cleaned to the solid.) All loose material was removed from the LLEM roof, ribs, and floor. No hitching or keying of the seal is required with pumpable cementitious seal designs. The upright posts of the walls consisted of 15- by 15-cm (6- by 6-in) rough-cut posts wedged at the floor and roof (figure 7). The post pattern required a 76-cm spacing, with a maximum spacing not to exceed 91 cm. The end posts of each form wall are set as close to the rib as possible. The front form

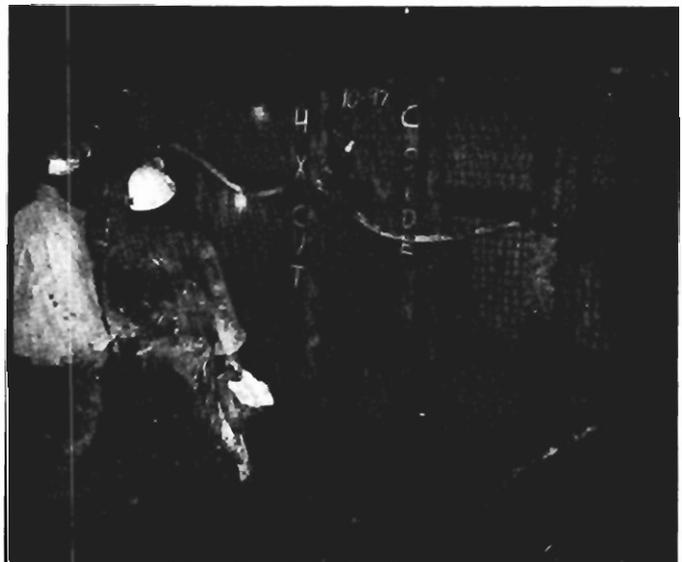
Figure 8.—Slurry injection using the three injection ports located near the mine roof.

The cementitious slurry is mixed and pumped into each seal using a mixer-type placer pump. For each seal design, a three-port injection process was used during the pumping of the final slurry. These injection ports, with equal horizontal spacings, are

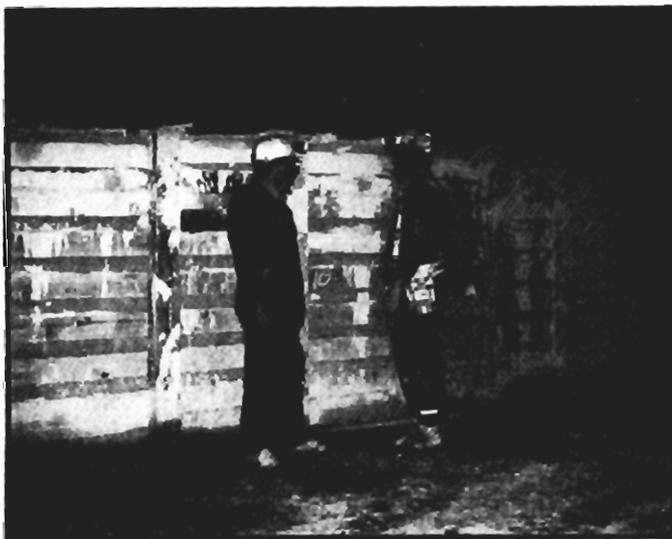
Figure 9.—Completed ribfill seal in crosscut 3.

The design in crosscut 3 consisted of a 915-mm (36-in) thick seal using HeiTech's ribfill cementitious material. Ribfill, manufactured by Blue Circle Special Cements, uses a water-to-grout ratio of 2:1 with an ideal density of 1,200-1,280 kg/m<sup>3</sup> (75-80 lb/ft<sup>3</sup>). As with the other seals, the ribfill was injected between the form walls and the final material was pumped using the three-port injection process (with bleeder tubes). Maximum recommended pumping distances should not exceed 365 m (1,200 ft). For this seal, ~90 m of 30-mm-diam hose was used during the LLEM installation. A total of 212 bags, or ~5,445 kg of material, was used for this seal. Compressive strength tests of the samples tested by MSHA averaged  $\sim 2.8 \pm 0.6$  MPa ( $\sim 400$  psi); those by an independent lab,  $\sim 3.3 \pm 1.1$  MPa ( $\sim 480$  psi). Figure 9 shows the completed seal in crosscut 3.

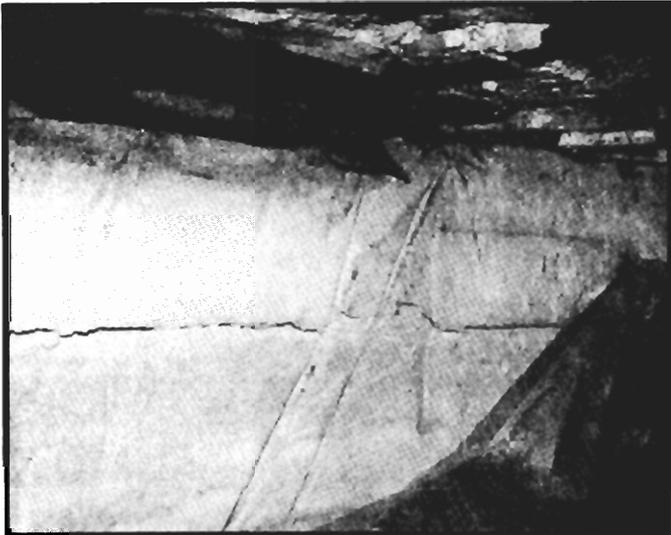
Figure 10.—Horizontal cracks evident near the mine roof on the ribfill seal in crosscut 3 after test 354. Large gaps between the mine roof and the top level of the cured ribfill are evident where incomplete closure was obtained during the initial grout injection process.

No damage was observed on the 865-mm-thick hydrocrete/aggregate seal in crosscut 2 after being subjected to the 190-kPa static pressure pulse. Also, no damage was evident on the 760-mm-thick hydroseal in crosscut 4 (155-kPa (23-psi) pressure) or the 610-mm-thick hydroseal in crosscut 5 (135-kPa (20-psi) pressure). Postexplosion air leakage rates (table A-2 of appendix A) for the seals in crosscuts 2, 4, and 5 were well within the guidelines. For the 915-mm-thick ribfill seal in crosscut 3, minor damage occurred along the seal interface with the mine roof after being subjected to a static pressure pulse of 165 kPa (24 psi). Several horizontal and vertical cracks were also observed on the C-drift (explosion) side of this seal where the explosion forces had pulled the brattice away from the seal (figure 10). Postexplosion air leakage rates for seal 3 (table A-2) were well in excess of the established guidelines. After the postexplosion air leakage test, the front and back form walls and brattice were removed to allow a more comprehensive examination of this seal. It was determined that the excessive postexplosion air leakage rates were caused mainly by the large gaps between the top level of the ribfill and the mine roof. Improper placement of the three injection ports on the front form wall along the mine roof resulted in inadequate contact of the ribfill grout with the mine roof. The pressure pulse generated from the explosion damaged the brattice contact with the mine roof, exposing the gap between the ribfill grout and the mine roof; this resulted in the excess air leakage rates.

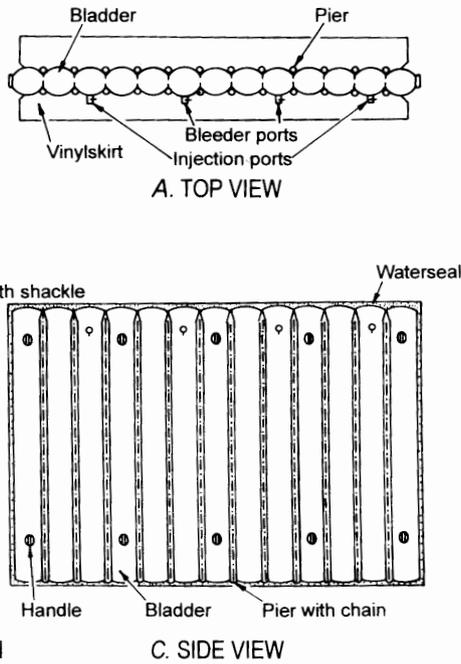
Figure 11.—Schematic of vinyl bladder with internal baffles used for construction of the seal and overcast designs. A, top view; B, cross section, C, side view.

At the start of the seal installation, a spreader bar, which is built from 50-mm by 50-mm medium gauge tubing spaced 300 mm apart, is attached to the mine roof. During installation, the spreader bar assembly is held in position by roof jacks (figure 12). A flat metal strap is placed over the spreader bars and then bolted to the mine roof using 900-mm-long by 25-mm-diam fully encapsulated resin roof bolts on 2-m spacings. After the spreader bar assembly is installed, the roof jacks are removed and shotcrete is applied to the spreader bar assembly (figure 13). The vinyl bladder is pulled into place by ropes attached to a series of hooks on the spreader bar (figures 13-14) and then inflated. Between each of the inflated large vinyl bladder tubes are smaller 100-mm-diam piers (see figure 11A)

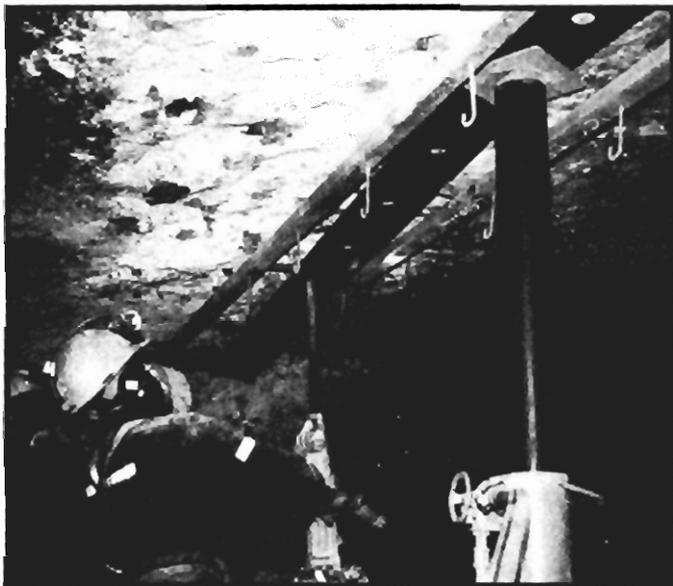
Figure 12.—Spreader bar anchored to the mine roof used to support the seal bladder system.

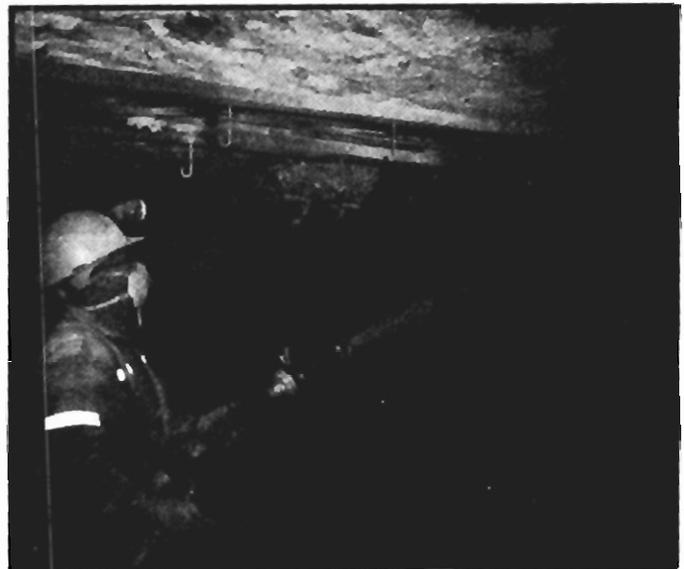
Figure 13.—Shotcreting of the spreader bar and hook assembly.

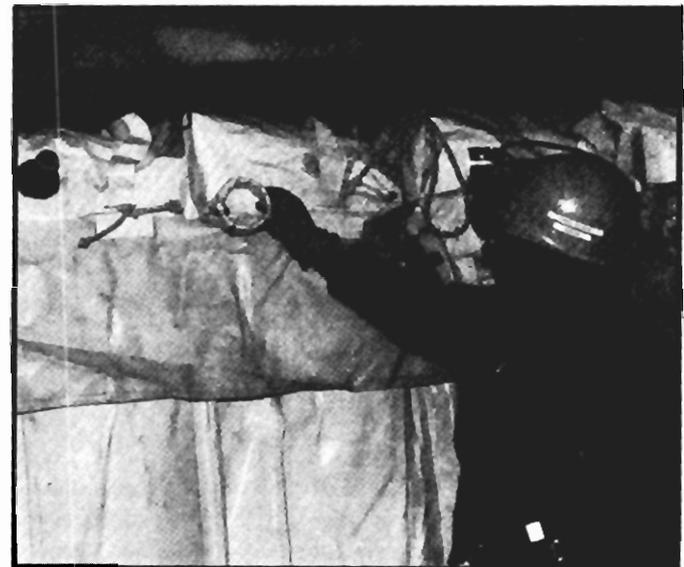
Figure 14.—Inflated vinyl bladder assembly showing the injection port for the piers.

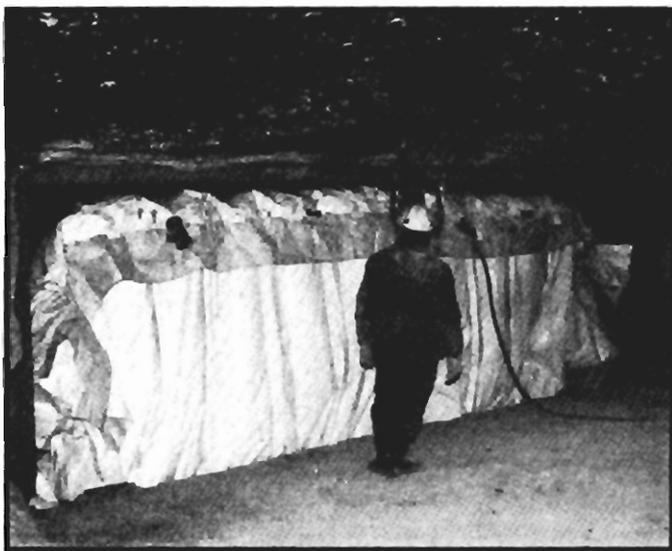
Figure 16.—Construction of seal in crosscut 2 showing vinyl bladder in place, but not yet filled.

After installation of the steel framework, the vinyl bladder was placed in position and inflated with air (figure 16). The bladder was then attached to the spreader bar using connecting chains that were looped over the spreader bar hooks. The piers on each side of the bladder were then shackled to these chains. After the support chain was dropped into the piers, it was also shackled to the spreader bar. The bottom of the vinyl pier and

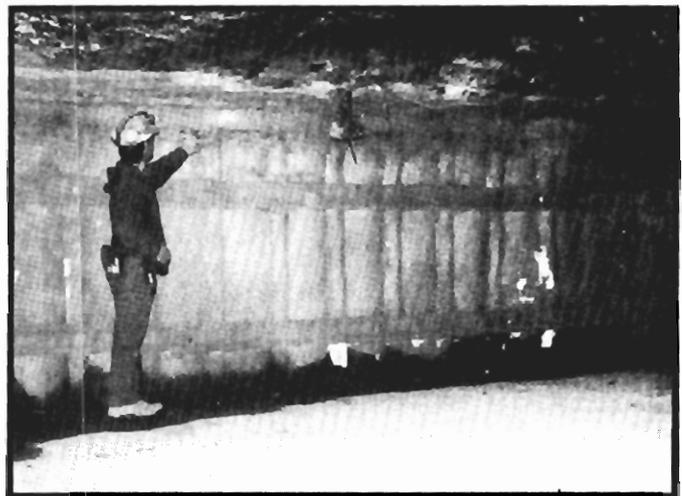
Figure 17.—Completed seal in crosscut 2.

The 450-mm-thick seal in crosscut 2 was built in the manner described in the above paragraphs (see figures 15-17). The 450-mm-thick seal in the 2.8-m-high roof section of crosscut 3 was also built (figures 18-19) in a similar manner, except that the spreader bar was not recessed into the mine roof. Samples were taken during the grout injection process for compressive strength analyses at an independent lab. The compressive strength of the grout samples averaged 2.4 MPa (350 psi) after

Before the first explosion test, the 450-mm-thick seal in crosscut 2 (figure 17) and the 170-mm-thick water-filled tube stopping (figure 37) in crosscut 3 were evaluated for air leakage resistance. The four differential pressures listed in table A-5 correspond to the four speeds of the main ventilation fan at the LLEM. As can be seen in table A-5, virtually no air leakage could be detected through the crosscut 2 seal for pressure differentials up to 1 kPa. The water-filled tube stopping showed significant air leakage up to 0.55-kPa pressure differential. At 1-kPa pressure differential, the water tubes separated from the bottom support (figure 38). Note that this stopping was designed to release in this manner during low-level explosion pressures. These water-filled tubes were reattached to the stopping base and shotcrete was reapplied. The air leakage through this stopping was then remeasured before the first explosion test, as listed in table A-5. The air-inflated vinyl

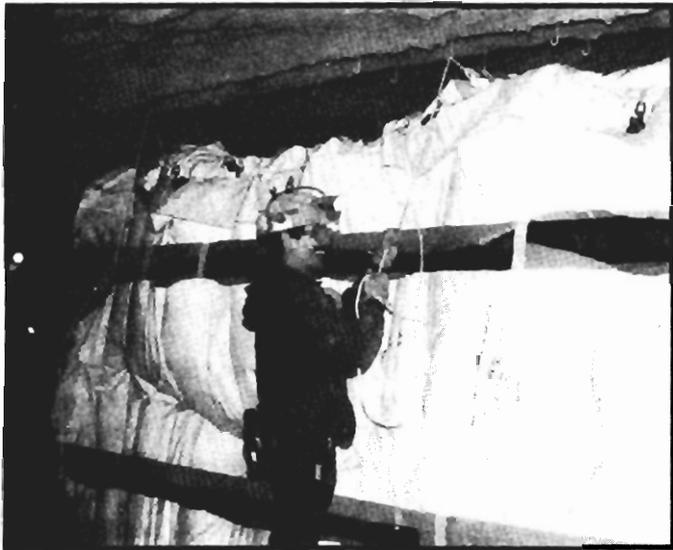
Figure 18.—Construction of seal in high roof section of crosscut 3, showing the vinyl bladder being installed.

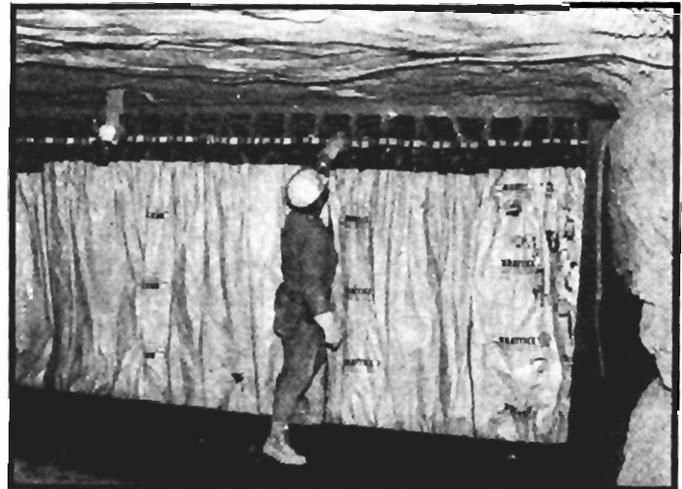
Figure 20.—Construction of seal in crosscut 4 showing the vinyl tubes before filling.

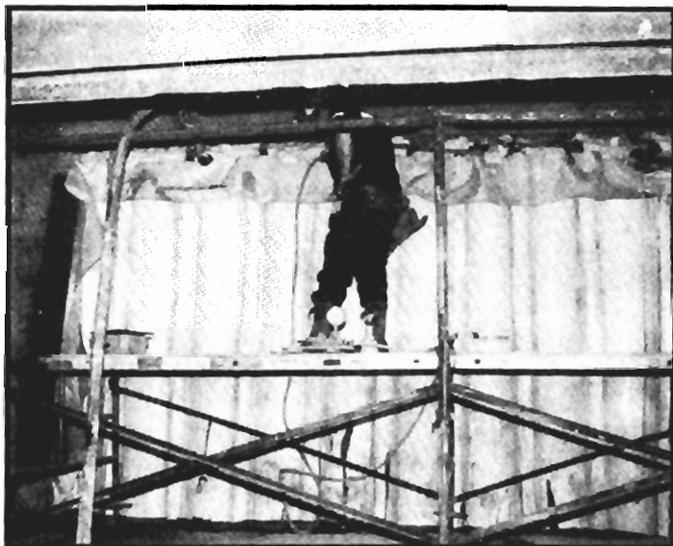
Figure 19.—Construction of seal in high roof section of crosscut 3, showing the grout injection hose attached to the bladder.

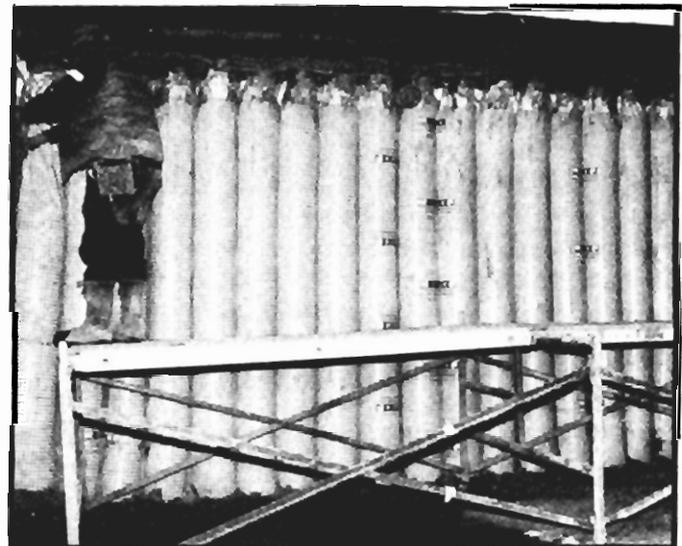
Figure 21.—Construction of second seal in high roof section of crosscut 3.

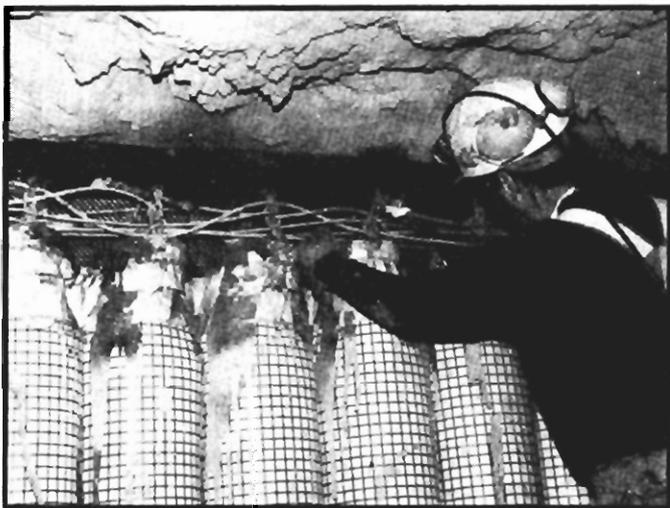
Figure 22.—Construction of seal in crosscut 4 showing details of the tops of the vinyl tubes and light meshing overlay.

For both seals, the tube assemblies were suspended (figure 22) from chains from a spreader bar, which consisted of a 50-mm by 50-mm steel tubing assembly similar to that used with the other seals described earlier in this report. The tube assemblies were suspended from the spreader bar with 6-mm chains on 170-mm spacings for the seal in crosscut 4 and 240-mm spacings for the seal in crosscut 3. The spreader bar was not recessed into the mine roof and was attached using 1,800-mm-long by 25-mm-diam full-resin bolts on 2-m spacings. A heavy coating of shotcrete was sprayed onto the spreader bar and edges. A light chain was placed in each tube and connected to the spreader bar by shackles. The tube modules were open at the bottom. The vinyl material on the

The grout was pumped fully into each tube for each seal. The wire cables across the tops of the tubes in figure 22 provided additional reinforcement and helped to hold the grout in place. When the grout had set, three steel straps were attached to the C-drift seal face at the top, middle, and bottom of the seal in crosscut 3, and two steel straps were used on the C-drift face of the seal in crosscut 4. No straps were used on the B-drift face of either of these two seals. The straps were attached using 150-mm-long by 25-mm-diam Hilti Dyna bolts. These steel straps were then bolted to the mine ribs using 1,800-mm-long by 25-mm-diam full-resin bolts. A light wire mesh was attached across the top portion of each seal on the B-drift face and formed around each rib to provide some reinforcement and to serve as a backing along the top open section of the seals when applying shotcrete from the C-drift side. A 25-mm-thick coating of shotcrete was sprayed on the entire face and perimeter of the C-drift side (explosion side) of each seal. Shotcrete was then sprayed on the back (B-drift side) perimeter of each seal.

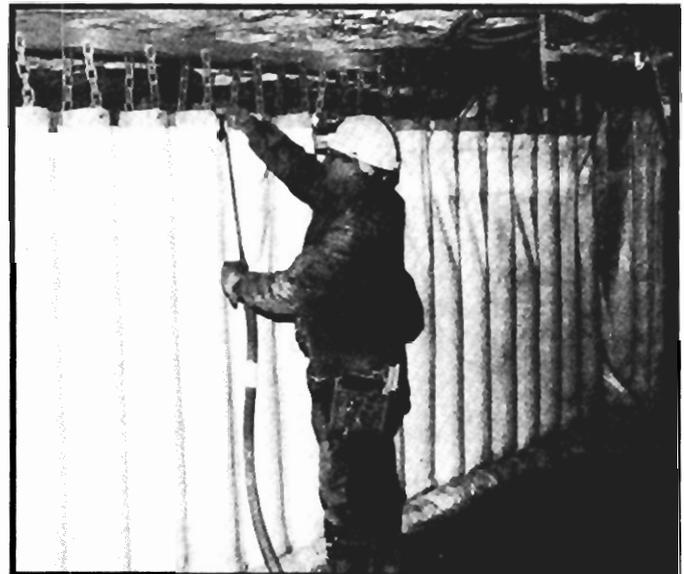
Figure 23.—Construction of water stopping in crosscut 3, with the individual tubes suspended from the roof-mounted spreader bar.

A Velcro strip (hook-and-latch fabric fastener) is sewn down each side of each of these tubes to allow each tube to be joined together to form a full-width curtain (figure 24). Plastic clips are also used to secure the individual tubes to one another. The floor seal is fabricated from two vinyl tubes sewn together on a vinyl pad. Between the two tubes along the entire length a Velcro strip was attached. These vinyl tubes are filled with stone dust in order to conform to the irregularities of the mine

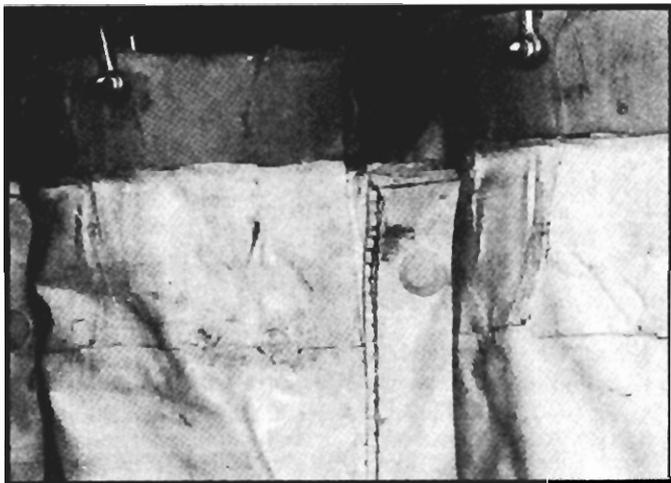
Figure 24.—Details of the Velcro and plastic clip fastening system for the water stopping in crosscut 3.

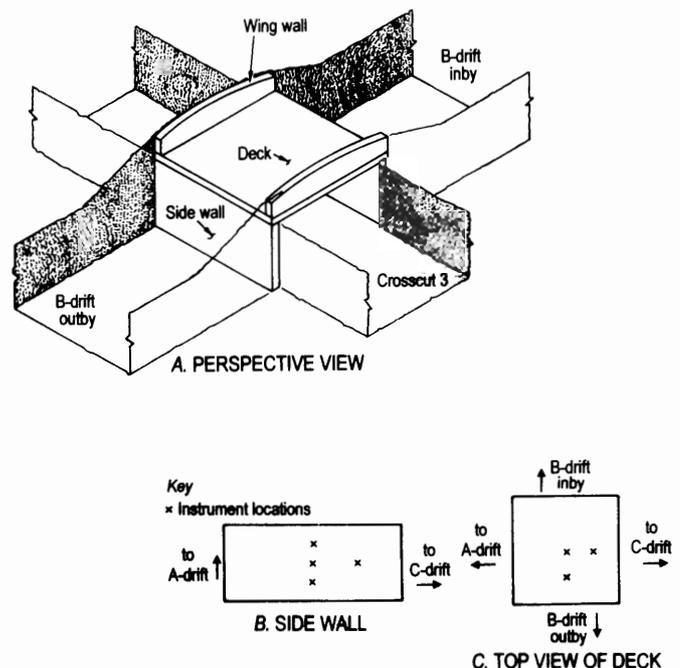
Figure 25.—Schematic drawing of overcast at the intersection of B-drift and crosscut 3. A, perspective view; B, side wall showing instrumentation positions, as viewed from B-drift outby; C, top view of deck showing instrumentation positions.

The overcast side walls form solid concrete walls across the B-drift entry and support the top overcast deck (figure 25). These side walls were built in a manner similar to the vinyl bag seal designs described in the earlier "Seals" section of this report. The 150-mm by 150-mm by 12-mm-thick steel angle

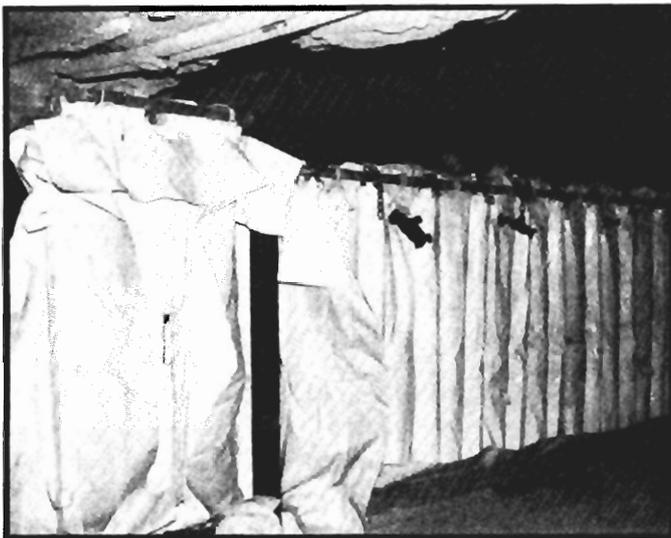
Figure 26.—Construction of side wall of overcast at the intersection of B-drift and crosscut 3.

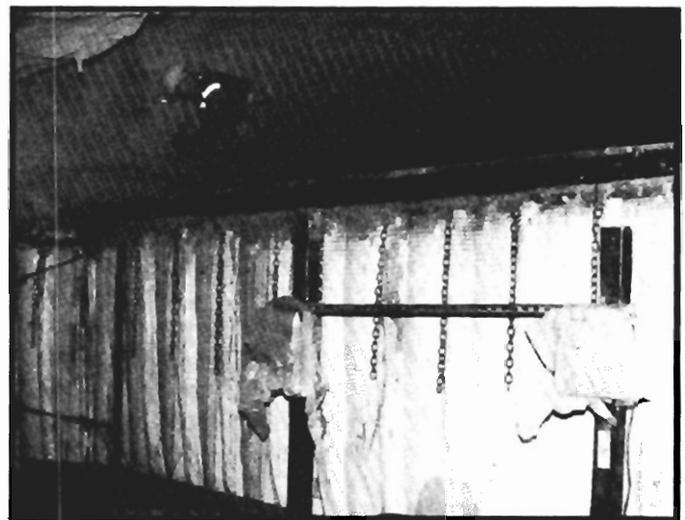
Figure 27.—Construction of overcast at the intersection of B-drift and crosscut 3: installation of deck on top of side wall.

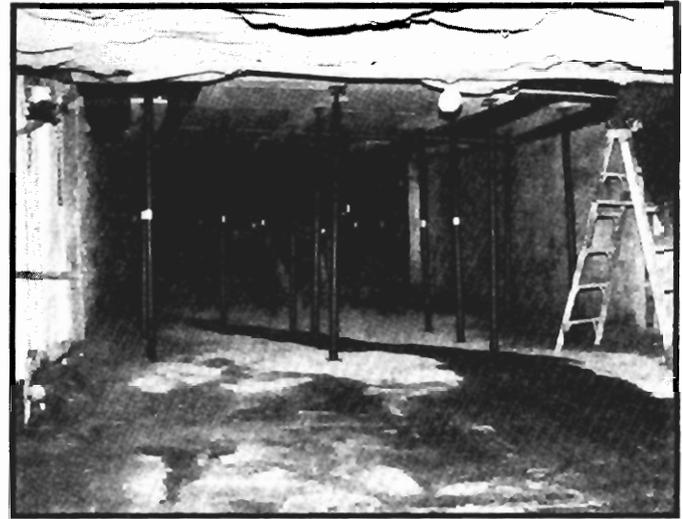
Figure 30.—View underneath the overcast deck showing temporary supports while the deck cement cured.

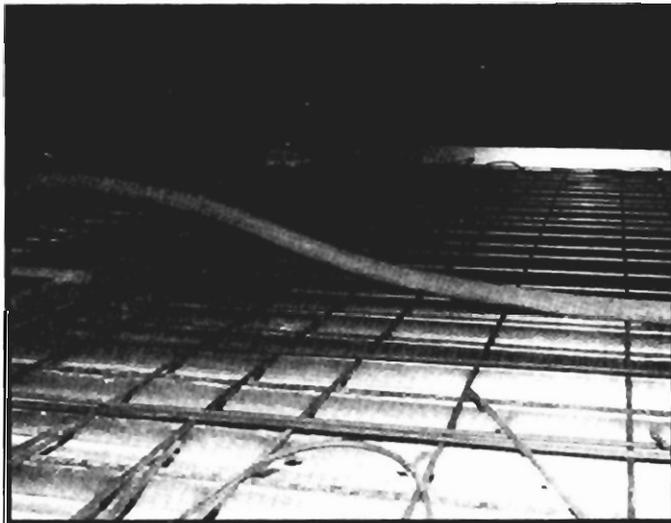
Figure 29.—Top view of overcast deck showing reinforcing bars.

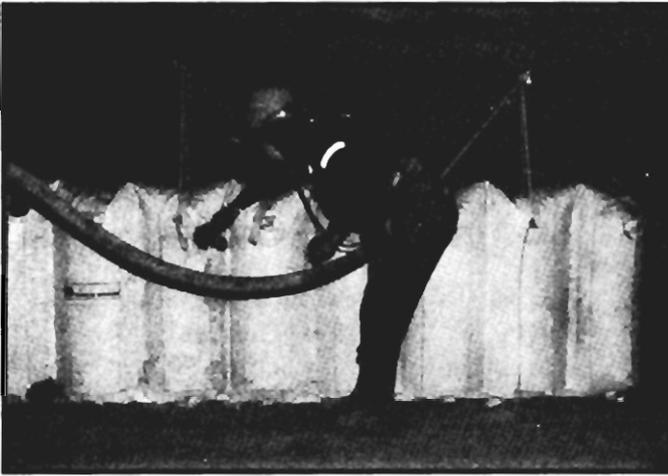
Figure 31.—Construction of wing wall along edge of overcast deck: side view of vinyl bladder for wing wall being installed.

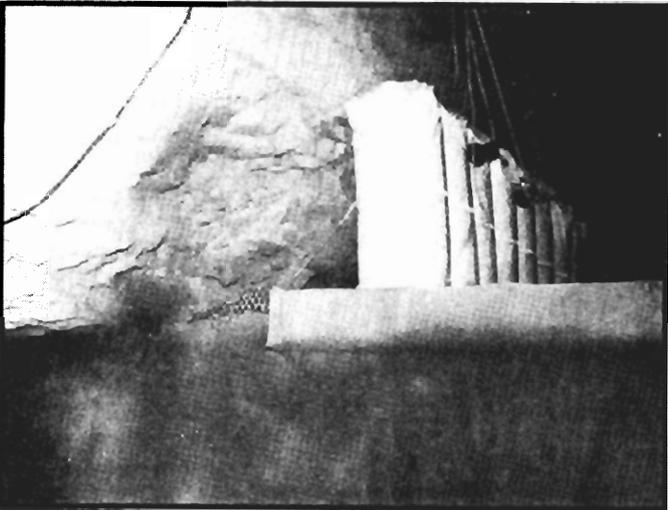
Figure 32.—Construction of wing wall along edge of overcast deck: end view of wing wall above deck.

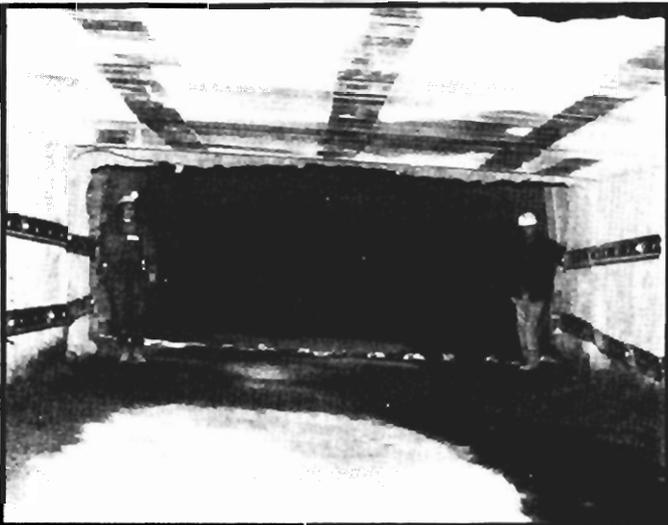
Figure 33.—Completed overcast viewed from under the deck.

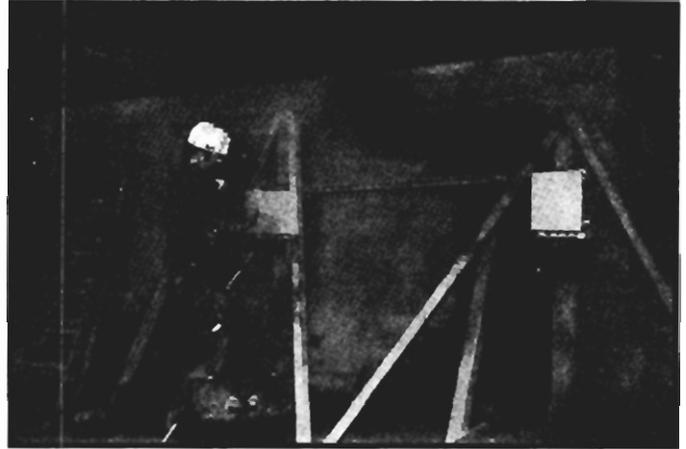
Figure 34.—Side wall of overcast, as viewed from B-drift outby, showing instrumentation boxes and support frames.

Instrumentation was then placed on the side walls, deck, and wing walls of the completed overcast. Steel angle frames were erected beside the outby side wall in B-drift to support the instrumentation boxes and LVDTs, as shown in figure 34. One LVDT was placed at the center of the side wall, one at quarter-height and midwidth, one at three-quarters height and midwidth, and one at midheight at one-quarter of the way from the side (figures 25B and 34). This was the same positioning used for the LVDTs on the seals. The LVDTs on the deck were suspended from the roof by steel frames (figure 35). A detail of the LVDT attached to the top of the deck is shown in figure 36. A top view of the deck showing LVDT positions is shown in figure 25C. One LVDT was also positioned at the middle of the wing wall facing C-drift.

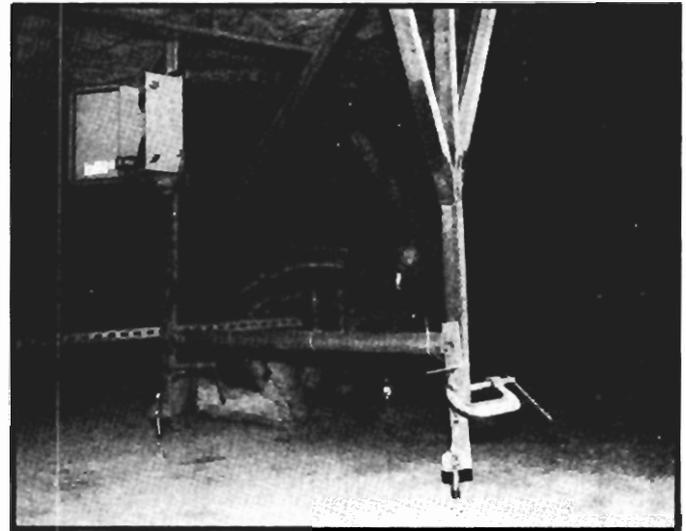
Figure 35.—Instrumentation on top of overcast deck: three LVDTs suspended above deck.

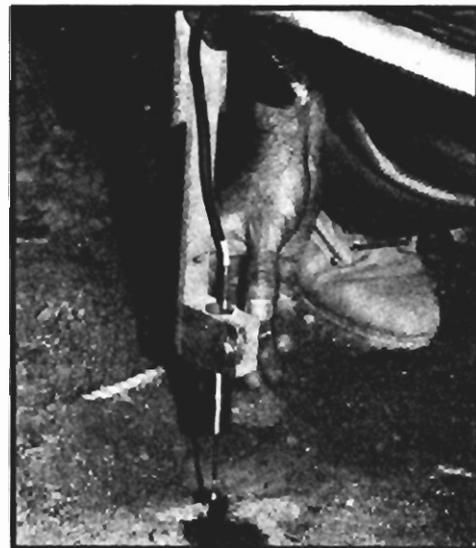
Figure 36.—Closeup of LVDT suspended from roof and attached to deck.

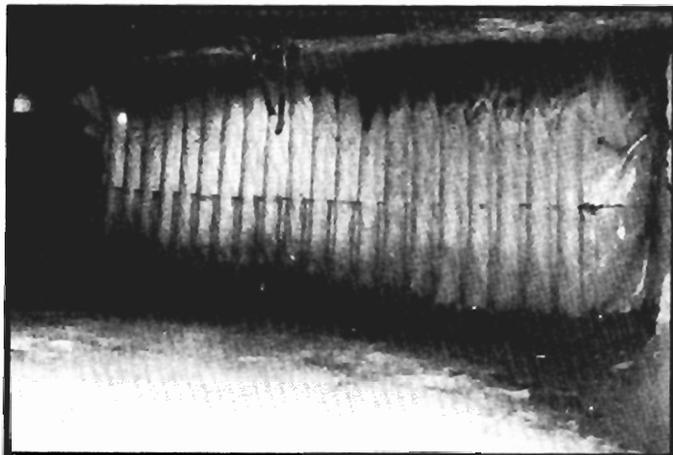
Figure 37.—Completed water stopping in crosscut 3.

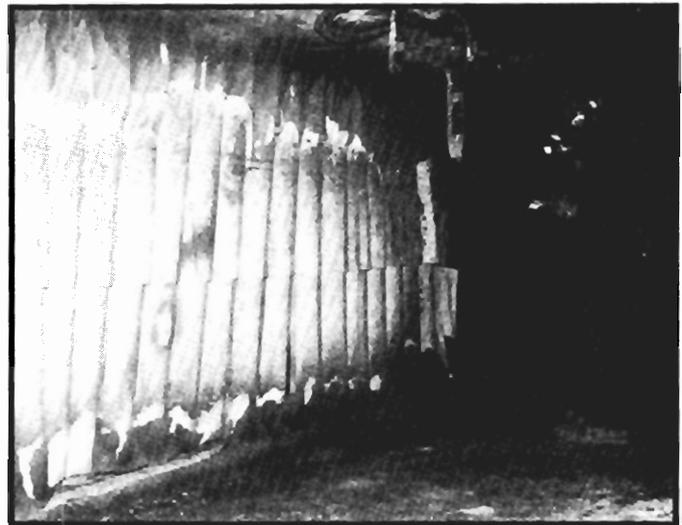
Figure 38.—Release of individual water tubes of stopping during air leakage test.

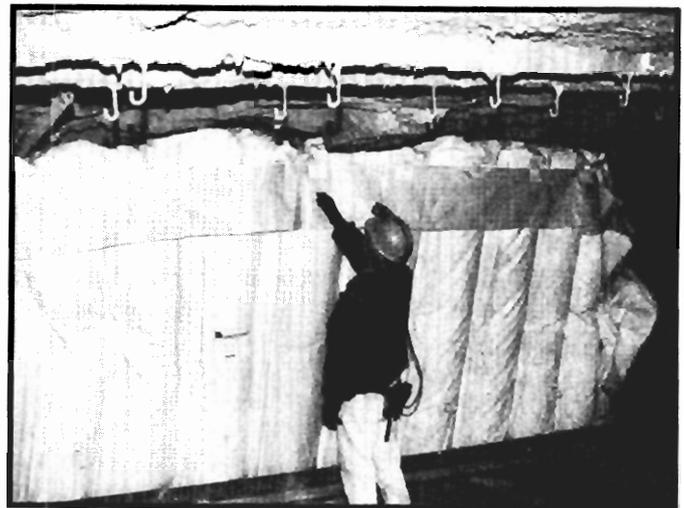
Figure 39.—Air-inflated vinyl bladder of quickseal in crosscut 4.

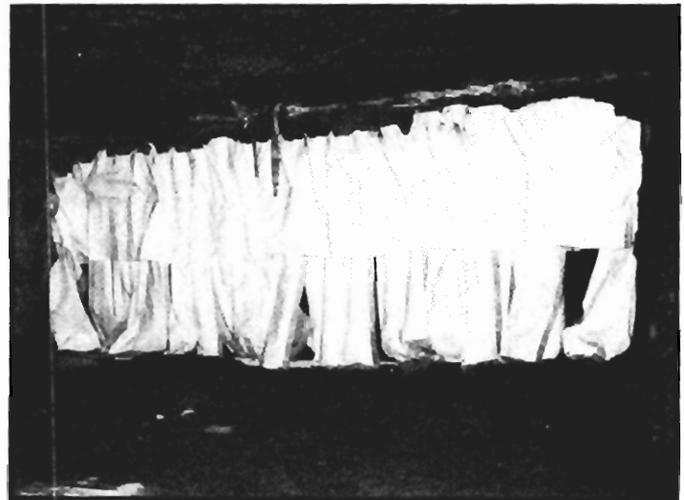
Figure 40.—Condition of water stopping in crosscut 3 after test 358.

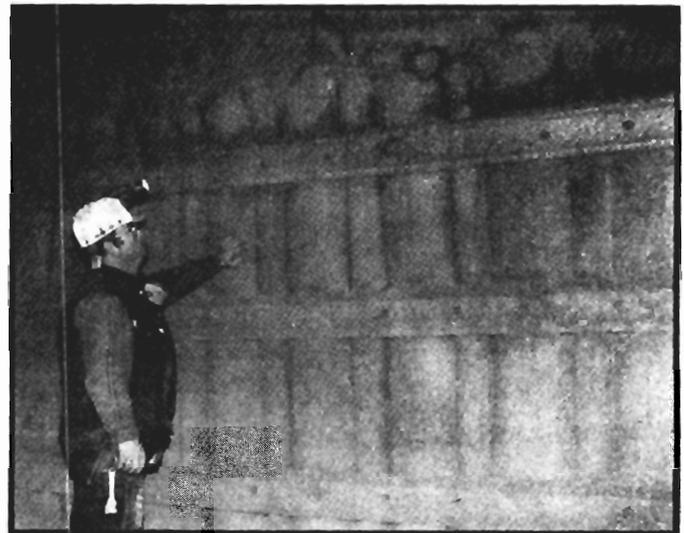
Figure 41.—Completed seal in the high roof section of crosscut 3.

After explosion test 358, the two stoppings were removed from crosscuts 3 and 4, and a new seal was built in the high roof area of crosscut 3 (see tables 3-4). This seal (figure 41) was similar to that previously installed in crosscut 2 except that the roof spreader bar was not recessed into the roof. A preexplosion air leakage test was conducted against the newly installed seal in crosscut 3. The results (table A-6) showed that the seal was well within the established guidelines (table 2). In order to more fully evaluate the strengths of these seals and to generate data to assist in developing a numerically based design tool for explosion seals, successive and more intense explosions were required.

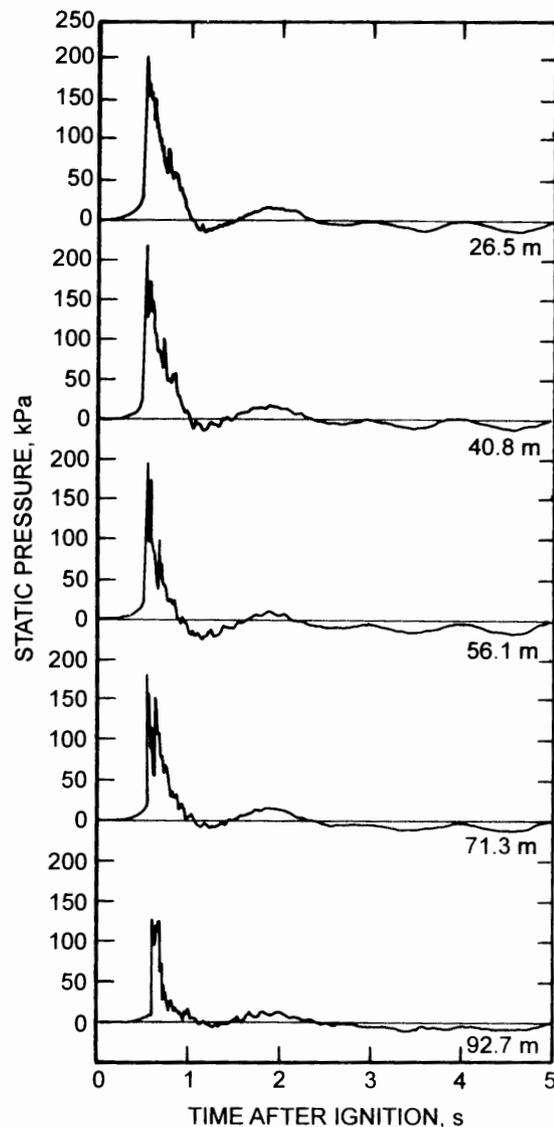
Figure 42.—Pressure traces as a function of distance from the closed end (face) in C-drift for test 359.

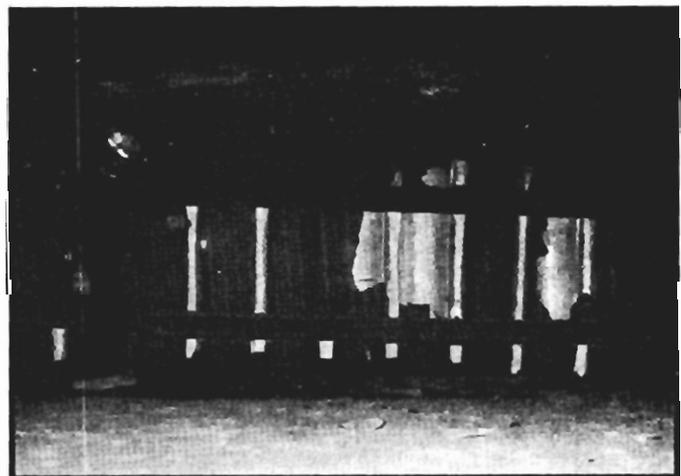
Figure 43.—Seal in crosscut 2 after test 359.

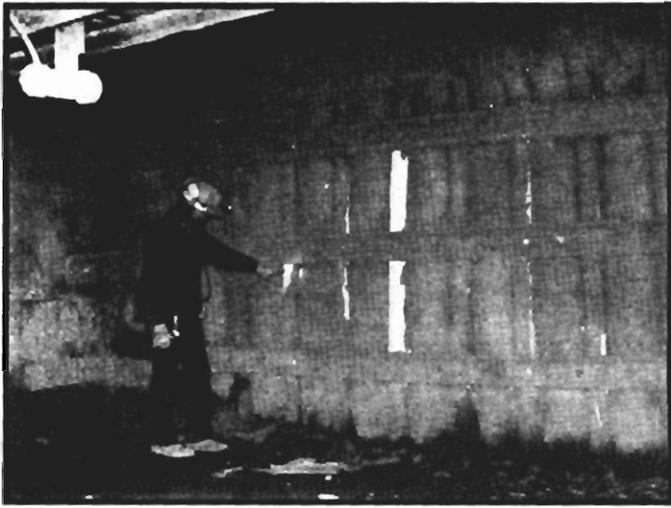
Figure 44.—Seal in crosscut 3 after test 359.

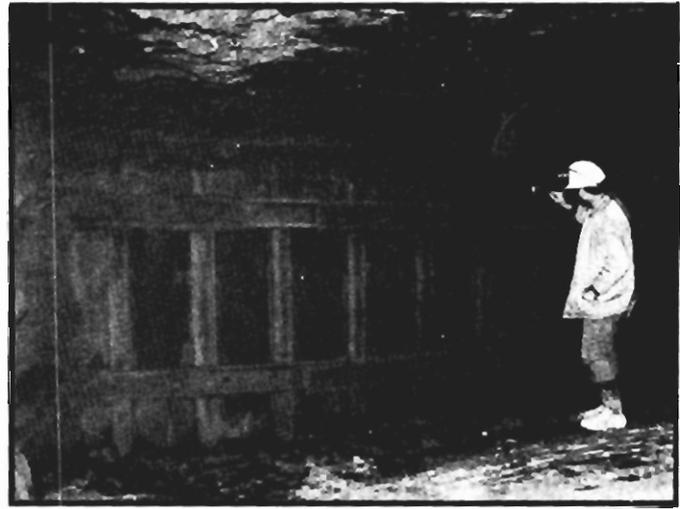
Figure 45.—Seal in crosscut 2 after test 360.

Postexplosion observations showed that the seal in crosscut 2 survived the 370-kPa static overpressure with only minor damage to the surface shotcrete coatings (figure 45). Subsequent air leakage evaluations for this seal (table A-8) showed that the leakage rates were at or slightly above the established air leakage guidelines. An interesting result of this test was that the postexplosion air leakage for seal 2 (table A-8) was lower than the preexplosion leakage (table A-7). For example, the postexplosion air leakage was 32% lower at 1-kPa pressure differential. One potential explanation for this phenomenon is that if a seal is not significantly damaged during an explosion,

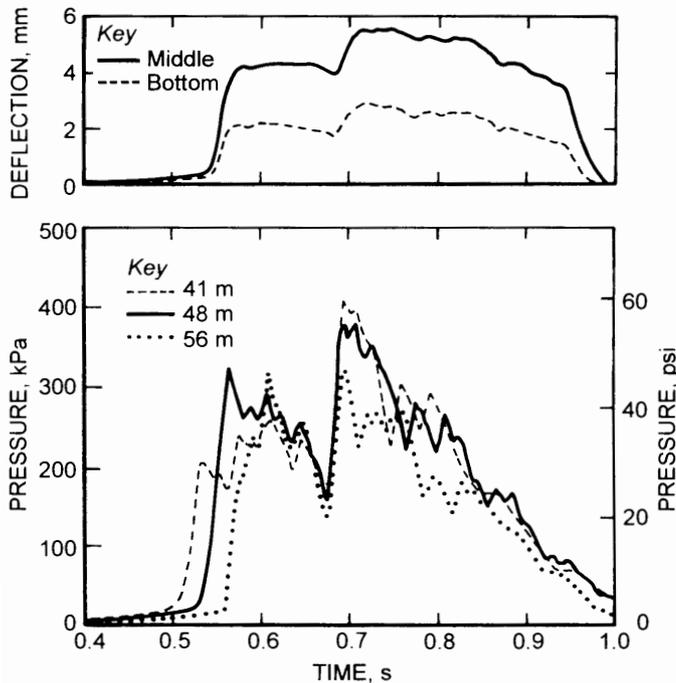
Figure 46.—Pressure and LVDT traces for seal 2 during test 360.
