**RI 9659**

# **Evaluation of Explosion-Resistant Seals, Stoppings, and Overcast for Ventilation Control in Underground Coal Mining**

**By Eric S. Weiss, Kenneth L. Cashdollar,  
and Michael J. Sapko**

December 2002

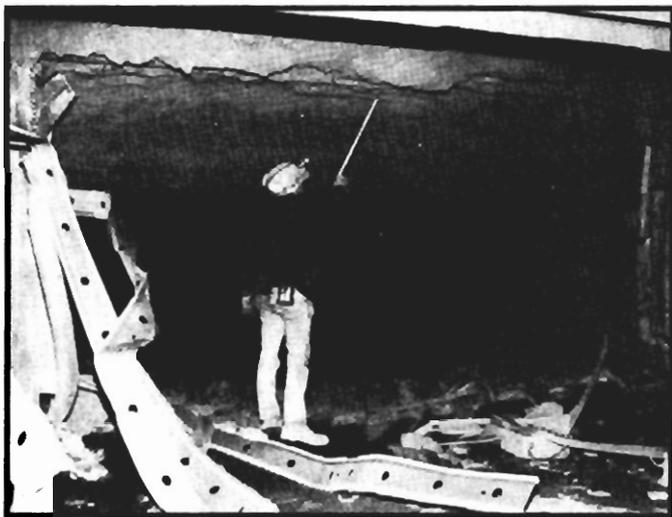
Figure 47.—Remains of crosscut 3 seal after test 360.

The seal in the high roof area of crosscut 3 was destroyed by the 475-kPa (69-psi) static pressure pulse (figure 47). From postexplosion observation of the seal, it seemed that the seal failure started at the top of the seal, where only a minimum of hitching was achieved due to the contour of the hard limestone mine roof. Figure 48 shows the static pressure data from the two transducers on either side (71 and 93 m) of the seal in crosscut 3 compared to the total pressure data from the transducer in front of the seal (75 m). As in figure 46, the time scales of the two static pressure traces were shifted so that the peaks matched with that of the transducer at the seal. In the upper part of figure 48 are the traces from the LVDTs at the middle and bottom positions on the seal. The maximum displacements for all of the LVDTs on this seal up to the time of seal failure are listed in table D-3. The greatest seal movement was ~30 mm at three of the LVDTs. The times of seal failure

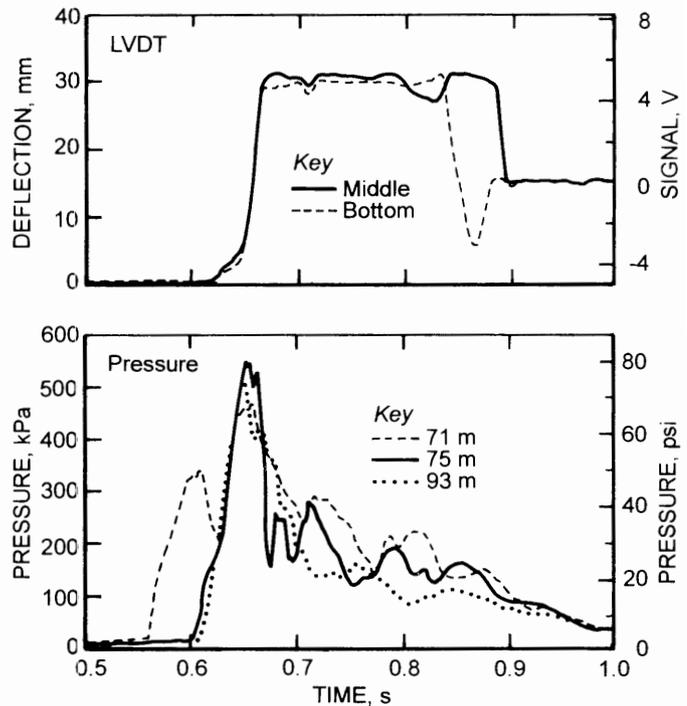
Figure 48.—Pressure and LVDT traces for seal 3 during LLEM test 360.

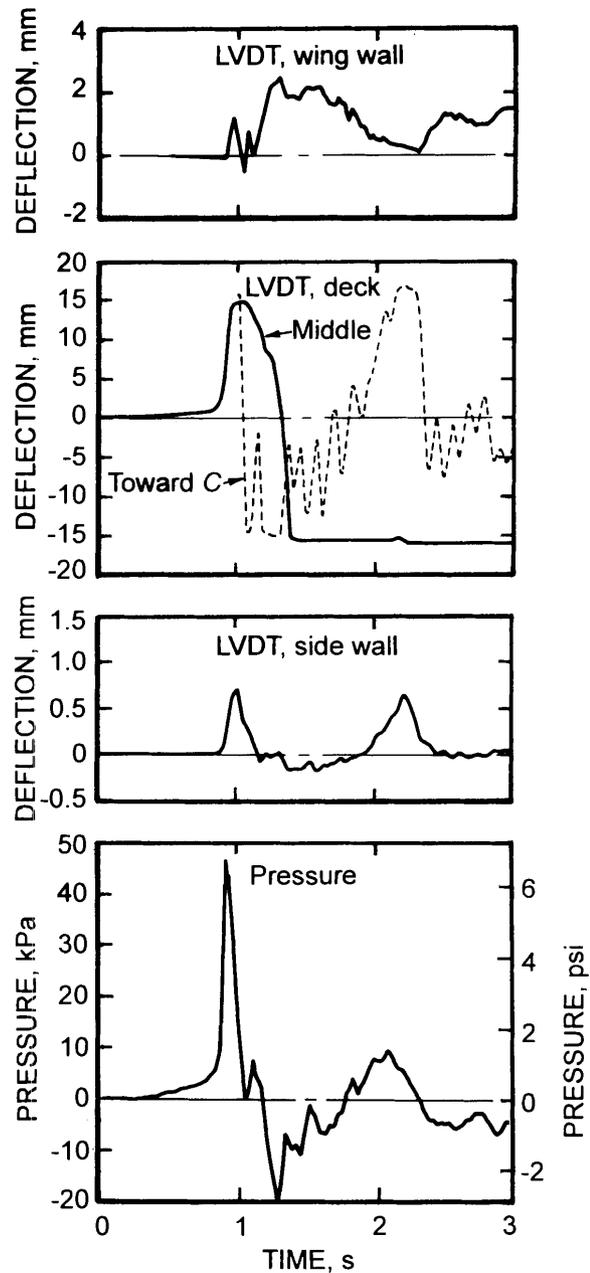
Figure 49.—Pressure and LVDT traces for overcast during LLEM test 363.

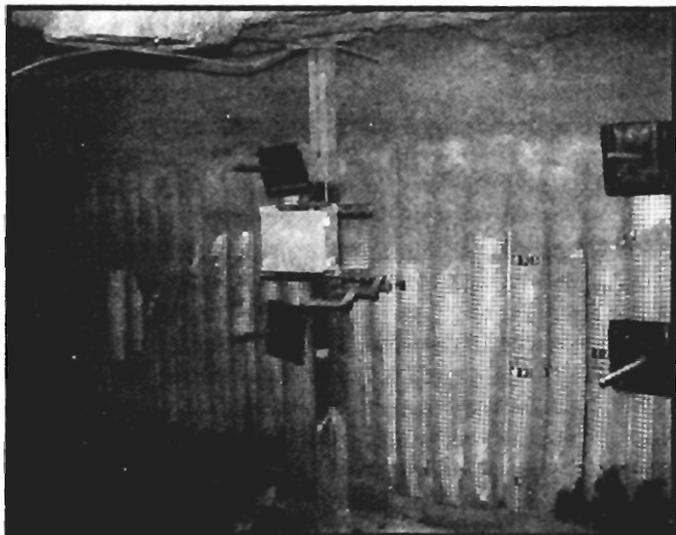
Figure 50.—Completed new (second) seal in high roof section of crosscut 3 (back side).

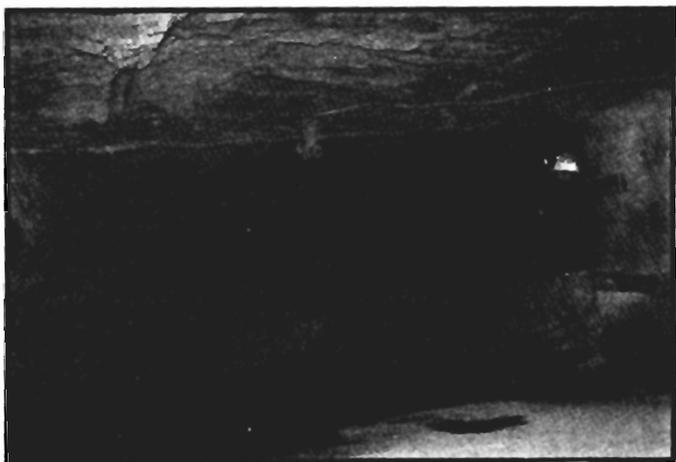
Figure 51.—Completed new seal in crosscut 4.

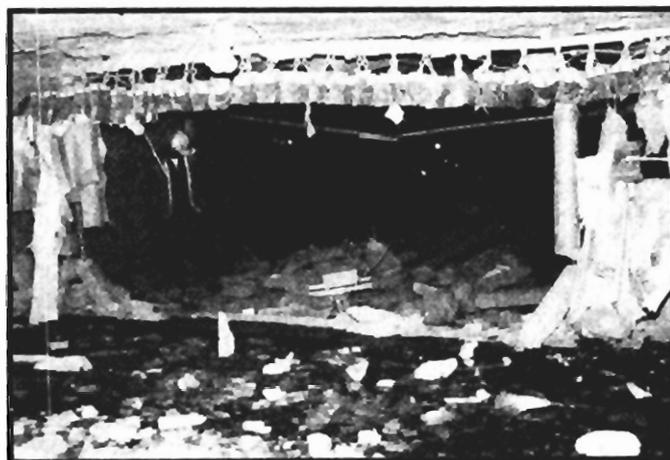
Figure 52.—Remains of crosscut 4 seal after test 364.

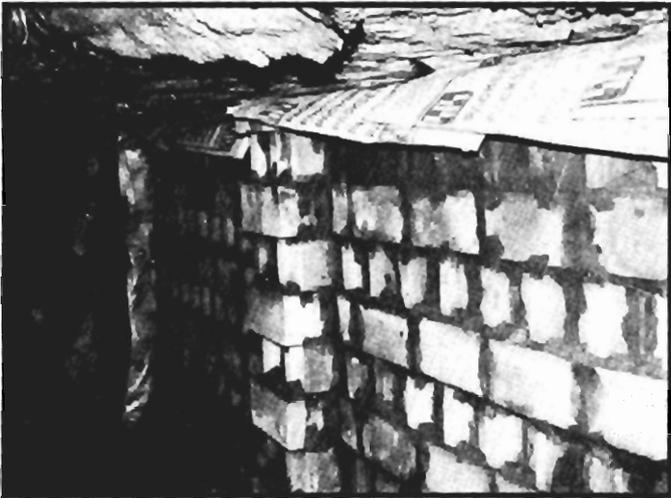
Figure 53.—Unfilled Packsetter bags at the seal interface with the mine roof and ribs.

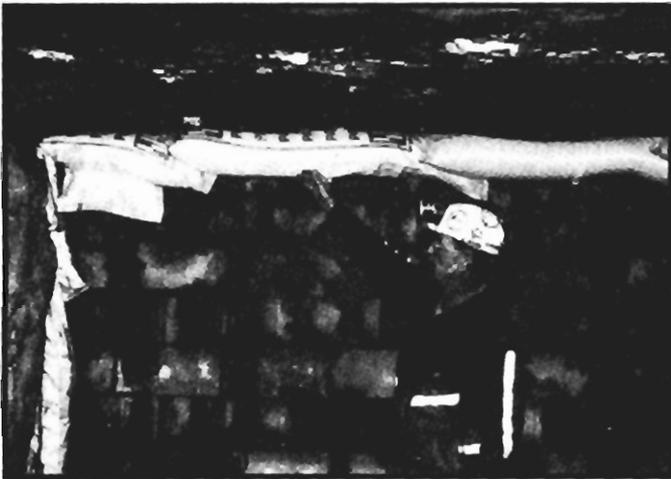
Figure 54.—Filled and pressurized Packsetter bags at the outby roof and rib seal interface showing full-size bags and one half-size bag on the left.

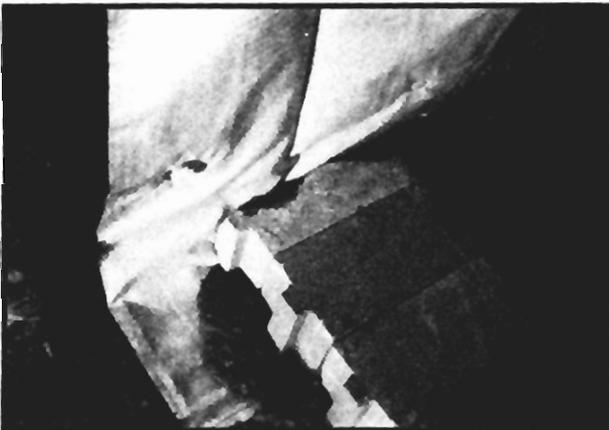
Figure 55.—Placement of the Packsetter bag at the mine rib and floor interface with the bottom course of the tongue-and-groove solid-concrete-block seal.

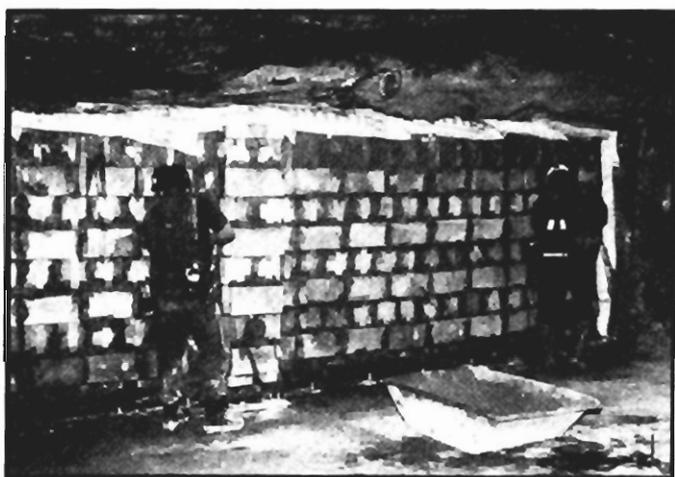
Figure 57.—Completed mortared seal with the Packsetter bags and floor hitching in crosscut 2.

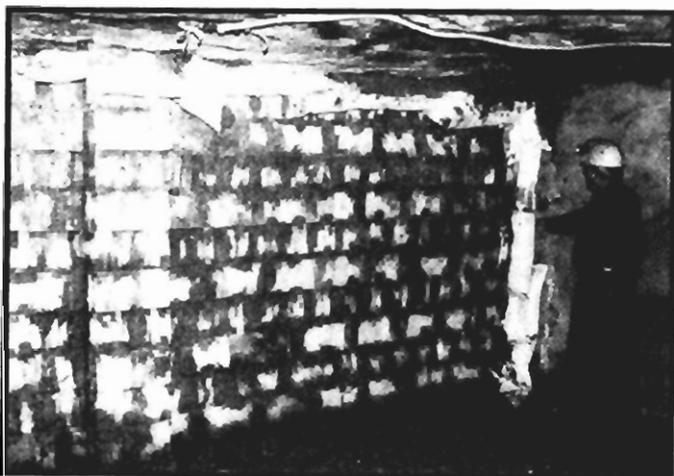
Figure 58.—Completed mortared seal with the Packsetter bags in crosscut 3.

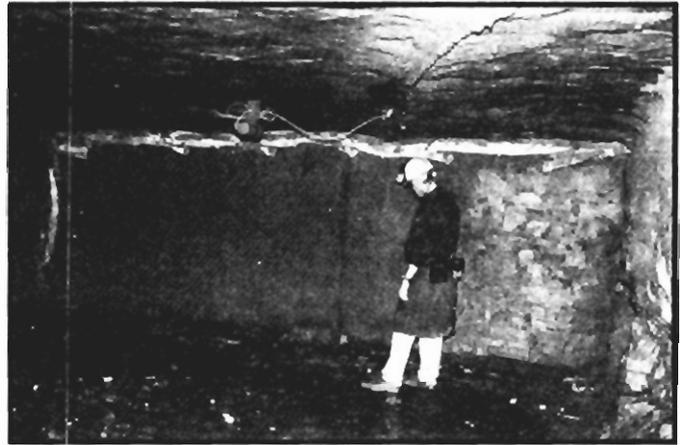
Figure 60.—Mortared seal with Packsetter bags in crosscut 3 after test 366.

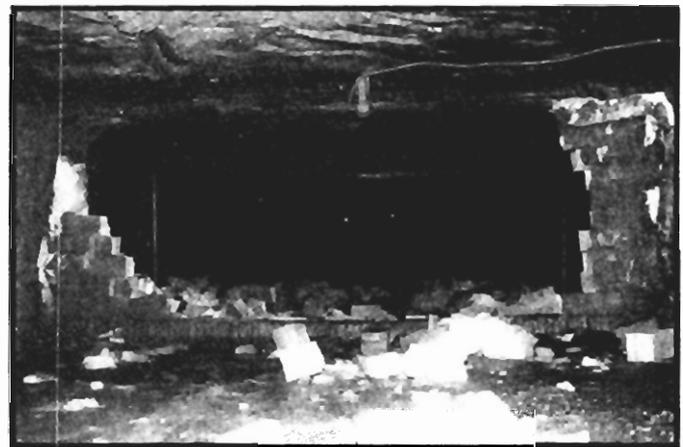
Figure 61.—Remains of the dry-stacked seal with the Packsetter bags in crosscut 4 after test 366.
