In-Depth Survey Report

Partnering to Control Dust from Fiber-Cement Siding

Division of Applied Research and Technology
Engineering and Physical Hazards Branch
EPHB Report No. 358-12a
St. Mary's Hospital
Greensboro, Georgia
November, 2013

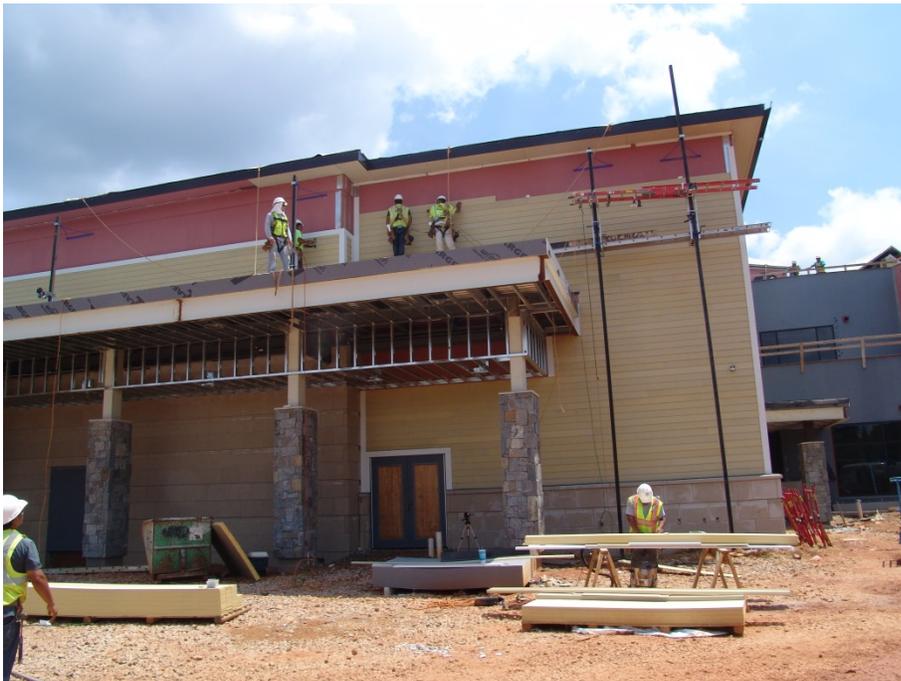
Figure 1 – The Construction Site.

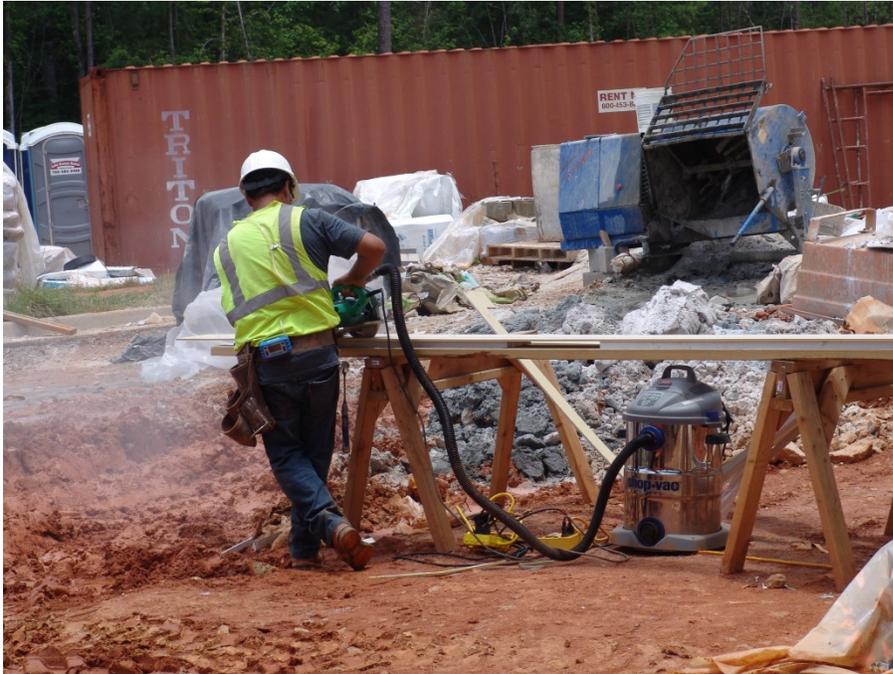
Figure 2 – A worker (cutter) cutting fiber-cement siding using a dust-collecting circular saw that was connected to a shop vacuum.

installers, who took the measurements, verbally communicated the size requirement to the cutter, and installed the siding. Figure 2 shows a cutter cutting fiber-cement siding on his work bench using a dust-collecting circular saw that was connected to a shop vacuum. Since fiber-cement siding was being installed on the second floor, the installers were normally on a pump jack scaffold or a boom lift. Personal breathing zone air samples were taken from the cutter and one of the installers from each group, giving a total of four sampled workers in this survey. None of the workers wore a respirator during the survey.

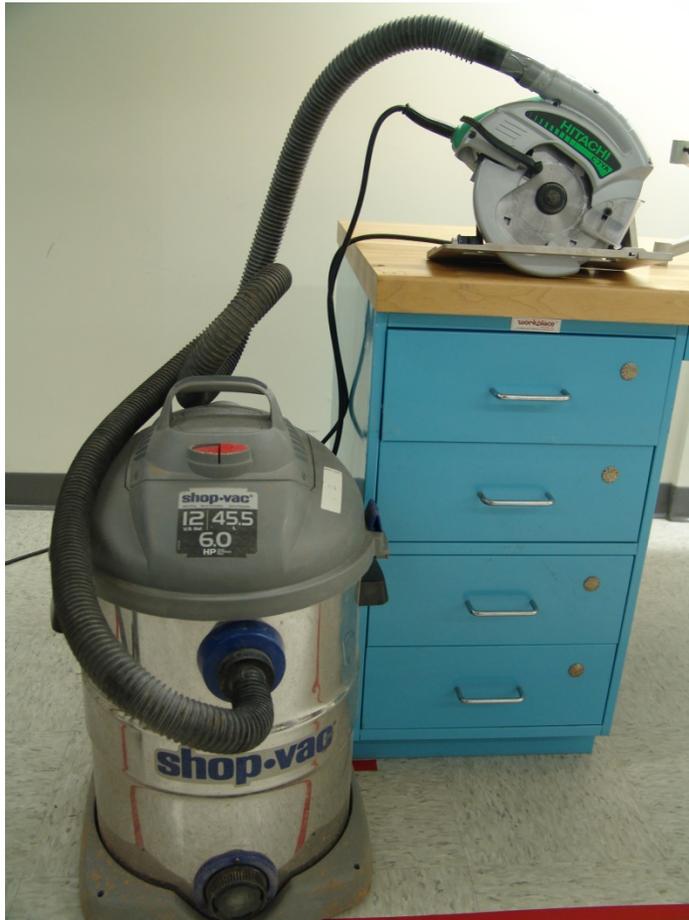
Figure 3 –The dust-collecting circular saw and its connection to the shop vacuum used in this survey.

In this survey, two 12-gallon shop vacuums (model # 586-62-11, Shop-Vac® Corporation, Williamsport, PA) were used to provide local exhaust ventilation for the two dust-collecting circular saws. As described earlier, the dust-collecting circular saws have a built-in shroud covering the saw blade and connecting to an exhaust port so that the flow induced by the running blade collects in the shroud a large amount of the dust generated while cutting and directs the dust to the exhaust port. A vacuum hose was used to connect the saw's exhaust port to the shop vacuum. Figure 3 shows the dust-collecting circular saw and how it is connected to the shop vacuum. A high efficiency disposable filter bag (fine filtration bag, part # 90672, Shop-Vac® Corporation, Williamsport, PA) was used in the shop vacuum to trap most of the dust and a Prolong cartridge filter (part # 90304, Shop-Vac® Corporation, Williamsport, PA) was used to capture the dust passing through the filter bag. Since most of the dust was captured in the filter bag rather than the cartridge filter, the life of the cartridge filter was greatly extended.

The shop vacuum was rated to provide a 0.094 m³/s (200 CFM) flow rate by the manufacturer, which is sufficient to provide good local exhaust ventilation for the cutting task, based on the NIOSH laboratory study. However, the actual flow rate can be affected when the shop vacuum is connected to the filters and vacuum hose. More importantly, the flow rate might change from dust loading on the filter bag and cartridge filter. Thus, a data logging pressure transducer (Smart Reader SRP-004-30G-128K 0-30 PSI-G, ACR Systems, Surrey, BC, Canada) was placed in the tank of the shop vacuum, between the filter bag and the cartridge filter in the flow path, to log the local absolute air pressure. A laboratory study at NIOSH found that the difference between the absolute air pressure in the shop vacuum tank when the shop vacuum is on and off is linearly correlated with the actual air flow rate, as measured using a Delta tube (model # 307BZ-11-AO, Mid-West Instrument, Sterling Heights, MI). In the laboratory study, a gate valve was used to adjust the air flow rate so that the correlation between the actual flow rate read from the Delta tube and the absolute air pressure difference from the data logging pressure transducer in the shop vacuum tank could be obtained. This correlation was used with the pressure data collected from the shop vacuums at the job site to estimate their actual flow rates. A battery pack (model # BP-101, ACR Systems, Surrey, BC, Canada) was used together with the data logging pressure transducer in each shop vacuum in order to obtain vacuum tank pressure readings every 2 seconds.
