Evaluation of Five Self-Contained Breathing Apparatus for Potential Contribution to a Fatal Event in the Fire Service

Kansas City, Missouri Fire Department Request for MSA Firehawk® M7 model, 4500 psi units with NIOSH Approval Numbers TC-13F-550CBRN and TC-13F-549CBRN (July 27, 2016)

NIOSH Task Number 20619

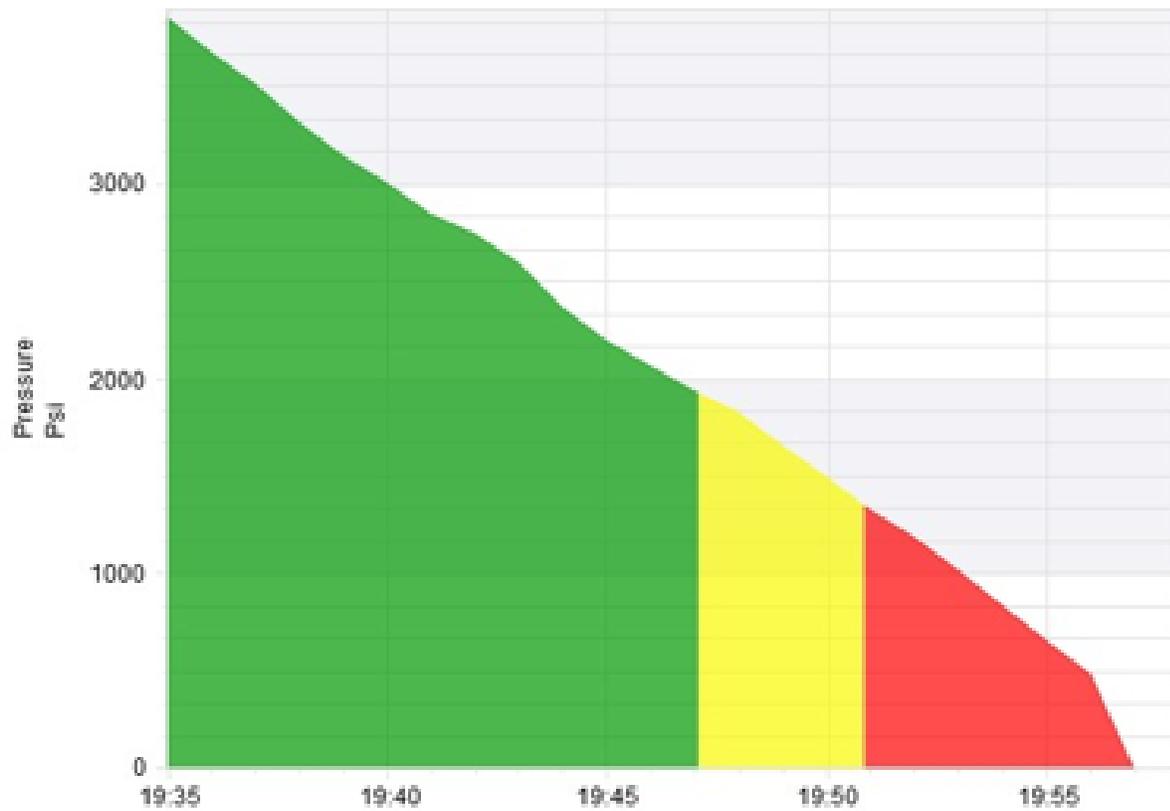
alpha3COUT: 11182477
TAG User:
TAG Team:

Incident start: 10/12/2015 7:35 PM
Incident End: 10/12/2015 7:58 PM

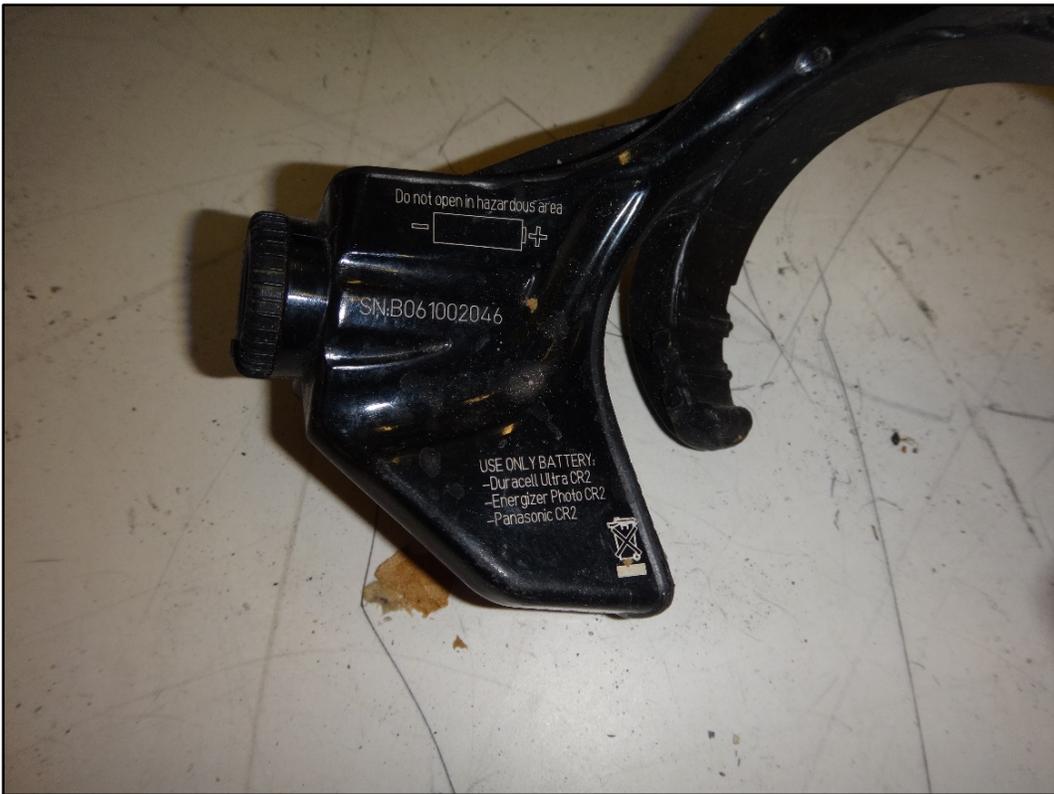
Figure 10: HUD Removed from facepiece to display markings (left side)

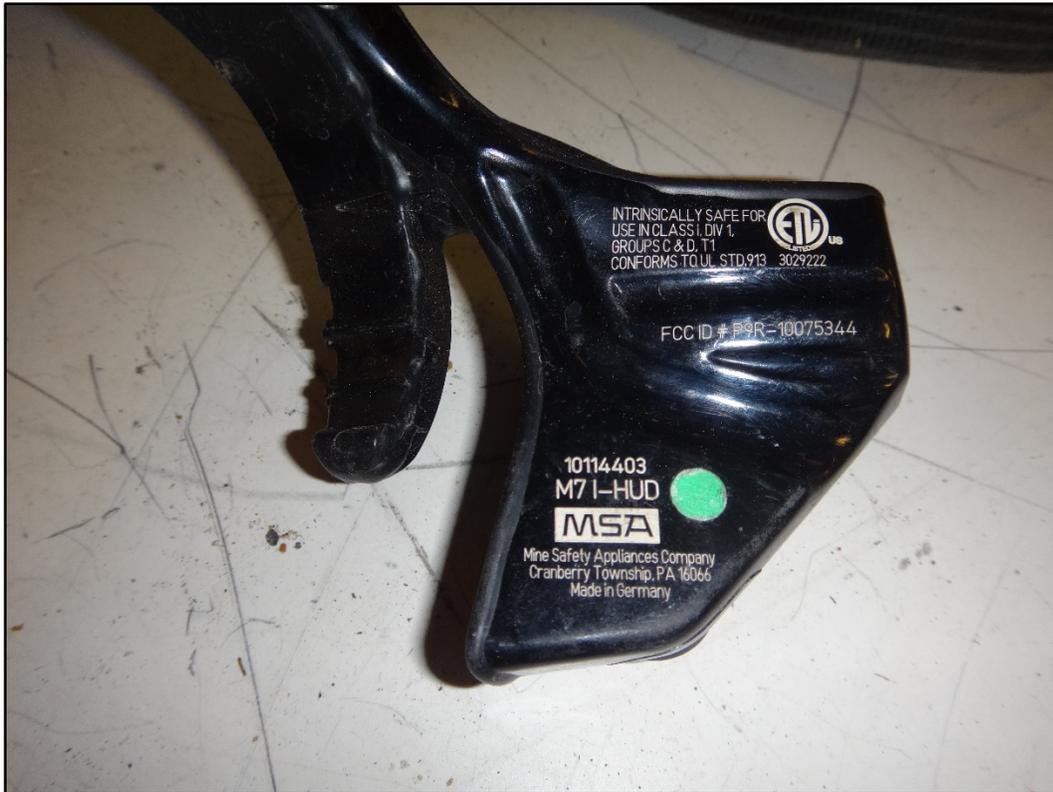
Figure 11: HUD removed from facepiece to display markings (right side)

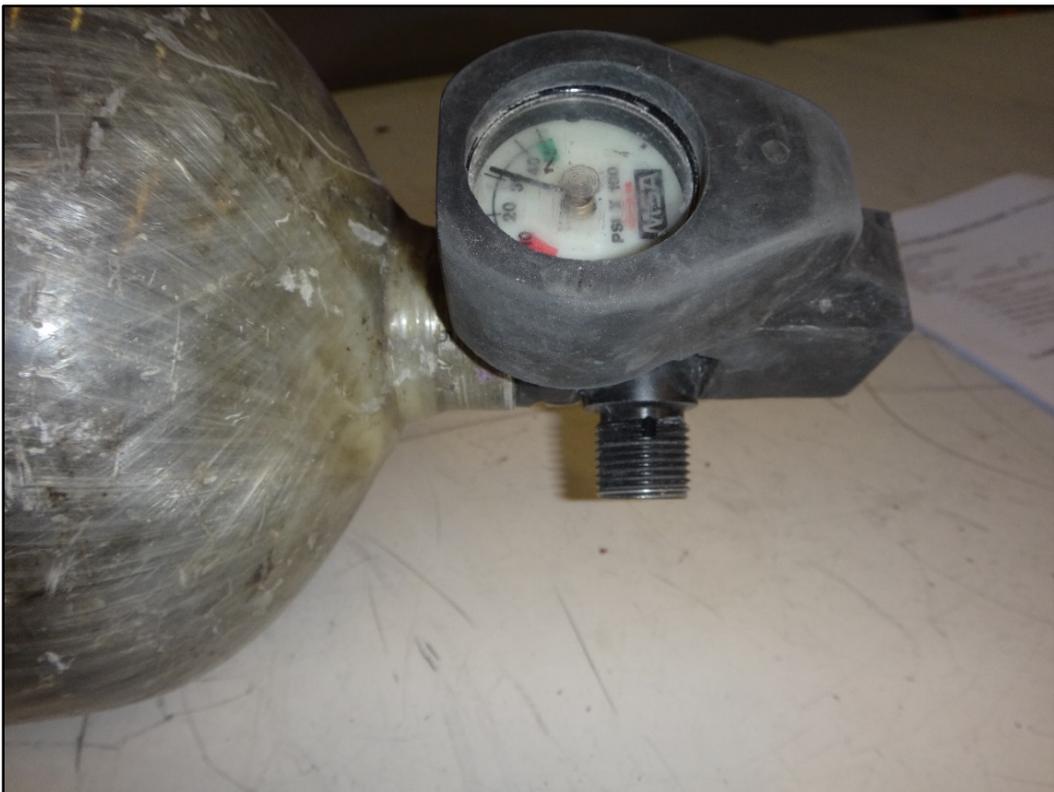
Figure 37: Cylinder gauge is readable and threads clean

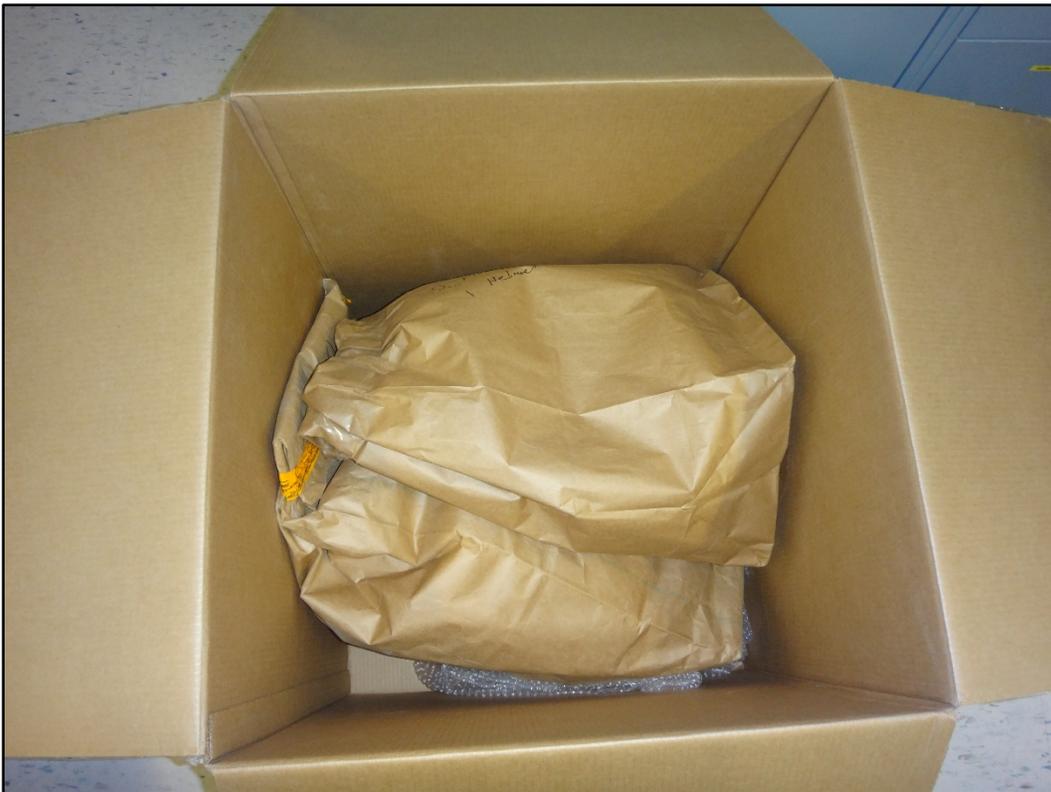
Figure 2: SCBA unit as received

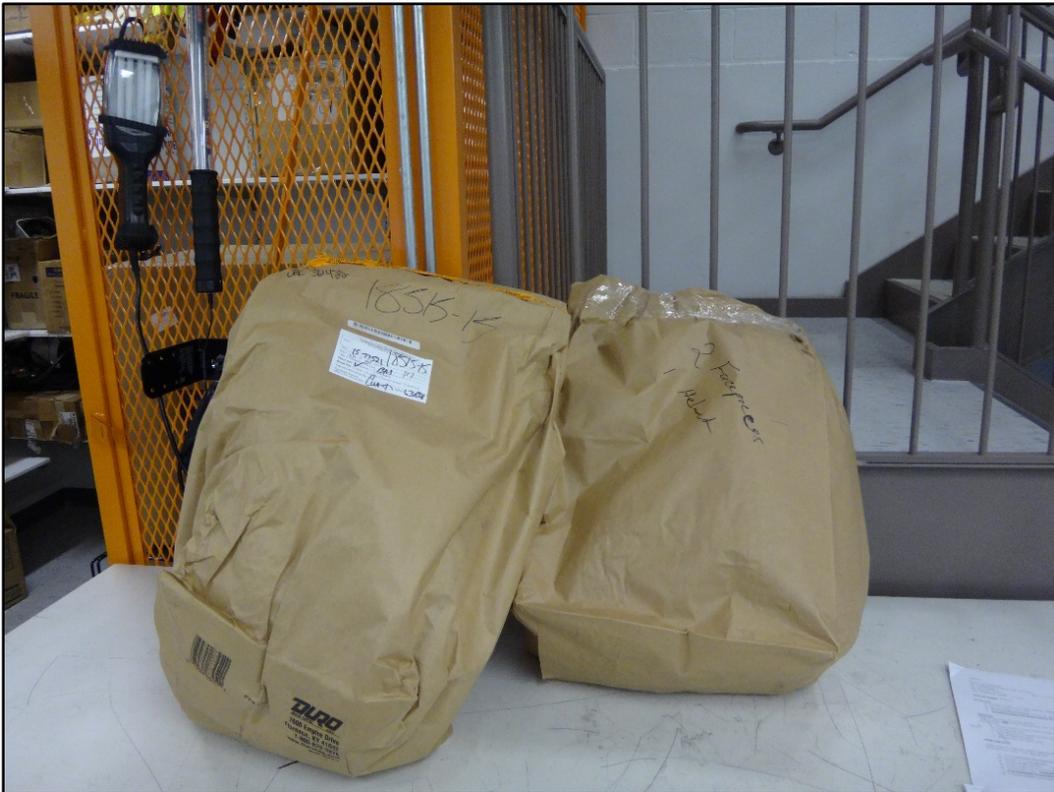
Figure 3: Two facepieces, one helmet, and SCBA unit out of box

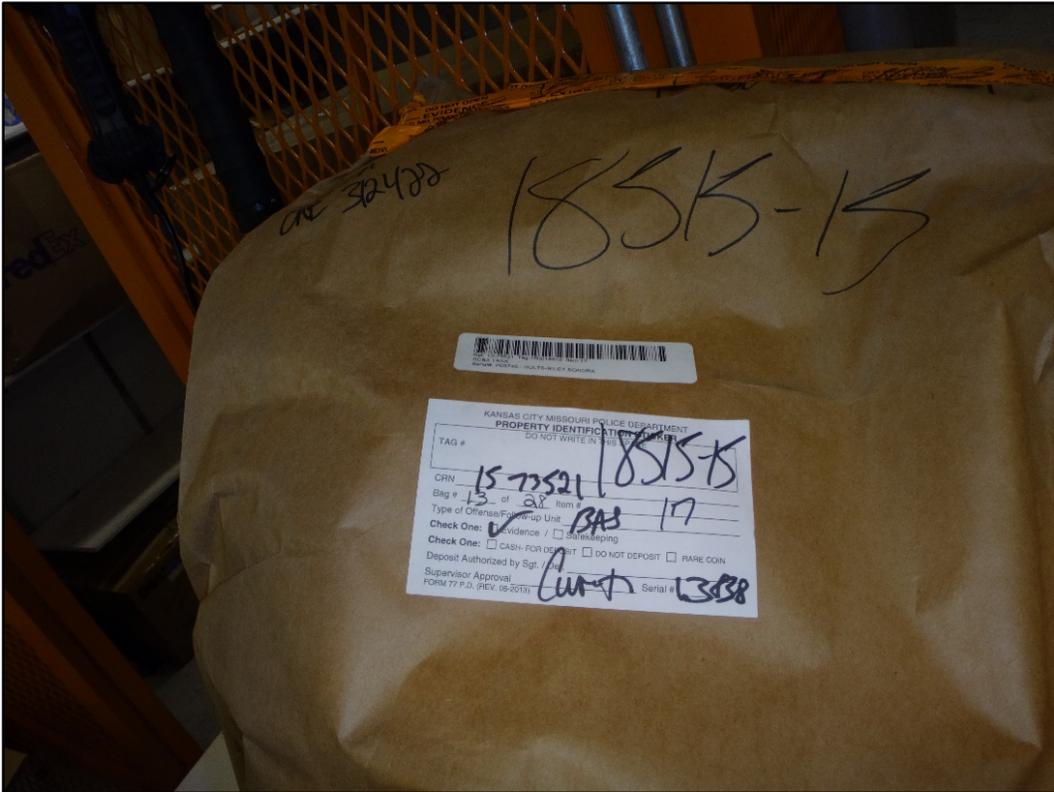
Figure 4: Identifying markings

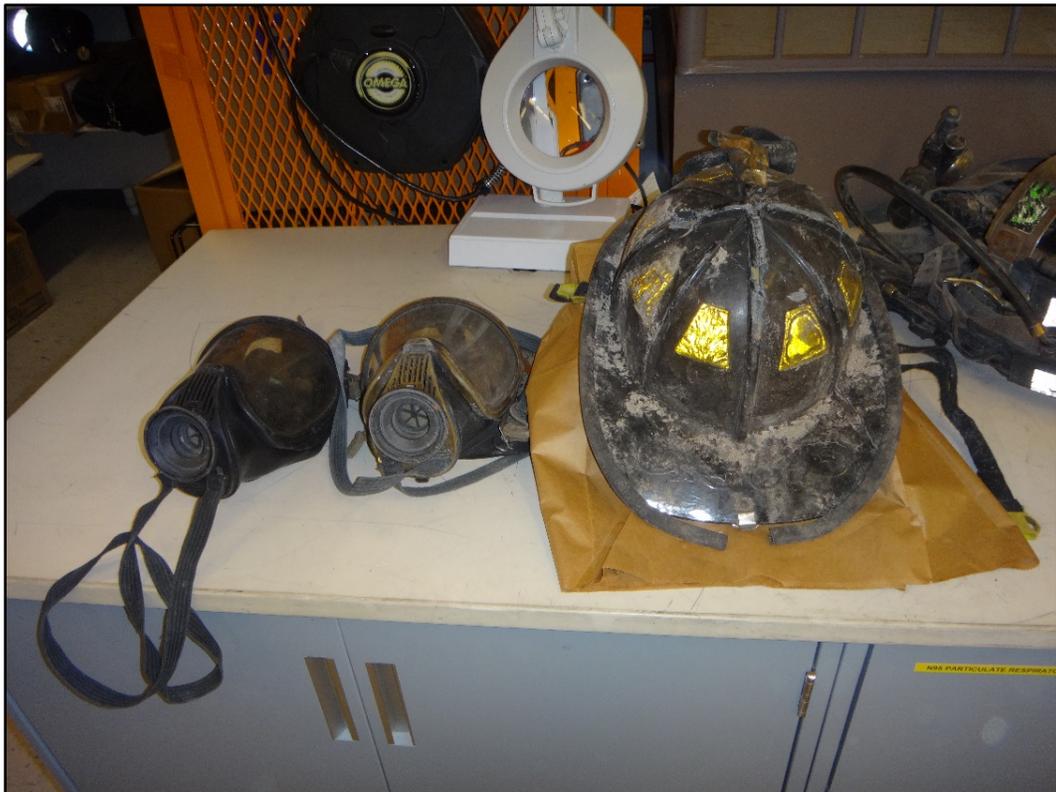
Figure 6: Helmet and two facepieces out of paper

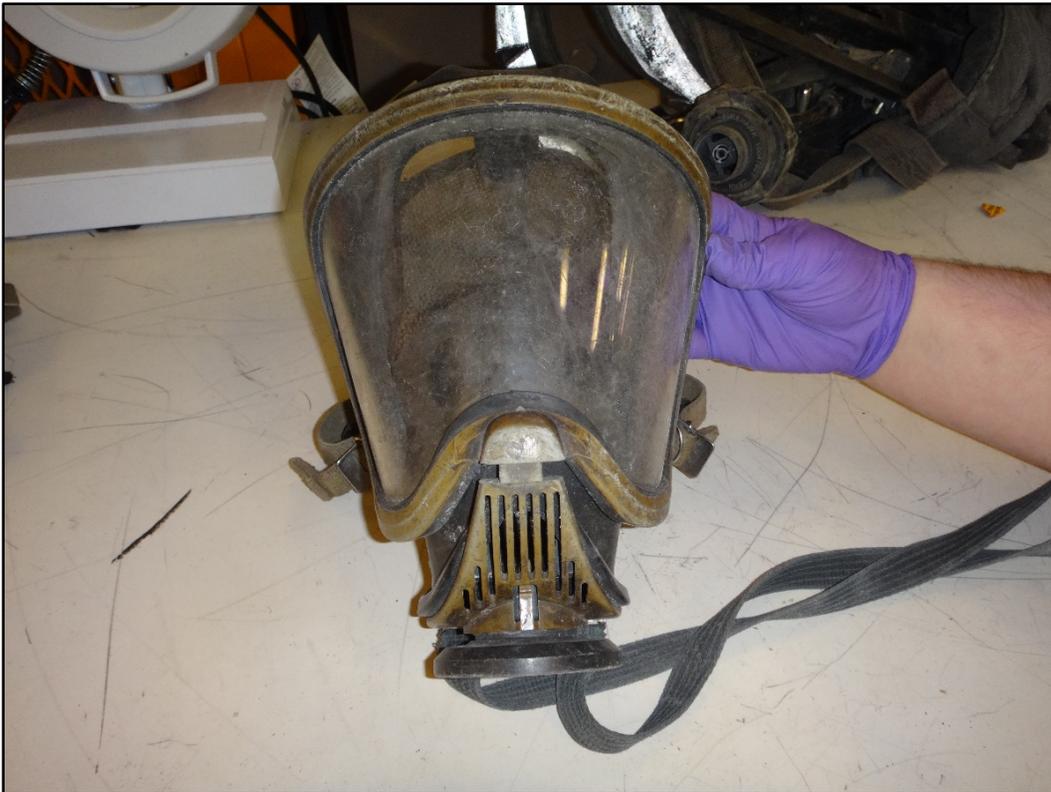
Figure 7: Overview of facepiece one

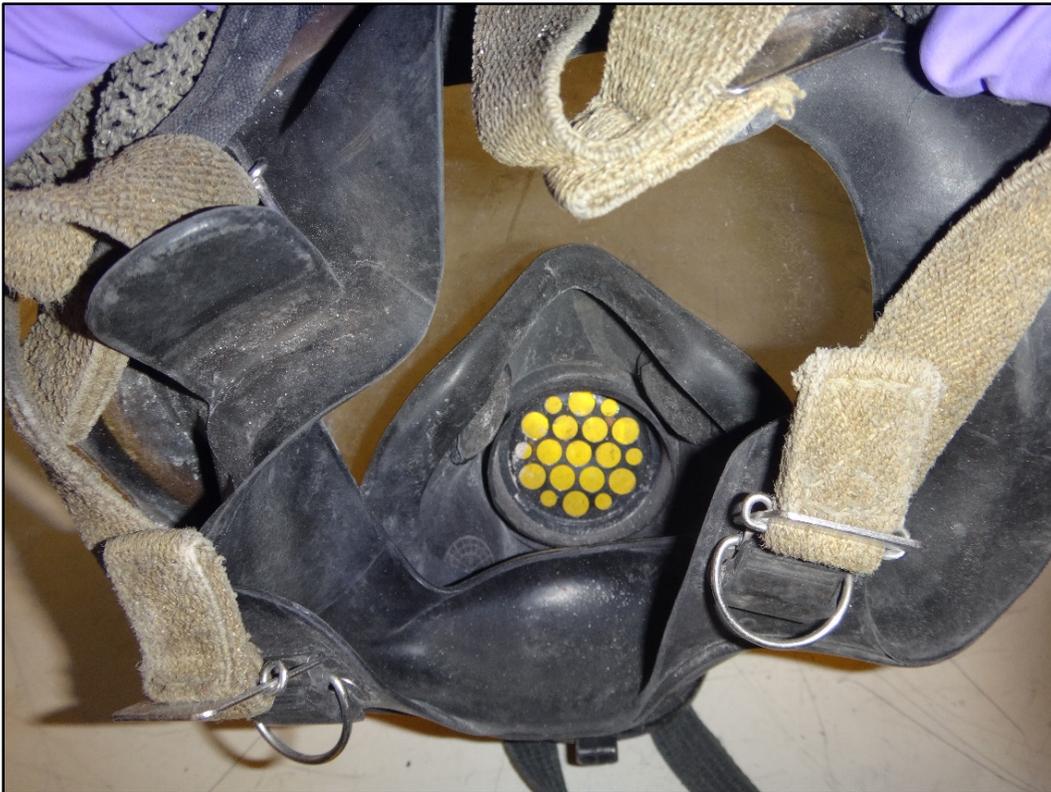
Figure 9: Inside of facepiece one, HUD is not present

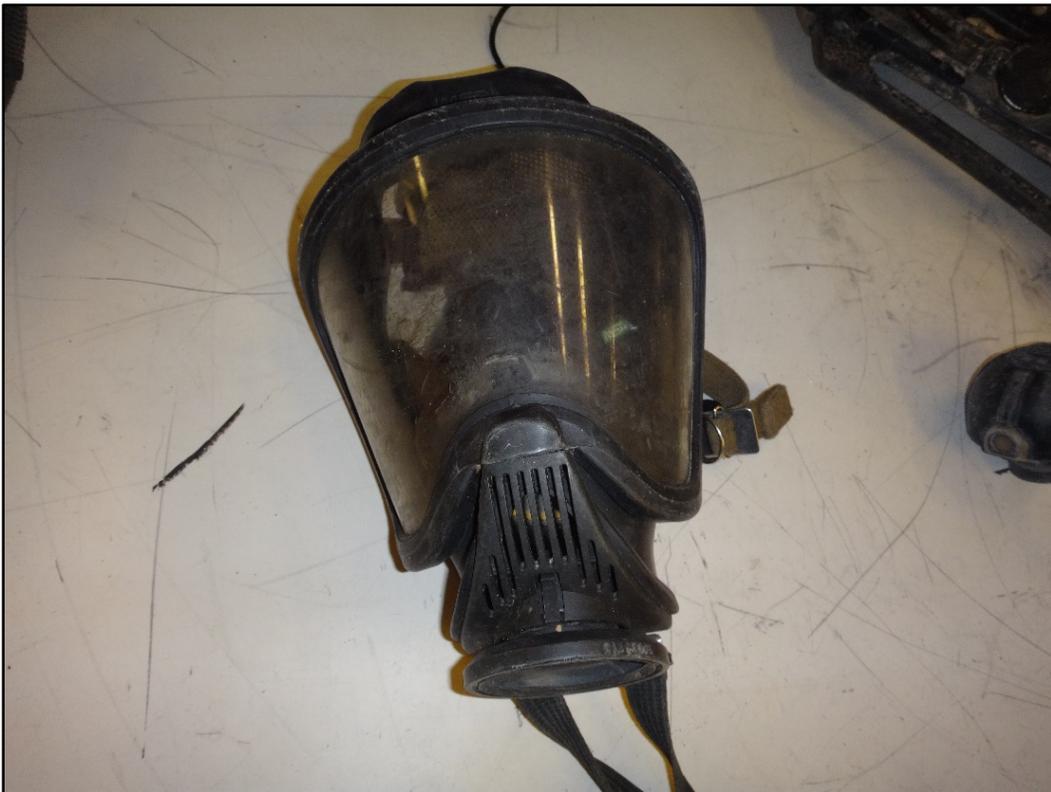
Figure 10: Overview of facepiece two

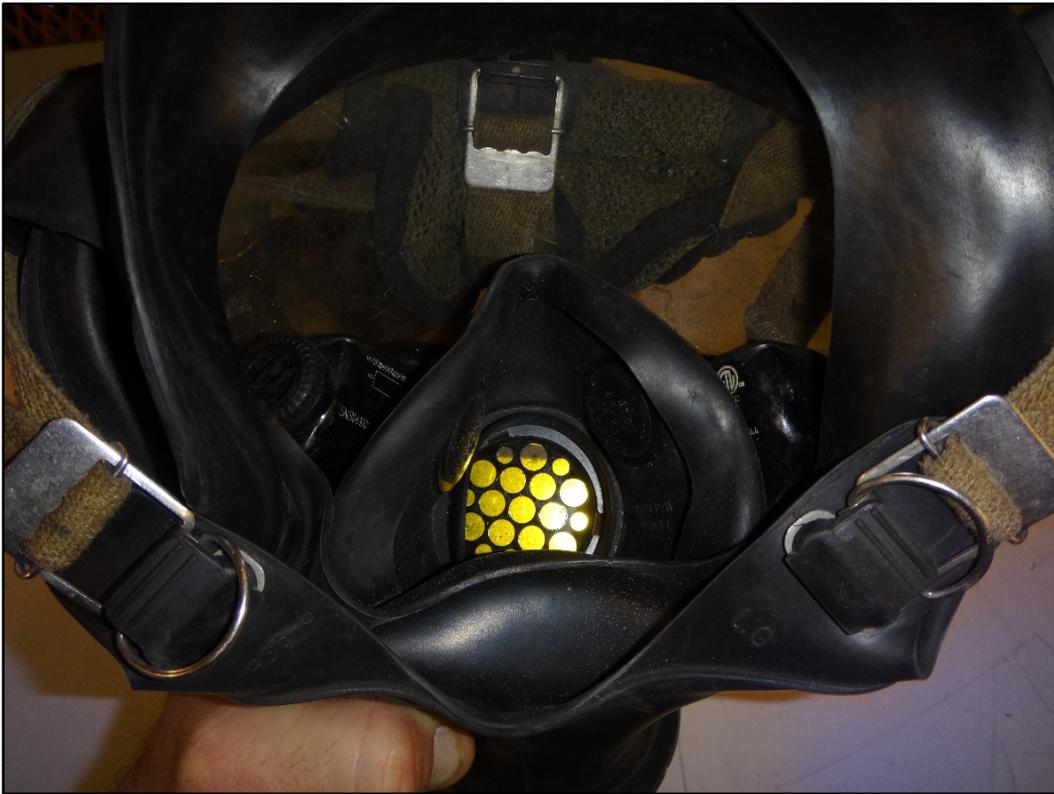
Figure 11: Inside view of facepiece two

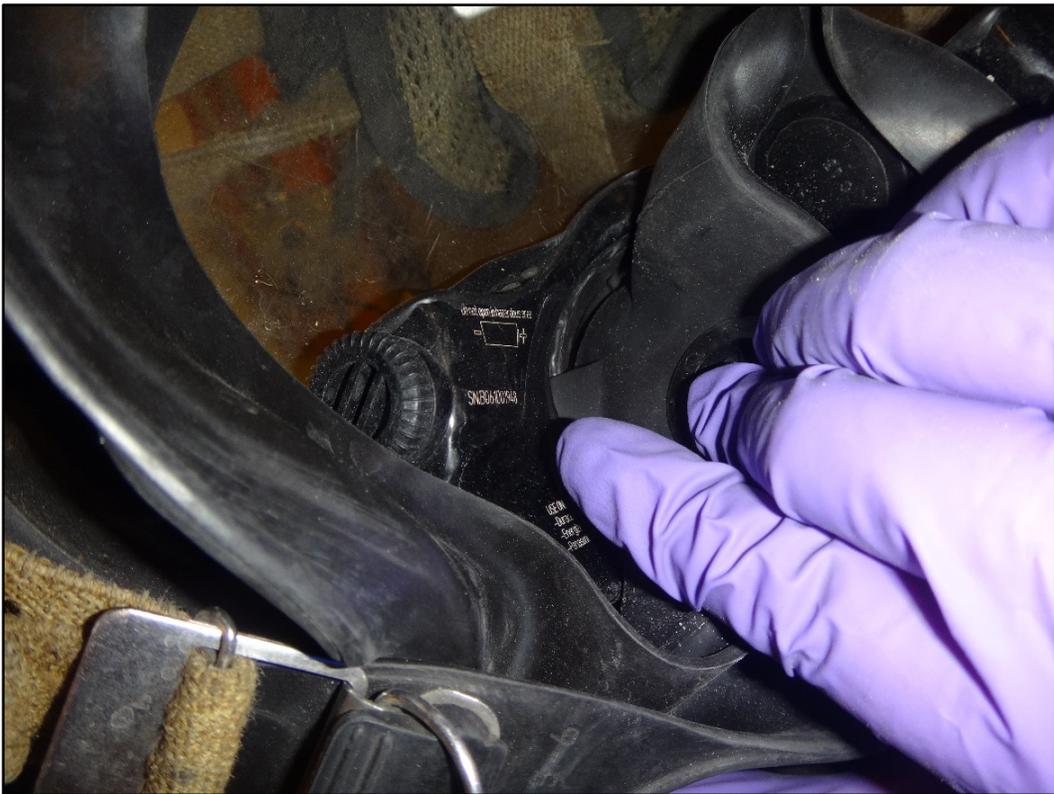
Figure 12: HUD inside of facepiece two

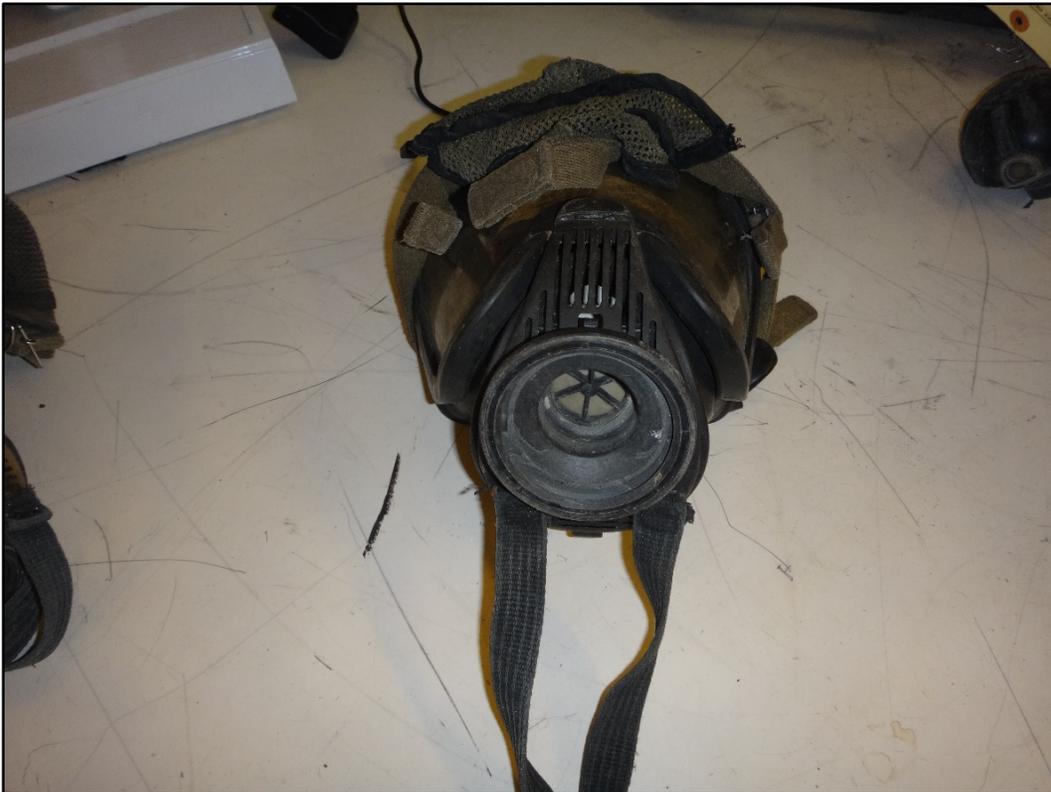
Figure 13: Overview of facepiece two

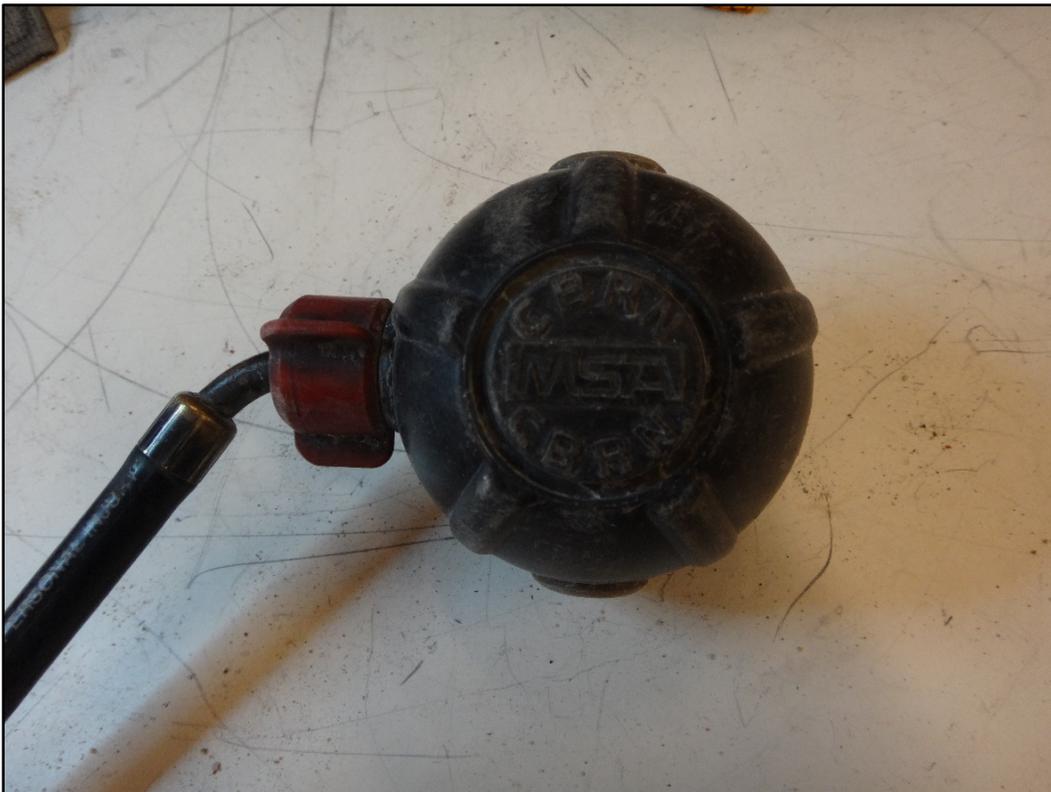
Figure 14: Mask mounted regulator (MMR)

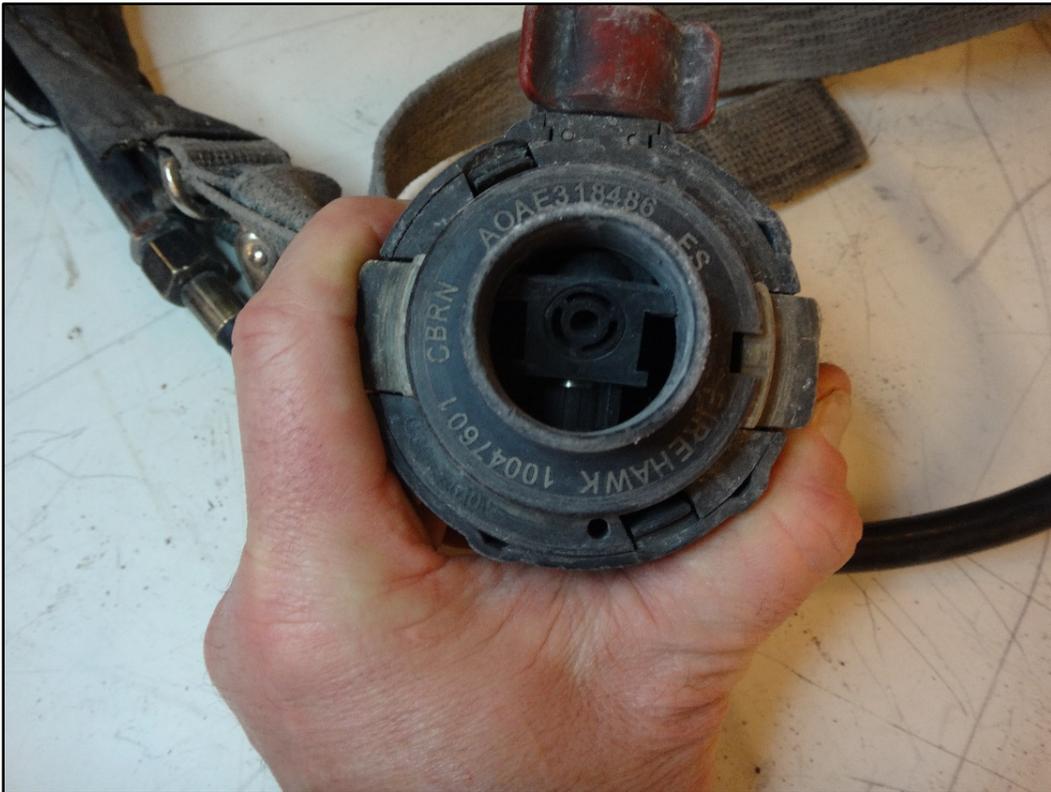
Figure 15: Inside flange, MMR

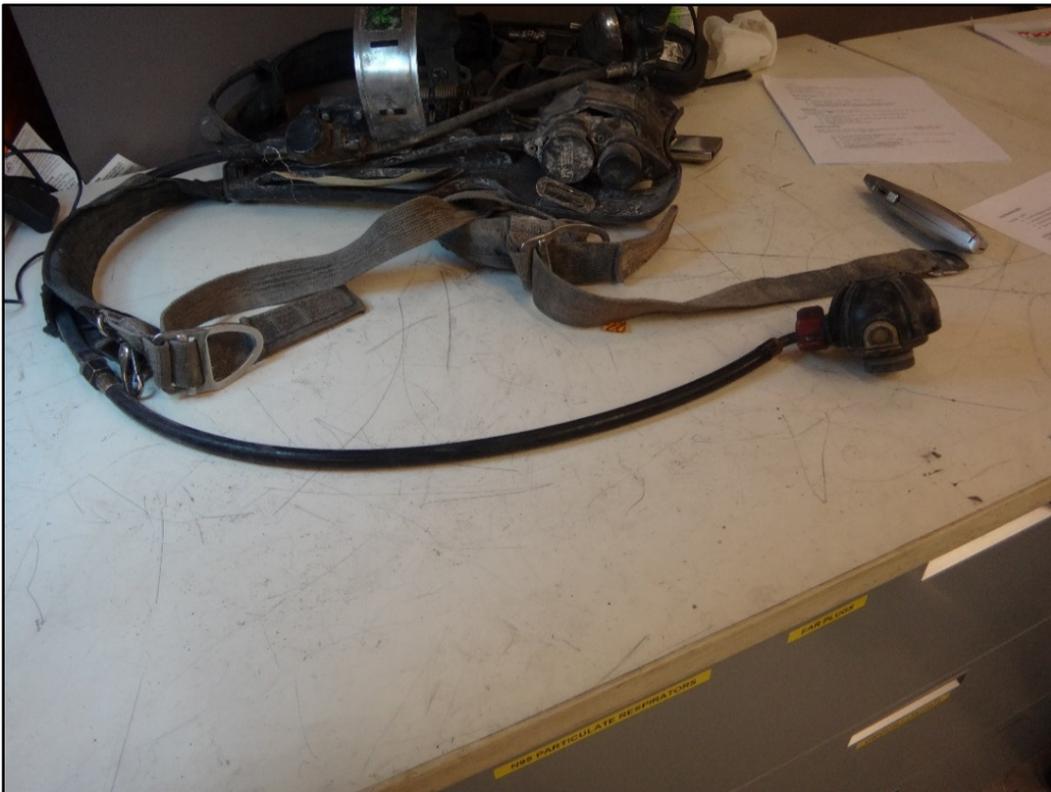
Figure 16: Low-pressure hose

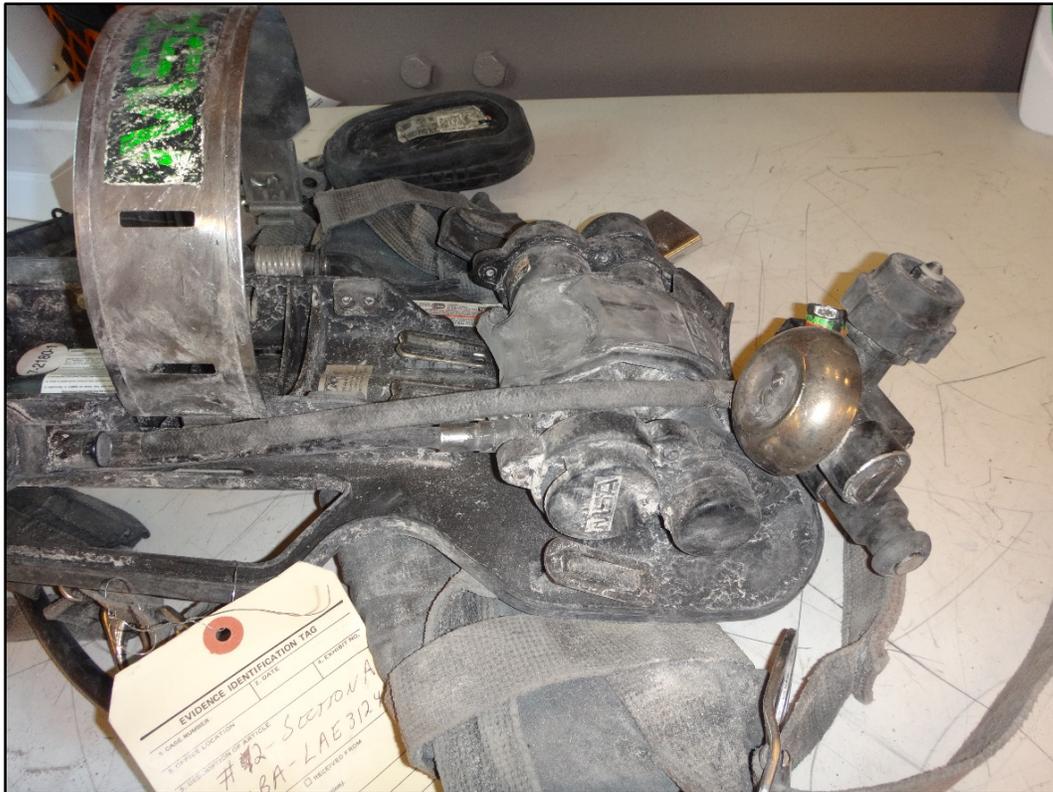
Figure 19: High-pressure hose and cylinder attachment

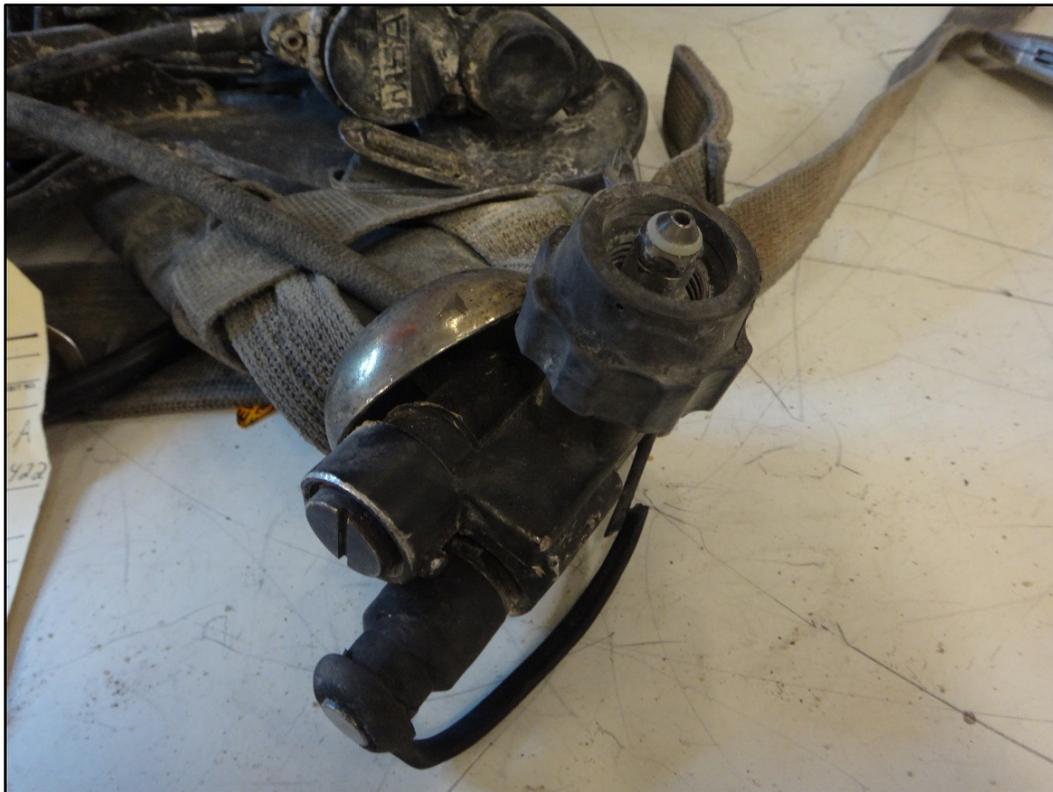
Figure 20: Cylinder attachment overview and relief valve with bell assembly

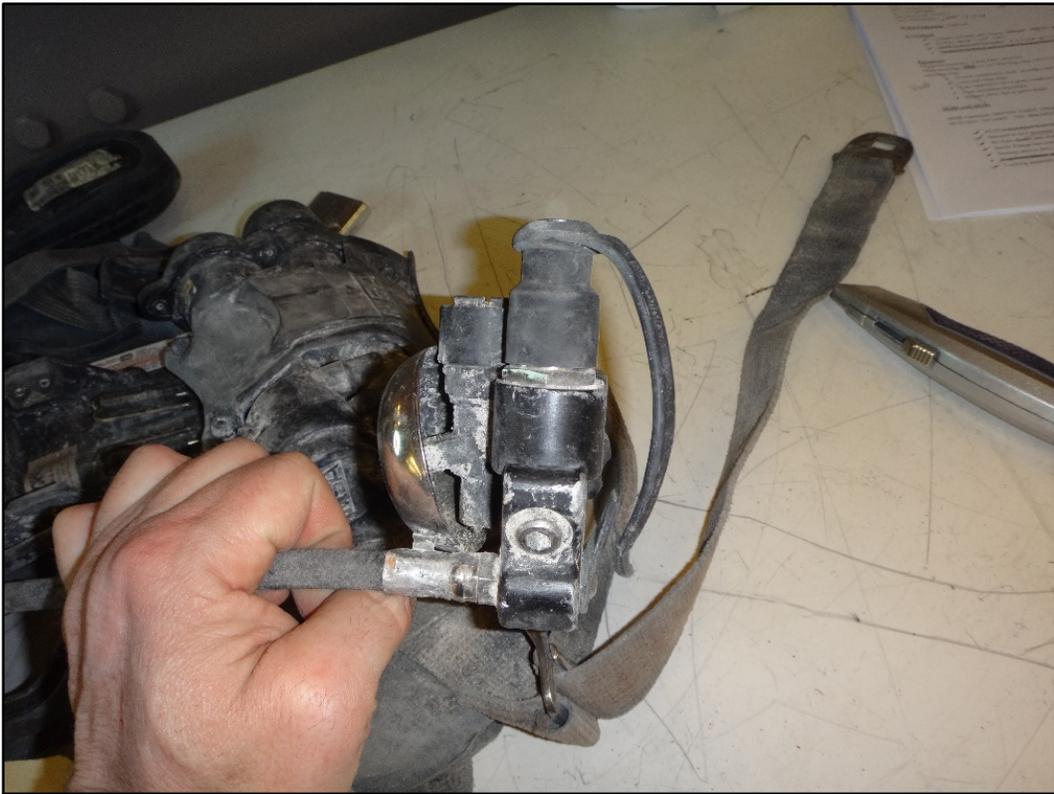
Figure 21: Quick-Fill port on cylinder attachment

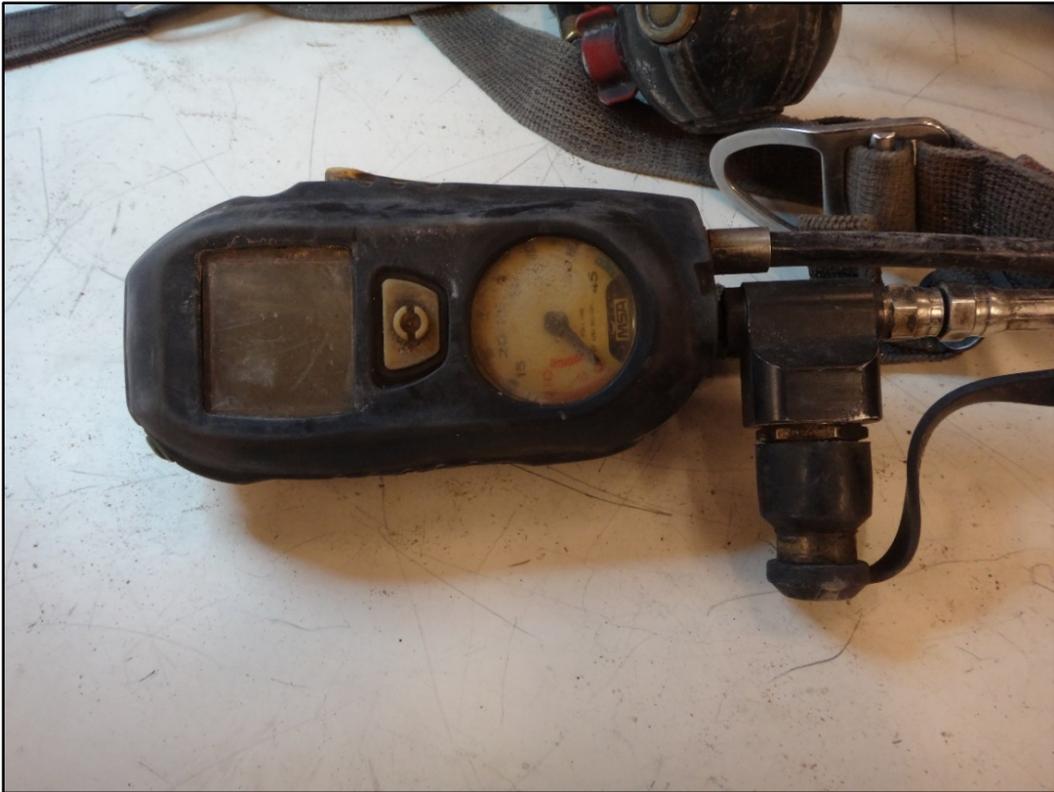
Figure 22: PASS console

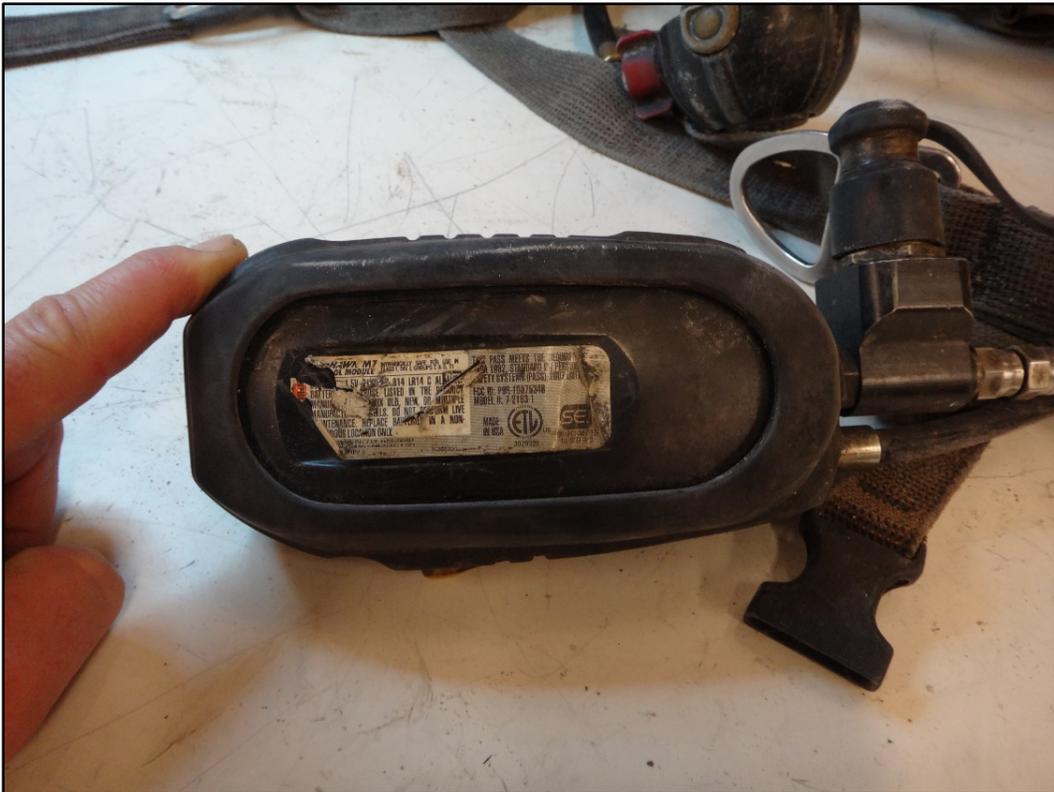
Figure 23: Back of PASS console, SEI label

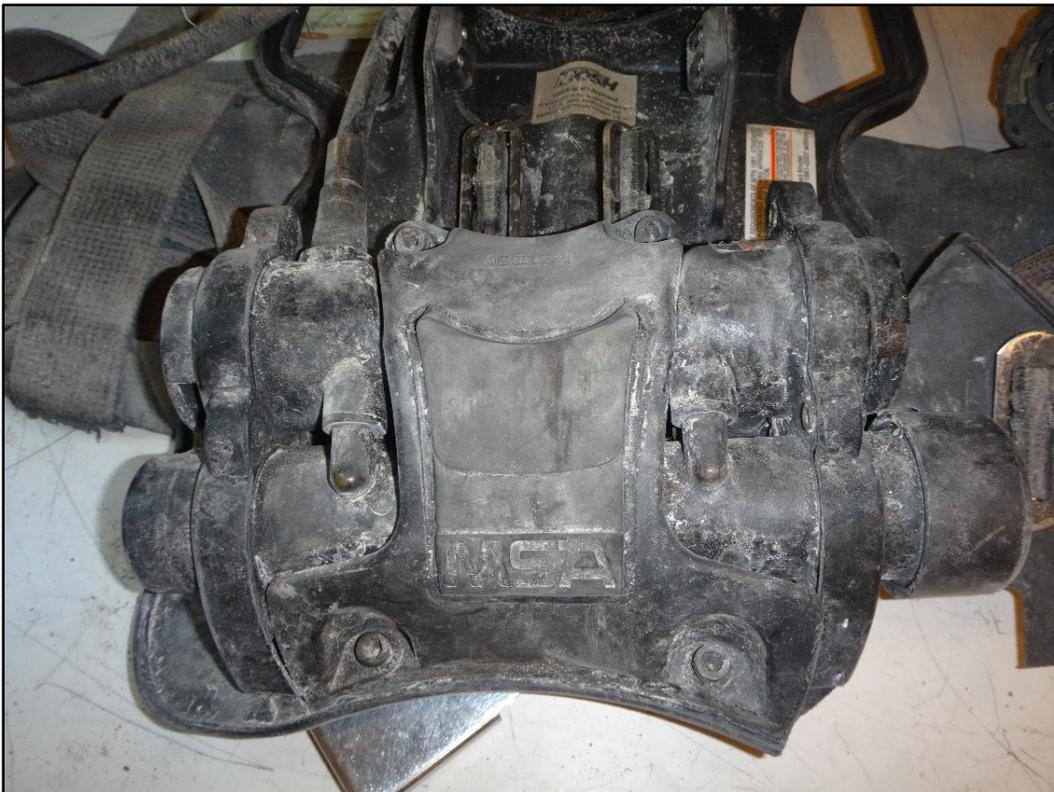
Figure 24: PASS control module

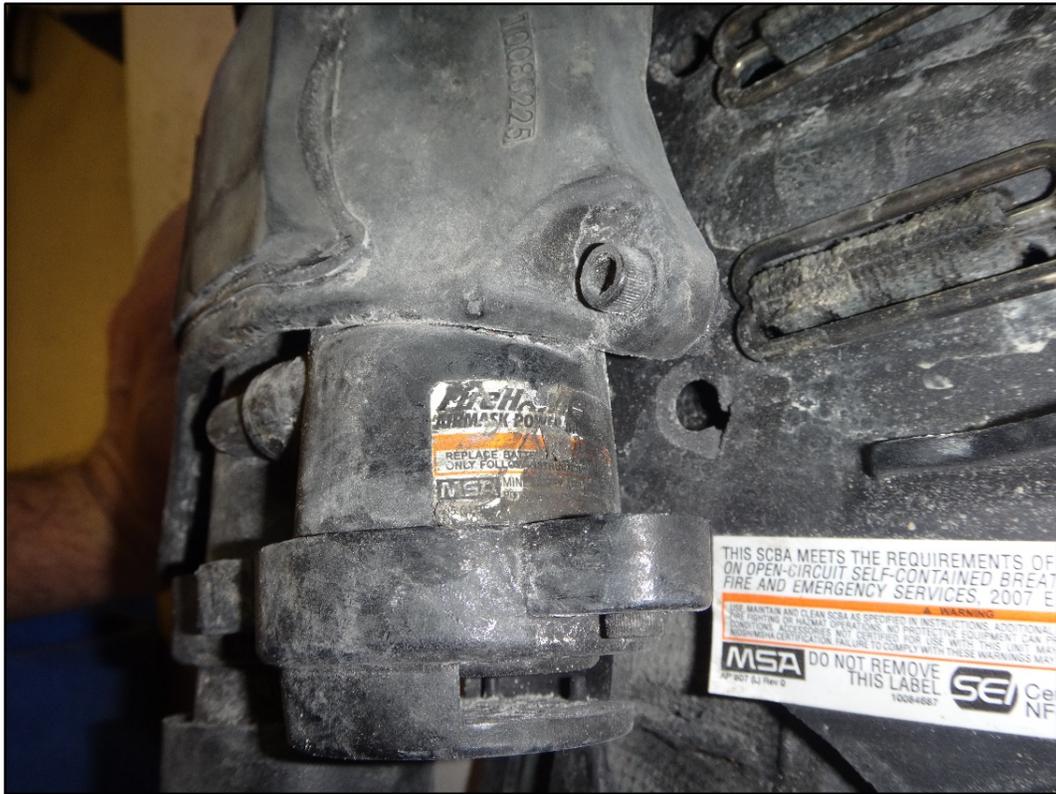
Figure 25: Label on side of PASS control module

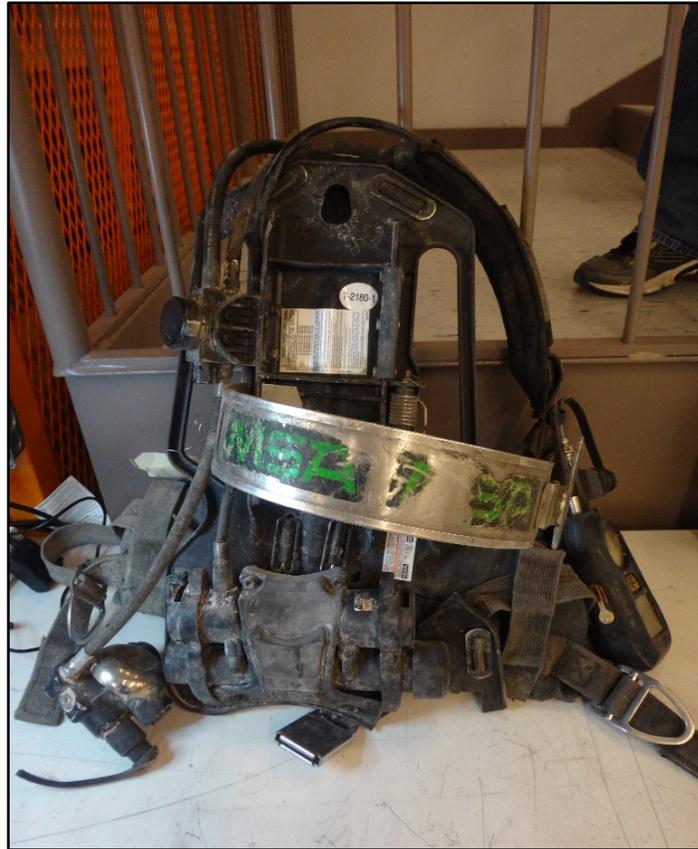
Figure 26: Overview of pack assembly

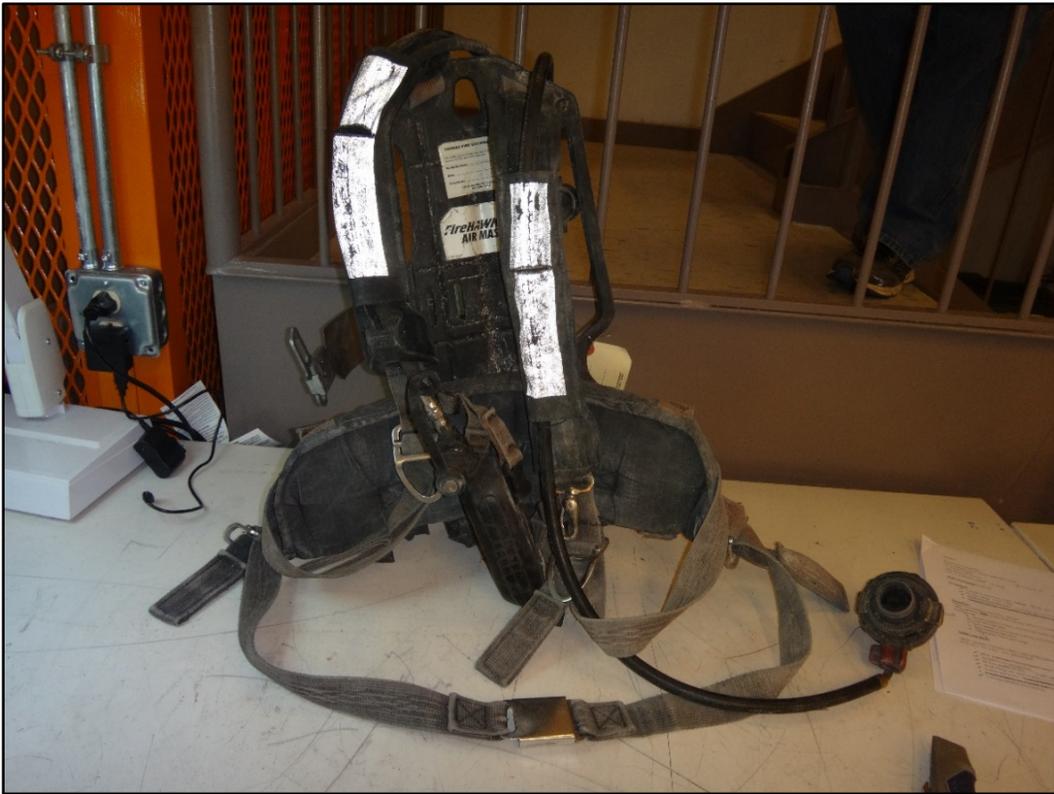
Figure 29: Overview of straps and buckles

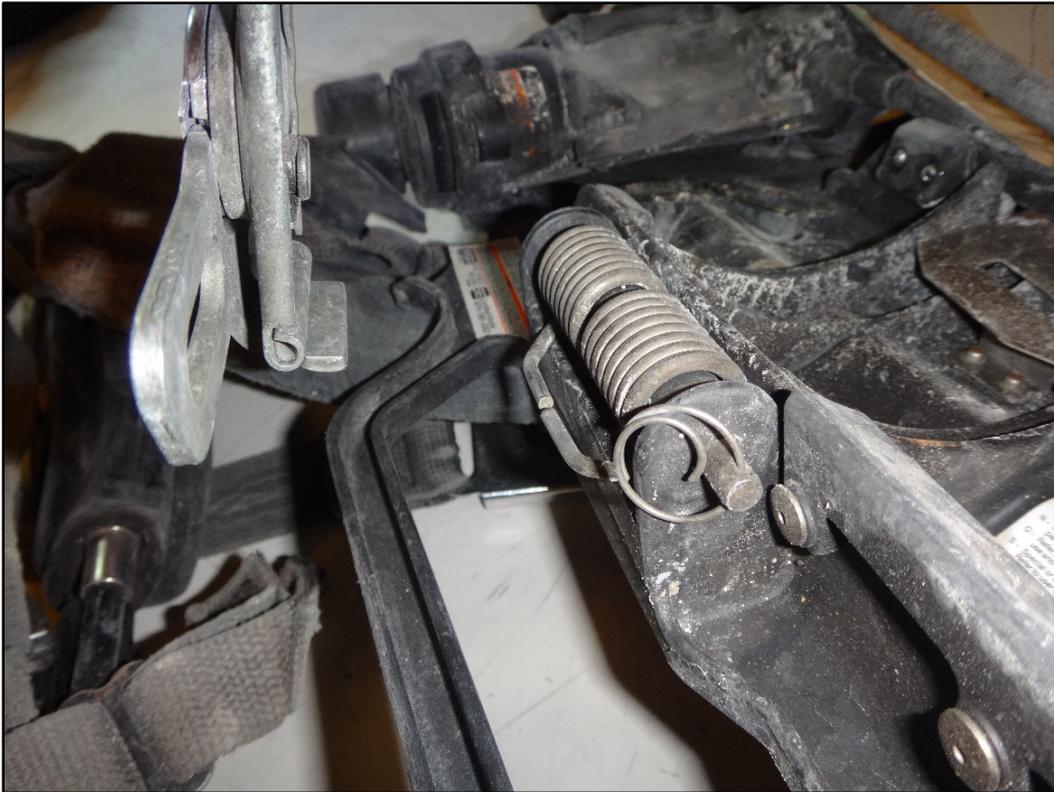
Figure 32: Attachment point for cylinder strap
