Evaluation of Five Self-Contained Breathing Apparatus for Potential Contribution to a Fatal Event in the Fire Service

Kansas City, Missouri Fire Department Request for MSA Firehawk® M7 model, 4500 psi units with NIOSH Approval Numbers TC-13F-550CBRN and TC-13F-549CBRN (July 27, 2016)

NIOSH Task Number 20619

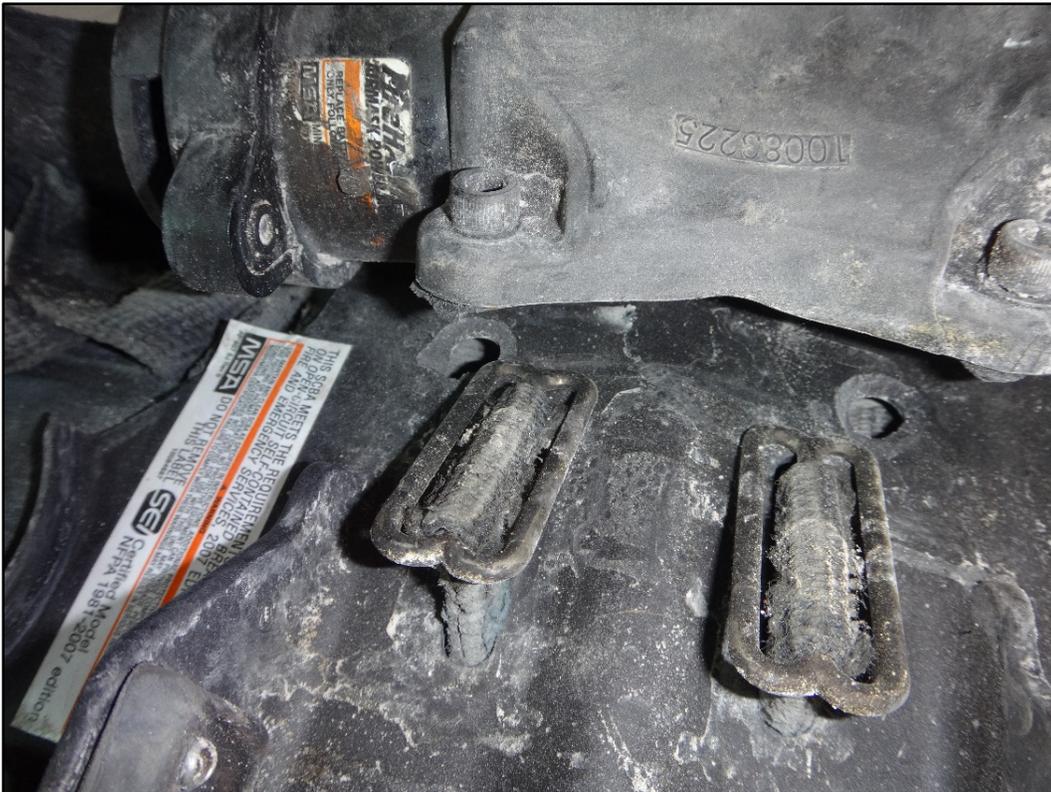
Figure 33: Identifying markings on inside of backframe

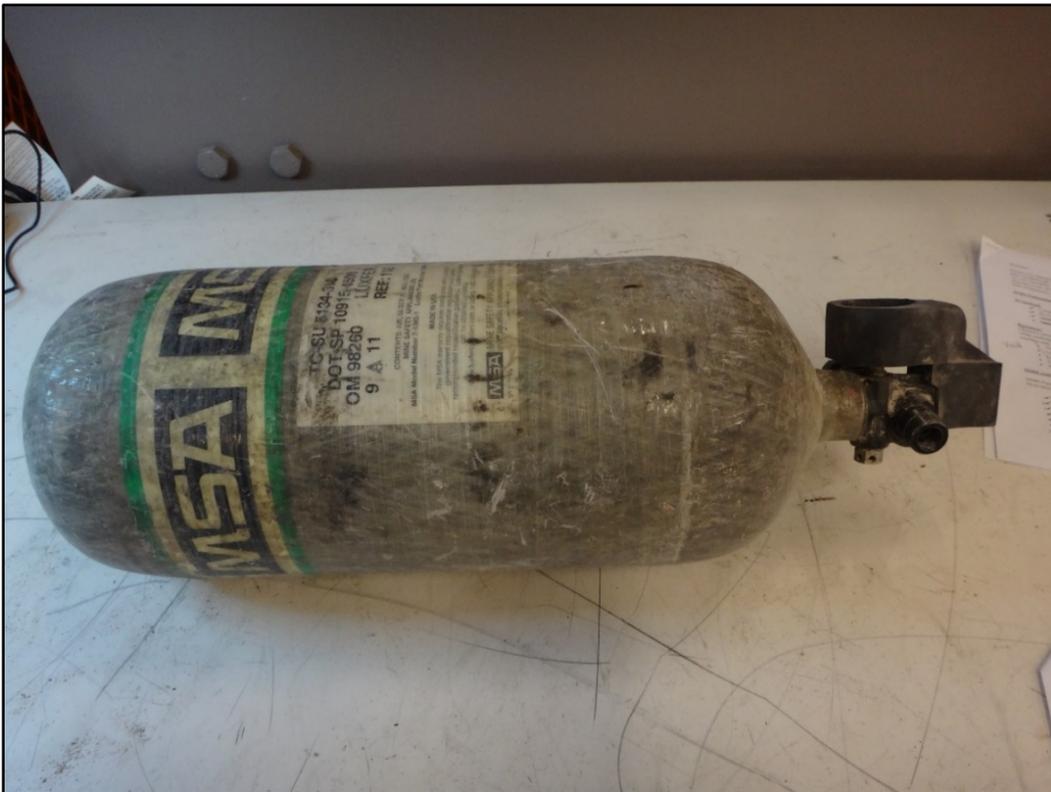
Figure 34: Overview of cylinder

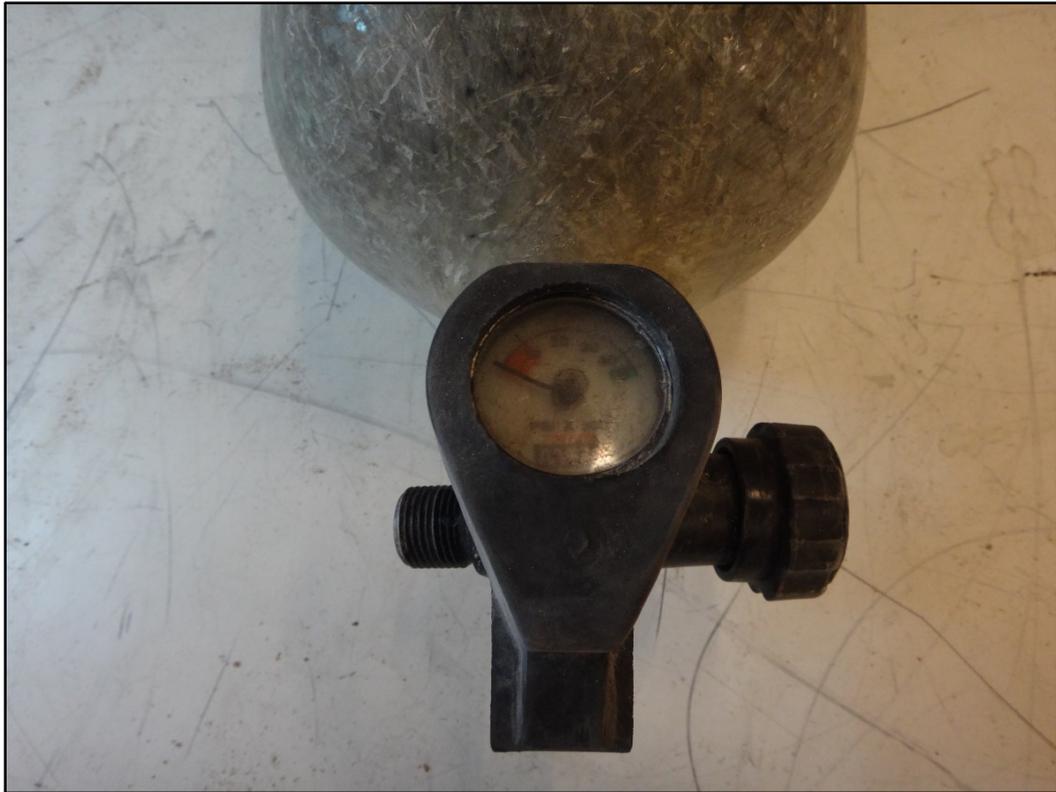
Figure 36: Cylinder gauge is readable

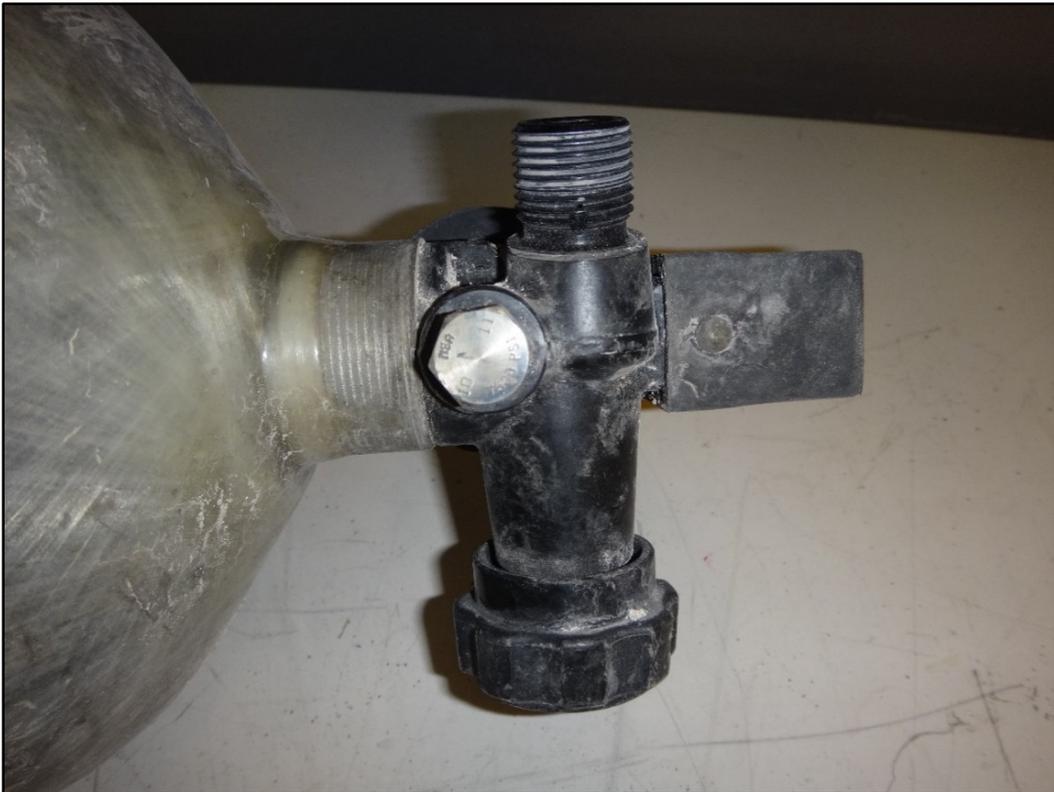
Figure 37: Cylinder threads

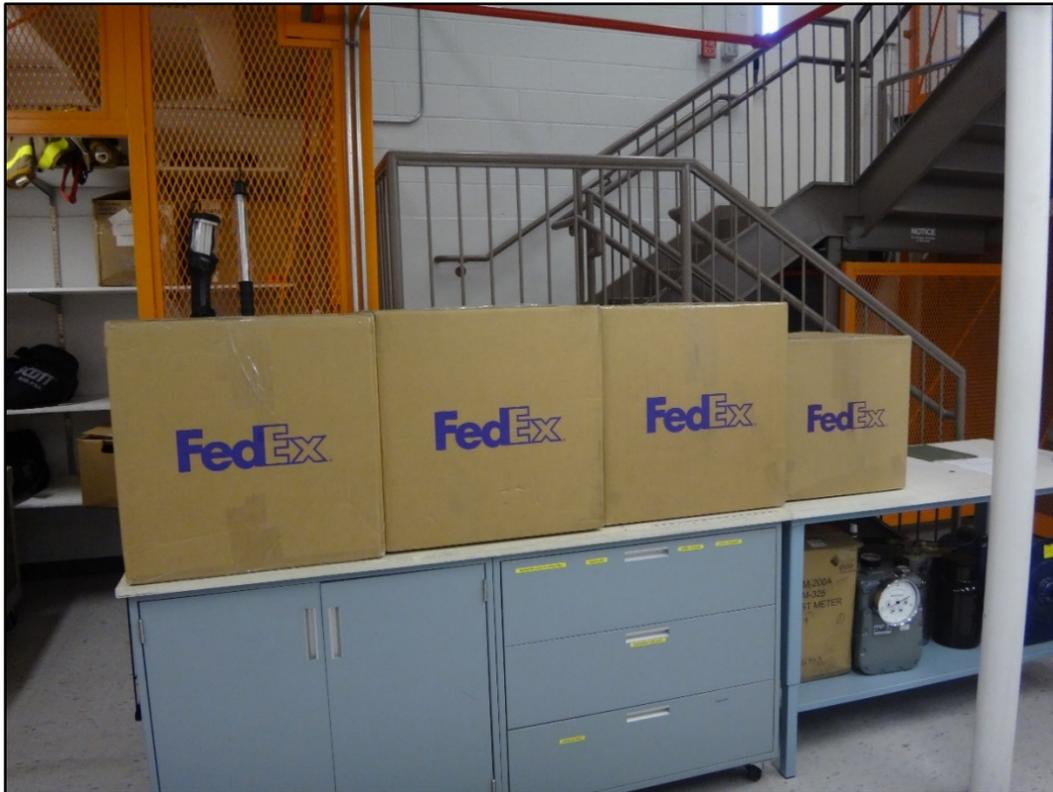
Figure 1: Cardboard box containing SCBA

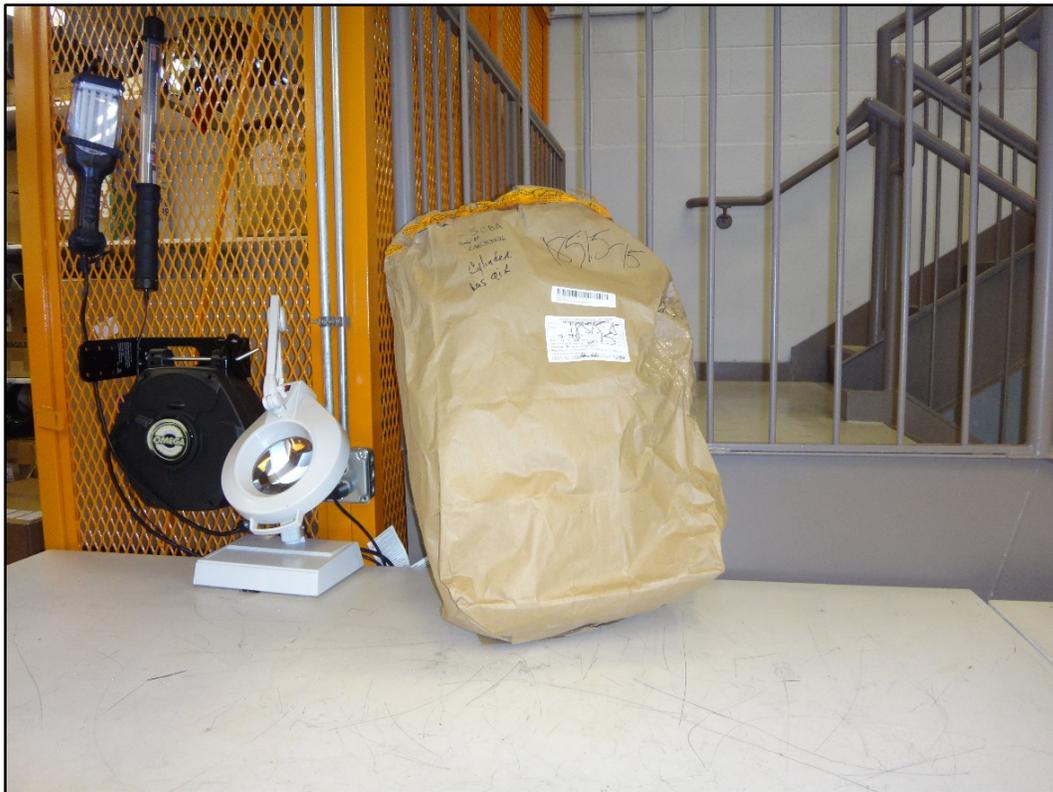
Figure 2: SCBA unit as received

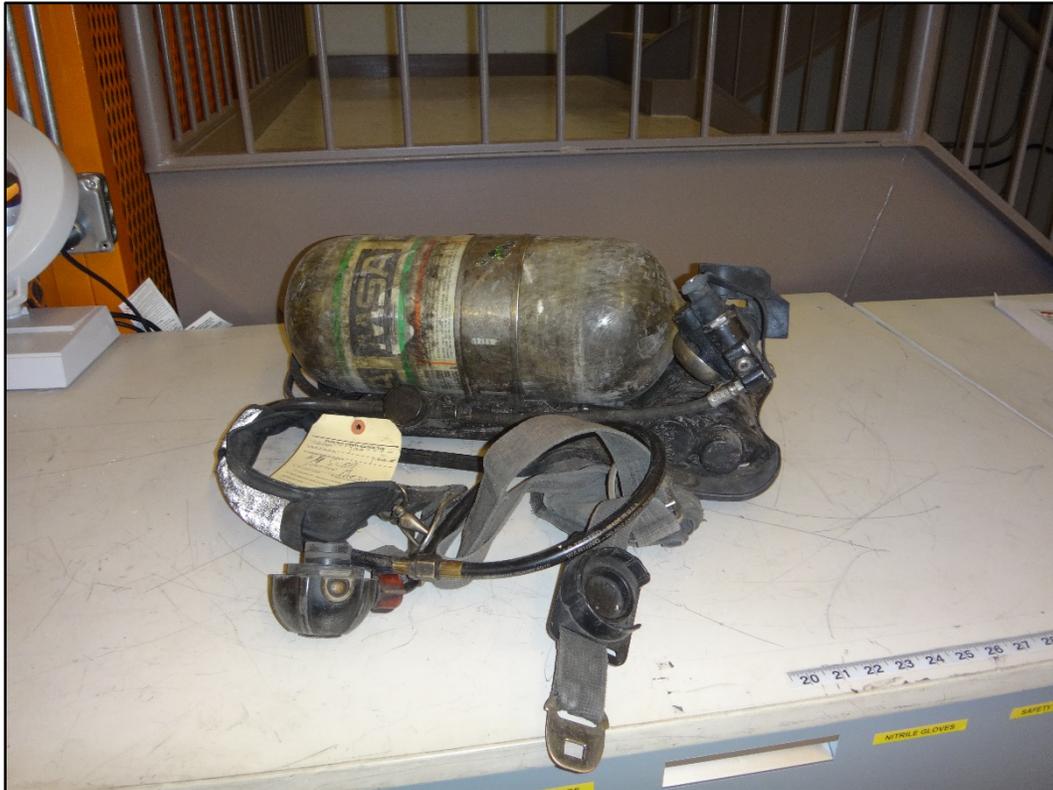
Figure 4: Unit out of paper, as received

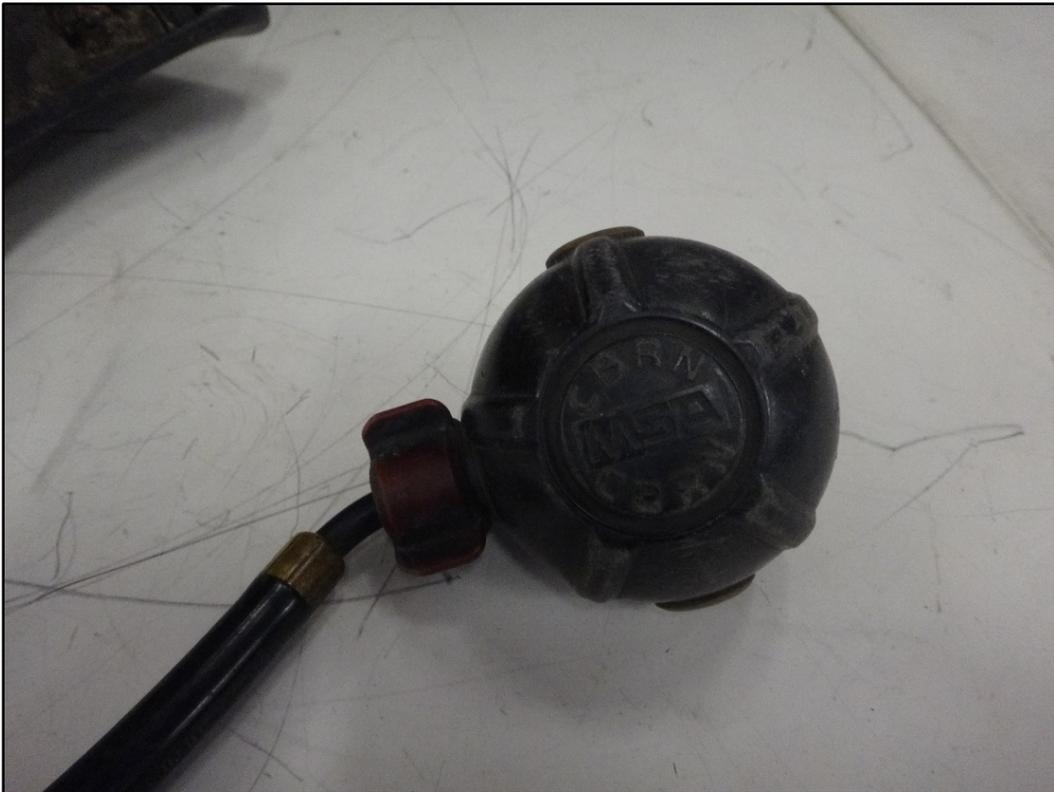
Figure 5: Mask mounted regulator (MMR)

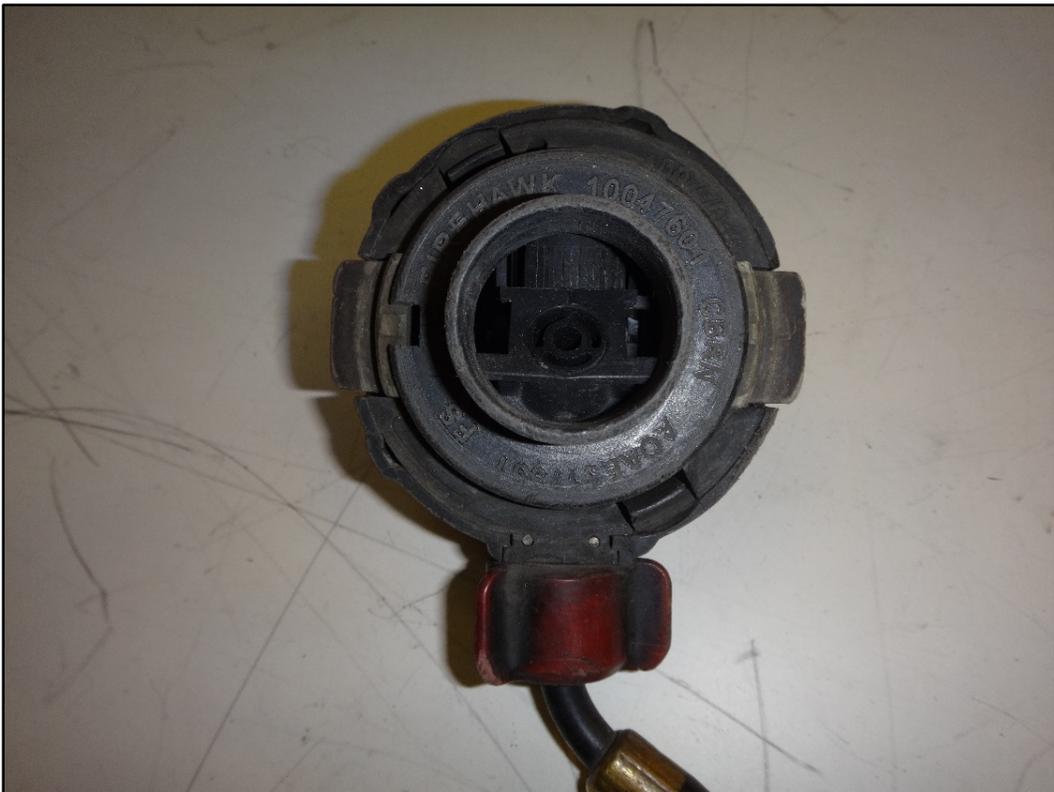
Figure 6: Inside flange, MMR

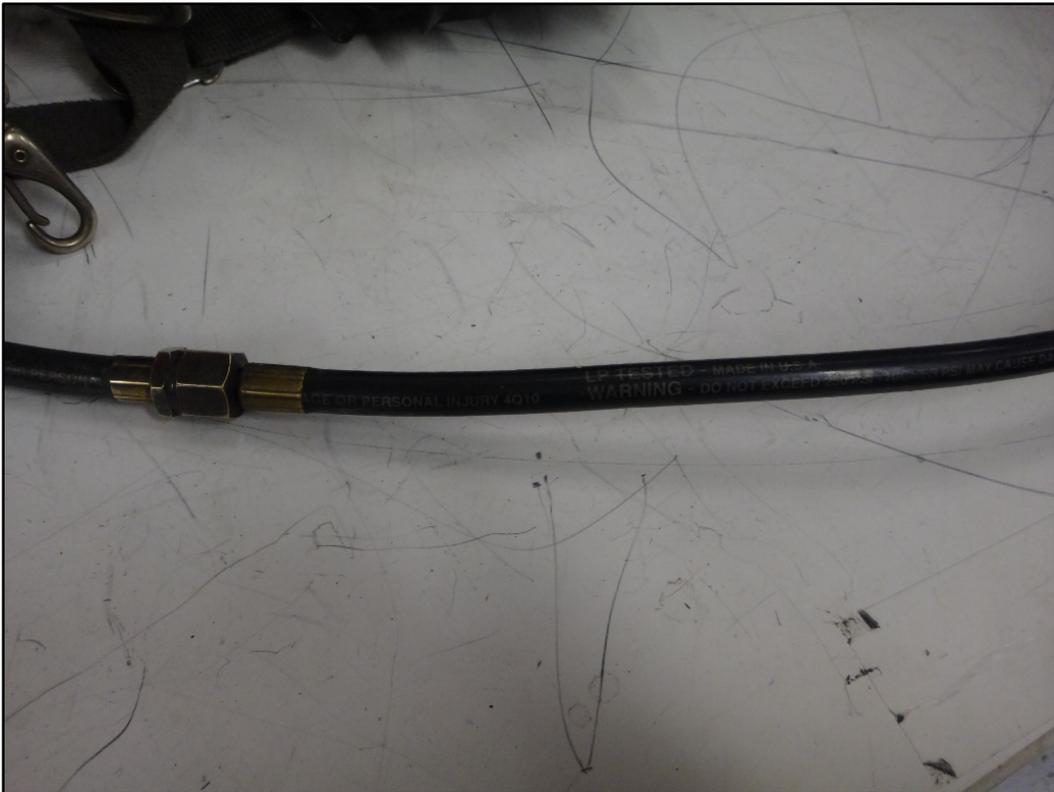
Figure 7: Low-pressure connection

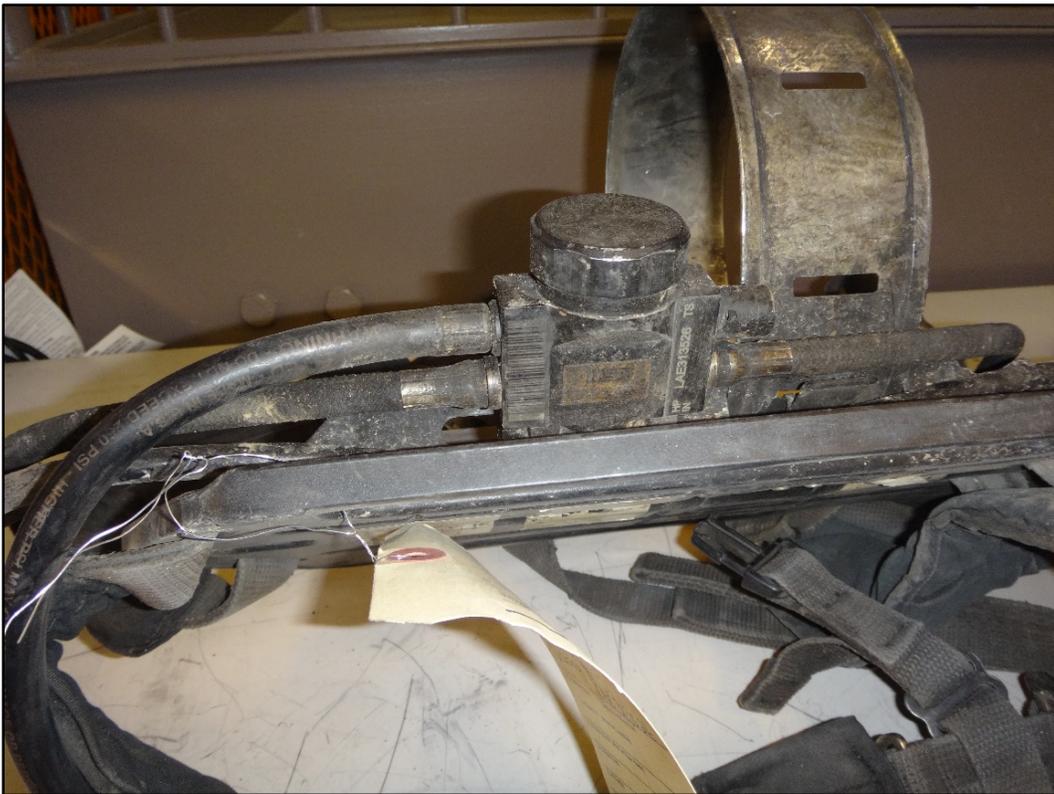
Figure 8: Pressure reducer assembly

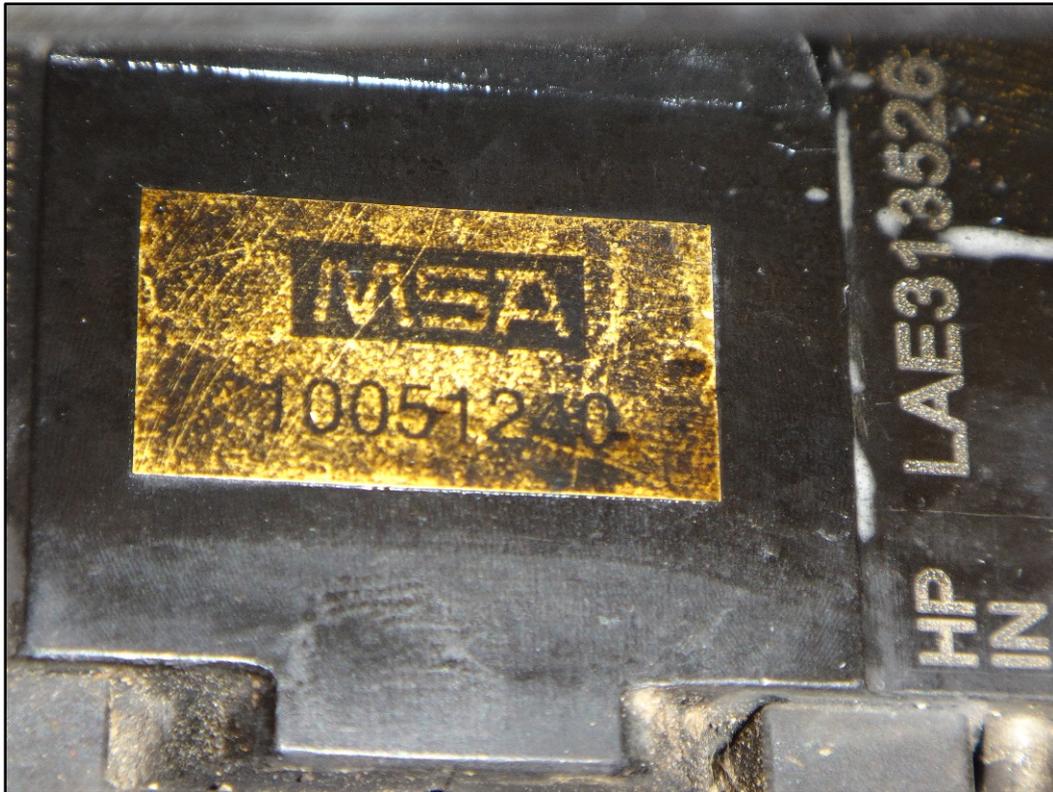
Figure 9: MSA label on reducer

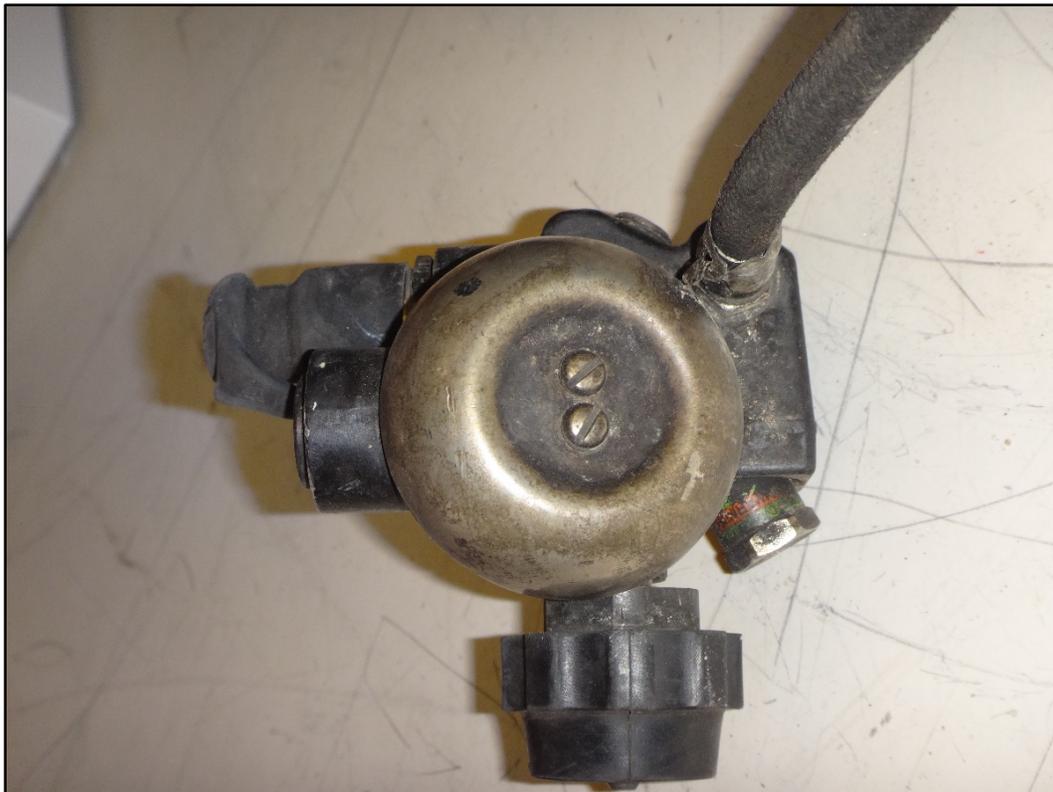
Figure 10: Cylinder attachment overview and relief valve with bell assembly

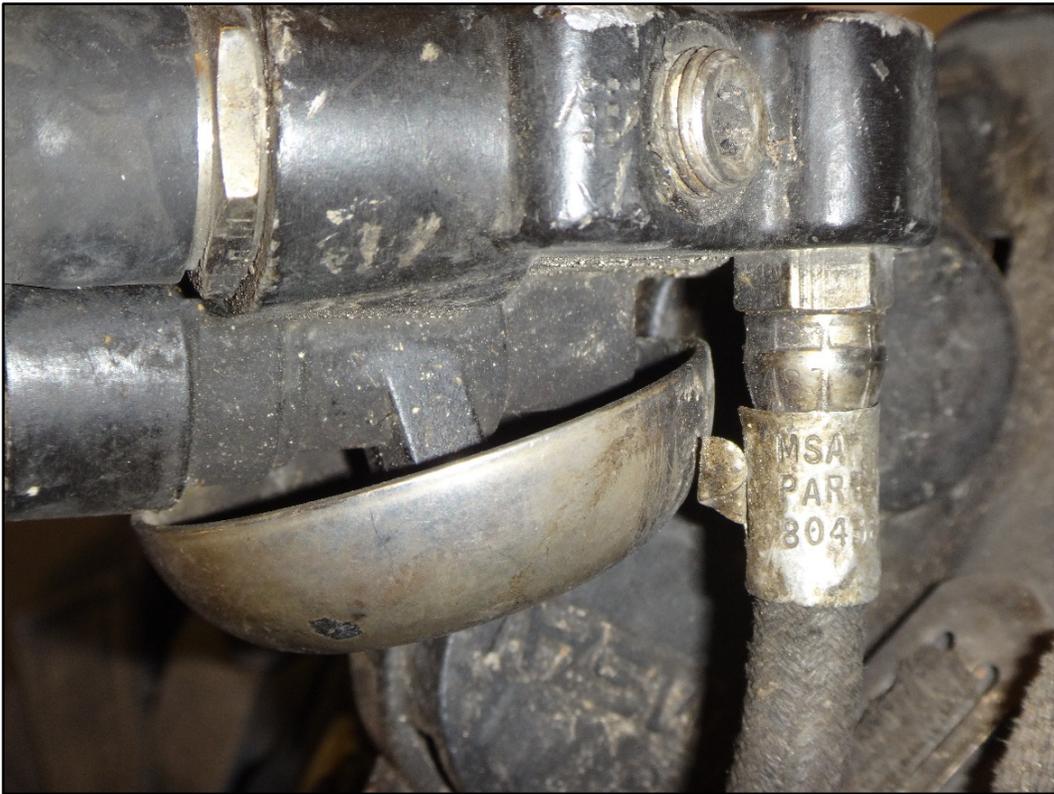
Figure 11: MSA part number

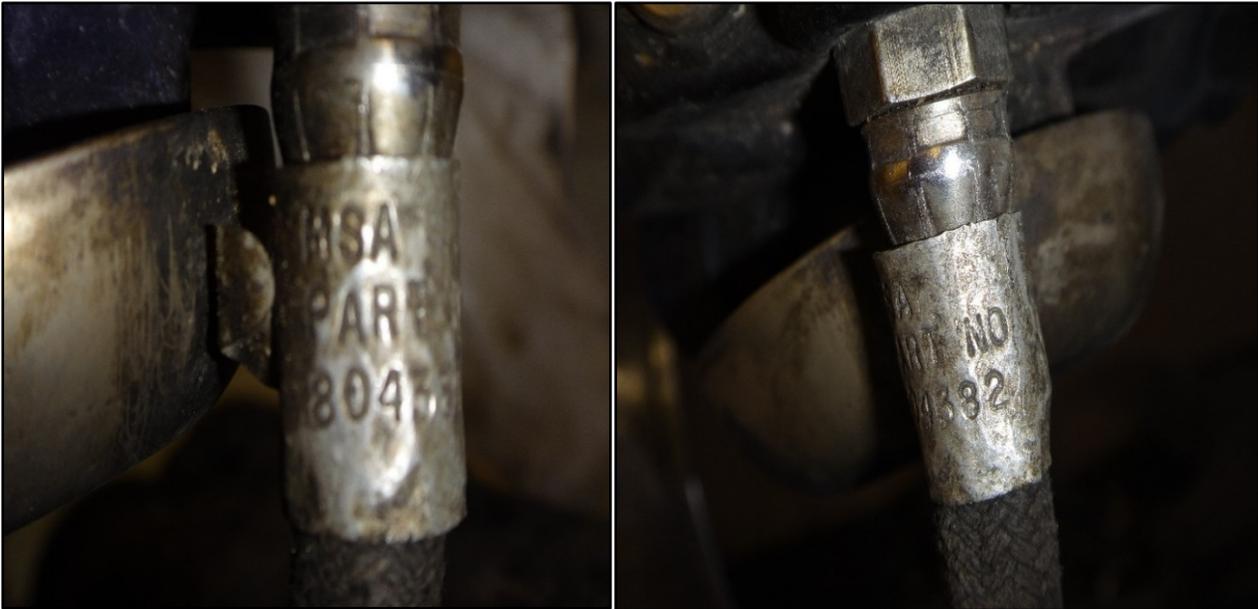
Figure 12: MSA part numbers

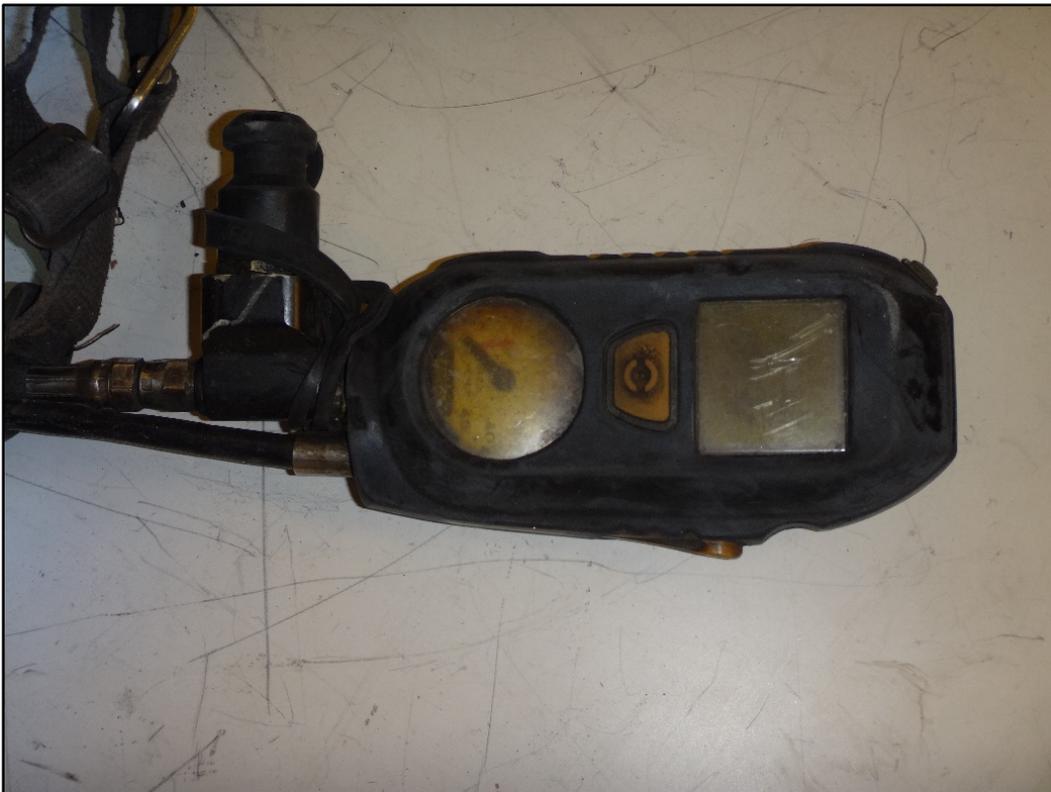
Figure 14: PASS console

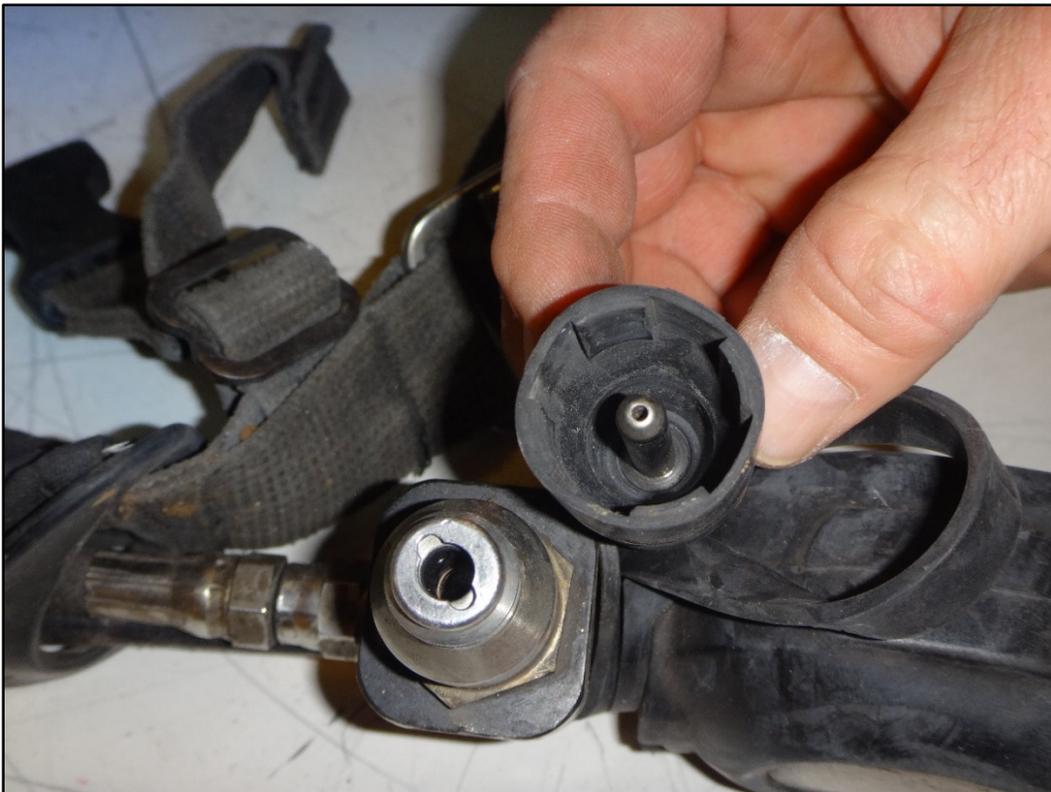
Figure 16: Additional Quick-Fill port on console

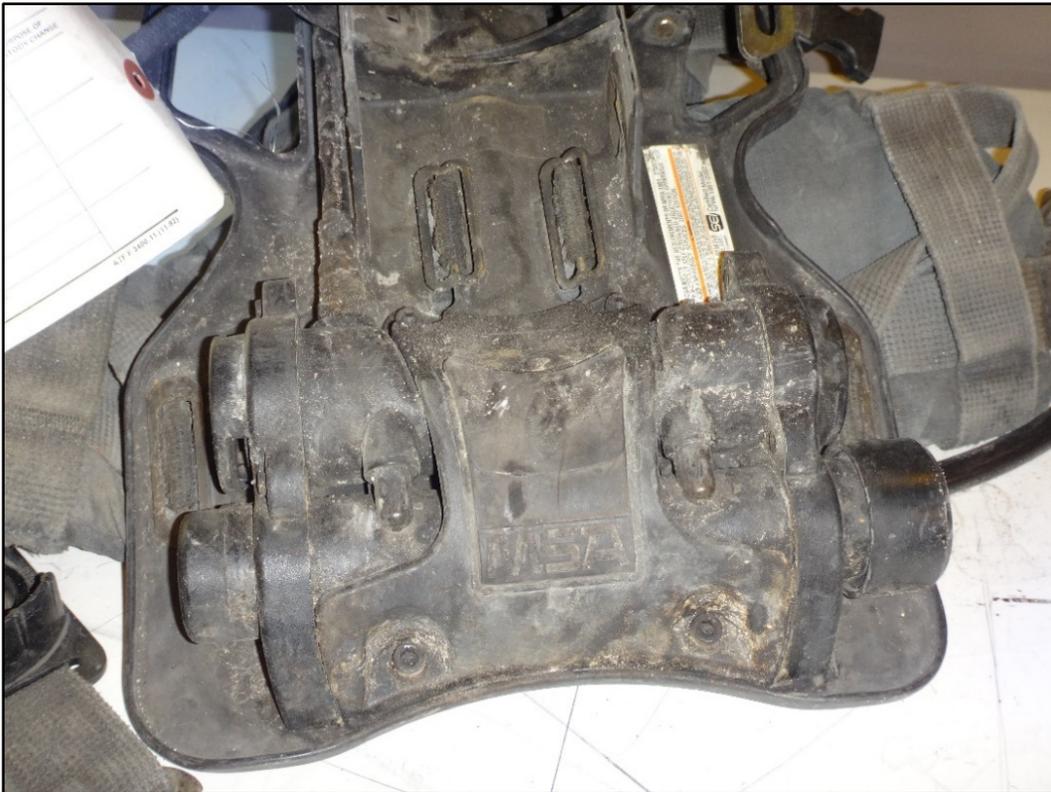
Figure 17: PASS control module

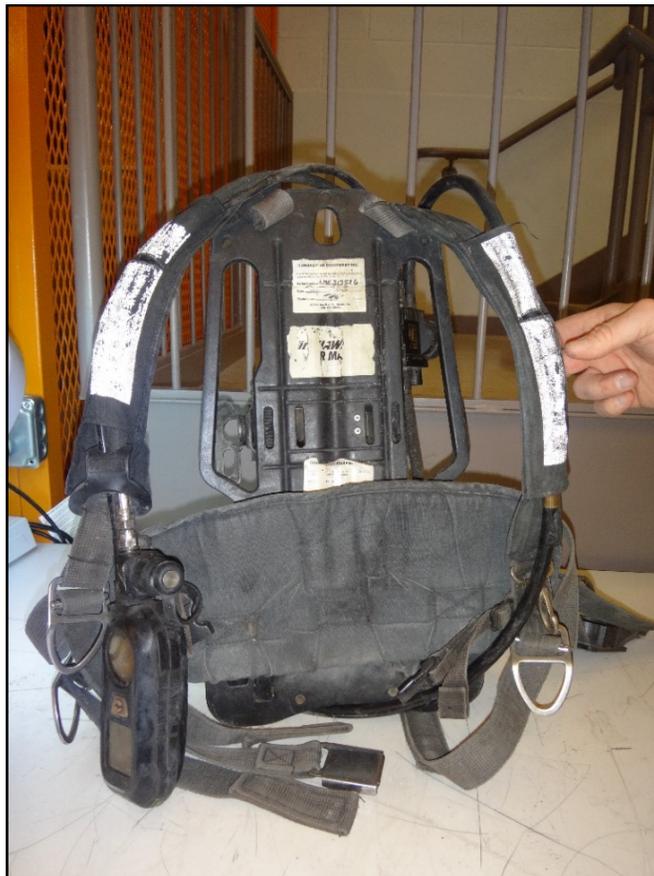
Figure 18: Overview of pack

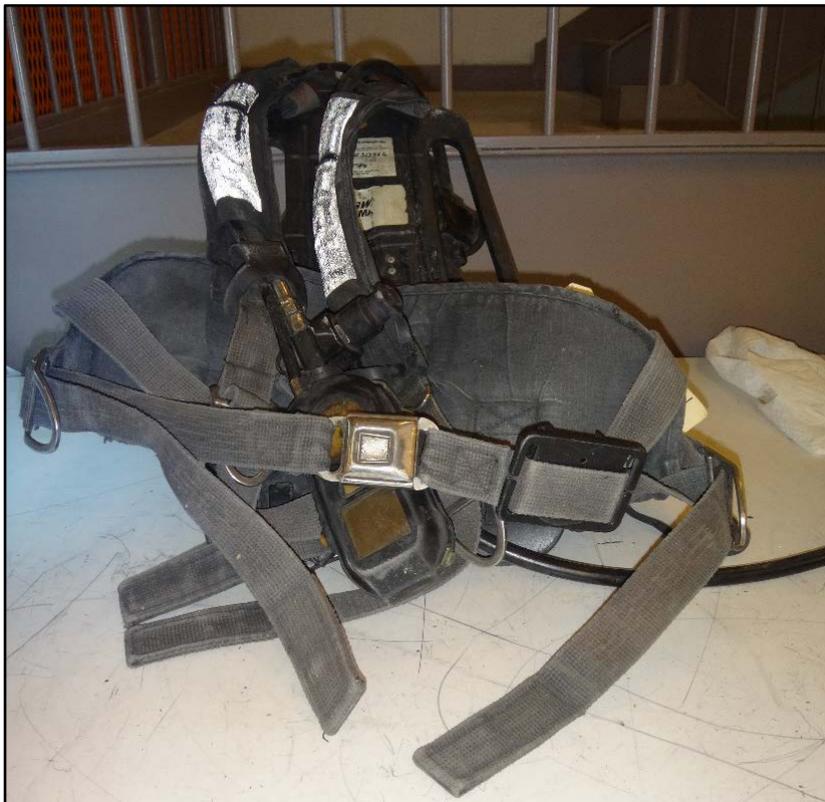
Figure 22: Overview of buckles and straps

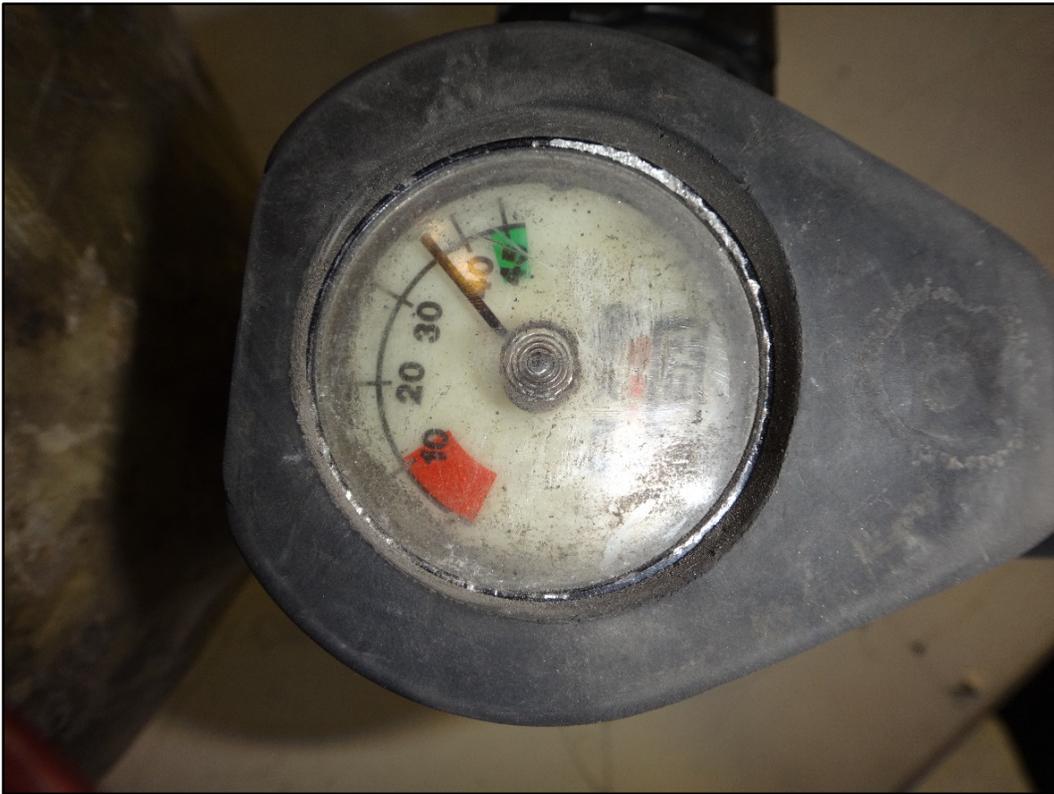
Figure 23: Gauge on cylinder connection

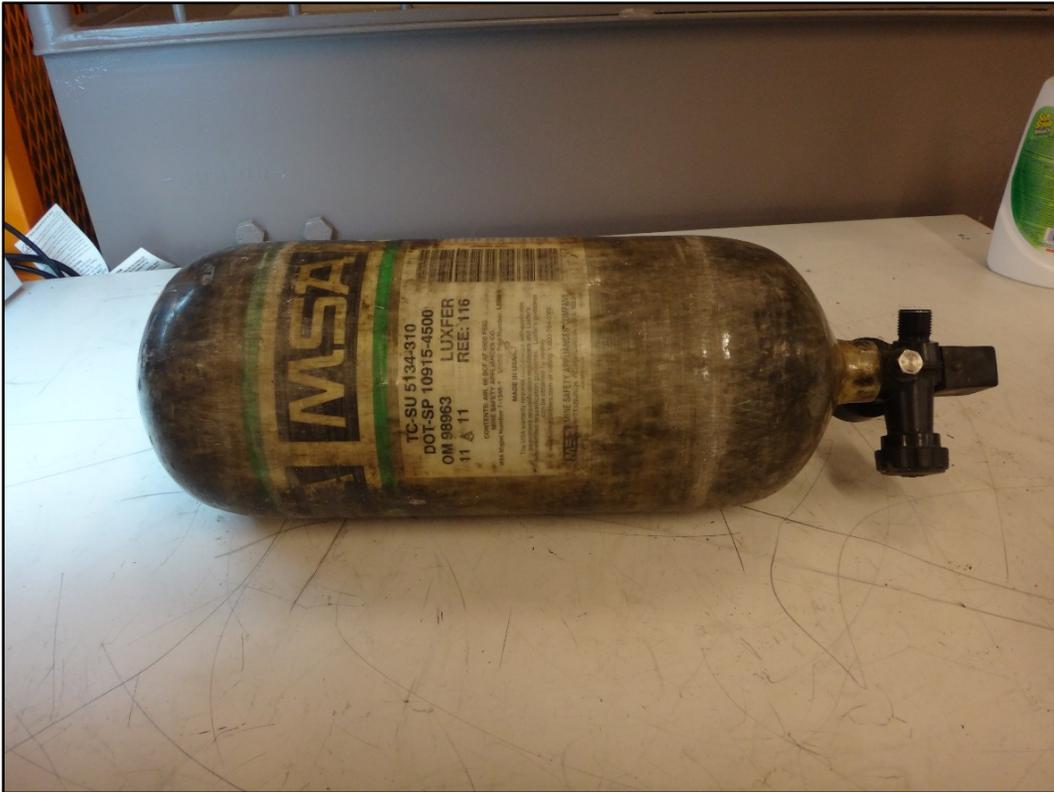
Figure 24: Overview of cylinder

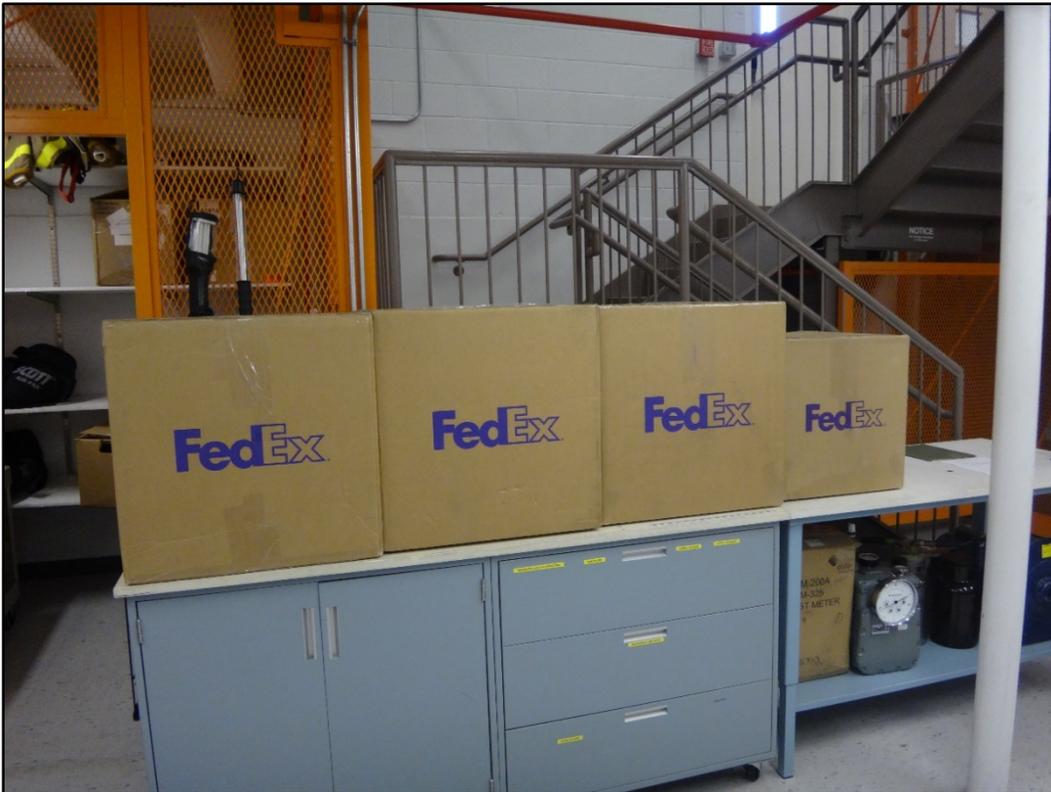
Figure 1: Cardboard box containing SCBA

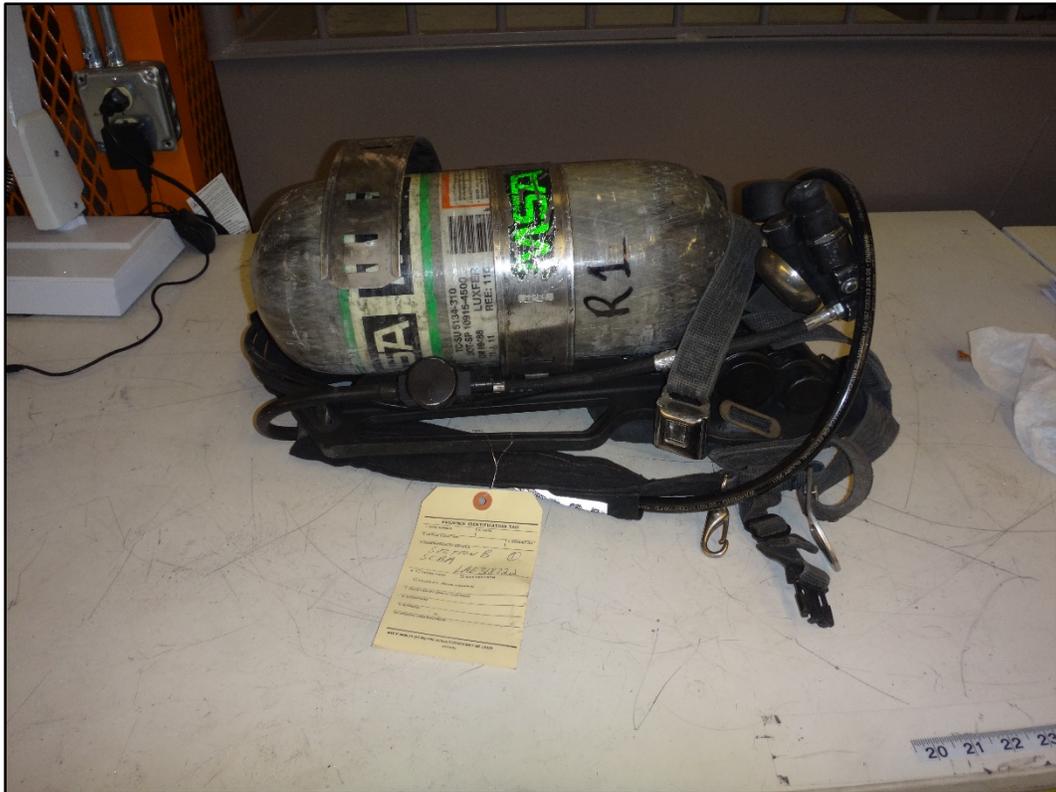
Figure 3: Unit out of paper, as received

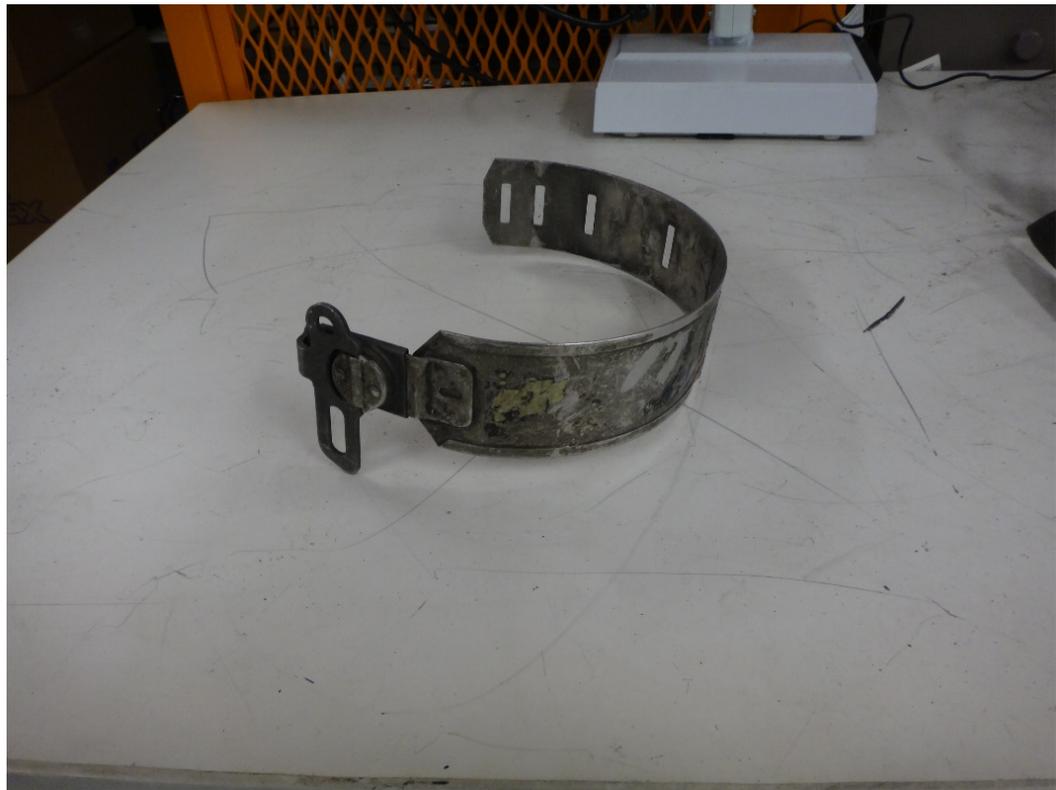
Figure 4: Extra cylinder strap included

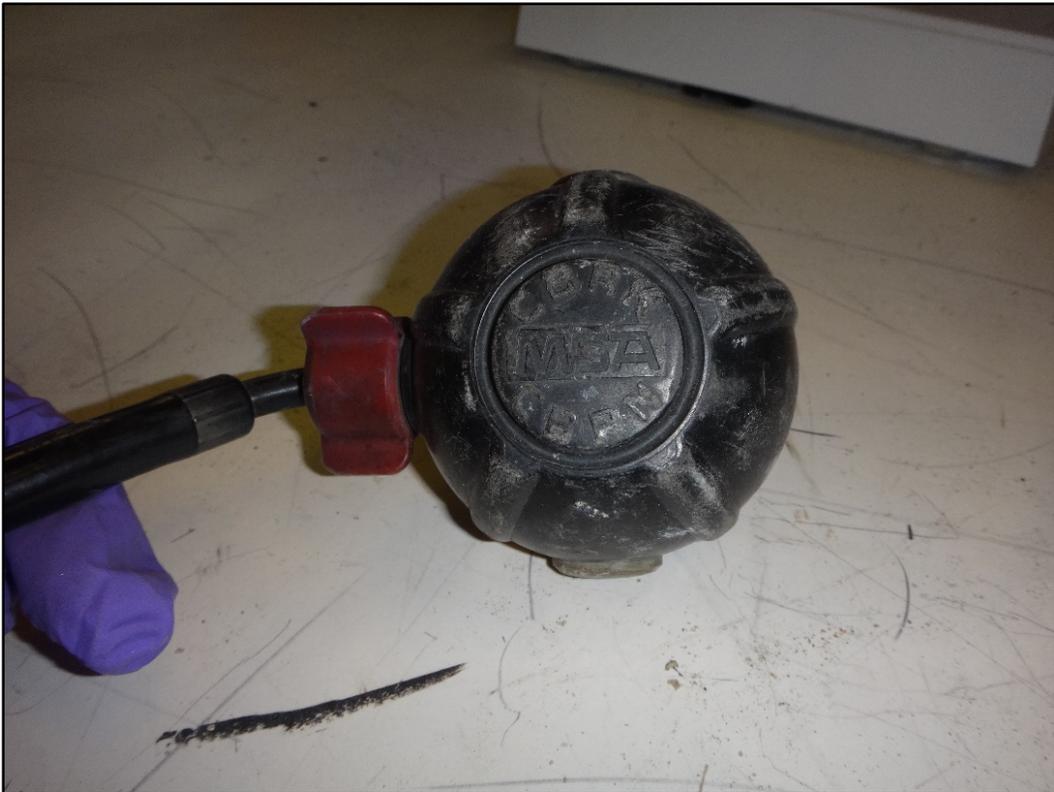
Figure 5: Mask mounted regulator (MMR)

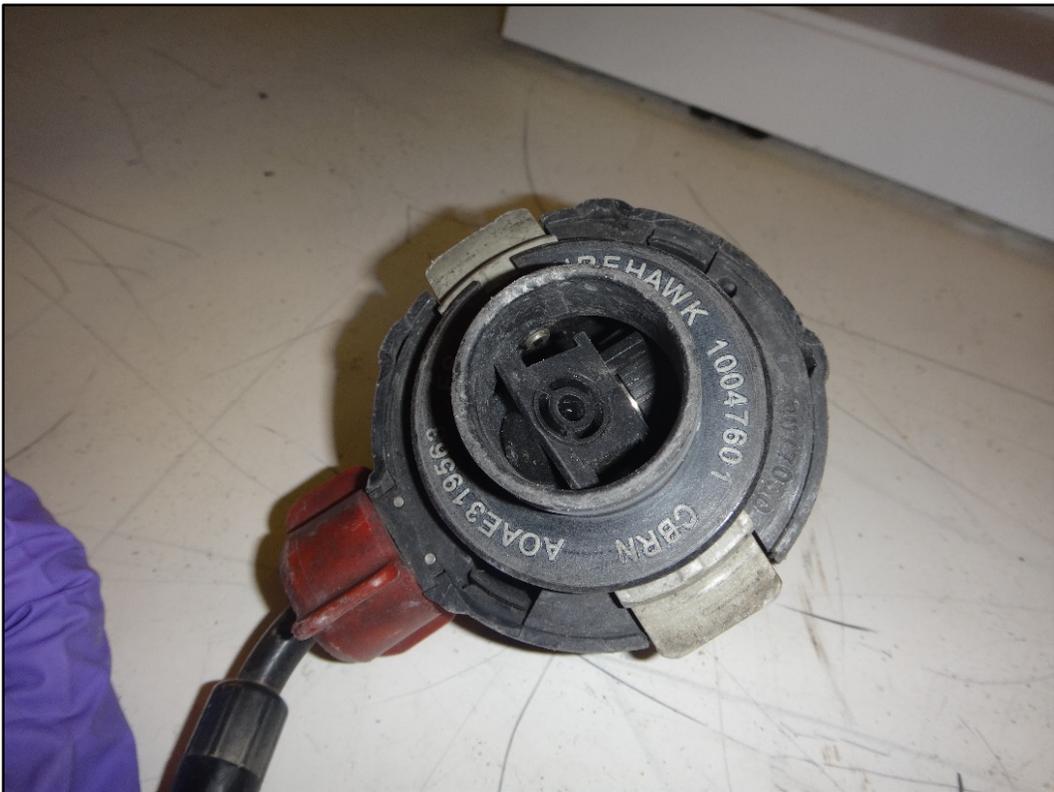
Figure 6: Inside flange, MMR

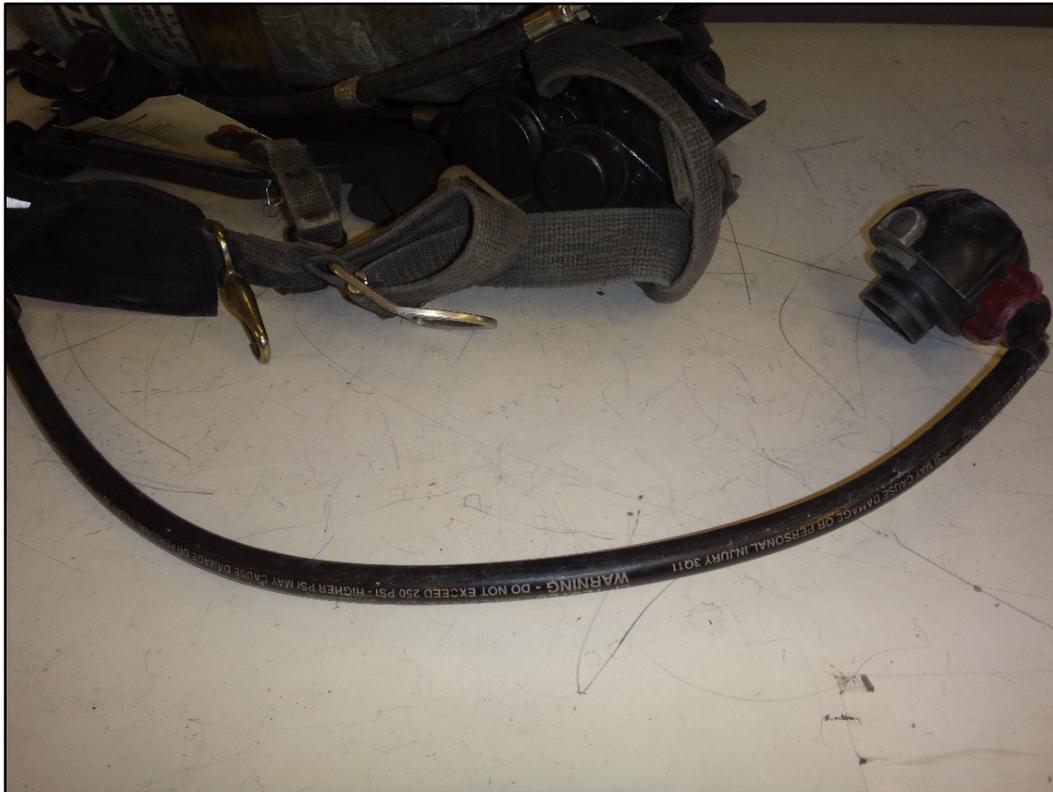
Figure 7: Low-pressure line
