Evaluation of Five Self-Contained Breathing Apparatus for Potential Contribution to a Fatal Event in the Fire Service

Kansas City, Missouri Fire Department Request for MSA Firehawk® M7 model, 4500 psi units with NIOSH Approval Numbers TC-13F-550CBRN and TC-13F-549CBRN (July 27, 2016)

NIOSH Task Number 20619

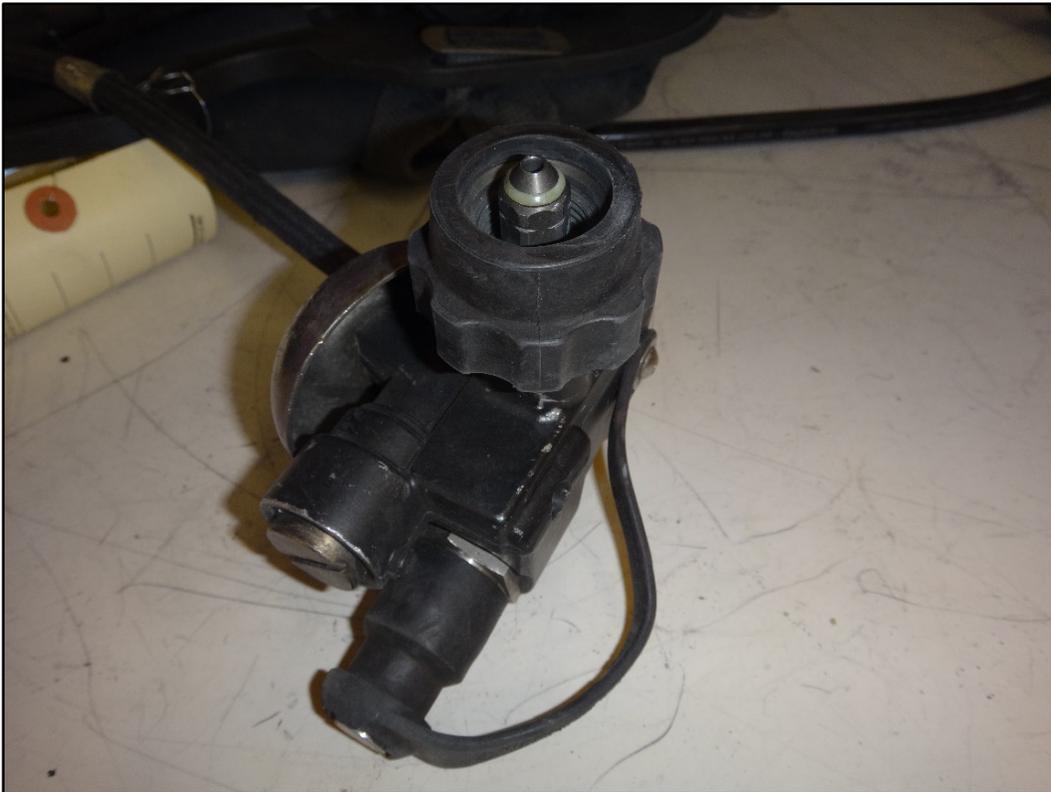
Figure 9: Cylinder attachment overview and relief valve with bell assembly

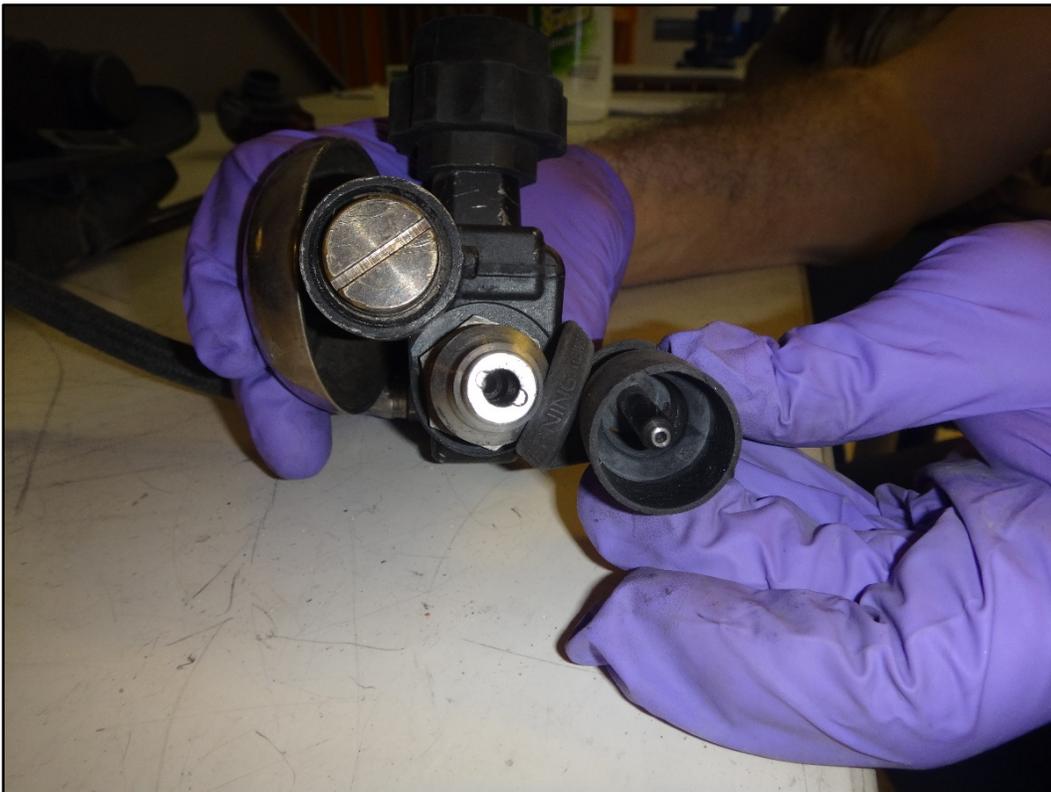
Figure 10: Quick-Fill port on cylinder attachment overview

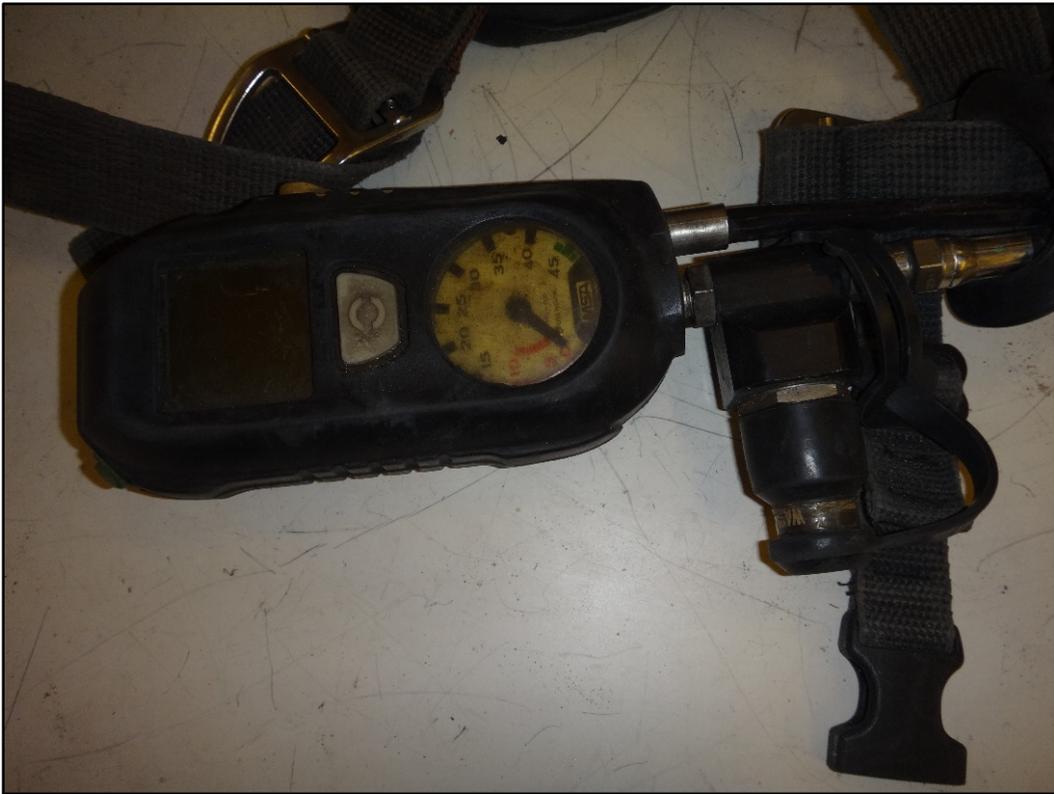
Figure 11: PASS console

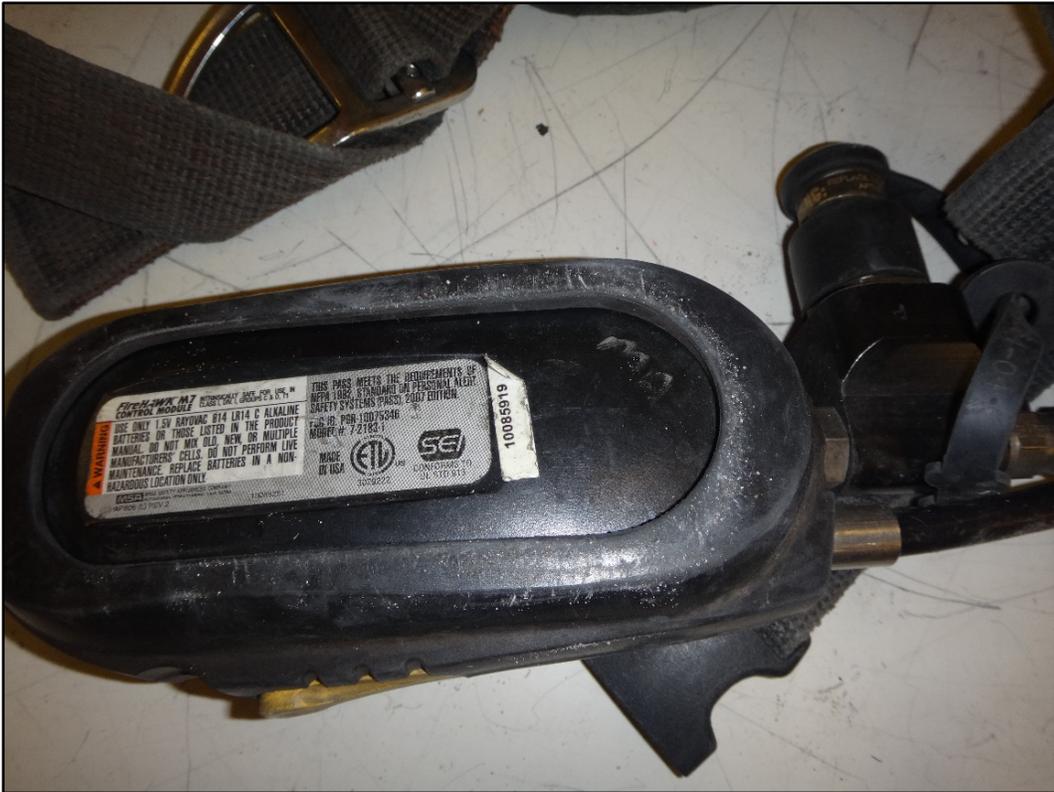
Figure 12: Back of PASS console

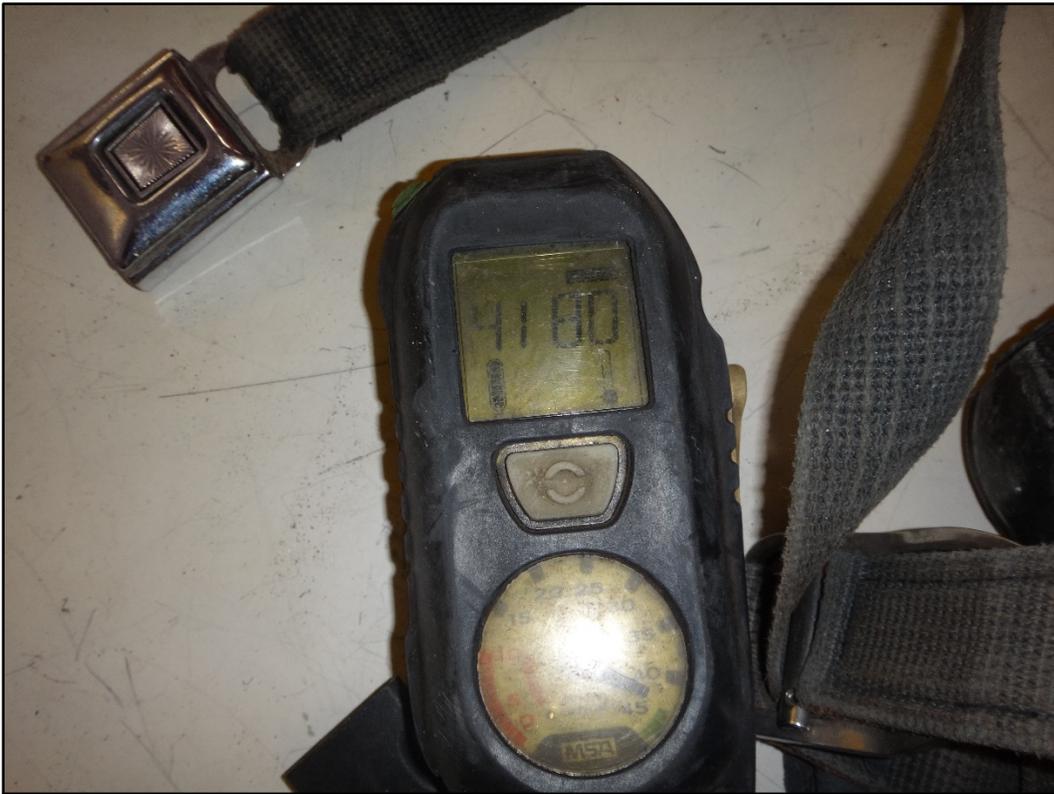
Figure 13: Active PASS console

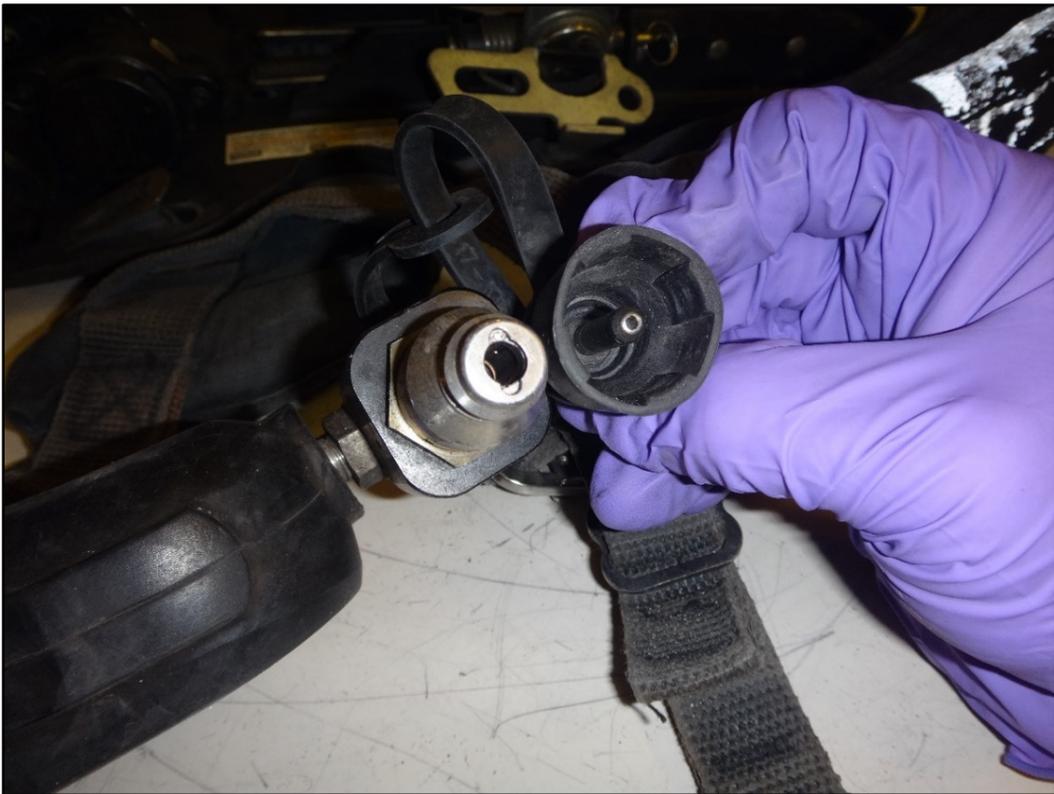
Figure 14: Additional Quick-Fill port on console

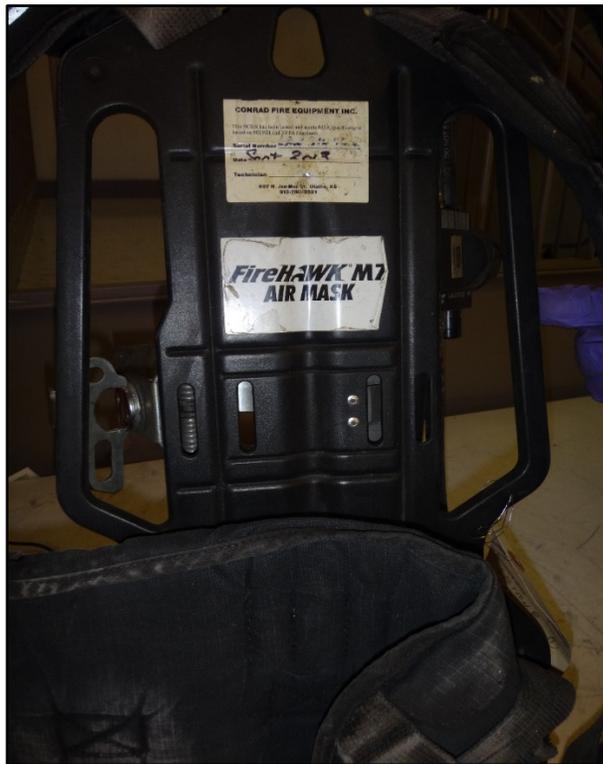
Figure 17: NIOSH label inside of pack

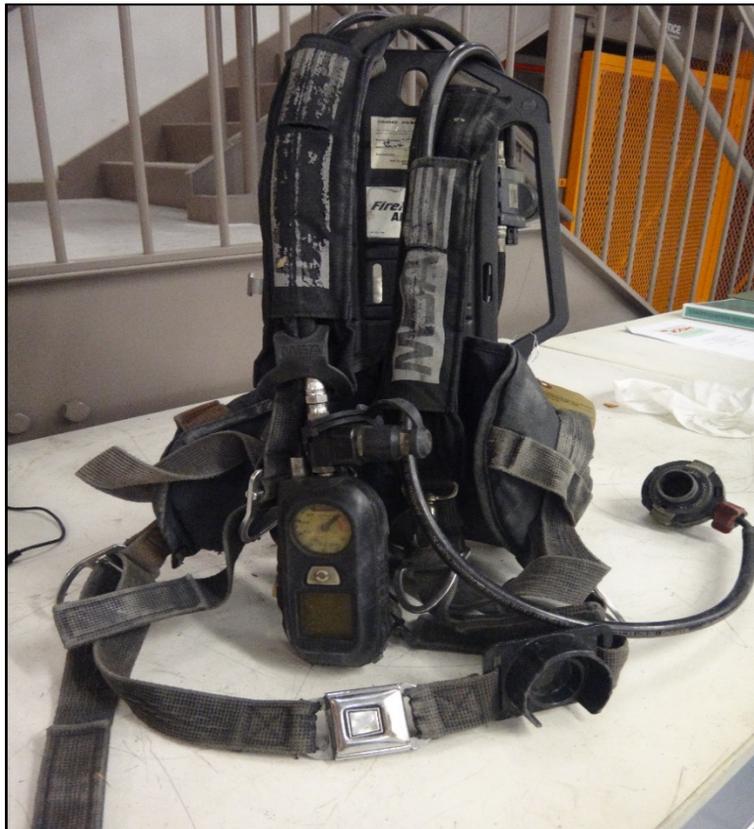
Figure 18: Overview of buckles and straps

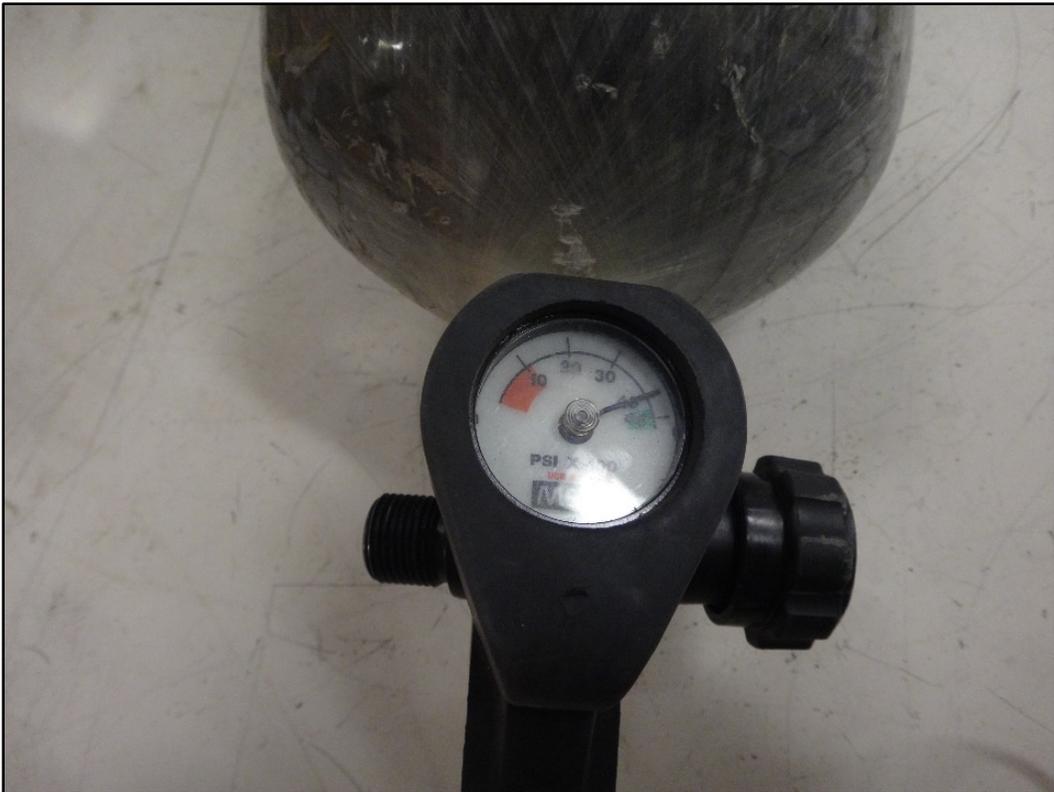
Figure 19: Gauge on cylinder connection

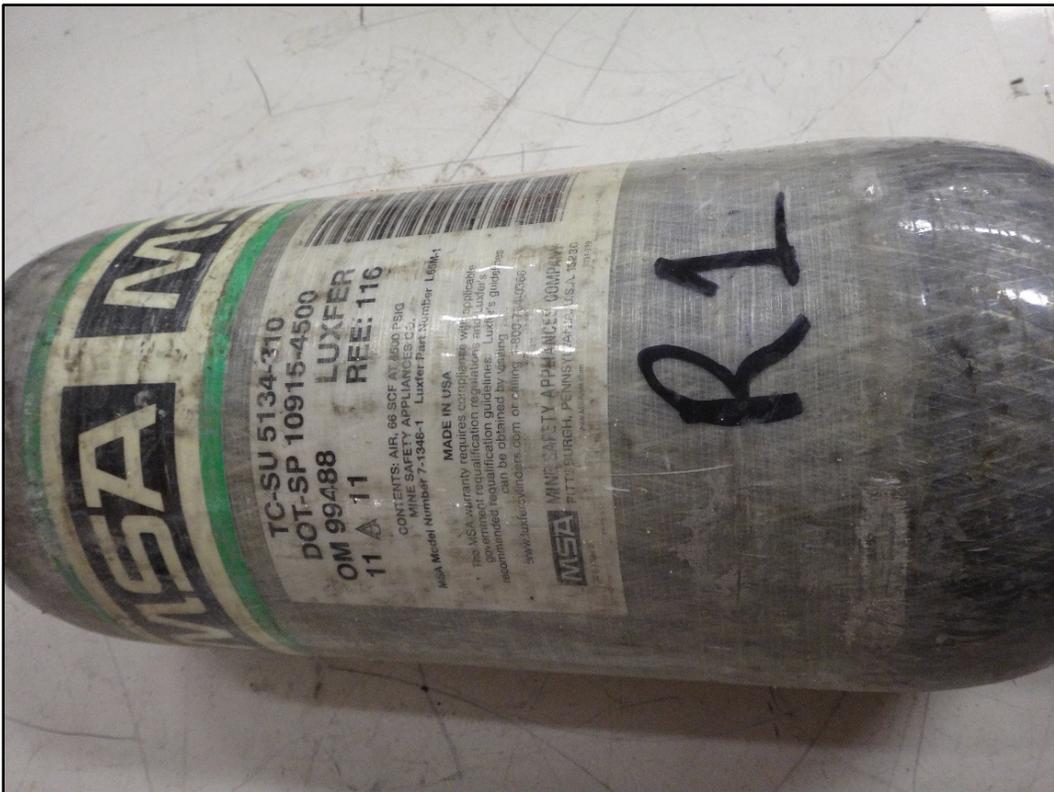
Figure 20: Overview of cylinder

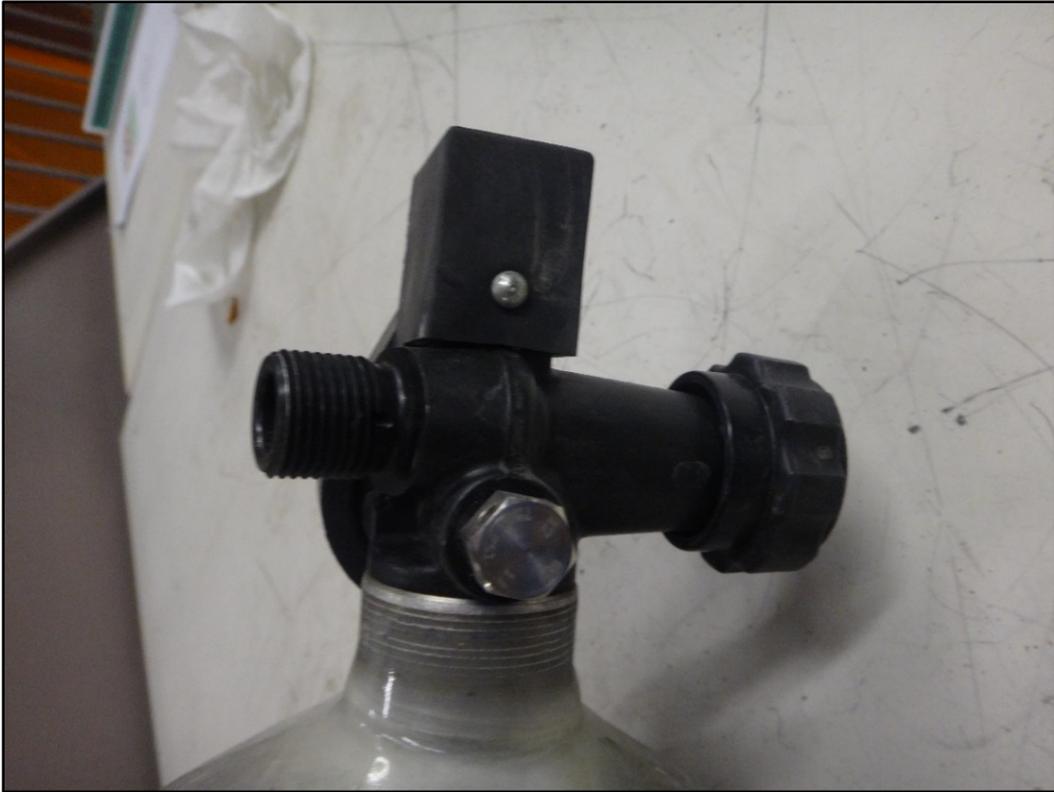
Figure 21: Threads on cylinder attachment

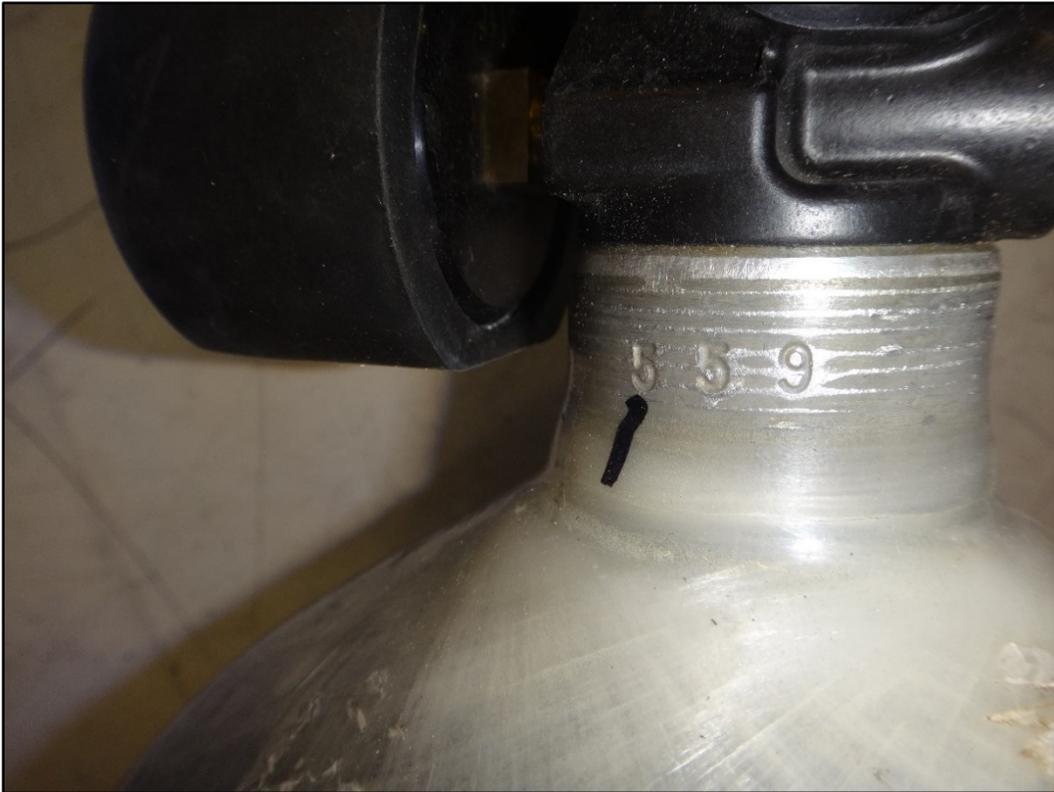
Figure 22: Cylinder identifier

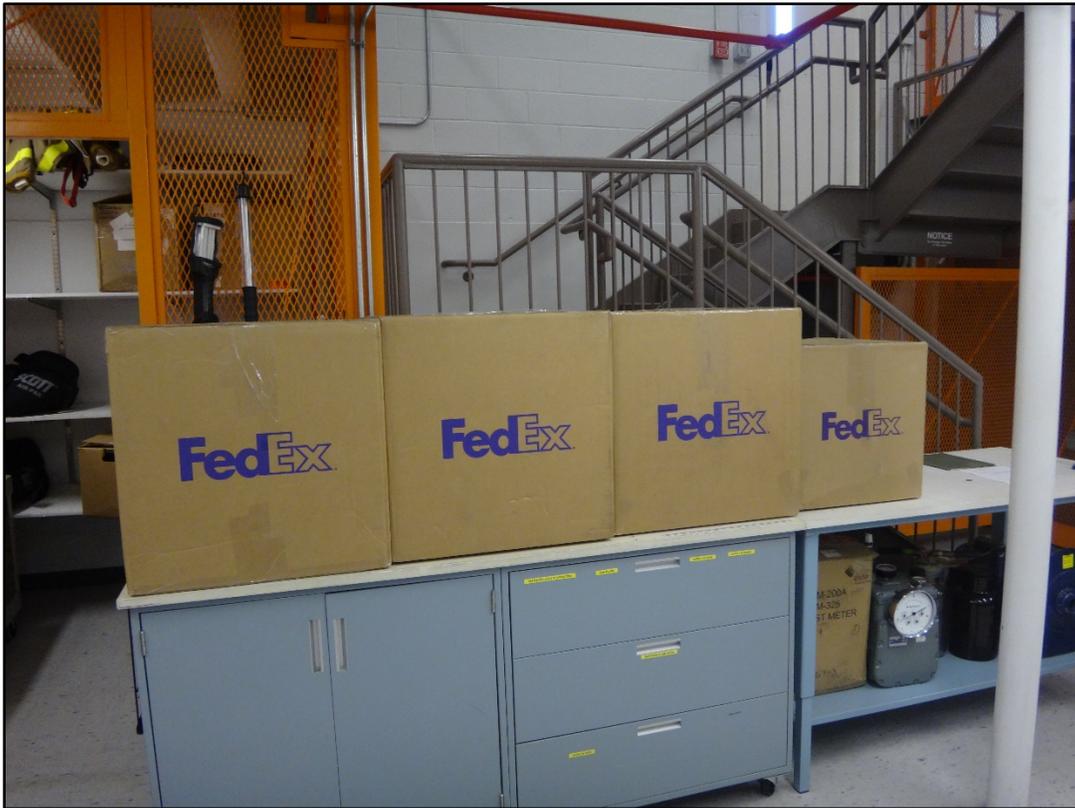
Figure 1: Cardboard box containing SCBA

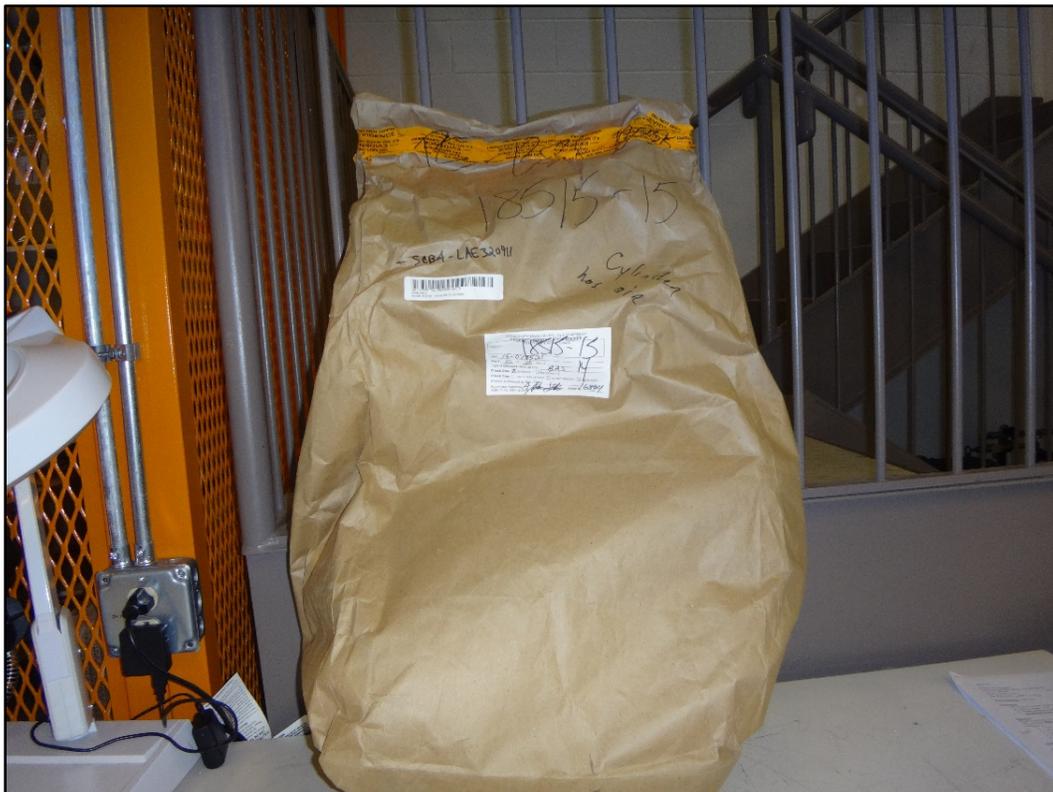
Figure 2: SCBA unit as received

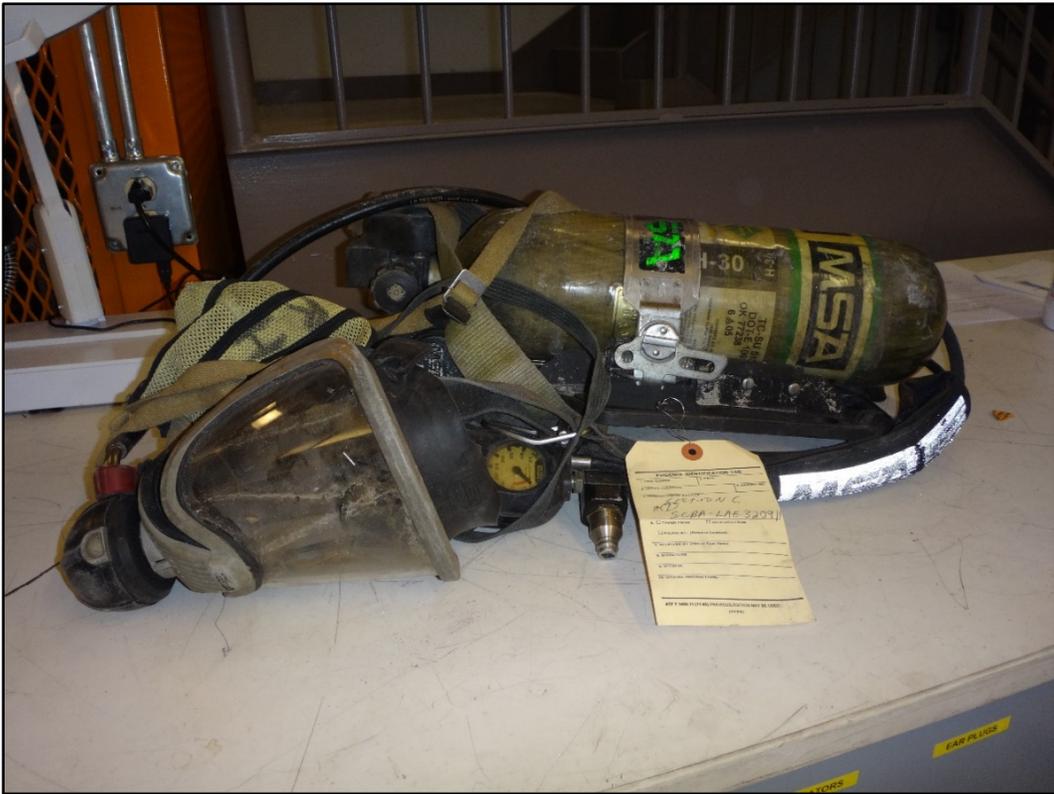
Figure 3: Unit out of paper, as received

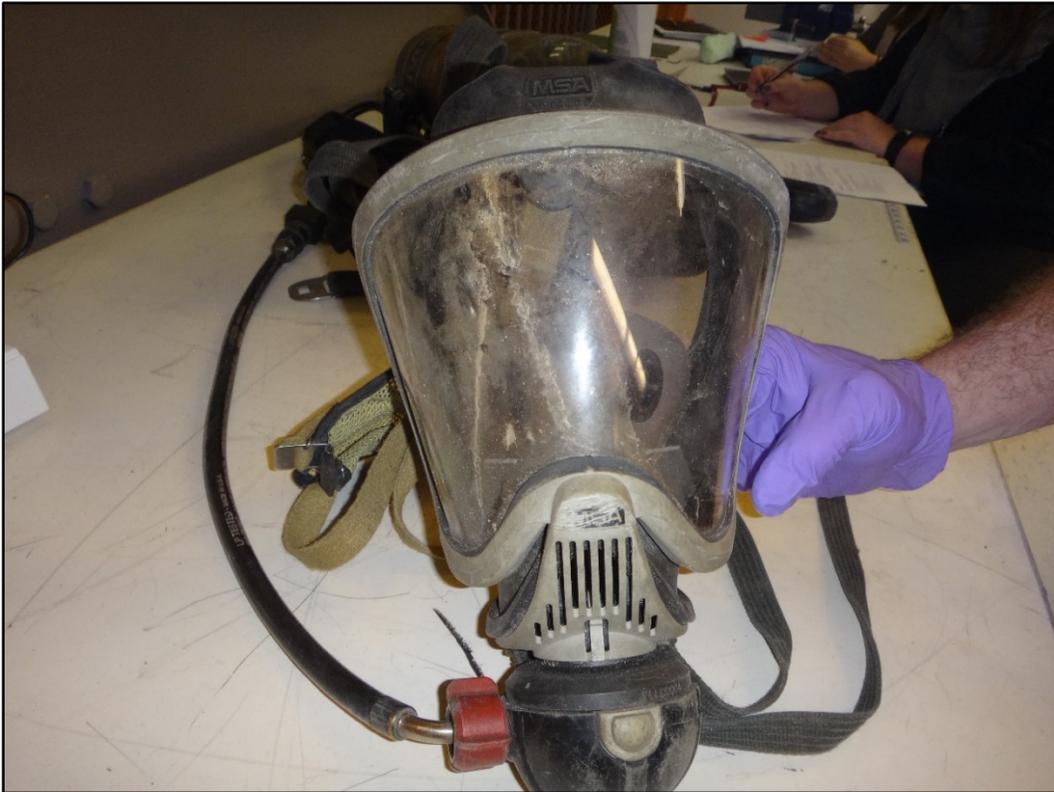
Figure 4: Overview of facepiece

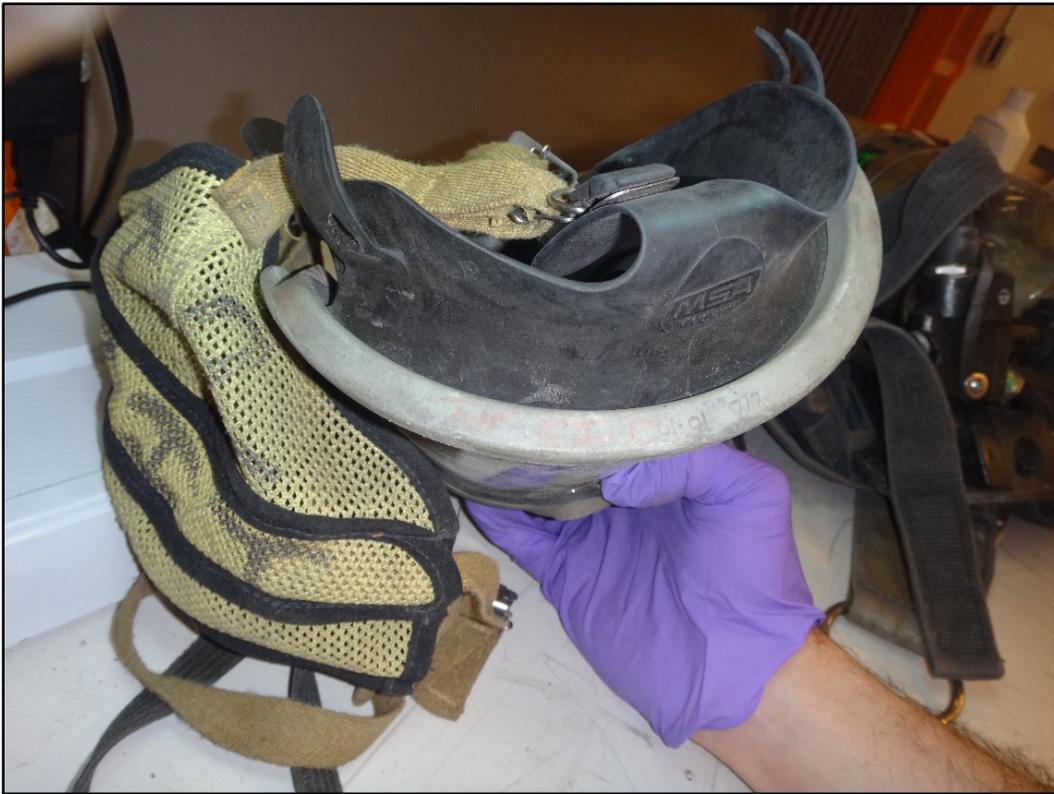
Figure 7: Red markings “the Kid”

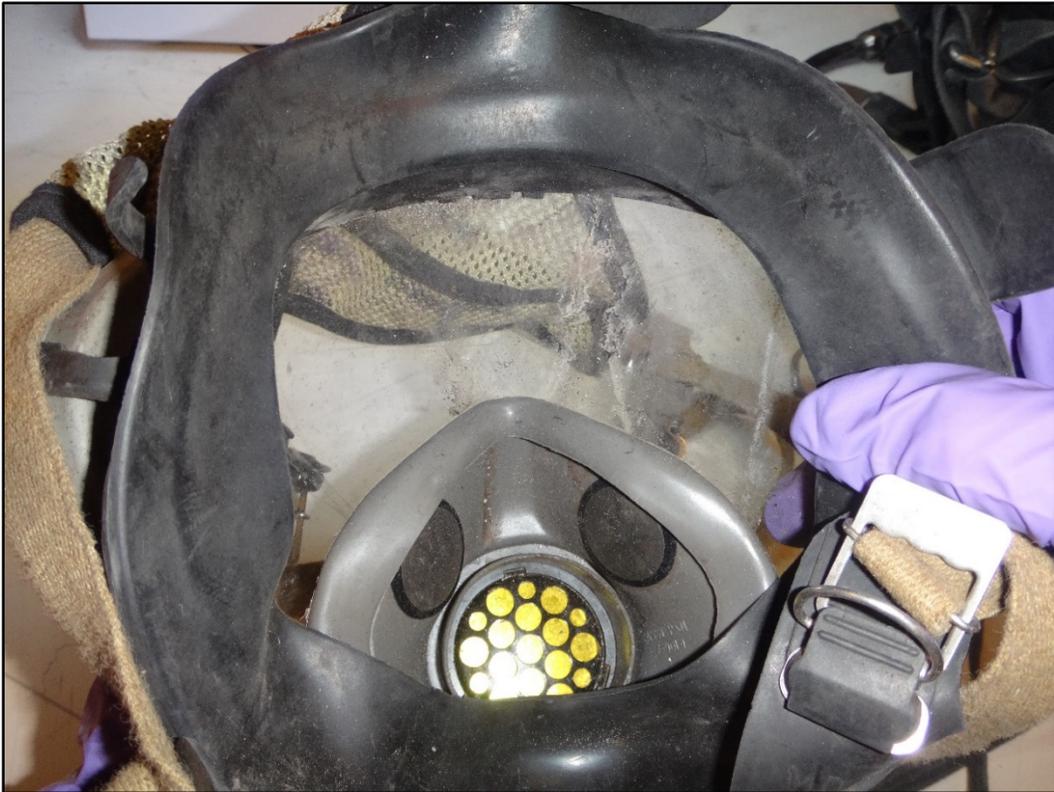
Figure 8: Inside view of facepiece, no HUD

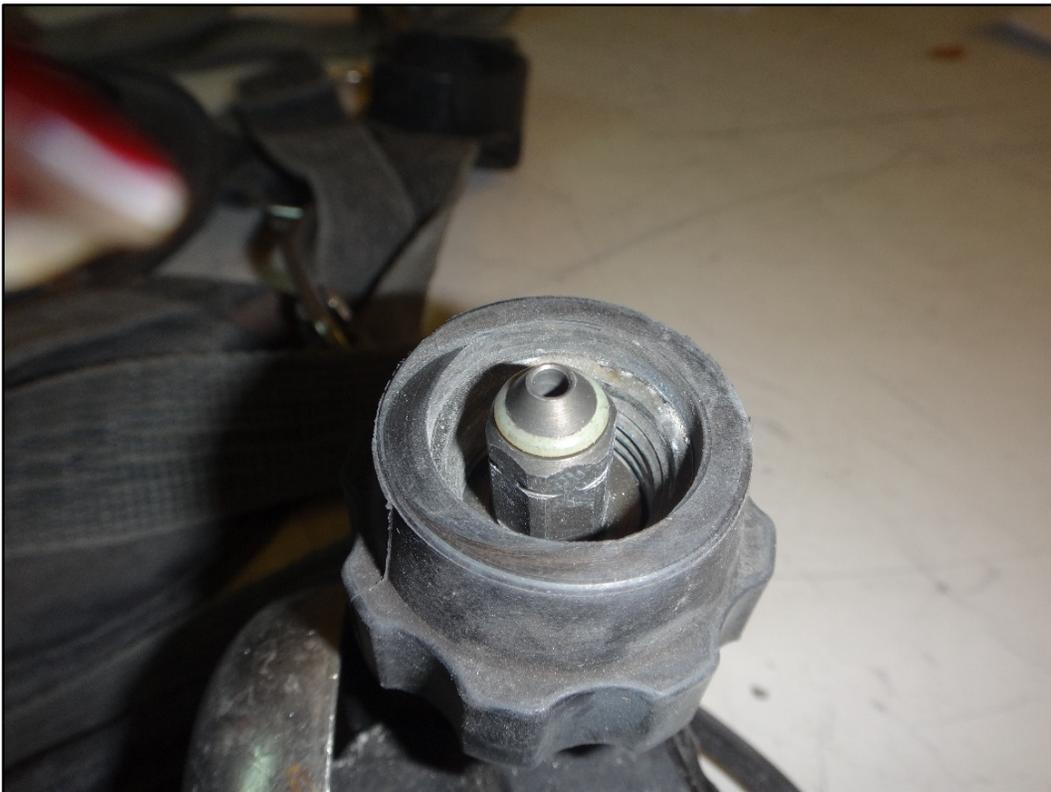
Figure 18: Cylinder attachment overview with O-ring present
